ROAD SAFETY AUDIT

Route 28 between Bourne Rotary and Otis Rotary

Town of Bourne

April 2013

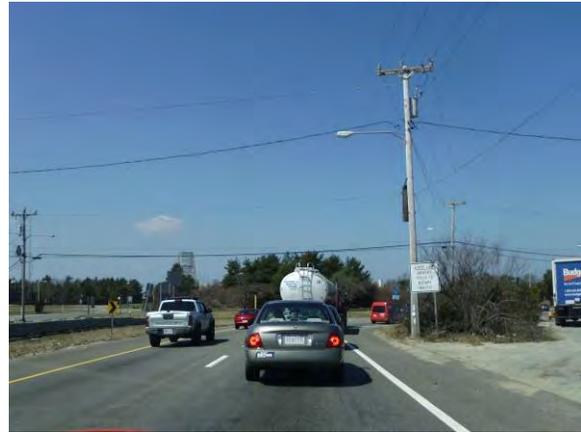
The RSA team noted that there is very little advance guide signage indicating the street names route numbers, and/or destinations of the available exits from the rotary. The only guide signage for exits to the rotary are within the rotary itself. This can create confusion, especially among drivers that are unfamiliar with the rotary, since motorists may not know when their exit is approaching until they read a sign located at the exit itself. There is no existing signage that indicates which lane a vehicle should be in if it is exiting the rotary or continuing to circulate. This lack of direction can cause angle crashes between vehicles exiting the rotary from the inside lane and vehicles remaining in the rotary in the outside lane. Twenty-nine crashes occurred between vehicles exiting the rotary onto Route 28 southbound from the inside lane and vehicles continuing around the rotary in the outside lane. Three similar crashes involved vehicles exiting to Sandwich Road, and one similar crash occurred involving a vehicle attempting to exit to Route 28 northbound occurred.

There is no advanced guide signage indicating the possible exits from the rotary.

2. Remove the guide signage from the center island of the rotary.
3. Remove guide signage that is too small for circulating traffic to read. Replace with MUTCD-compliant signage if the signage is deemed necessary. Ensure that all guide signage visible from the rotary or the approaches to the rotary is useful and necessary.

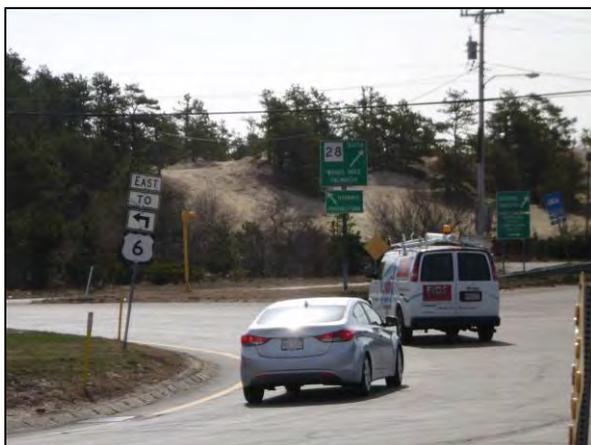
Guide signage for Route 6 eastbound is misleading and poorly placed. Some signage is too small to read.

Team members also noted that some of the existing guide signage is too small to read, and that some motorists slow down unexpectedly to read guide signage.

A second sign, located across from the Trowbridge Road eastbound entrance to the rotary, indicates vehicles should turn left for Route 6 eastbound. This sign is misleading; while continuing to circle the rotary will eventually allow for access to Route 6 eastbound, the sign implies that the turn is imminent, and entering Route 6 eastbound will require a traditional left turn, where in reality, motorists bear right to exit the rotary onto Route 6. The sign is visible to motorists entering the rotary from Trowbridge Road; this may lead to motorists that are unfamiliar with the area turning left into the rotary. Signage placed on the center island of the rotary distracts motorists from signage along the outside of the rotary.

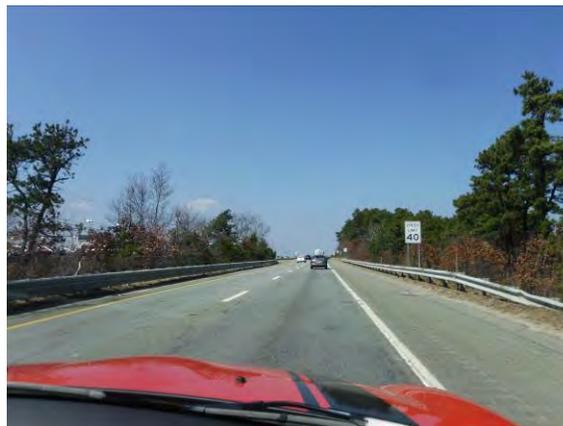
The speed limit on Route 28 northbound drops from 55 mph to 40 mph about 0.36 miles south of the rotary, and drops to 25 mph less than a quarter-mile later.

RSA team members noted that the posted speed limits along the Route 28 northbound approach to the rotary are very closely spaced. According to speed regulations provided by MassDOT, the speed limit changes from 55 mph to 40 mph approximately 0.36 miles south of the Bourne Rotary. After another 0.23 miles the speed limit drops again, to 25 mph just 0.13 miles from the rotary, resulting in a 64% reduction in speed over less than a quarter-mile. Thirteen rear-end crashes occurred along the Route 28 northbound approach to the Bourne Rotary, including three that involved three vehicles and four that resulted in personal injury. For comparison, only four rear-end crashes occurred along the Route 28 southbound approach to the rotary. “Reduced Speed Ahead” (W3-5) signs are provided between the 40 mph speed limit signage and the 25 mph speed limit signage to warn motorists of these changes in the speed limit; however, these signs

are too small to read from a distance, and motorists may see the downstream 25 mph speed limit signs prior to being able to read the “Reduced Speed Ahead” signage. According to *Manual on Uniform Traffic Control Devices* (MUTCD) guidelines, “Reduced Speed Ahead” (W3-5) should be placed in advance of a location where the speed limit decreases by 10 mph or more.

4. Provide larger “Reduced Speed Ahead” signage (W3-5) along the Route 28 northbound approach to the rotary. Consider whether more gradually reducing the speed limit along the approach would reduce the number of rear-end crashes.

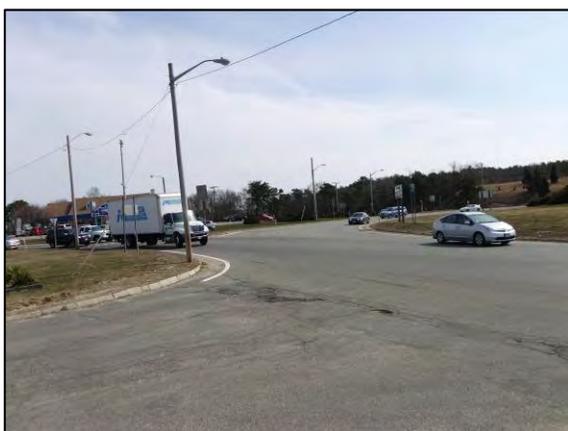
There are no longitudinal lane markings or arrow markings within the Bourne Rotary to guide vehicles through the rotary.

There are also no pavement markings within the rotary to indicate lane use. It is unclear as to whether exiting the rotary from the inside lane is permitted at any exit, at the Route 28 exits only, or not at all. As mentioned previously in the *signage* section, 33 crashes involved a vehicle exiting the rotary from the inside lane while a vehicle continued to circulate the rotary in the outside lane.

7. Consider the safety benefits of providing longitudinal markings and arrow pavement markings within the rotary, including dashed pavement markings to assist entering and exiting vehicles, as part of the upcoming Route 28 corridor resurfacing project.

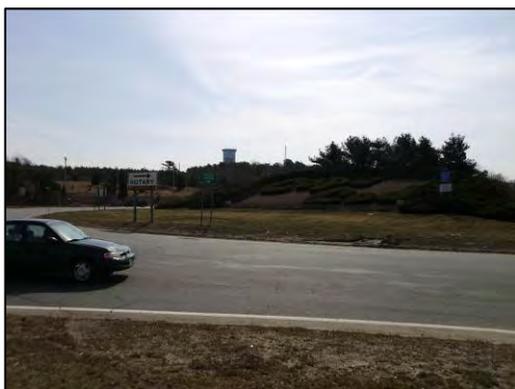
The vegetation in the center of the Bourne Rotary may be distracting, and may restrict sight lines of entering traffic.

RSA team members noted that the decorative vegetation facing Route 28 southbound traffic entering the rotary, spelling out “Cape Cod”, may be distracting for motorists. It was also noted that the height of the vegetation behind the Cape Cod topiary in the center of the rotary may make it difficult for motorists to judge the speed of circulating traffic. However, team members said anecdotally that the number and severity of crashes through the rotary has dropped dramatically since the mound was built.

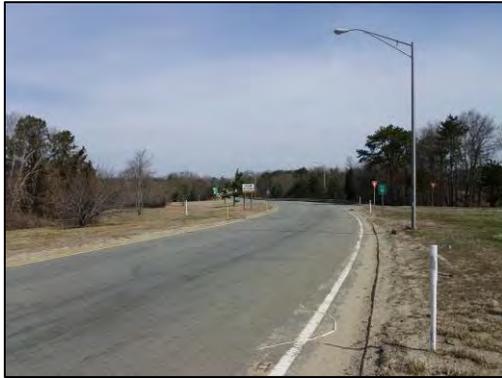
The oval shape of the Otis Rotary means that Route 28 through traffic may not need to slow down when traveling through the rotary.

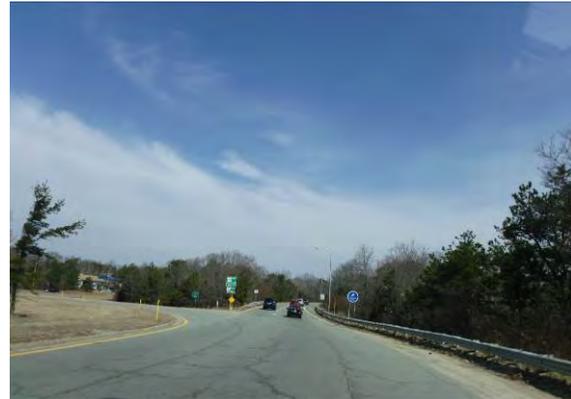
Similar to the Bourne Rotary, there are no pavement markings formalizing two travel lanes within the Otis Rotary. Four sideswipe crashes were reported within the Otis Rotary.

There are also no pavement markings that would indicate lane use within the rotary. Twenty-five crashes involved a vehicle exiting the rotary from the inside travel lane while a vehicle continued to circulate around the rotary in the outside travel lane.

There are no lane striping or lane-use arrows within the rotary.

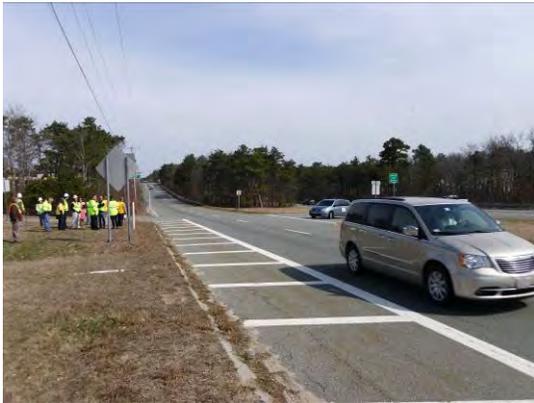
Sight lines to the north of the turnaround in the vicinity of Waterhouse Road are obstructed by vegetation in the median and a crest vertical curve.

Seven angle crashes, four of which resulted in personal injury, involved a vehicle traveling along Route 28 southbound and a vehicle crossing Route 28 southbound from the northbound-to-southbound turnaround onto Waterhouse Road. RSA team members noted that sight distance to the north of the turnaround is obstructed by overgrown vegetation. Sight lines to the north of the turnaround are also impacted by the crest vertical curve on Route 28 southbound. This may make it more difficult for vehicles in the turnaround area to judge the speed of traffic on Route 28, which, according to team members, often travels at speeds that exceed the 50 mph posted speed limit.

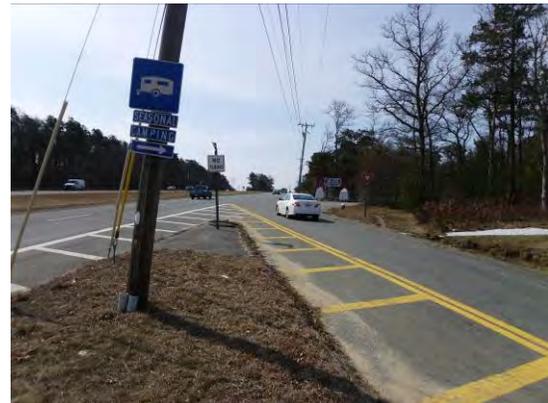
The Waterhouse Road eastbound approach intersects Route 28 southbound at an acute angle. Motorists waiting to merge onto Route 28 southbound must look over their left shoulder in order to see oncoming traffic. This makes it difficult to see and judge the speed of oncoming traffic, and may lead to rear-end crashes when a motorist assumes the vehicle at the front of the queue on Waterhouse Road will accept a gap, but does not. An RSA team member also stated that motorists often “piggyback” one another when merging onto Route 28, meaning two vehicles will often attempt to enter Route 28 at once. This may lead to rear-end crashes if the first vehicle unexpectedly decides not to merge.

Waterhouse Road intersects Route 28 southbound at an acute angle.

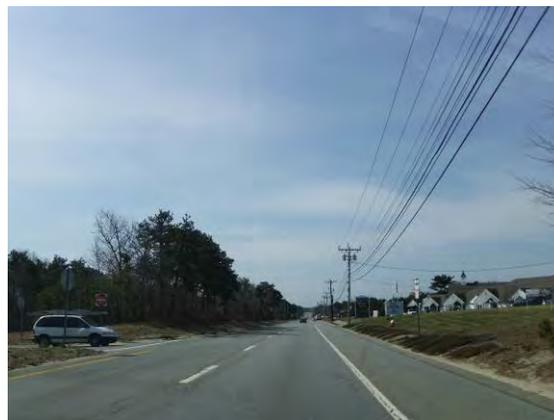
Nine turnarounds are located along the Route 28 corridor between the Bourne Rotary and the Otis Rotary. Five turnarounds allow Route 28 southbound traffic to turn to Route 28 northbound and four turnarounds allow Route 28 northbound traffic to turn onto Route 28 southbound. The northbound-to-southbound turnaround north of Clay Pond Road and the southbound-to-northbound turnaround just north of Otis Park Drive are the only turnarounds that provide acceleration lanes; vehicles using the other turnarounds must wait for an acceptable gap in Route 28 traffic, and then accelerate in the travel lanes. This can lead to rear-end crashes both within the turnaround and on the Route 28 mainline. It can also lead to angle crashes when vehicles attempt to exit a turnaround into the left, high-speed lane. Four crashes were reported involving vehicles exiting turnarounds at locations with no acceleration lanes.

Most turnarounds between the northbound and southbound directions on Route 28 do not provide an acceleration lane.

Deceleration lanes are provided at each of the turnarounds along Route 28, though these deceleration lanes are typically too short to slow down safely and comfortably to enter the turnaround. Additionally, during peak periods, these deceleration lanes act as queuing lanes, making the effective length of the deceleration lane even shorter. Team members noted that queues from turnarounds may obscure the view of adjacent turnarounds from Route 28 through traffic. RSA team members also noted that advance signage for the turnarounds are typically too close to the deceleration lanes. Two crashes were reported involving vehicles traveling too fast when entering the turnaround areas.

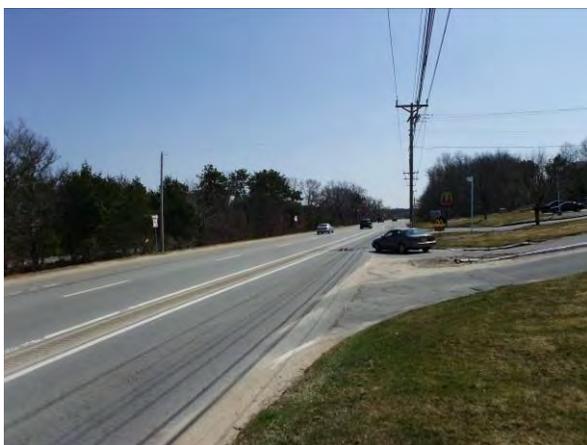
A flush concrete median separates Route 28 southbound through traffic and traffic entering and exiting commercial businesses in the vicinity of Clay Pond Road.

confusion could cause serious head-on crashes.

As part of long-term reconstruction efforts, consider replacing the flush concrete median with a raised median to prevent wrong-way travel along Route 28.	High	Long-term	High	MassDOT
	As part of long-term reconstruction efforts, repair or replace damaged drainage structures and ensure that all areas drain properly.	Medium	Long-term	High	MassDOT
	As part of long-term reconstruction efforts, consider providing pedestrian and bicycle accommodations, such as the planned shared-use path parallel to Route 28. Consider pedestrian/bicycle crossing infrastructure in conjunction with the proposed Route 28 parallel shared-use path.	High	Long-term	High	MassDOT
	Consider enlarging signs and sign legend/text, providing better lighting, and maintaining pavement markings to accommodate the rising population of older drivers on Cape Cod.	Medium	Short-term	Low	MassDOT
