# Lane Departure Road Safety Audit for Route 28 in Barnstable, Massachusetts

*Prepared by*  
**Cape Cod Commission**  
*and*  
**University of Massachusetts Traffic Safety Research Program**

**Massachusetts Highway Department**

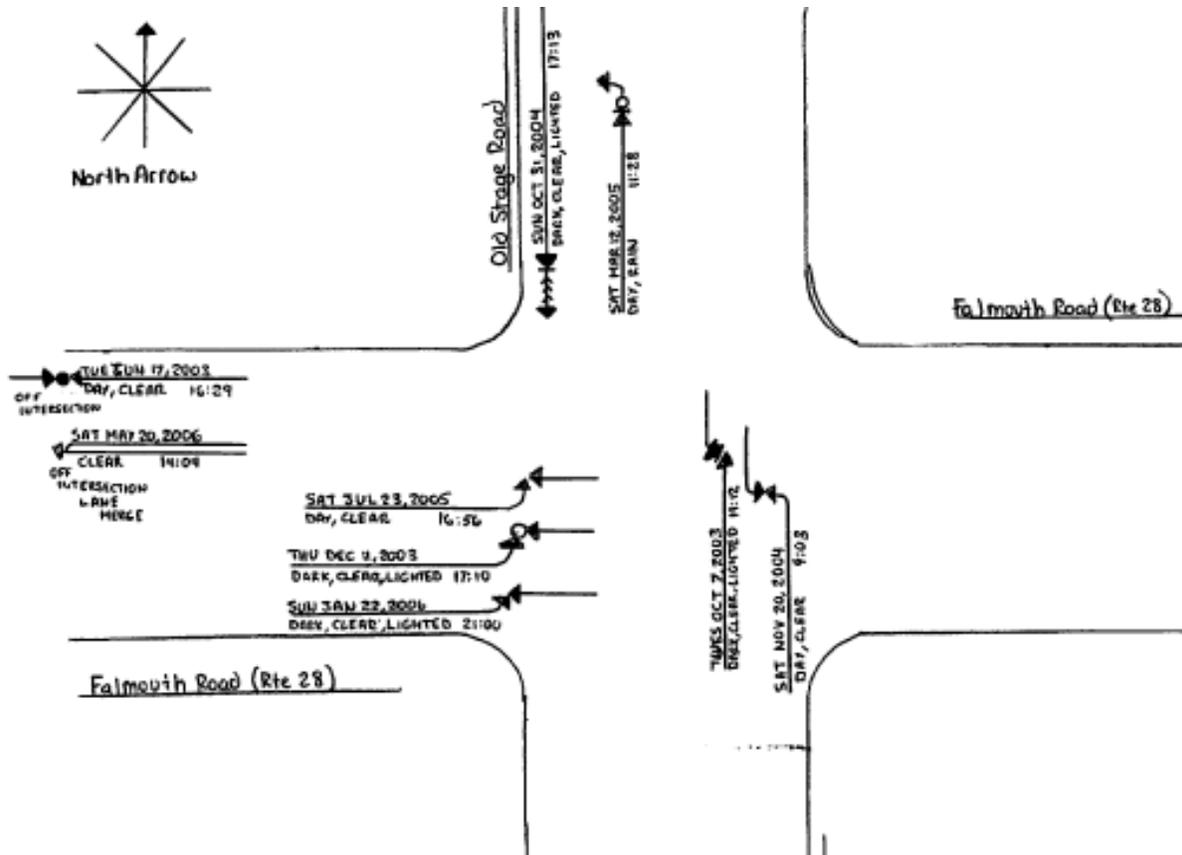
Appendix Figure 1. Collision Diagram in the Vicinity of Route 28 @ Old Stage Road

- Over the 4-year period spanning between 2003 and 2006 there were 30 reported crashes along this segment of Route 28. Not surprisingly, the crashes were clustered in the vicinity of the signalized intersections and major plaza access locations, and included mostly turning vehicles.

- It is recommended that the intersection of Old Stage Road and Route 28 be further analyzed. Of specific concern from a safety perspective would be the demand associated with justification of an EB left-turn phase to allow protected-permissive left-turn signal phasing (PPLT). An additional consideration would be the reconfiguration of existing lane usage, based upon the resulting signal phasing changes. It is also recommended the adjacent intersection of Old Stage Road and Camp Opechee Road be studied in a similar fashion and at the same time.

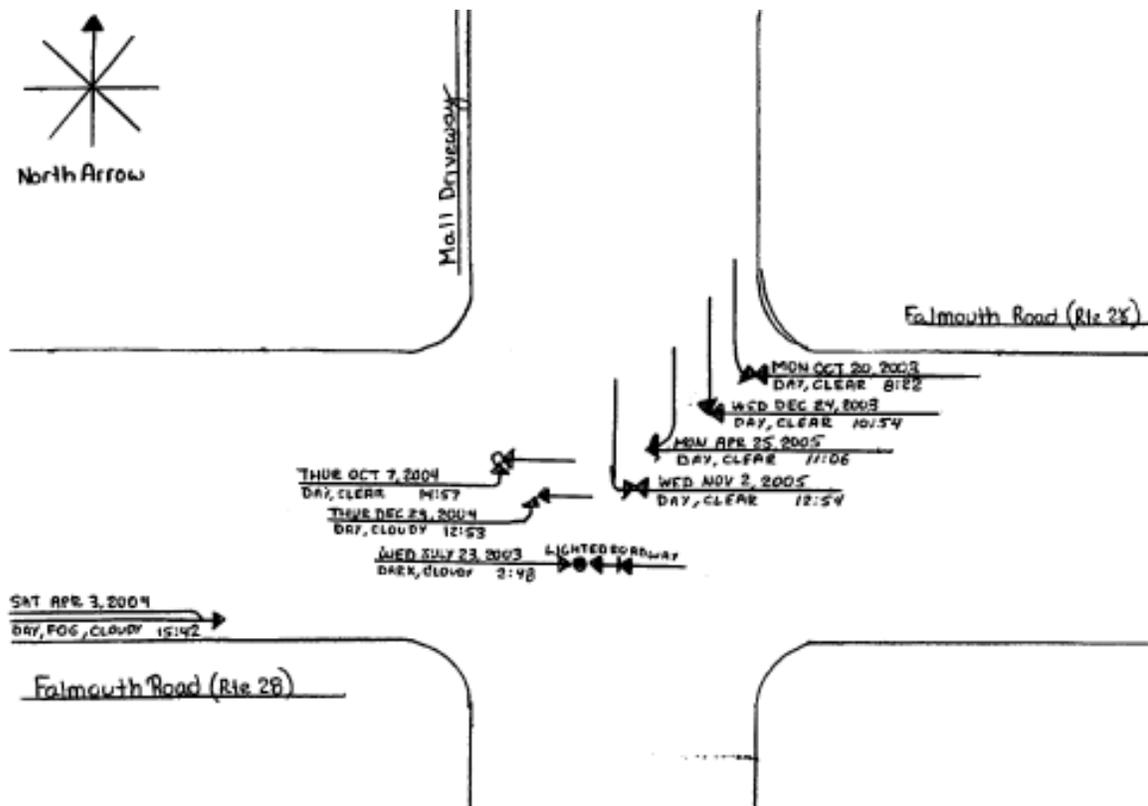
Appendix Figure 2. Collision Diagram in the Vicinity of Route 28 @ Centerville Plaza Drive

- The majority of the discussion centered upon the access points for the various plazas along this stretch of Route 28. Of primary concern was the access point at the Centerville Plaza, which was associated with a significant number of crashes. The specific two scenarios by which the crashes typically occur at these locations were summarized as follows:

- Vehicles that travel EB and attempt to turn left are involved in crashes with opposing WB vehicles proceeding straight through the intersection. Of concern to some RSA team members was the inability of driver's to select appropriate gaps due in part to 1) difficulty and variation in judging speeds of vehicles approaching, and 2) drivers seeking smaller gaps due to aggressive maneuver which results from having been queued on Route 28 while waiting to complete the turn.

- Vehicles exiting the plaza crash with the WB through vehicles. The primary cause was attributed to driver's selecting inappropriate gaps in traffic, based in part on vehicles speeds; however, another multi-threat crash scenario was also cited. In this multi-threat scenario drivers traveling WB in the curbside lane will stop to allow vehicles to exit (i.e. turn left) from the plaza parking lot, and WB through driver's in the center lane are not able to see / comprehend why the vehicle has stopped.

- *Controlled access from Centerville Plaza* – Adding control at the intersection of Centerville Plaza and Route 28 would undoubtedly improve safety along the corridor. Please note this option would be feasible either with or without the addition of a center median. Several alternatives were discussed at the RSA meeting and warrant consideration:

- One approach could be to signalize the intersection and totally control vehicles flows to provide an orderly flow. Please note that a traffic signal warrant analysis would be required to determine if this alternative is indeed feasible. Nevertheless, this configuration would likely allow for the creation of turn lanes with storage. It should be noted that this plan has been discussed, but was referred to as a “dead issue” at the time of the RSA meeting. Given its potential on both safety and efficiency this should be considered to the extent possible.

- Another alternative was to design and construct a roundabout at this location. In addition to the previous stated concerns of available right-of-way and public acceptance another possible concern would be the unbalanced nature of vehicle flows for the developed approaches, which may hinder the operational efficiency of a roundabout. Nevertheless, this warrants further consideration.

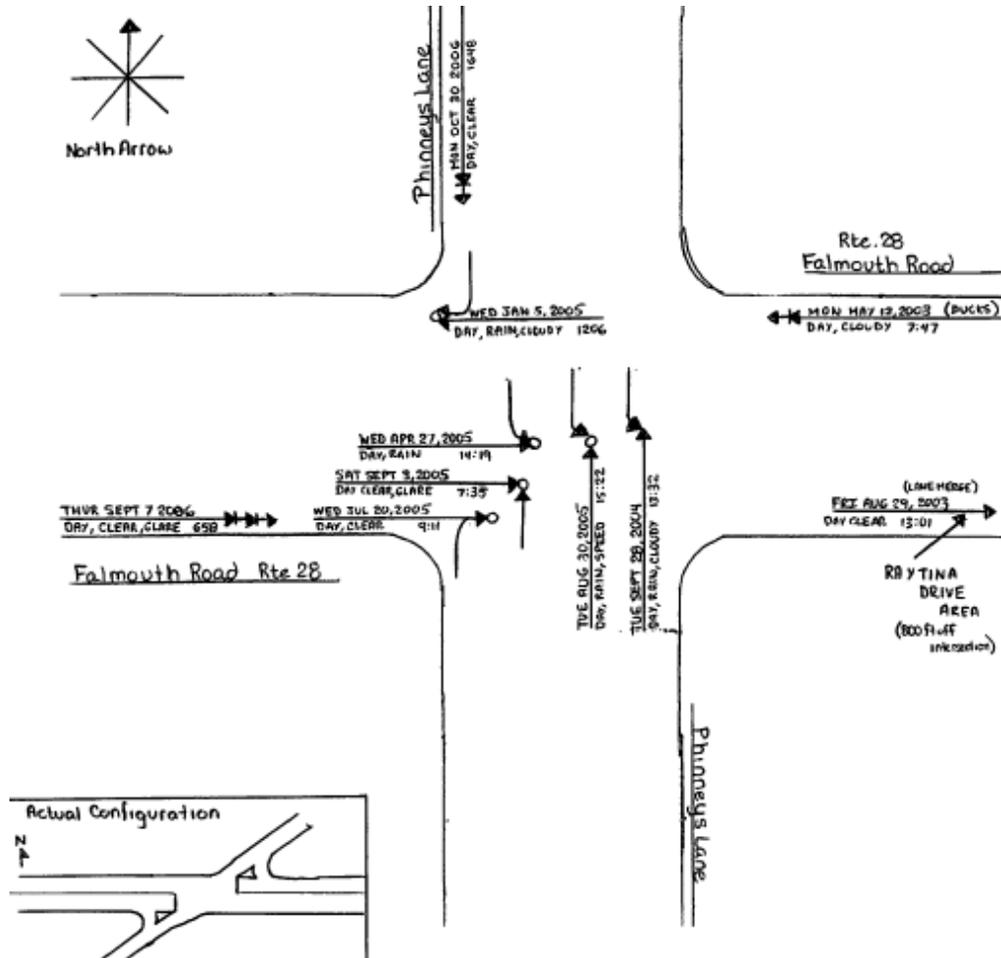
Appendix Figure 4. Collision Diagram in the Vicinity of Route 28 @ Phinney's Lane

- *Route 28 at Phinney's Lane* The current skewed intersection results in sight distance challenges and is a likely contributor to existing crashes. Another long-term consideration would be any potential for realignment which would allow for the northbound and southbound approaches to be squared. In the meantime, some considerations should crashes remain problematic would be to fully split the phasing for the skewed approaches.

- One recommendation suggested at the RSA meeting was to explore the possibility of converting the existing lane usage at the intersection of Phinney's Lane. For consideration would be the designation of an exclusive right turn lane, which once reconfigured would make

the center lane a shared left/through lane. This request was based upon a perceived dominant movement and would better utilize the existing slip lane. At a minimum this idea warrants further consideration.
