**CAPE COD PLANNING AND ECONOMIC DEVELOPMENT COMMISSION**  
1ST DISTRICT COURT HOUSE, BARNSTABLE, MASSACHUSETTS 02630  
TELEPHONE: 617-362-2511

HIGH HAZARD LOCATIONS - -

OBSERVATIONS

August, 1981

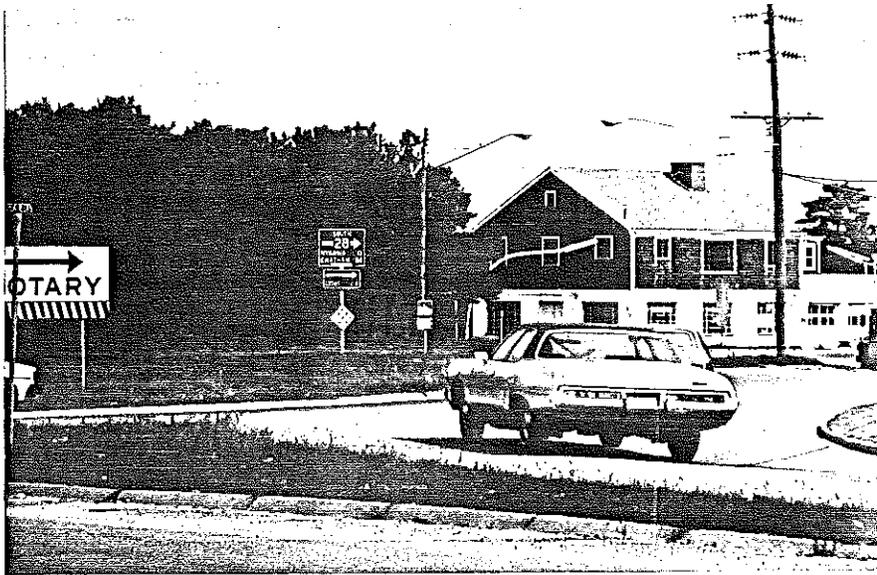
Rt. 151/Rt. 28 Mashpee Rotary

Merging problems which are typical of rotaries are occurring on all approaches. Great Neck Road seems to be the worst approach. There are no yield or control signs at the approach. Warning signs reminding the driver of a rotary ahead are present but their position, size, type and visual functions are suspect. Speeds are not necessarily reduced at the time of a merger.

While the Mashpee Circle intersections record the highest total accidents in town, the accident rate, because of the volume of traffic (24,300 AADT) is the lowest. Only a token amount of accidents produce injuries. The cost for corrective measures would be extremely high (elimination of rotary) in relation to benefits derived. However, low cost improvements such as re-evaluation of signing at all approaches and the proper placement of yield signs would seem to be sufficient.

A request by the town has been made in the past for the Massachusetts Department of Public Works to add yield signs on all approaches. However, nothing has been done to date. The project has been and remains on the Transportation Improvement Program for Cape Cod.

No further analysis would be needed to substantiate improvements to this project and until improvements are completed, this project should remain on the region's FY 1982 Transportation Improvement Program, Annual Element.

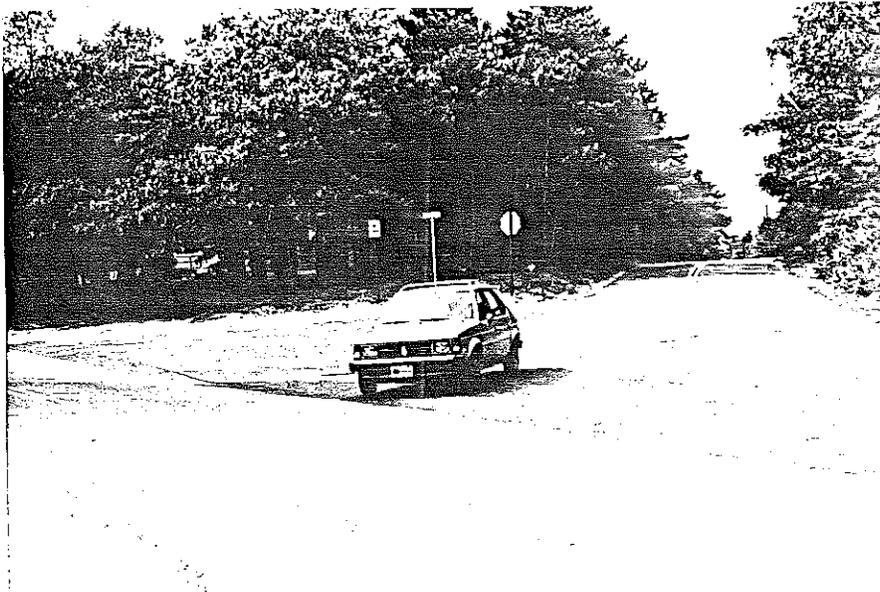
Lowell Road/Central Avenue - Y Intersection

This is a stop control intersection (Lowell Rd.). There is no stop line at approach and the stop control on Lowell Road appears to be positioned well ahead of the intersection. The intersection is wide open causing turning movements to be extremely confusing and potentially dangerous. A good deal of development is planned off Lowell Road and will add to the existing problems.

This project will require surveying work with significant geometric changes made. Adding a 30-35" radius to close off the intersection with filler might be in order. Bringing the stop line perpendicular with Central Avenue might be part of the improvements.

Since this intersection was not included in a High Hazard Location analysis, accident data will have to be obtained from the Town's Police Department. This will be initiated by the Town's Highway Superintendent. No traffic counts or movement data would be necessary.

This project is recommended for further analysis and will remain on the Transportation Improvement Program (TIP) at the request of the Town. It will be included on the TIP's Annual Element for FY 1982.

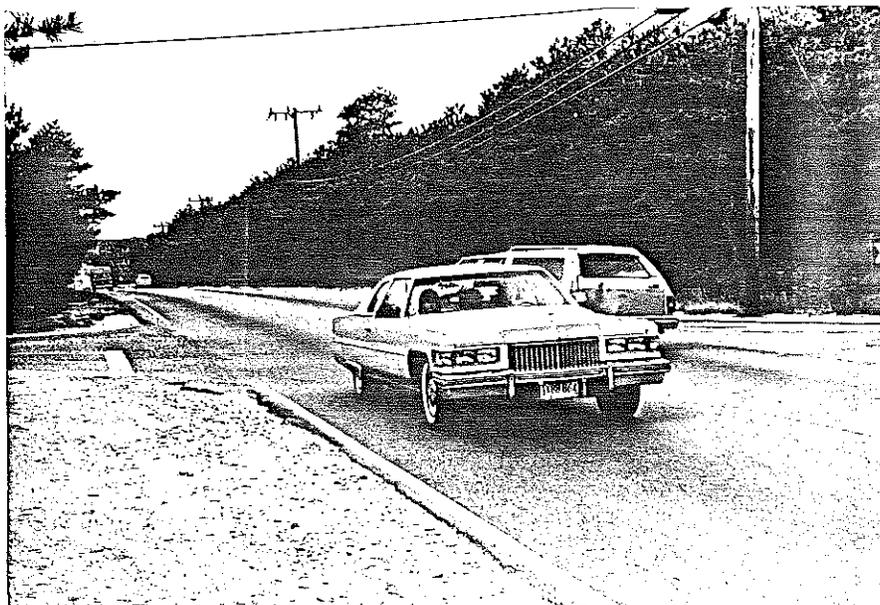
Rt. 151 & Old Barnstable Road - Four-Way Intersection

This is a four-way stop control intersection (Old Barnstable Road).

Left hand turns entering Old Barnstable Road are dangerous. Double yellow stripes stop too soon on Rt. 151 thereby causing turns onto Old Barnstable Road to be made well before the intersection. Rt. 151 is a high speed road (50 mph) and is locally known as the "Mashpee Turnpike".

Accident data in the past indicates that this intersection causes a moderate number of accidents involving injuries. The intersection volume is around 10,000 AADT with an accident rate of .9.

The problems at the intersection could be corrected by the town. Double yellow lines should be extended closer to the intersection to allow for safe left hand turns on all approaches. Center lines on Old Barnstable Road should also be made to align with one another. Some minor signing improvements (position) should also be made.

It is recommended that no further analysis is needed to substantiate the improvement. It is no longer necessary for the project to be included on the region's FY 1982 Transportation Improvement Program.

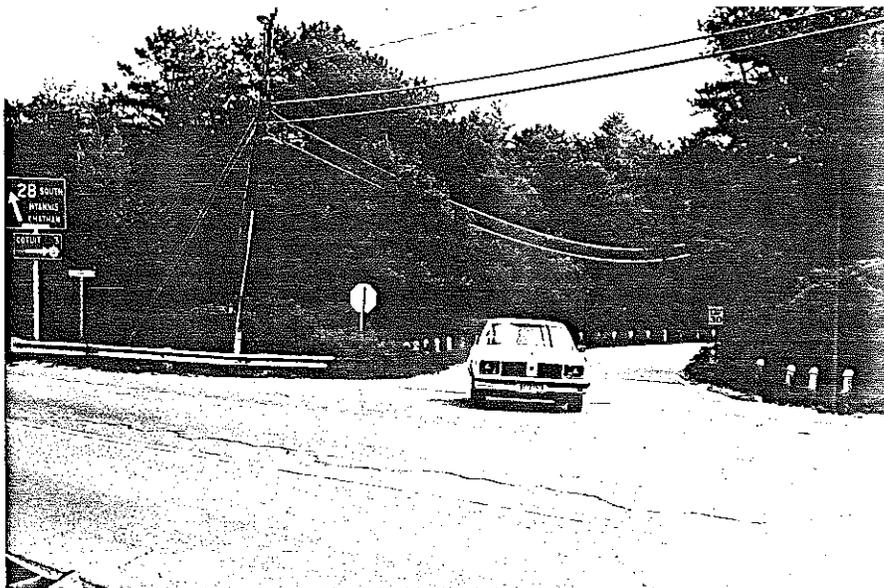
Rt. 28/Quinaquisset Avenue - T Intersection

This is an extremely dangerous intersection which possesses a combination of safety related problems. There is poor sight distance coming out of Quinaquisset Ave. There is a tendency for vehicles to pass to the left when entering Quinaquisset Ave. The lanes on Quinaquisset Ave. are narrow ranging from 7-9'. Approaches to the intersection are both downhill and a sharp curve exist on Quinaquisset immediately before the intersection.

This project has been overlooked as far as its safety conditions and should be programmed for planning and analysis.

The geometrics should be changed. A signing survey and evaluation on Quinaquisset Ave. should be conducted. Curve symbol signs and signals at the intersection should be considered.

Because this intersection was not included in previous High Hazard Location analysis, accident data will be needed. Turning movement information along with traffic counts will be necessary on Quinaquisset Ave. Traffic counts on Rt. 28 are available from the Massachusetts Department of Public Works (MDPW). Right-of-way information can also be obtained from MDPW.

This project should be added to the FY 1982 Transportation Improvement Program (TIP) Annual Element.

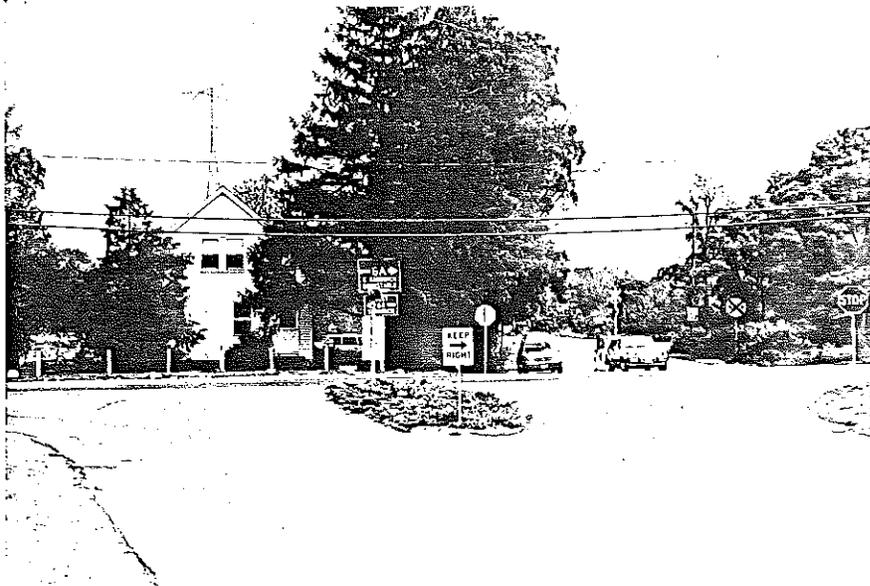
Rt. 6A/Quaker Meetinghouse Rd. - T Intersection Blinking  
Yellow/Red Controls

Vehicles especially at night have a tendency to continue through the intersection and onto private property. Right-of-way (ROW) could be necessary to improve conditions. Quaker Meetinghouse Rd. is heavily traveled during the school season.

This intersection was not part of a recent High Hazard Location analysis.

The intersection should be re-designed. The intersection should also be aligned into a four-way intersection. Traffic accident data will be needed if additional analysis is to be carried out. Massachusetts Department of Public Works should have traffic counts for Rt. 6A however, the Town would have to take counts for Quaker Meetinghouse Rd. ROW at the intersection would probably be necessary.

This project should be included on the region's FY 1982 Transportation Improvement Program, Annual Element.

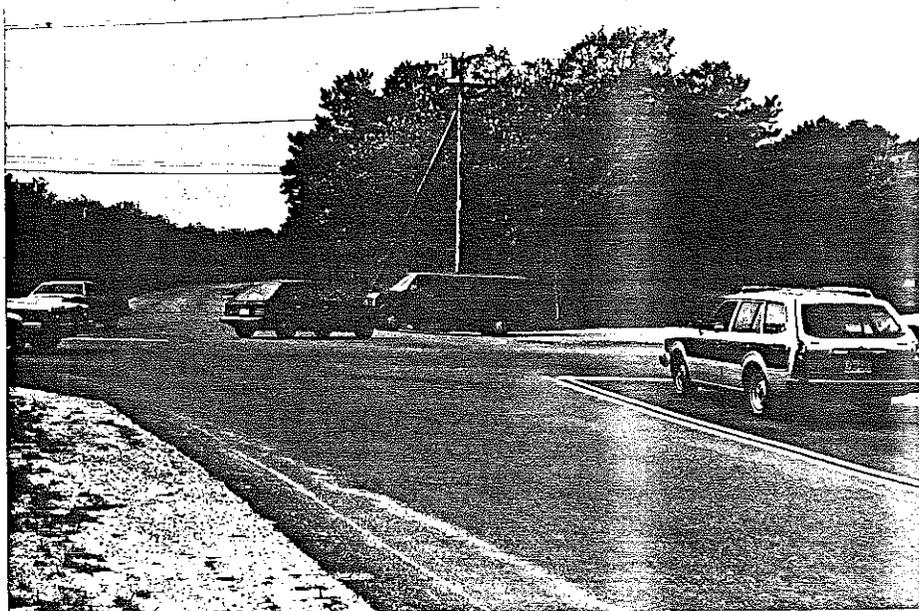
Cotuit Rd/Quaker Meetinghouse Rd. - Four Way Intersection  
Stop control

This intersection is wide open. It is very dangerous crossing or turning onto Cotuit Rd. The initial design of the intersection was approved by the Massachusetts Department of Public Works (MDPW), however the intersection was not constructed according to the design.

This intersection was not part of a recent High Hazard Location analysis although it did appear on the region's FY 1981 Transportation Improvement Program at the request of town officials.

At the moment the Town Engineer is seeking response from the MDPW District #7 office to use Chapter 90 funds to complete the project according to the initial approved designs.

This project should remain on the region's FY 1982 Transportation Improvement Program, Future Element until such time the town resolves it's request with District 7.

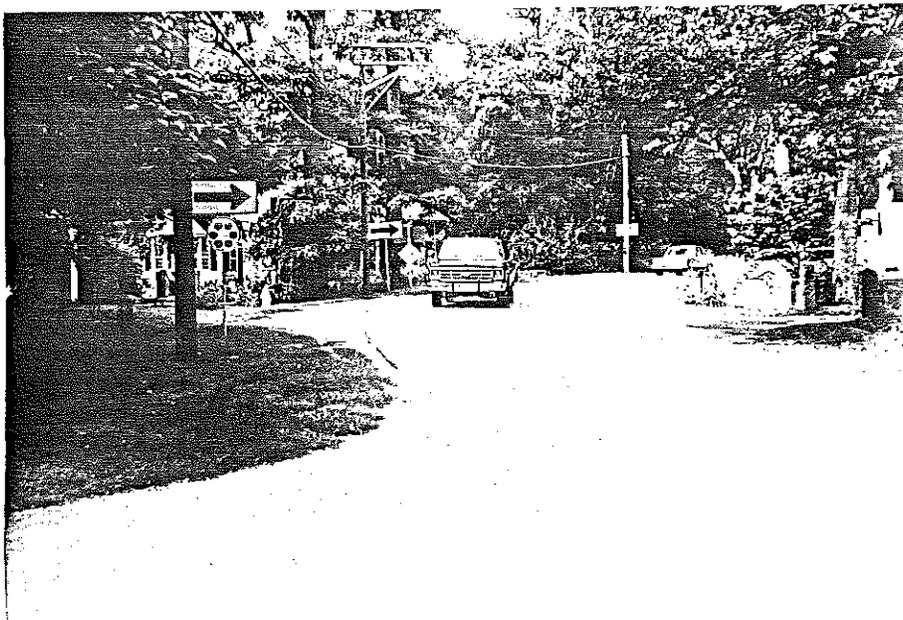
Rt. 130 Curve Near Pine St. - Dangerous Curve

There is a dangerous curve on Rt. 130 which is compounded by poor sight distance. Right of way problems exist because of the potential land takings from a cemetery which creates the curve. Some taking could be done but it would not correct the situation. Two isolated fatalities have caused concern by the Town Selectmen.

It would seem appropriate to let the Town resolve this issue on its own. Local circumstances together with Massachusetts Department of Public Works interest would not be conducive to further analysis. It is recommended that this project not be included on the region's FY 1982 Transportation Improvement Program (TIP).

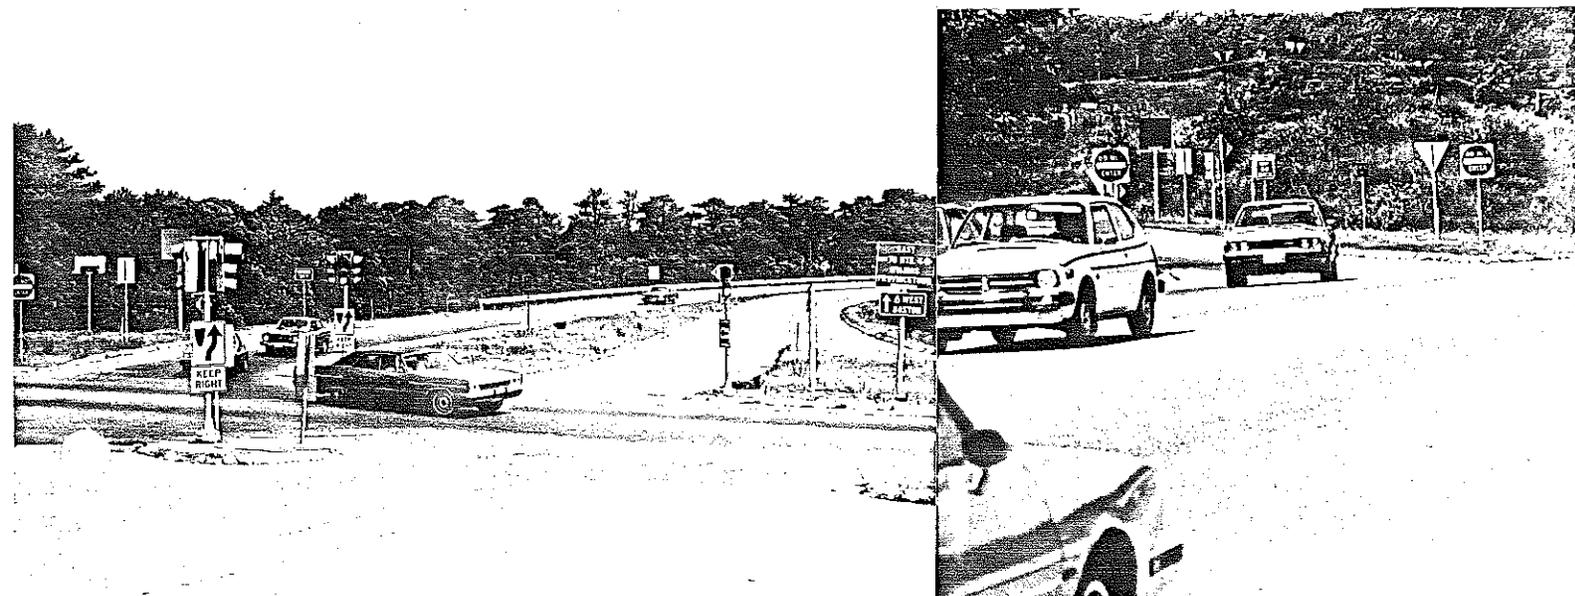
Route 6/Rt. 132 - On/off Ramps

Rt.6 off ramps create dangerous situations especially on the Rt.132 south bound ramp. Cars are accelerating onto a high volume roadway (Rt. 132) with Shootflying Hill Rd. just short of the end of the ramp. At the Howard Johnson's intersection, cars have been known to run the lights causing serious accidents.

This area produces approximately twenty accidents per year with over 27% of the accidents being injury related. The accident rate is 4.4.

It would appear that the ramp and signalization associated with the Howard Johnson's exit is functioning normally - - geometrics appear to be appropriate. Speed signs and/or caution signs might be added on the off-ramp at Howard Johnson's to control the approach to the lights.

It is not recommended that a major redesign of the intersection(s) take place on Rt. 6 and 132. However, it would be proper to re-evaluate the signal system and the sign controls to the off-ramps.

If local priority is given to this project in the future, a joint effort should be made between the town, MDPW District 7 and the Cape Cod Planning and Economic Development Commission to gather traffic information necessary for preliminary design.

This project should remain on the region's Transportation Improvement Program Future Element for FY 1982.

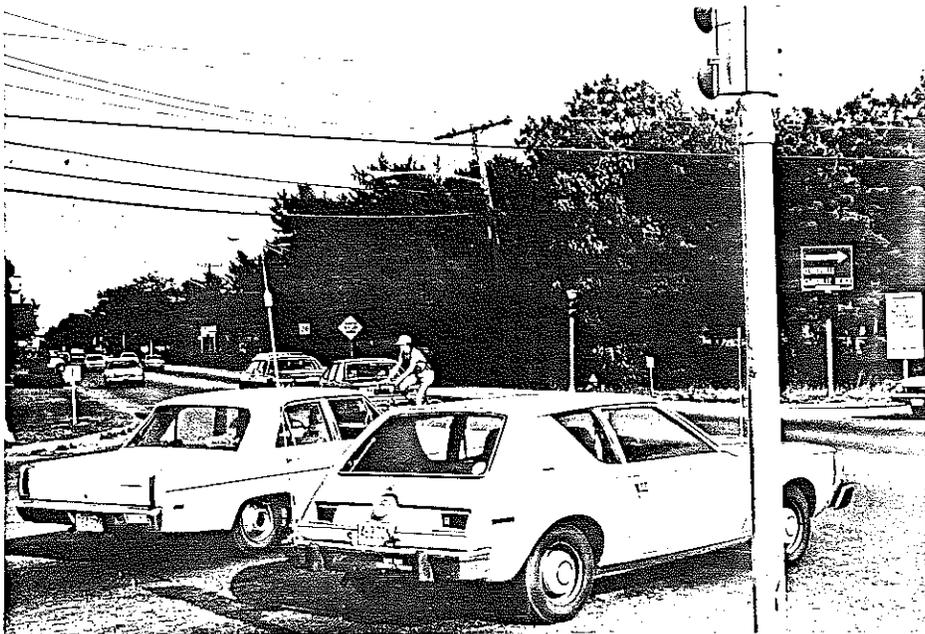
This is a complicated intersection which would seem to warrant further analysis and re-design. The project is not a high priority project at the moment and should be placed on the region's FY 1982 Transportation Improvement Program (TIP), Future Element.

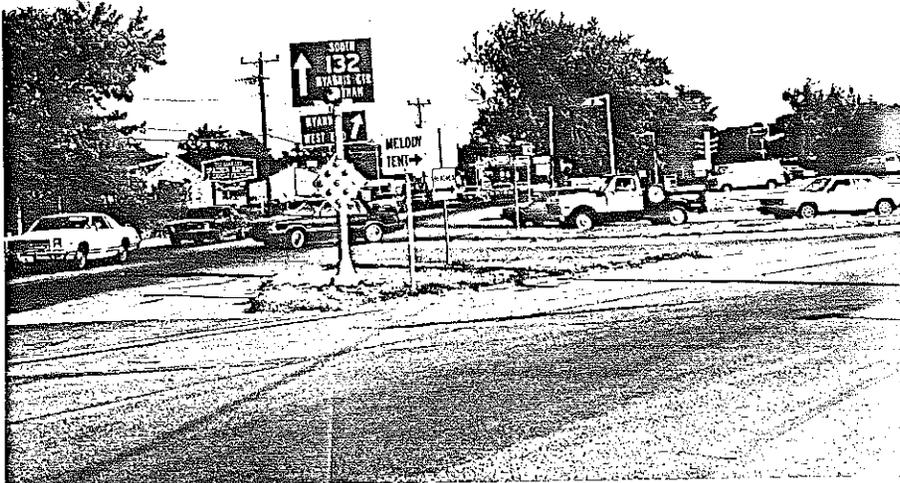
This is an extremely dangerous intersection where drivers must take a risk when entering or exiting Bearses Way. Traffic volume is heavy on Rt. 132 and the calculated intersection volume is about 31,500 AADT. Blinking yellow/red lights do not seem to be working effectively. Traffic coming from the Bearses Way off-set cross street causes additional traffic tie-up. Curb cuts also add to the congestion. Of the twenty-two accidents occurring during a three year period, eleven people sustained injuries at this intersection.

It would appear that signalization is warranted. Traffic counts for Rt. 132 should be obtained from MDPW and counts should be taken by the Town on Bearses Way. The causes for the documented accidents should also be researched. If left hand turns are needed there appears to be sufficient right-of-way to do so.

Special attention should be made on future widening improvements involving this intersection which would be part of a long range widening project from Phinney's Lane to the Barnstable Airport Rotary.

This project is locally supported as a high priority project and is recommended for further analysis. The project should be included on the region's FY 1982 Transportation Improvement Program, Annual Element.

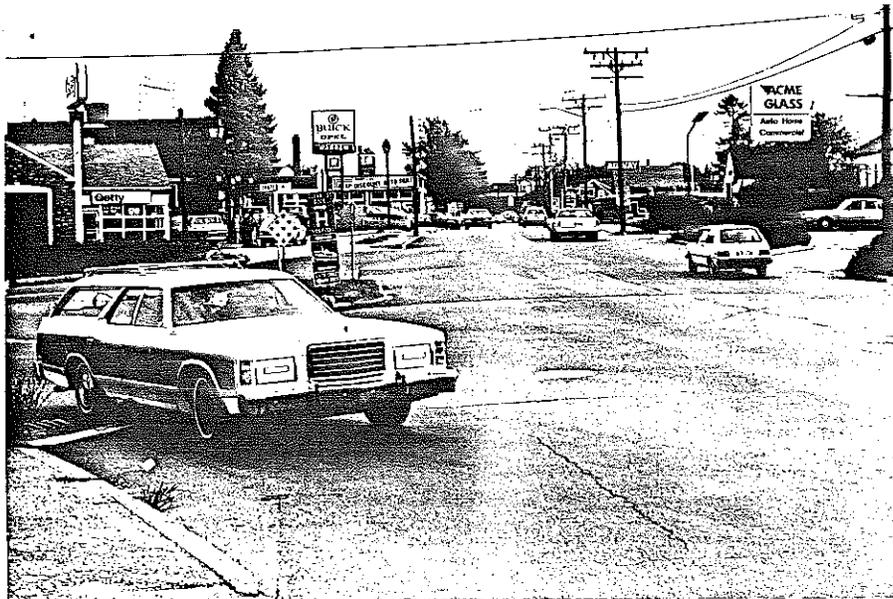
This is an extremely complicated intersection with dangerous head-on conditions. Traffic is fairly heavy. This intersection was not part of a recent High Hazard Location analysis.

A properly aligned four-way intersection could improve traffic flow. The traffic island should be eliminated. Stop control should be re-evaluated over the short-term. It would seem a stop control would work more successfully on the Barnstable Road approach rather than on Center Street. Accordingly, the placement of stop control should be re-evaluated.

This is not a high priority project although additional analysis is warranted. It should be on the region's FY 1982 Transportation Improvement Program, Future Element.

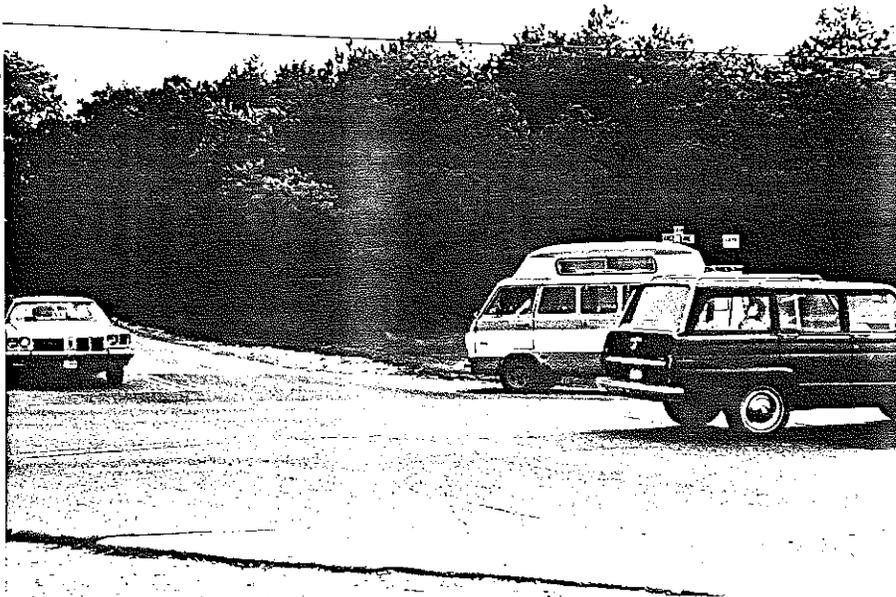
This intersection needs additional brush clearing to improve sight distance problems on all approaches. STOP AHEAD signs should be placed on Rt. 149 ahead of the stop signs. Four way stop signs could also be a possibility. The safety concern for this intersection was the result of a High Hazard Location analysis which illustrated that the accident rate at this location was 7.2, highest in the town. Fifteen accidents occurred at this intersection from 1976-1978. The low calculated intersection traffic volume accounts for the high accident rate.

This is not the type of project which should be on the region's improvement program. Low cost improvements could be made by the town without involving the Massachusetts Department of Public Works. It is not necessary to include this project on the region's FY 1982 Transportation Improvement Program.

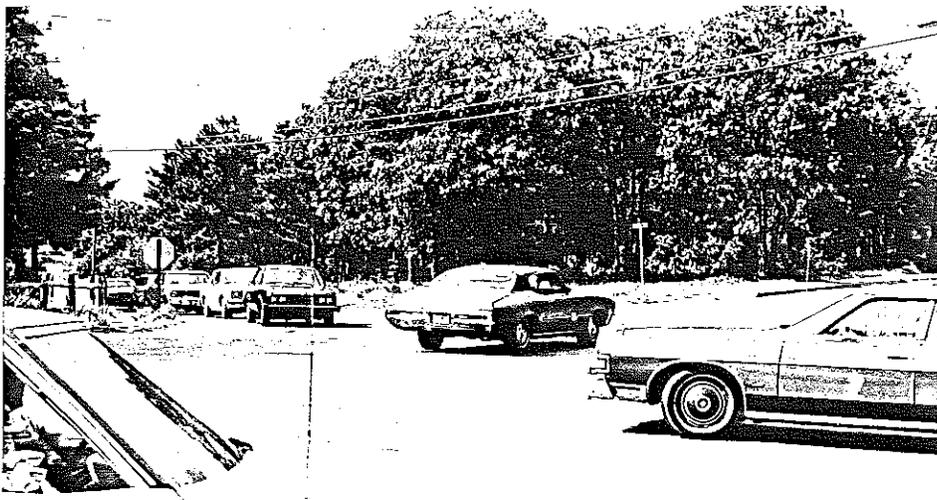
Approaches are too wide on Forest Road (south side intersection) causing driver indecision. There is poor sight distance to the west on Long Pond Drive for a north bound driver on Forest Road. There is high volume traffic on both roadways. Most accidents involve property damage and minor injuries. Illumination is not good.

Trees and brush on the west corner should be cleared (Forest Rd.). Stop signs and pavement markings should be refurbished. Early D.P.W. channelization design should be followed by using temporary curbing (sandbags), warning clusters and pavement markings. Traffic counts and turning motion counts will be needed. The intersection may warrant Pond Drive and Route 28 which could pose a problem for signalization.

This project is recommended for further analysis. It should be added to the regions FY 1982 Transportation Improvement Program, Annual Element.

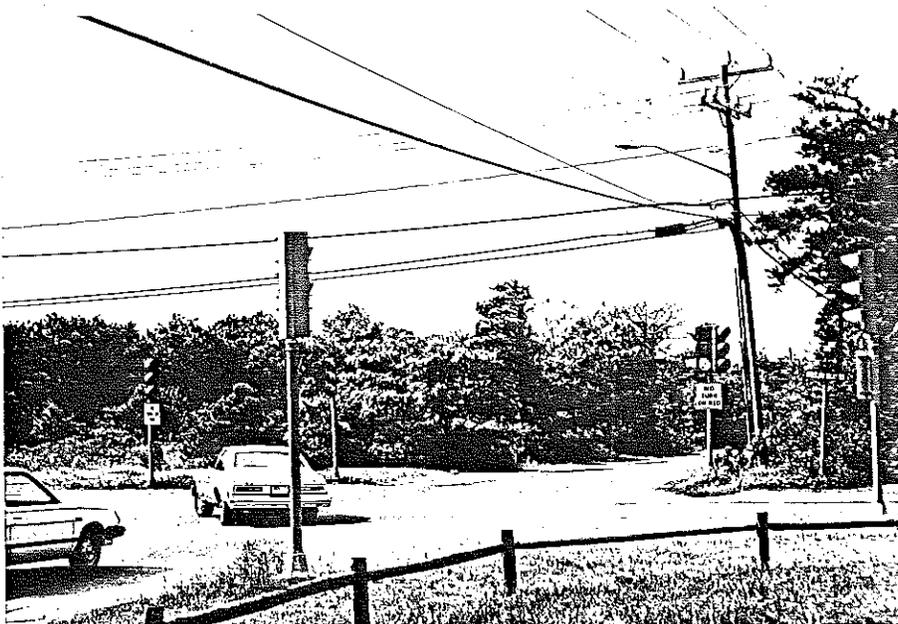
Signals seem to be working well and illumination is good. However, it is recommended that a redesign be done at the signals (overhead signals on mast arm for better visibility). Forest Road acts as a by-pass for Route 28 and therefore there is significant traffic volume. Also, speed signs and regulatory signs on all approaches should be checked for proper location and right-turn-on-red is also recommended.

This intersection is recommended for further analysis and should be included on the region's FY 1982 Transportation Improvement Program, Annual Element.

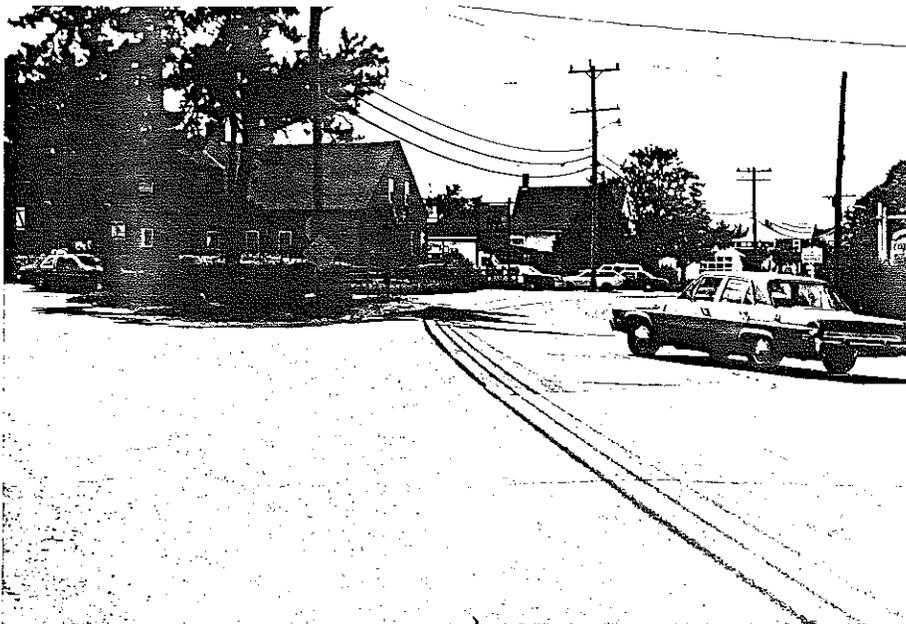
There is poor sight distance on Rt. 28 westbound - turning into Chase St. -- the obstruction is on a curve. A recent accident occurred where the vehicle did not negotiate the curve and hit a telephone pole on the opposite side of Rt. 28. A short entrance road before the intersection is narrow and adds to the intersection's safety problems. This intersection was not analyzed as part of a recent High Hazard Location Study.

This intersection is recommended for further analysis. Data on accidents and the cause of the accidents will be necessary. Traffic counts would not be necessary because the improvements would be to change the geometrics. Some turning movement data might be needed.

The project should be included on the region's FY 1982 Transportation Improvement Program, Annual Element.

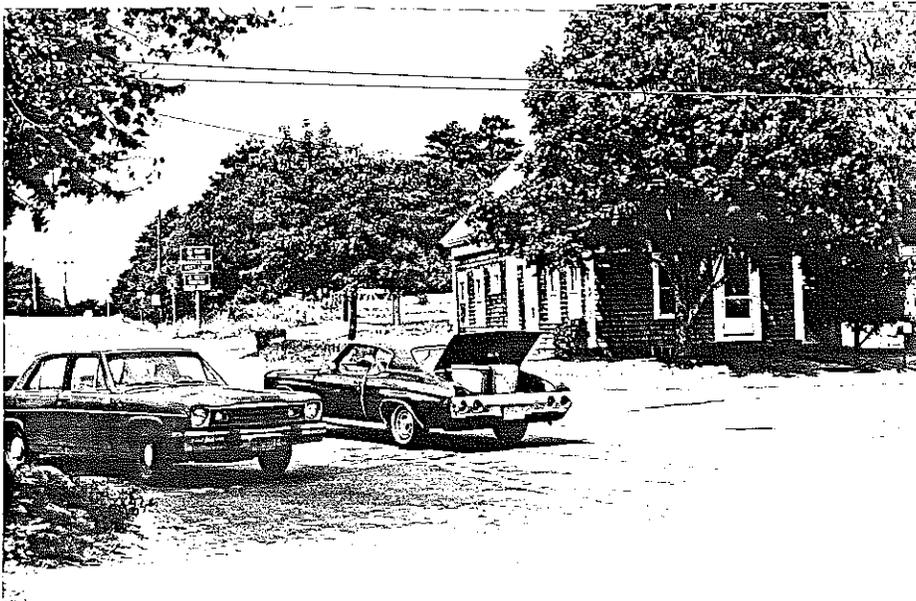
This intersection ranked number one in the 1980 High Hazard report as the most hazardous in Harwich. The problem is rather vague. Many accidents occur according to the police reports of "Running the STOP sign". An additional far side STOP sign together with the legal sign appears to have some beneficial effect as has removal of other signs and certain tree and shrub trimming. This year there is additional activity at the intersection because of the Cape Cod Rail Trail (Regional Bikeway) having been constructed nearby.

It is certain that a flashing beacon would be appropriate. Town officials requested to have at least a traffic control signal. This project should be included on the region's FY 1982 Transportation Improvement Program, Annual Element.

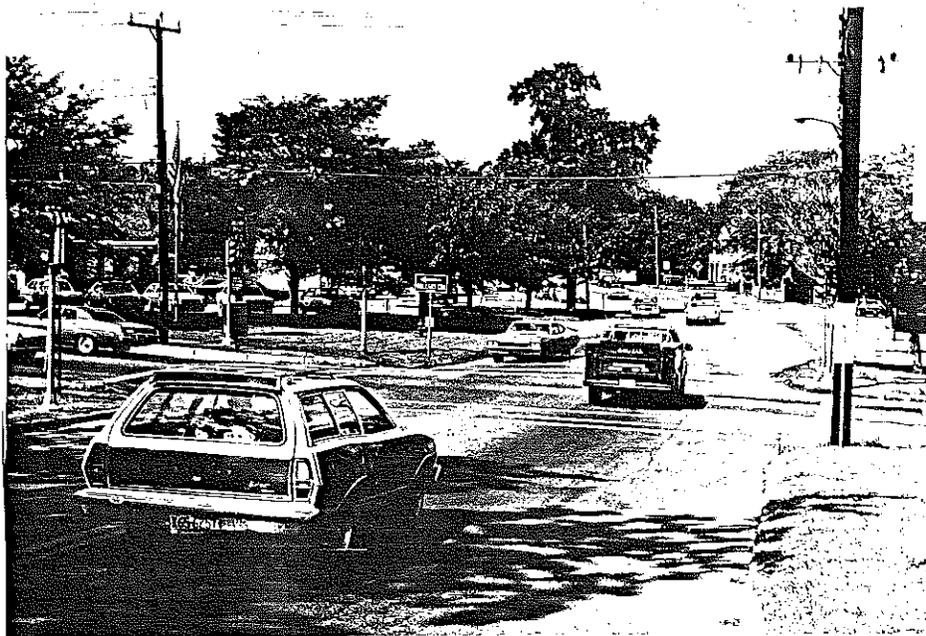
This intersection is already programmed for signalization improvements. Several curb cuts are located around the intersection causing traffic tie-ups and accident conditions. This is the worst accident intersection in town although only 30% of all accidents involve injuries. The calculated intersection volume is 17,700 AADT.

It is recommended that the Massachusetts Department of Public Works go beyond signalization improvements and consider geometric improvements as well.

The intersection at the moment is not recommended for further analysis. The project should be included on the region's FY 1982 Transportation Improvement Program, Future Element.

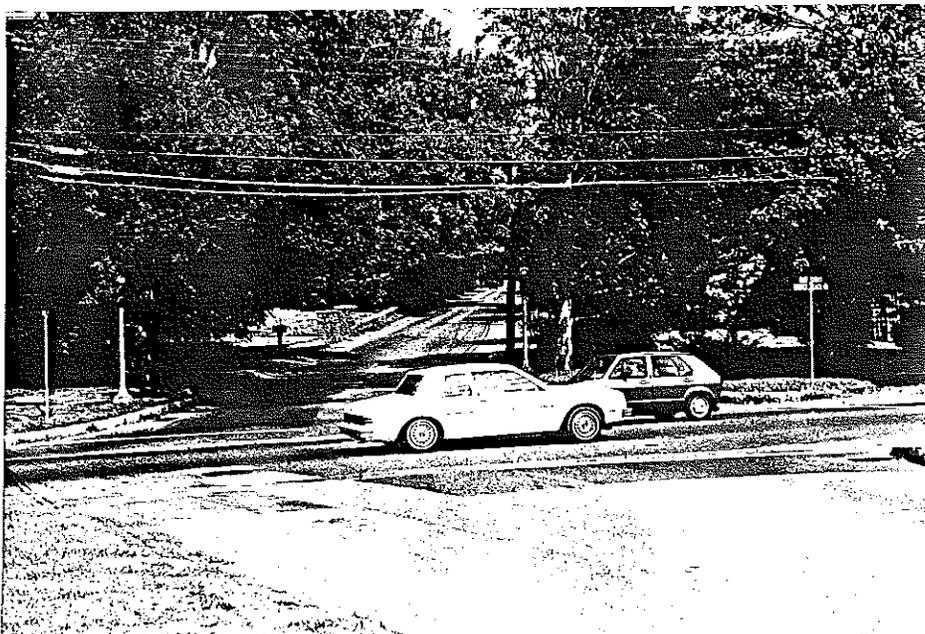
This intersection is not an immediate priority with the town and does not currently warrant further analysis. It should be contained on the region's FY 1982 Transportation Improvement Program, Future Element.
