TOWN OF TRURO

- Town Map
- Chart of Site Characteristics
- Sites 1 to 7

Location of Selected Salt Marsh Restrictions

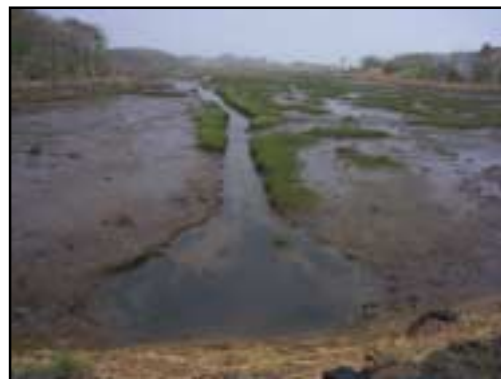
The seaward marsh area is degraded, displaying vegetation die off, ponded water, and a major scouring basin.

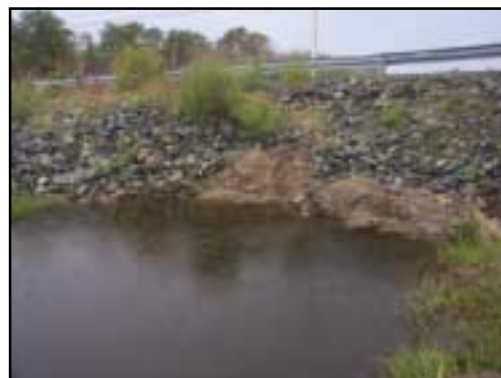
Eagle Neck Creek flows under Old County Road via a 2-foot corrugated plastic pipe. The pipe was only visible on the upstream side of the road and is in need of immediate repair – rocks are visibly clogging the opening. Eagle Neck Creek is connected to tidal flow in Cape Cod Bay through Pamet Harbor. An abandoned, breached railroad bed running through the Harbor and its surrounding marshes lies seaward of this crossing. Storm tides eroded the bed that was partially breached in the late 1980s and finally by the no-name storm in 1990. While Eagle Neck Creek itself does not appear to support shellfish resource areas, Pamet Harbor supports areas that are open seasonally to shellfishing. The upstream affected area of this site is within the Cape Cod National Seashore.

The berm of Old County Road partially dams Eagle Neck Creek. The upstream pipe is visible in this pool and is blocked by rocks – further restricting tidal flow.

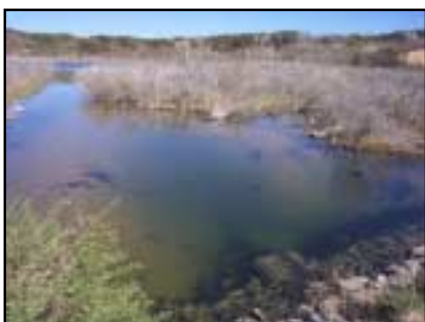
Dead shrubs comprise much of the vegetation currently observed in the upstream affected area – a symbol of the reintroduction of tidal flow and associated slow changes in vegetation.

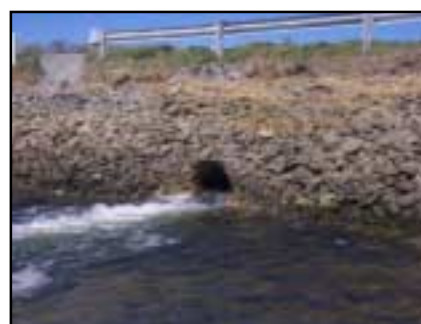
This 3-foot culvert passes tidal flow under Mill Pond Road, here water is seen rushing seaward on an outgoing tide.

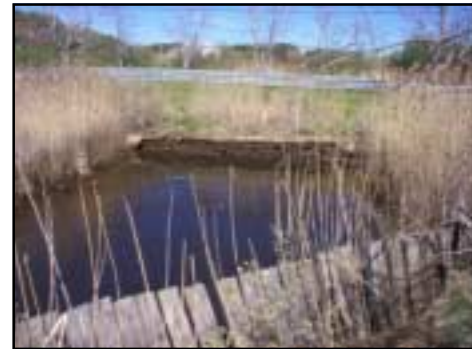
The 3-foot metal pipe and clapper gate set within this headwall (visible below the water line) pass only the seaward flow of the Pamet River under Wilder Dike (Truro Center Road/Route 6A).

In 1996 the Cape Cod National Seashore and the Town of Truro initiated a study, conducted by the Cape Cod Commission (CCC) and the Army Corps of Engineers (ACOE). The ACOE determined that enlarged culverts (6 by 16 feet) at Route 6 and Wilder Dike could provide sufficient cross-sectional area to allow overwash water to exit the upper Pamet in less than two days. This resizing and removal of the tide gate would also allow enough regular seawater flooding to cause salt marsh restoration through much, but not all, of the upper Pamet.³ The CCC Water Resources Office evaluated the potential groundwater impacts associated with removal of the clapper valve at Wilder Dike (site TR-3). One primary concern of removal is the potential impact on private wells and septic systems in the upper Pamet River valley. The CCC study concluded that, with removal, the tidal ranges within the river will have minimal effect on groundwater levels in the river valley and that saltwater flow from the river into the surrounding groundwater lenses will be prevented, indicating that wells and septic systems will not be adversely impacted.⁴

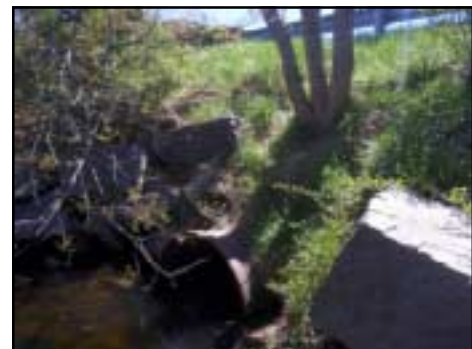
The 3-foot pipe opening is visible here upstream of Wilder Dike.

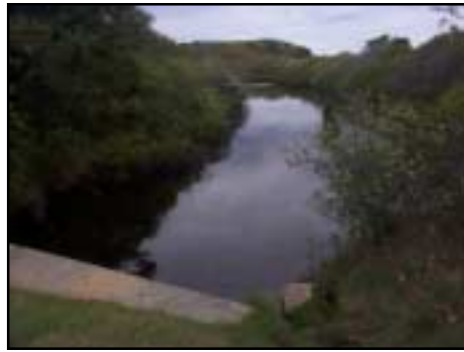
Once upstream of both restrictions the banks of the Pamet River take on a freshwater, riverine appearance.

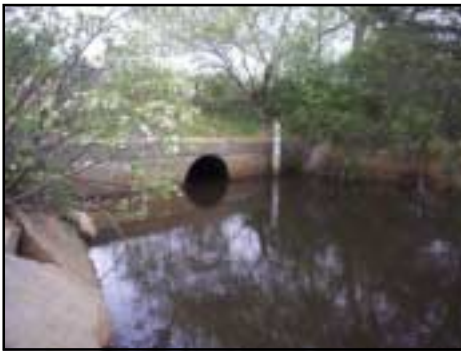
After crossing underground for approximately 375 feet the Pamet River emerges upstream of Route 6 through this 4-foot opening in the concrete headwall.

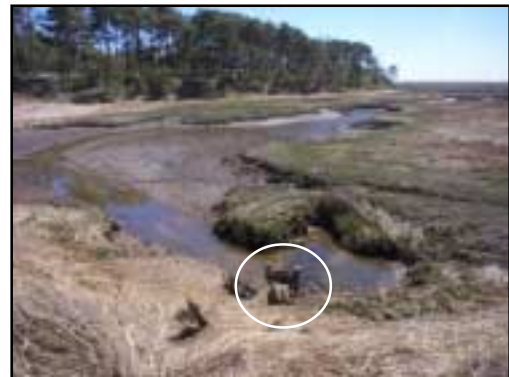
The small concrete, wooden-framed pipe that conveys flow under the berm is visible in the foreground. The seaward marsh area exhibits vegetation die off and major erosion.

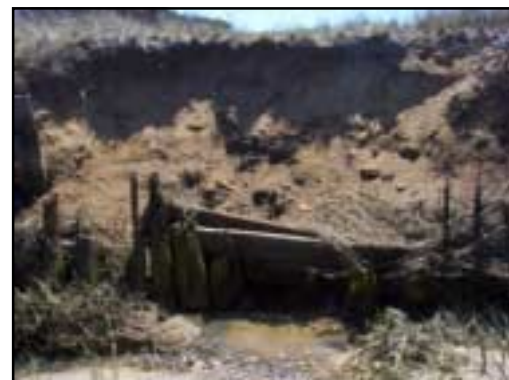
Major bank erosion occurs around the upstream side of this small pipe – a 10-inch opening framed by wooden boards and a retaining wall.

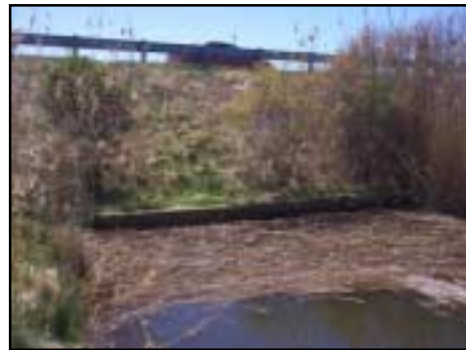
Set far below the roadway of Route 6, this concrete headwall marks the upstream opening of the pipe conveying flow from Cape Cod Bay all the way under Routes 6A and 6 – crossing length estimated at one-eighth of a mile. The pipes' opening is submerged beneath stagnant water and obscured by dead reeds.

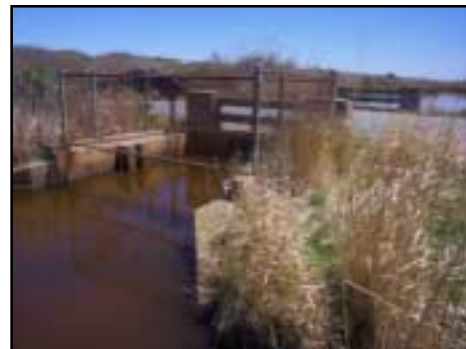
A weir controlling the flow under High Head Road is protected from possible vandalism by this chain link fence.
