TOWN OF WELLFLEET

Town of Wellfleet – Site Characteristics

WELLFLEET

Route 6 restriction of Fresh Brook

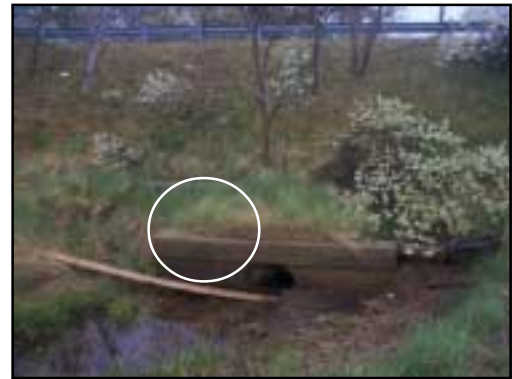
Fresh Brook flows in a westerly direction from east of Route 6 and discharges into Wellfleet Harbor. Fresh Brook travels under Route 6 for approximately 120 feet via a 2-foot (approximate) pipe set under a stone head-wall. This culvert is in poor condition. The seaward opening was submerged in murky water during a low, outgoing tide cycle and obscured by a significant volume of trash and debris that collected at the Route 6 berm. Fresh Brook does support shellfish resource areas but does not act as an anadromous fish pathway. The boundary of the Wellfleet Harbor Area of Critical Environmental Concern runs parallel to Route 6 at this site and does not incorporate it or its upstream affected area.

A large quantity of debris has collected near this seaward headwall and partially blocks the pipe, which is submerged beneath the brown murky water and located just to the left of a Route 6 drainage pipe (clearly visible here to the right of the stone headwall).

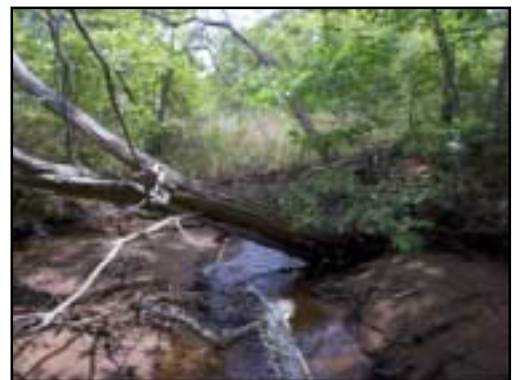
The upstream area is forested near the Route 6 berm, however a large area of *Phragmites* is visible a short distance from the culvert.

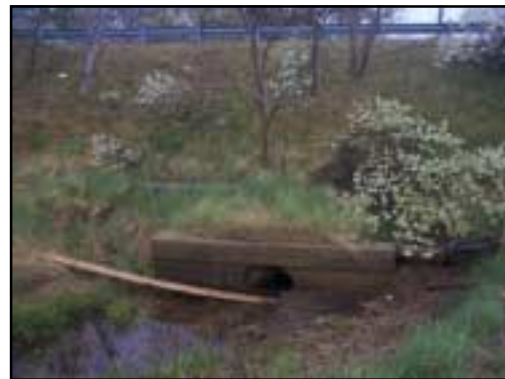
This 2-foot diameter concrete culvert passes tidal flow under Route 6, but it first must pass through the seaward channel that is clogged with dead grasses.

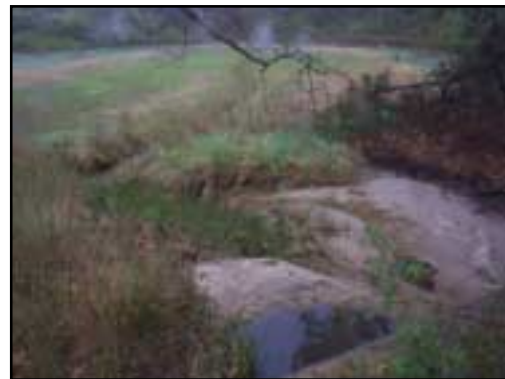
The seaward channel is approximately 2 feet wide, narrowing to approximately 1-foot upstream. Flow appeared to be minimal in both channels. A large sand bar has formed near the upstream culvert opening. Visual indicators of restriction include minor scouring both seaward and upstream and a minor amount of vegetation die off along the seaward channel banks. The Wetlands Conservancy Program delineated salt marsh adjacent to the seaward side of Route 6 and 0.55 acres of salt marsh upstream. There was no *Phragmites* observed in the upstream affected area, however a minor amount was visible along the edge of the marsh lying seaward of Route 6.

Upstream of Route 6, channel width is reduced to approximately 1-foot. A large sand bar has formed near this opening and silt and sand partially clog the culvert.

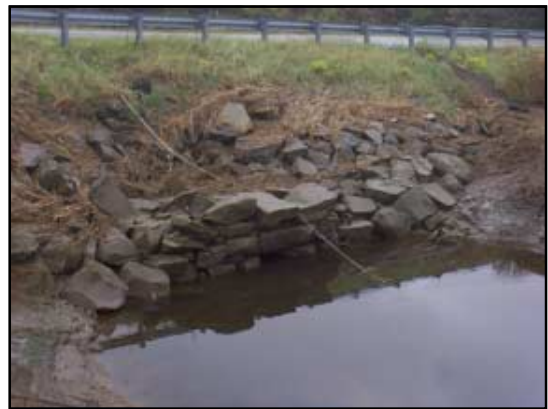
The seaward channel is approximately 15 to 25 feet wide, narrowing upstream to approximately 5 to 10 feet. This site is severely degraded and visual indicators of a restriction were numerous. On both sides of Route 6 scouring, erosion, and vegetation die off are major. Marsh slumping is major on the seaward side and minor within the upstream affected area. There was no *Phragmites* observed. 4.16 acres of salt marsh lie upstream of this site, with 1.96 acres found between Route 6 and upstream site WE-d and 2.20 acres upstream of site WE-d.

This stone headwall houses the 2-foot metal pipe that conveys Blackfish Creek under Route 6. Erosion of the roadway berm is seen above and around this seaward headwall.

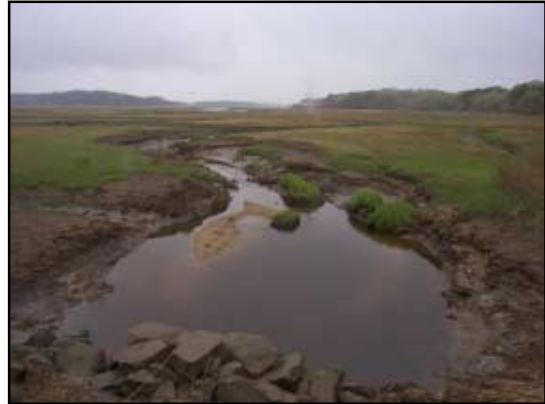
Looking from the culvert into the seaward salt marsh area several visual indicators of a restriction dominate the view, including vegetation die off, scouring, erosion, and marsh slumping.

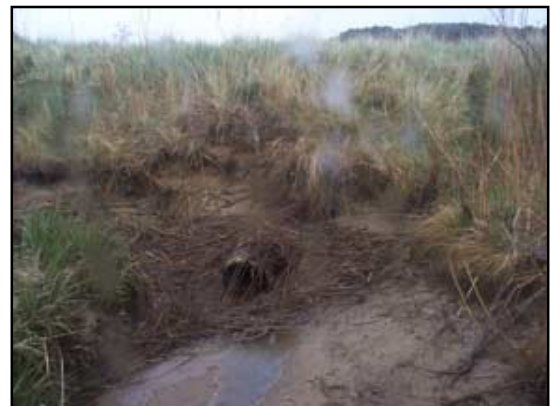
Both the seaward and upstream channels are approximately 2 feet wide. Visual indicators of restriction include significant scouring and erosion both seaward and upstream of the dike, with conditions slightly more degraded on the upstream side. The vegetation change is dramatic when crossing the dike – changing from seaward salt marsh to upstream shrub swamp with significant *Phragmites* growth.

This 1-foot pipe passes tidal flow through the berm, which has suffered from major erosion on this upstream side. This pipe appears to be set too high in the dike to pass the full tidal range.

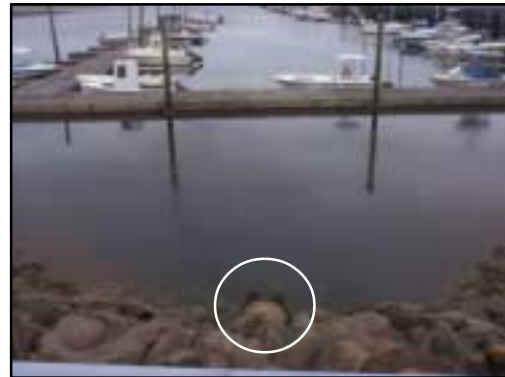
When standing on Commercial Street above the culvert, the view is of town pier and Duck Creek Harbor. The tide gate and pipe are visible in the foreground below the rock wall.

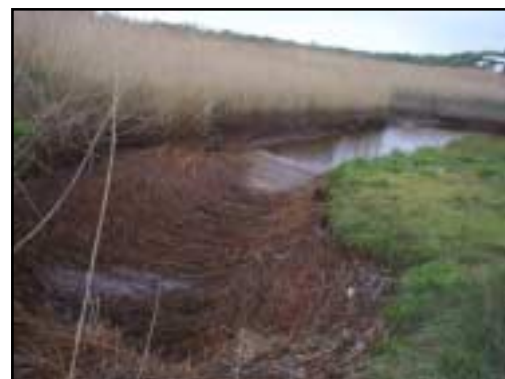
Mayo Creek is approximately 10 feet wide upstream of Commercial Street. Visual indicators of a restriction include the flapper gate on the seaward opening and significant scouring and erosion near the upstream opening. The portion of Commercial Street that abuts Duck Creek Harbor is armored by large boulders – therefore no scouring or erosion were visible near the seaward pipe opening. *Phragmites* dominated the upstream affected area.

Phragmites dominates the upstream affected area. Dead reeds and debris have collected near the upstream opening, obscuring the pipe from view.

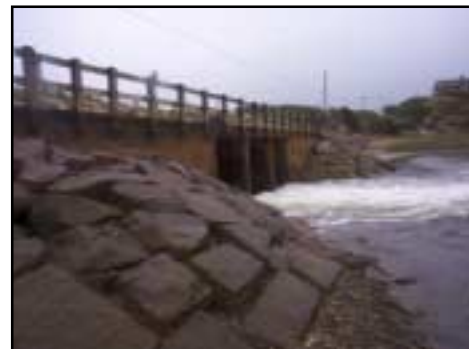
These 3 box culverts viewed from the seaward side of Chequessett Neck Road, two fitted with flapper gates and one with a sluice gate, control the exchange of salt and fresh water between the Herring River and Wellfleet Harbor.

The Wetlands Conservancy Program delineated salt marsh adjacent to the seaward side of the Herring River dike. A 0.81 acre patch was the only salt marsh delineated upstream of the dike. According to a recent study, “[t]he restriction in flow imposed by the hydraulic control structures has resulted in the conversion of hundreds of hectares of the original inter-tidal, salt marshes into upland vegetation eliminating habitat for estuarine plants and animals, including fish and shellfish. In addition it has resulted in adverse impacts on water quality including acidification of river waters, leaching of metals from the sediments and episodic anoxia. It has also resulted

in subsidence of the wetlands.”¹ Analysis showed that site WE-6 “reduced the mean tidal range from 2.53 meters in the bay to 0.56 meters in the river.

This is a reduction of a factor of 4.52 in the tidal range across the dike.”³ *Phragmites* growth was significant upstream of the dike and fringed most of the visible marsh area.

Restoration of the Herring River’s natural free-flowing system has been discussed for years. The most recent study done on this system concluded that, “[r]estoration of pre-existing conditions in Herring River, defined as similar tidal ranges up and downstream of the dike, will require increasing the width of the opening to at least 30 meters.”⁵ According to the National Seashore, a 30-meter opening could equate to approximately 600 acres of potentially restored area.

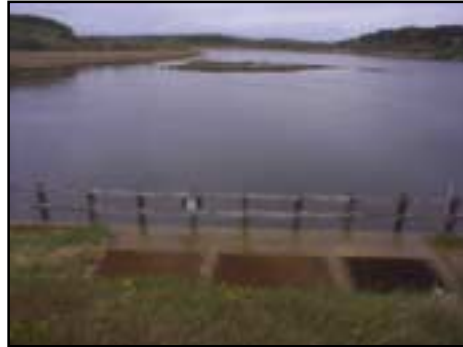
Looking upstream from Chequessett Neck Road a small patch of salt marsh is visible, along with Phragmites that lines the Herring River banks.
