ROAD SAFETY AUDIT

Iyannough Road (Route 28) at Yarmouth Road

Town of Barnstable

September 2012

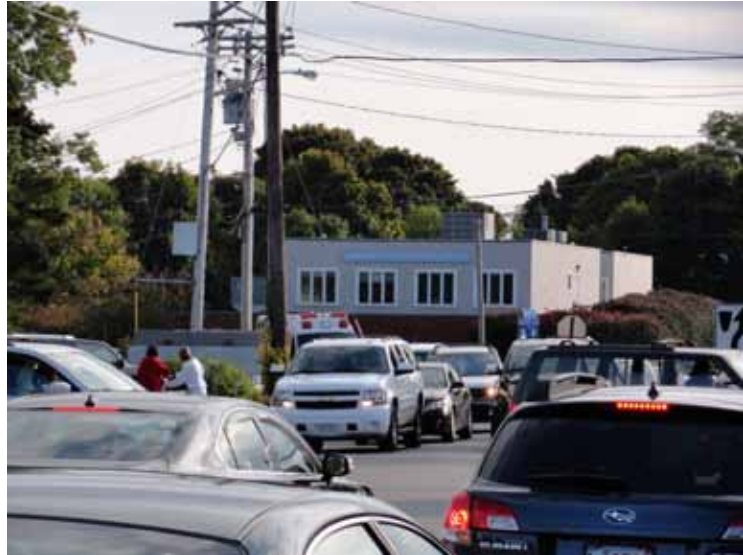
Congestion at Route 28/Yarmouth Road

Team members commented that these corridors are regularly congested, especially during peak hours and during the summer months, which contributes to increased motorist frustration and aggressive driving behavior. From September 2009 to September 2012, 9 (or 53%) of the 17 angle type crashes and 8 (73%) of the rear-end type crashes were reportedly as a result of aggressive driving behavior (e.g. traveling too fast, running red lights, following too closely, etc.) or not paying sufficient attention.

The study team observed that queues on Route 28 eastbound often experience very long queues, which can result in motorist inattention and frustration and may have contributed to rear-end crash experience at the intersection. During the field visit, which was conducted during off-peak hours, the team observed fairly substantial queues at all intersection approaches. A team member stated that he had observed queues as far back as the Radisson Hotel on Route 28 eastbound, which is located about a quarter-mile west of the intersection. Three of the 11 reported rear-end crashes occurred on Route 28 eastbound; one of these crashes resulted in personal injury. One rear-end crash was reported on Route 28 westbound. Five reported rear-end crashes occurred on Yarmouth Road northbound, one of which resulted in personal injury, another of which occurred north of the intersection at the Dunkin Donuts/Hess driveway. Two rear-end crashes occurred on

1. Consider the feasibility of improving traffic signal operations (e.g. traffic signal improvements, signal phasing changes, roadway widening, lane use modifications, etc.) to reduce queuing conditions and motorist frustration.
2. Consider the appropriateness and safety benefits of providing a protected left-turn signal phase for Yarmouth Road northbound.
3. Enforce red light running violations where possible.
4. Review, and adjust as appropriate, clearance intervals per current standards in an effort to reduce rear-end and angle-type crashes.

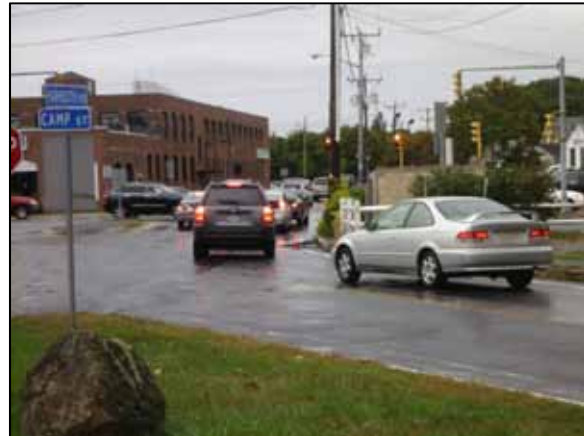
The Yarmouth Road northbound approach at Route 28 has no clear intended lane use. It is wide enough for two separate lanes, though a team member noted that sometimes the first car queues in the middle of the approach so no other vehicle can queue next to it. Otherwise, when the Yarmouth Road northbound approach functions as two lanes, team members observed vehicles traveling northbound through from both lanes even though there is only one receiving lane on the departure side of the intersection. Thus, since there is no clear lane use, it is possible that two lanes of vehicle traffic could travel northbound at the same time into one receiving lane on Yarmouth Road, which would require these vehicles to merge within the intersection. According to the crash data, four sideswipe crashes involving Yarmouth Road northbound through vehicles in both lanes occurred between September 2009 and September 2012.

Unclear lane use on Yarmouth Road northbound

1. Review traffic volumes and operations at the Yarmouth Road northbound approach to evaluate the appropriateness of formalizing two lanes. Repaint and maintain lane use pavement markings along Yarmouth Road southbound.

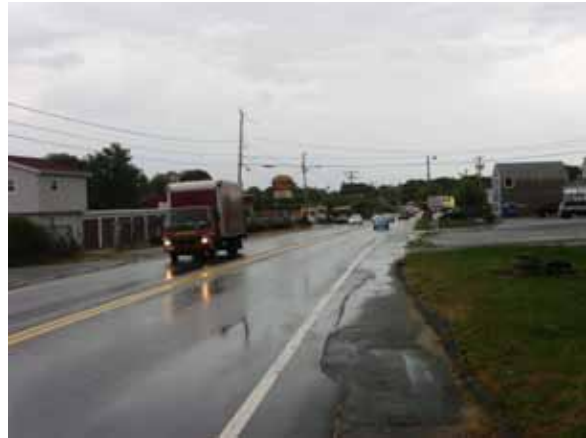
Team members noted that heavy vehicles have difficulty making left turns at the intersection due to small corner radii and the presence of vehicles that queue beyond the stop line. According to the crash data, one crash involved a tractor trailer traveling on Route 28 eastbound used the outside travel lane to make a left turn onto Yarmouth Road northbound. Another crash involved a vehicle traveling on Route 28 eastbound that attempted to turn left and hit the signal post on the northeast corner of the intersection.

Truck traveling on Route 28 westbound.

During the field observations, the team noted that the signal post was tilted slightly and the curbing was damaged. A third crash involved a motorist turning left from Route 28 eastbound that oversteered and hit a car on Yarmouth Road southbound that was queuing at the signal.

1. Consider the feasibility of increasing curb radii, particularly at the northeast corner of the intersection, and/or staggering stop bar placement to allow/facilitate truck turns.
2. Consider the appropriateness of replacing the current signalized intersection with a multi-lane modern roundabout to reduce the occurrence of angle type crashes.

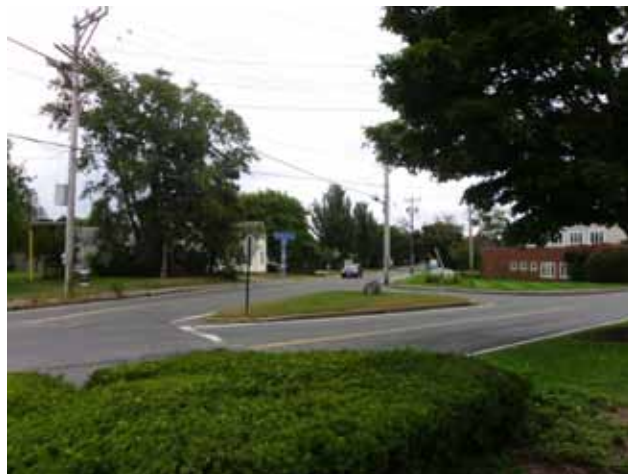
Camp Street intersects Yarmouth Road at an acute angle resulting in an awkward intersection geometry. The Camp Street northwest-bound approach consists of a single uncontrolled travel lane, where vehicles can either make a sharp left turn onto Yarmouth Road southbound or continue straight along Yarmouth Road northbound. Vehicles were also observed taking lefts onto Yarmouth Road southbound from Camp Street northwest-bound via the slip lane. The close proximity of the Yarmouth Road/Camp Street intersection to the Route 28/ Yarmouth Road intersection creates potential conflict, in that traffic coming from Yarmouth Road northbound are directed into the left lane of the northbound approach at the Route 28/Yarmouth Road intersection, while traffic coming from Camp Street northbound are directed into the right lane at the Route 28/Yarmouth Road intersection. Thus, vehicles wishing to access the other lane must at some point merge in to the other lane, which would be difficult if a queue has already formed.

Camp Street intersects Yarmouth Road at an acute angle.

Due to the acute intersection geometry, it is difficult for motorists waiting at the Yarmouth Road northbound stop line to see oncoming traffic on Camp Street northwest-bound, since they need to look over their shoulder. Meanwhile, southbound traffic from Yarmouth Road southbound continues to flow through the intersection, which Yarmouth Road northbound vehicles waiting at the stop line would not be able to see if they are looking for traffic coming from Camp Street northwest-bound.

1. Explore the feasibility of making geometric changes, such as creating a 90 degree "T" intersection between Yarmouth Road and Camp Street, or a roundabout, to reduce conflicts, improve sightlines, reduce driver confusion, and improve overall safety. Consider emergency vehicle access/response times to Cape Cod hospital, queuing conditions along Yarmouth Road northbound at Route 28, and access to and from DJ's Family Sports Pub.
2. Consider the appropriateness of adding a dotted double yellow center line and dotted white edge lines through the Camp Street/Yarmouth Road intersection to clarify the main road from the side street.

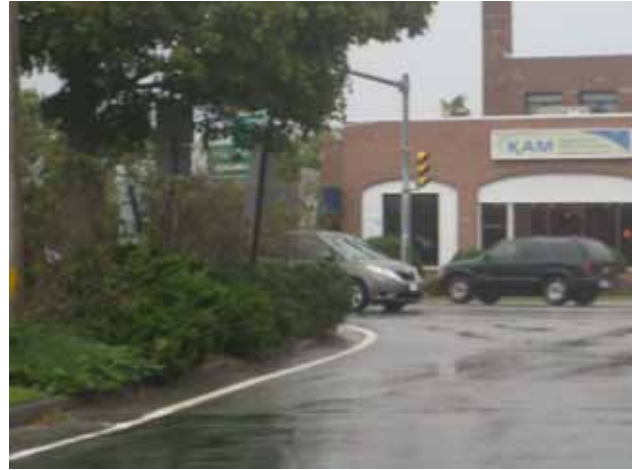
- Along Yarmouth Road northbound, guide signage for Route 28 northbound and southbound is provided on the southwest corner but is located behind a tree and is not visible. Also, no signage is provided for Route 6 along Yarmouth Road northbound.

Guide signs facing Yarmouth Road the northbound approach are blocked by trees.

1. Relocate “Left Lane Must Turn Left” (R3-7) sign along Route 28 eastbound so that it is visible to motorists.
2. Consider improving guide signage for Route 28 eastbound to direct motorists to Route 6.
3. Trim and maintain overgrown trees along Yarmouth Road northbound to improve visibility of Route 28 guide signage.
4. Consider appropriateness for installing guide signage for Route 6 along Yarmouth Road northbound.
5. Remove “Caution Crossing Traffic” sign near Dunkin Donuts/Hess driveway to reduce sign clutter.

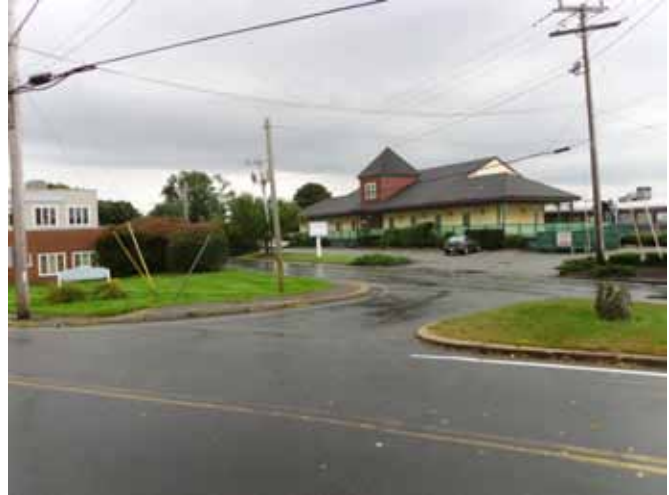
Slip lane between Yarmouth Road and Camp Street

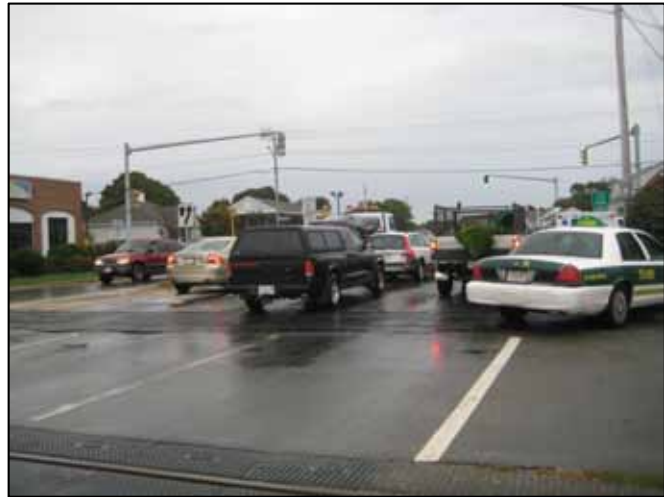
Two railroad crossings run across Route 28 approximately 65 feet and 100 feet west of Yarmouth Road, respectively. The tracks are currently primarily used by the Cape Cod Central Railroad. An audit team member stated that trains cross Route 28 approximately 6 to 8 times per day during the peak summer months.

Currently, the train must stop short of the intersection while railroad personnel manually stop traffic on Route 28 before lowering the arms. A team member commented that pre-emption for the railroad crossing was

provided, but may no longer be operational. When the arms are lowered, Route 28 eastbound traffic receives a red light from an upstream signal, which otherwise flashes yellow; however, no signal indications are provided for Route 28 westbound. Meanwhile, the traffic signal at Route 28/Yarmouth Road is not coordinated with the railroad crossing. Thus, vehicles continue to enter the intersection when trains are crossing, resulting in queues that block the intersection. Public safety officials noted that they have extreme difficulty getting through the intersection from Yarmouth Road when trains are crossing.

Railroad tracks across west leg of Route 28

1. Consider the feasibility of providing preemption for the railroad crossing and ways to coordinate Route 28/Yarmouth Road signal to reduce/eliminate queuing within the intersection and to improve emergency vehicle response time.
2. Consider the appropriateness of adding “Do Not Block Intersection” signage and appropriate pavement markings at Route 28/Yarmouth Road to discourage motorists from blocking the intersection during train crossings.
3. Consider the long-term feasibility of creating grade separation between Route 28 and the railroad crossings

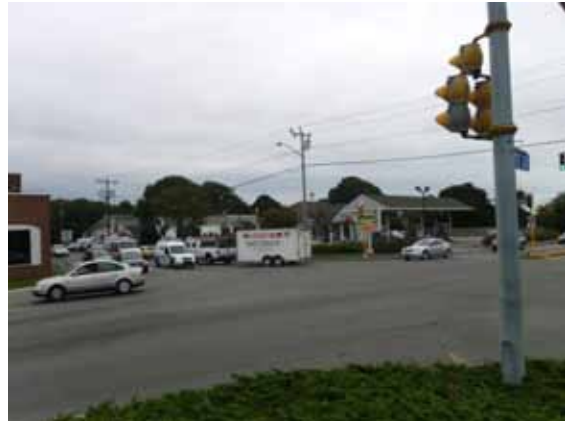
The Yarmouth Road northbound approach is provided with two post-mounted signal indications located on the northeast corner of the intersection. During field observations, the team noted that the visibility of the signal indications is easily blocked when large trucks are present in the Yarmouth Road northbound queue or turning at the intersection. Similarly, a team member commented that the signal indications along Route 28 westbound are also easily blocked by large trucks and that their visibility is further reduced by the horizontal curvature of Route 28 combined with overgrown trees on the north side of the roadway.

No overhead signal indications facing the Yarmouth Road northbound approach.

1. Evaluate the visibility of the signal indications as part of the design process to ensure that it meets current Manual on Uniform Traffic Control Devices (MUTCD) standards. Relocate signal heads, and/or install additional overhead and/or post-mounted signal indications as appropriate to improve visibility.
2. Consider the appropriateness of installing backplates on all traffic signal indications to reduce solar glare.
3. Trim overgrown trees to improve visibility of the signal indications.

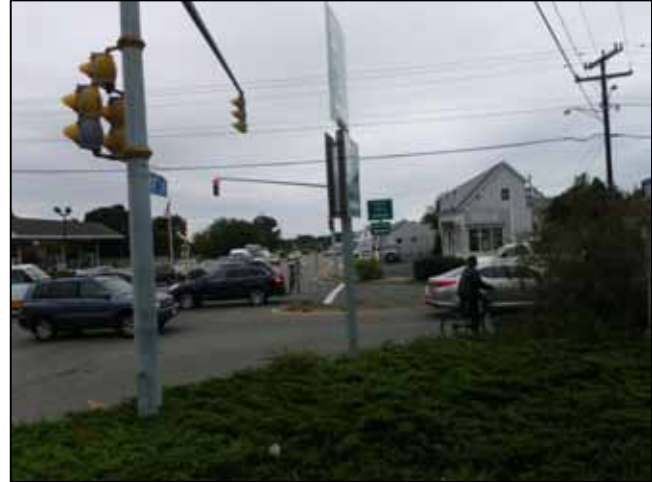
No bicycle provisions are currently provided at the intersection of Route 28/Yarmouth Road. Route 28 has a narrow shoulder upstream and downstream of the intersection; however, cyclists generally must travel in mixed traffic.

Bicycle accommodations are limited at the intersection.

1. Consider the feasibility/appropriateness of providing bicycle accommodations at the intersection (i.e., shared lanes and/or within a 4-foot shoulder, bicycle detection at signals, signage, and pavement markings) in accordance with the *2006 Project Development and Design Guide*.
2. As part of the design process and long-term planning efforts, include a Route 28 bicycle/pedestrian crossing to connect the future extension of the Cape Cod Rail Trail through the intersection.

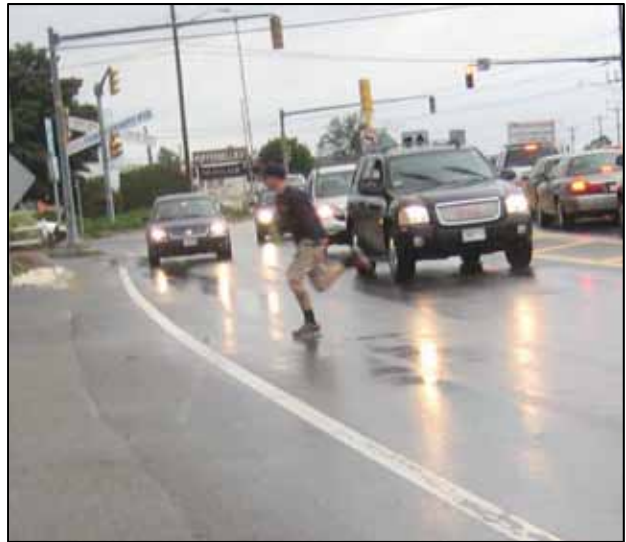
While conducting the audit, the team observed a moderate level of pedestrian activity along the study area roadways and crossing between gaps in the passing traffic stream. One crash was reported to have involved a pedestrian crossing in the vicinity of the railroad crossing; however, the pedestrian was not found.

Pedestrian running across Route 28.

1. Evaluate the feasibility and safety benefits of providing pedestrian accommodations at the Route 28/Yarmouth Road intersection, including crosswalks, accessible ramps, and pedestrian signal indications, and providing a connection between the intersection and the existing sidewalks on Camp Street and Yarmouth Road south of Route 28.

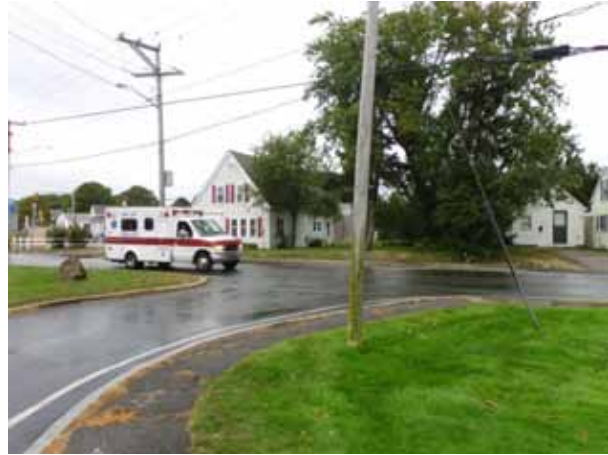
Audit team members noted that there is currently no emergency vehicle preemption system at the intersection of Route 28/Yarmouth Road, despite the high volume of ambulances that use the intersection to access Cape Cod Hospital. Three (7%) of the 45 crashes reported at the intersection between September 2009 and September 2012 involved an emergency vehicle. Two of these crashes involved ambulances. One crash occurred when an ambulance traveling on Yarmouth Road southbound was struck by a driver traveling on Route 28 eastbound, who could not see the ambulance due to solar glare. Another occurred when a car traveling on Route 28 eastbound stopped for an ambulance traveling on Yarmouth Road southbound and was rear-ended by another vehicle. The third crash involved a police vehicle attempting to navigate through the intersection.

The study area experiences frequent ambulance traffic.

1. Provide Opticom detection at the intersection of Route 28/Yarmouth Road to improve emergency vehicle response times.
