# ROAD SAFETY AUDIT

Route 28 at Santuit-Newtown Road

Town of Barnstable

December 9, 2021

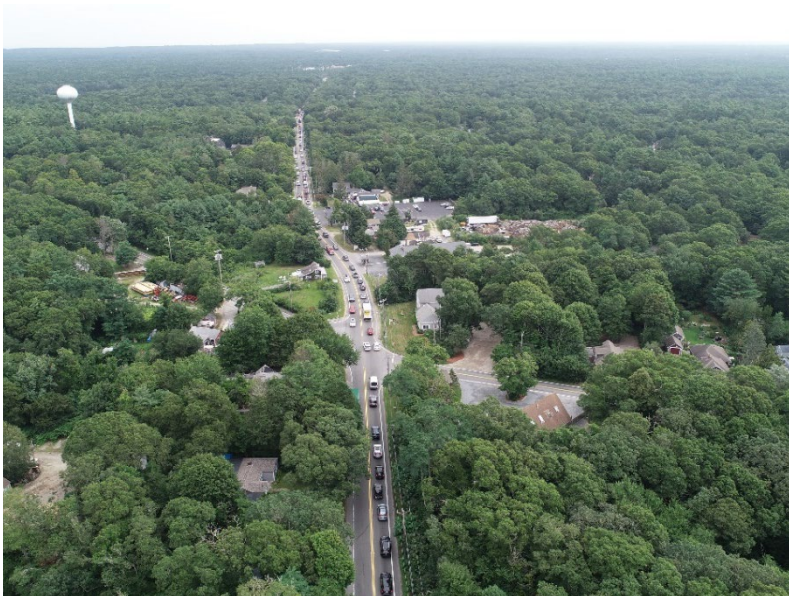
**Image 1: Route 28 congestion (drone view looking east)**

Westbound rear-end crashes occurred at various points within the intersection, ranging from downstream of the intersection, within the intersection, and upstream of the intersection. Route 28 westbound vehicle queues were noted to extend through the Santuit-Newtown Road intersection due to the downstream traffic signal located about a third of a mile west, at Route 28 at Route 130. Rear-ends also likely occurred as motorists were not aware of stopped traffic ahead due to limited visibility from a horizontal curve on Route 28 west of the intersection. Overall, there were 11 westbound rear-end crashes at the

intersection (or within close proximity), with five resulting in personal injury. The majority of Route 28 eastbound rear-end crashes occurred in advance of the intersection and may be due to Route 28 left turn vehicles queued at the intersection (Crashes #7, #32, and #35). Rear-end crashes are overrepresented in the summer when congestion is worse. Approximately 71% of rear-end crashes occurred during the summer peak (July-September), while only 51% of overall crashes were rear-ends in the study period.

Heavy congestion on Route 28, along with the lack of adequate gaps in traffic, may cause excessive delays which can lead to certain unsafe crossing and turning behaviors from drivers on Santuit-Newtown Road. For example, many participants mentioned that drivers, especially from the southbound approach, can become impatient and take insufficient gaps in traffic to make turns (or go straight). Participants noted that many drivers familiar with the area avoid making left turns at this intersection, due to this difficulty of this maneuver. This is reflected in the traffic count data where right turns from Santuit-Newtown Road are the predominant movement. Additionally, as a four-way unsignalized intersection, drivers exiting Santuit-Newtown Road must also anticipate the movement of an opposing vehicle on the other side of Santuit-Newtown Road when looking for an adequate gap in traffic. The lack of right-of-way assignment may lead to driver confusion and further hinder intersection operations.

- Examine the possibility of adjusting signal timing (or otherwise improving traffic flow) at the Route 28/Route 130 intersection to reduce congestion and vehicle queues that extend to the study intersection.
- Install a traffic signal at the Route 28/Santuit-Newtown Road intersection to provide safe gaps in traffic, significantly reducing angle and “courtesy crashes.”<sup>1</sup> The traffic signal should also include emergency vehicle preemption and signalized pedestrian crossings.

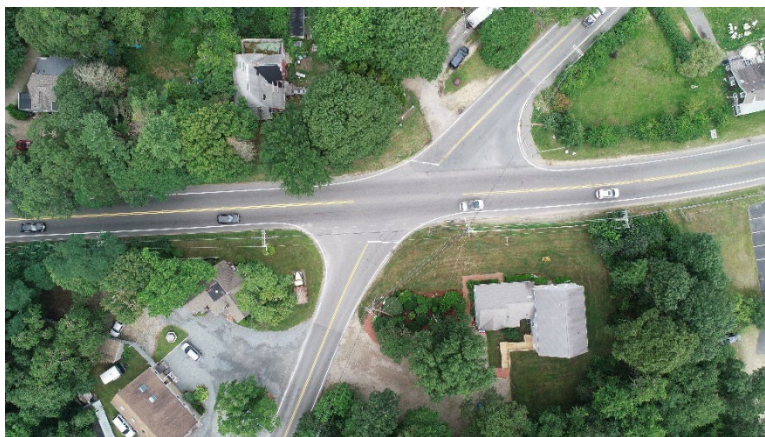
The intersection's skew angle and offset means that the distance that vehicles on Santuit-Newtown Road must travel across Route 28 is increased (as compared to a perpendicular intersection). These long crossing distances may cause drivers to misjudge the amount of time needed to cross the intersection. This could result in crashes, particularly angle crashes. The skewed nature of the intersection also means that vehicles on Santuit-Newtown Road going straight across Route 28 must often make a partial turn onto Route 28, (that complex maneuver contributed to Crash #22).

A similar issue with geometry occurs for vehicles on the minor approaches attempting to turn left. Because of the skew, drivers attempting these maneuvers must make obtuse (greater than 90 degrees) turns. Drivers require additional time to make this turn (compared with right angles) and may misjudge the gap required to complete it. Crashes #6, #11, #13, #18, and #20 all involved southbound drivers attempting a left turn onto Route 28 eastbound, and then being struck by westbound drivers on Route 28.

**Image 2: Drone view of the intersection, looking north**

- Consider installing a roundabout to better facilitate movements across Route 28.
- Consider installing an overhead flashing signal for increased awareness and improved visibility of the intersection for vehicles on Route 28.
- Examine the possibility of installing delta islands to ban left turns and/or through movements from Santuit-Newtown Road.
- Reconstruct the intersection to improve the roadway geometry to a more conventional 90-degree layout so that all approaches are perpendicular.

- Widen Route 28 to allow the creation of exclusive left turn lanes.
- On both approaches of Santuit-Newtown Road, consider narrowing the single lane width by striping a wider shoulder line to eliminate side-by-side queuing on this approach.
- Tighten curb radii at all the approaches to the intersection. Extending into Route 28, this would discourage or eliminate the ability of through-moving vehicles on Route 28 to pass on the right those attempting to turn left.
- Consider installing delineators on the double yellow centerline on both northbound and southbound approaches to prevent encroachment into opposite lanes.

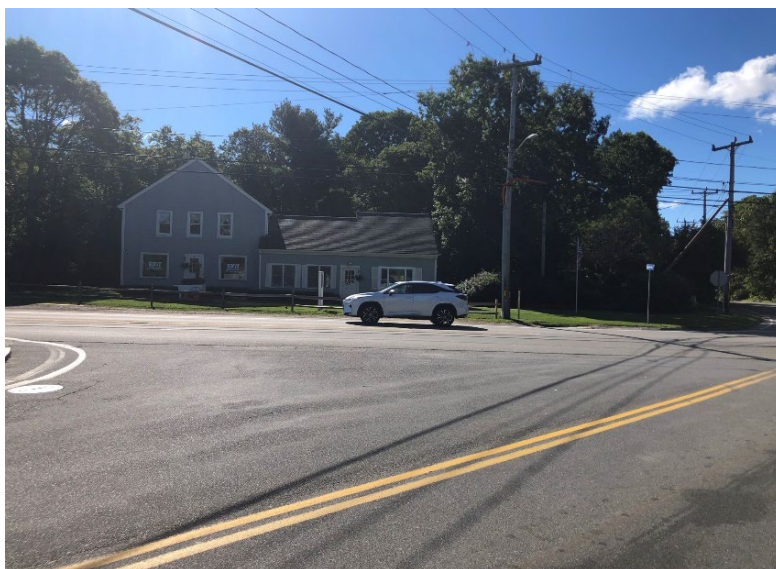
The skewed angle of the intersection results in large corner radii, most notably in the northeast quadrant, that creates additional area of pavement surface at the intersection. With the additional pavement at the corners of the intersection, vehicles on the minor approaches have been observed to queue side-by-side with one car attempting a right turn lane and the other attempting a left turn or a through movement. During this occurrence, sight lines are affected for each driver. Southbound left turning vehicles have been observed to encroach over the double-yellow centerline on the northern Santuit-Newtown Road

**Image 3: A view of the wide corner radii in the northeast corner of the intersection**

approach in an attempt to improve their sight lines at a more conventional 90-degree angle. This may impede drivers attempting to go north on Santuit-Newtown Road.

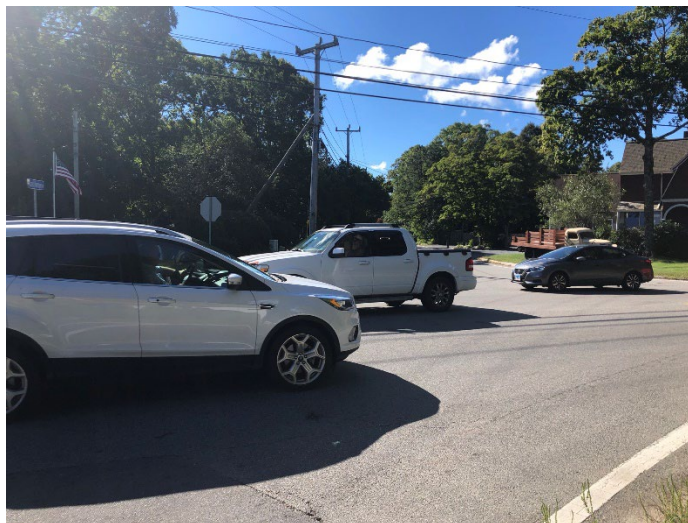
Drivers on Route 28 also encounter safety issues related to the roadway geometry. The skewed nature of the intersection means that when drivers on Route 28 attempt a left turn onto Santuit-Newtown Road, drivers behind them often go around them, which can cause additional conflicts. One risk of this maneuver is that the passing driver can collide with vehicles edging out from the Santuit-Newtown Road. (see Crash #16).

**Image 4: An eastbound vehicle passing a left turning vehicle on the right-hand side**

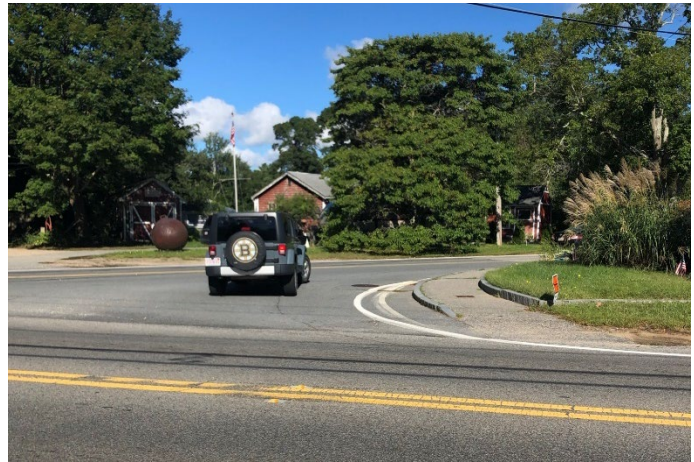
RSA participants noted that multi-modal accommodations at this intersection are generally lacking, which creates an uncomfortable environment for potential users. There is a sidewalk located on the eastern side of Santuit-Newtown Road (northern approach only) that was noted to be overgrown with vegetation in some areas. The sidewalk ends at the Route 28 intersection with no other connections or accommodations. There are also no delineated bicycle accommodations (although shoulders are present on Route 28, as described earlier). Those shoulders, however, are not comfortable throughout the corridor for bicycling. RSA participants noted that the lack of pedestrian and bicyclist crashes at this intersection is likely due to pedestrians and bicyclists avoiding the intersection.

**Image 5: Where the sidewalk ends on Santuit-Newtown Road**

- Remove overgrown vegetation along the existing Santuit-Newtown Road sidewalk.
- Install sidewalks where missing on all approaches of intersection.
- Consider identifying pedestrian desire lines and, if appropriate, install a crosswalk and curb ramps within the study area to safely accommodate pedestrians crossing Route 28. Evaluate treatments such as a Rectangular Rapid-Flashing Beacon (RRFB) for potential marked crosswalks.
- Consider a sidepath on Route 28 and a lower-level bicycle facility on Santuit-Newtown Road.
- Work with the CCRTA to explore installing permanent bus pull-off locations and bus stops on both sides of Route 28.

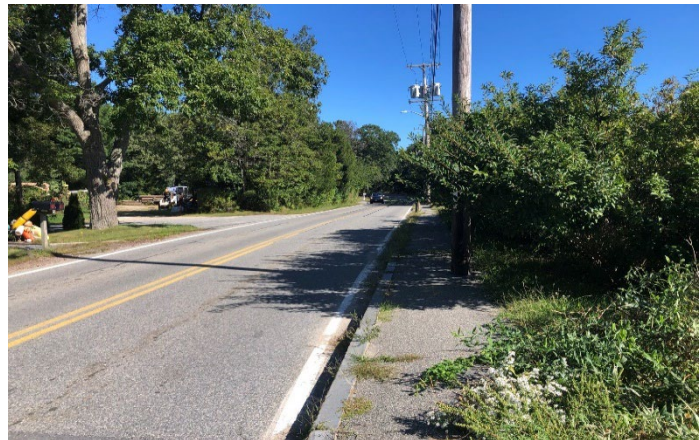
**Image 6: Existing sidewalk on Santuit-Newtown Road to the north**

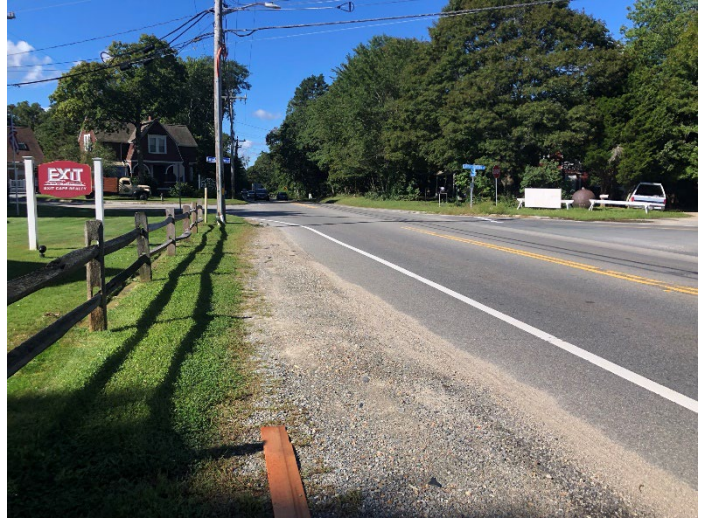
As mentioned earlier, Route 28 is served by the Sealine Route of the CCRTA. Buses stop on request east and west of the intersection, utilizing informal dirt pull-offs; however, there are no sidewalk accommodations for transit riders when accessing this intersection. It was also noted that eastbound buses, in particular, often pull over just east of the intersection. However, this pull-off is close to the intersection and is narrow; consequently, buses often block vehicles behind them, creating the potential for trailing vehicles to encroach on the opposing travel lane while passing.

**Image 7: A View looking westward toward the intersection. Bus pullout for eastbound buses is in foreground. Note the lack of bicycle and pedestrian accommodations (except for shoulders)**

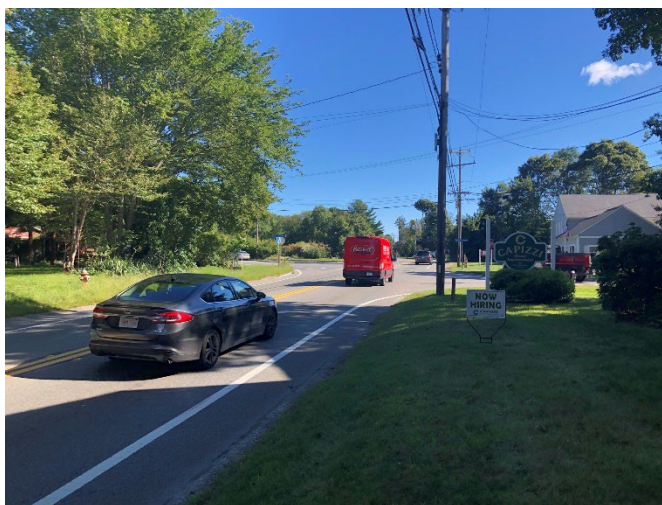
Secondly, there is significant vegetation on the northeast corner of the intersection, and to a lesser extent, other corners, which can impede visibility. Finally, the Capizzi Home Improvement sign on the southwest corner blocks sightlines for westbound drivers on Route 28 and northbound drivers on Santuit-Newtown Road who are preparing to turn left and travel straight.

**Image 8: View of the Capizzi Home Improvement sign (looking eastward)**

- Clear vegetation on all corners of the intersection with the northeast corner of the intersection being the highest priority.
- Consider installing improved intersection warning signage on Route 28, with flashing assemblies triggered by detectors. Options could include “Be Prepared to Stop” (for congestion on Route 28) or an Intersection Conflict Warning System (flashing when vehicles on Santuit-Newtown enter/cross 28).
- Add road name sign placards on advanced assemblies to ensure greater intersection visibility.
- Evaluate lighting and consider upgrading or installing additional street lighting.
- Relocate the Capizzi Home Improvement sign further back from the intersection.
- Coordinate with snowplow operators to ensure that any snowdrifts are of a limited height and are placed away from intersection corners.

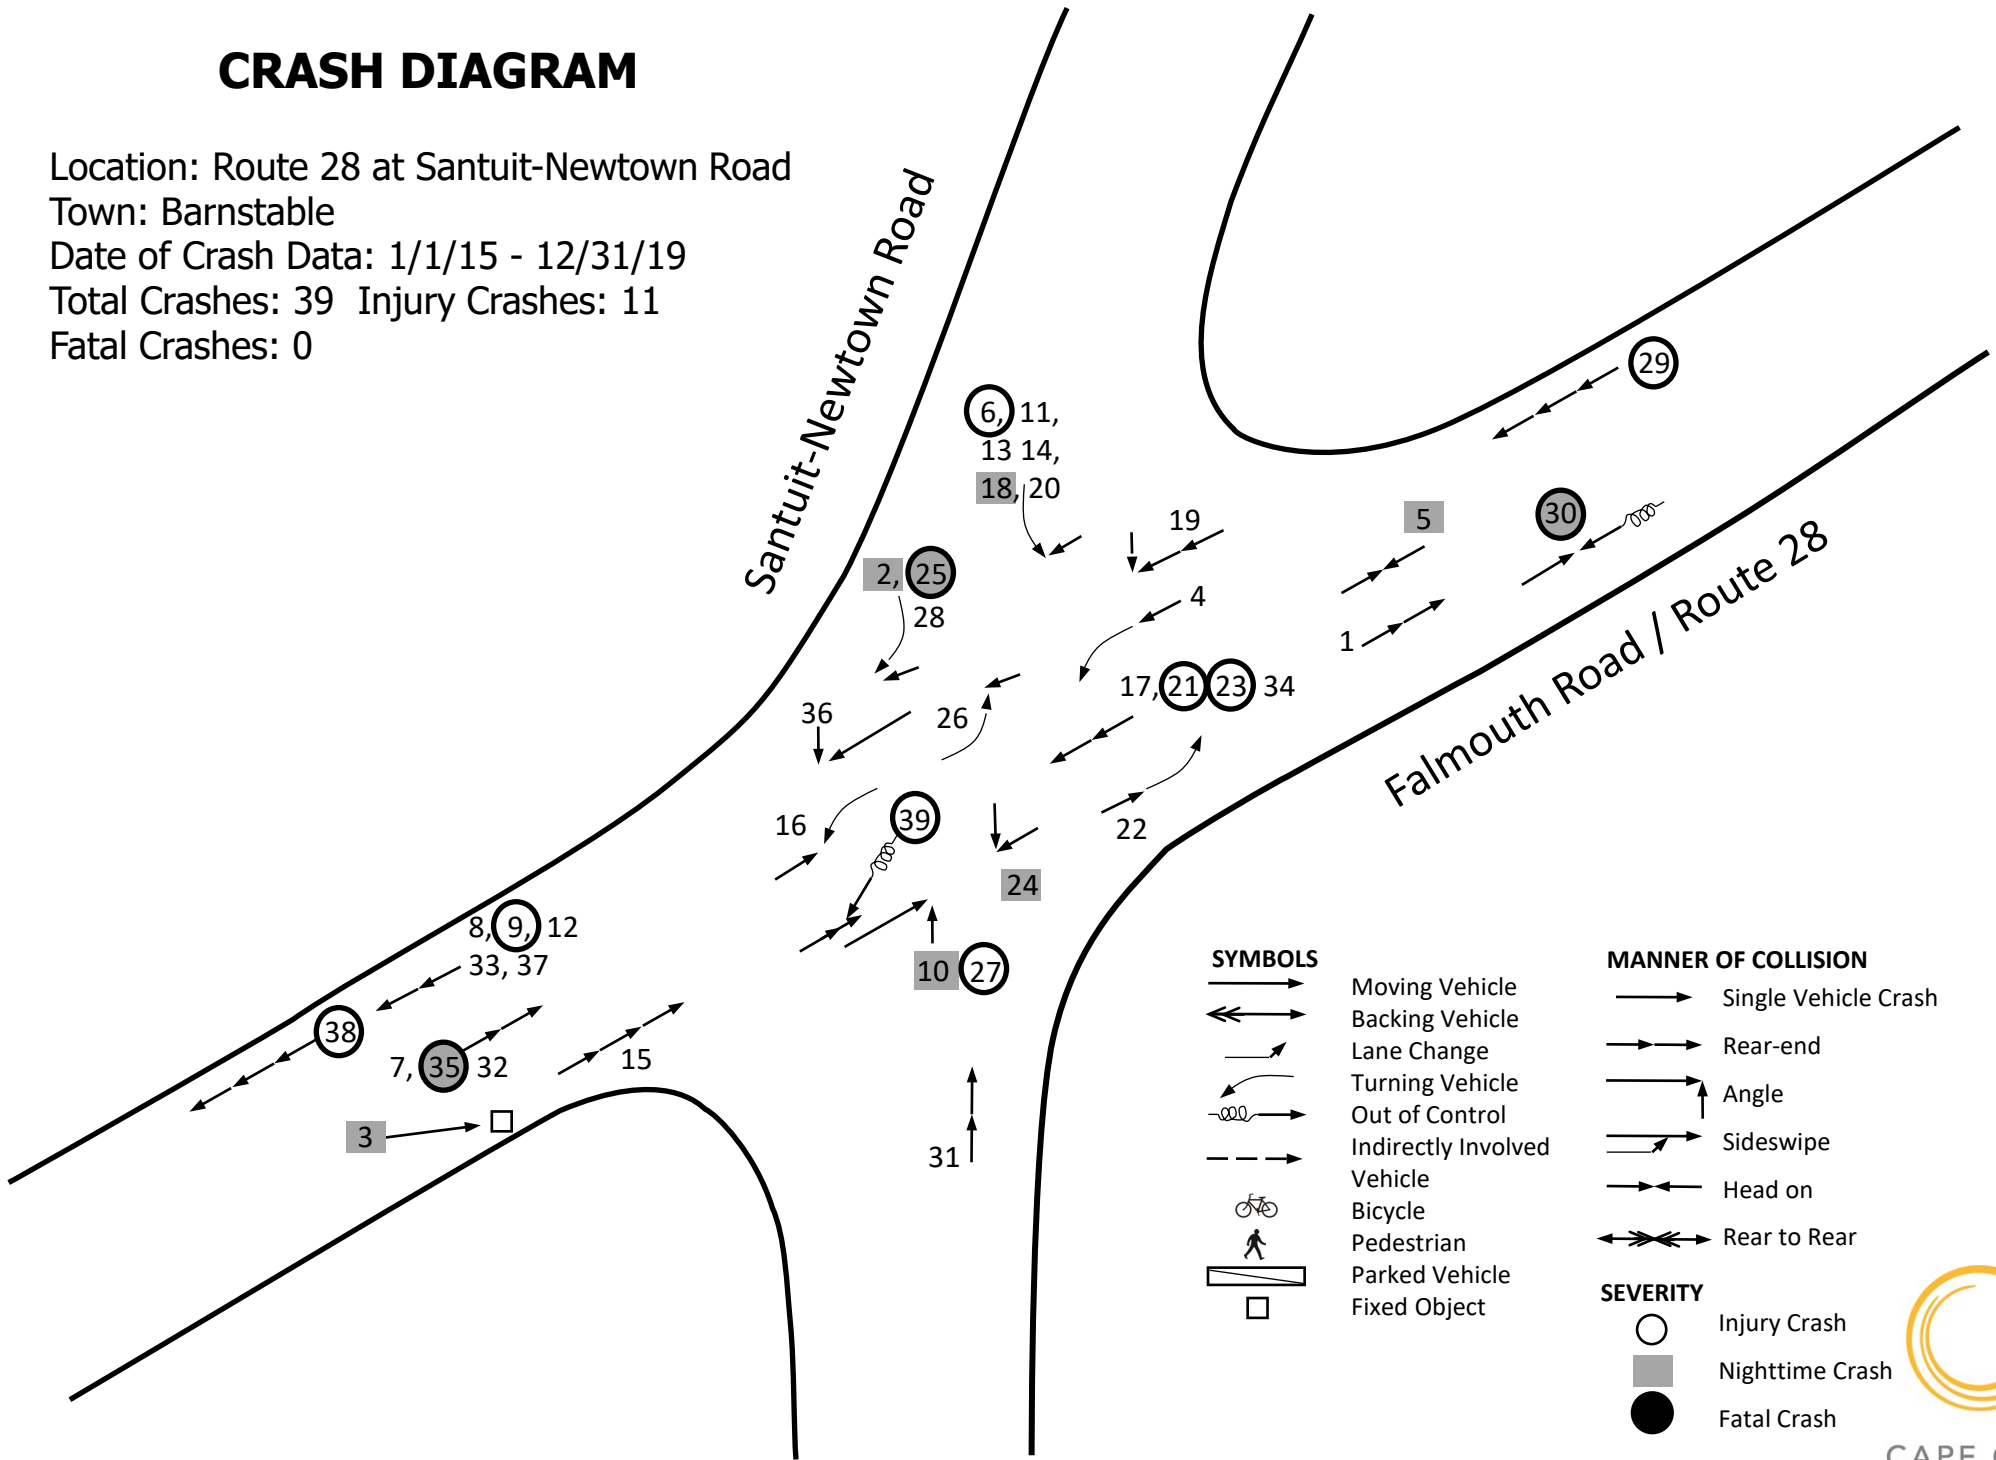
# CRASH DIAGRAM

Location: Route 28 at Santuit-Newtown Road  
 Town: Barnstable  
 Date of Crash Data: 1/1/15 - 12/31/19  
 Total Crashes: 39 Injury Crashes: 11  
 Fatal Crashes: 0
