ROAD SAFETY AUDIT

Town of Bourne

June 21, 2022

Prepared For:
MassDOT

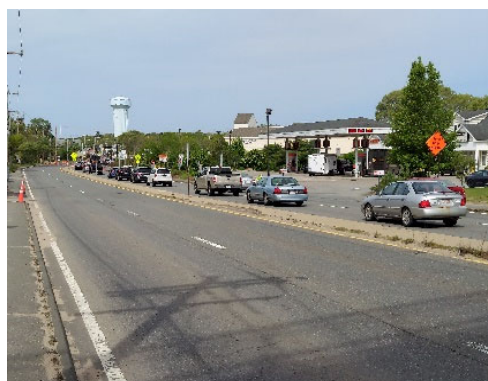
1. It was noted that there is not sufficient street lighting along the segment, aside from indirect lighting from the Speedway Gas Station. Non-uniform street lighting can make it difficult for a driver's eyes to adjust to see properly at night and maintain drivers' expectations along the roadway. It was noted that three of the seven of crashes (Crashes #3, #5, and #6) happened during low-light conditions, including dawn, dusk, and nighttime (dark-not lighted) periods of the day.

Image 1: Lack of shoulder or right turn lane by the Speedway Gas Station

1. Evaluate increased street lighting on this segment of Scenic Highway. Increased street lighting is expected to improve lighting conditions for drivers, particularly those in the left lane, further from the gas station, to see and provide uniform illumination.
2. Consider using pavement markings that have higher reflectivity, such as thermoplastic, to increase the visibility of the markings affected by the lighting.

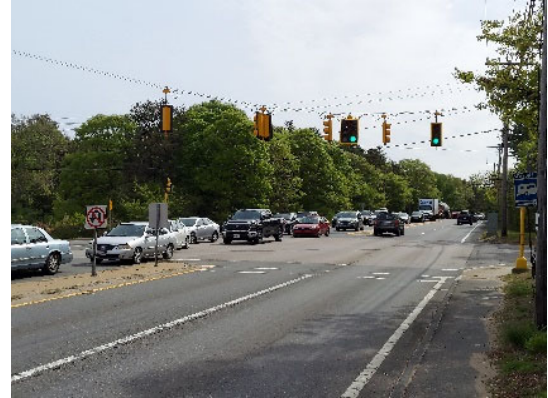
1. At the intersection of Scenic Highway with Nightingale Pond Road, it was noted that the Scenic Highway eastbound protected left-turn phase was inconsistently activated. During the Audit, vehicles in the left-most lane (designated as a shared left/through lane) on the Scenic Highway eastbound approach waiting to turn left were observed to be provided the leading, protected left-turn green arrow signal approximately half of the cycles in which a vehicle was queued in this lane.

Image 2: Lack of left turn lane on Eastbound intersection approach

Members of the Audit team suggested that there may likely be faults in the loop detection system for the eastbound left-most approach lane, in which the detectors were not detecting vehicles consistently. This would affect a left-turning driver's normal expectation of making the protected left turn under a left-turn protected phase assigned by the traffic signal (green arrow), instead requiring them to make a permissive (unprotected) left turn across the path of oncoming traffic. When drivers attempt to make left turns during the permissive phase, they may be more inclined to turn when there are shorter gaps in opposing traffic. The lack of a consistent protected left-turn phase leads to an increase in vehicles needing to use the permissive phase, which could result in angle crashes (Crash #16). Accepting shorter gaps in opposing traffic could result in additional angle crashes between the left turning vehicles and through vehicles, as there is less time for the through vehicles to slow or stop to avoid a crash.

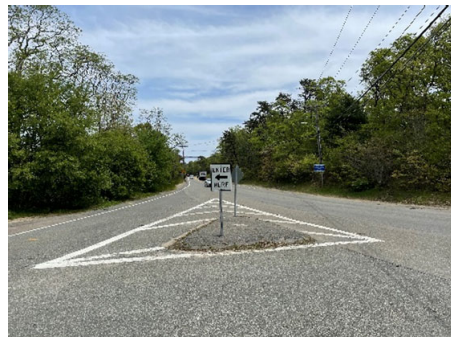
Image 3: Signs obstruct sightlines to east, from stopped approach

7. It was noted that signs on both raised islands at the intersection were posted at heights obstructing the sightlines of vehicles (looking to the east). Obstructed sightlines reduce intersection sight distances necessary for stop-controlled vehicles to see and judge whether or not there are adequate gaps in oncoming traffic. Insufficient sight distances increase the risk of angle crashes between vehicles turning out of Sandwich Road southbound.

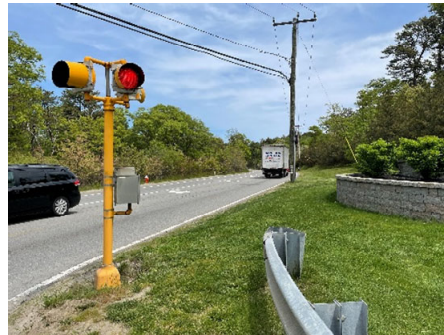
1. It was noted by members of the Audit team that the current location of the post-mounted flashing beacon at this intersection is not the ideal location for it to be seen by drivers. It is located at one corner of the intersection, adjacent to the larger lighted Upper Cape Cod Regional Technical School sign. Lack of awareness of the presence of this intersection may contribute to rear-end crashes (Crashes #4, #5, and #8).

Image 4: Beacons at the intersection with the School Driveway

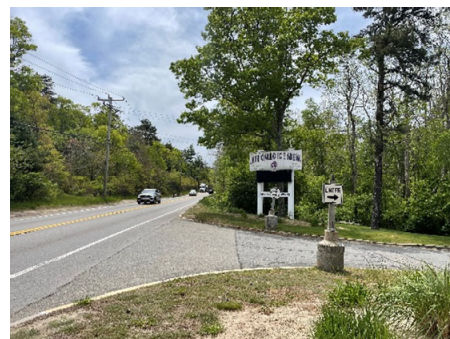
Image 5: Vegetation was observed obstructing sightlines to the entrance to Gallo Arena

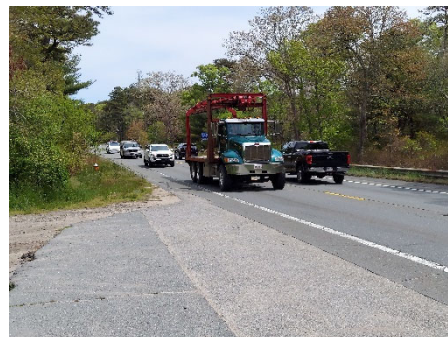
Image 6: Lack of “No Parking” signs on Sandwich Road leads to parking along the road

2. It was observed that vehicles were parked in gravel areas outside the shoulder along the north side of Sandwich Road and at the access driveways to the Canal Service Road. It was noted that people park in these areas and walk to the Canal to engage in recreational activities (fishing, biking, etc.). The Audit team identified that there were no signs prohibiting parking in these areas. Unauthorized parking along the roadside increases the number of potential conflict points along Sandwich Road as vehicles leave the areas used for unauthorized parking along Sandwich Road. These frequent conflict points cannot be easily anticipated by drivers on Sandwich Road and increase the risks of angle crashes or rear end crashes due to sudden stops along Sandwich Road (noted for Crashes #2 and #5).
