# ROAD SAFETY AUDIT

Station Avenue at White's Path/Workshop Road

Town of Yarmouth

Final  
October 5, 2023

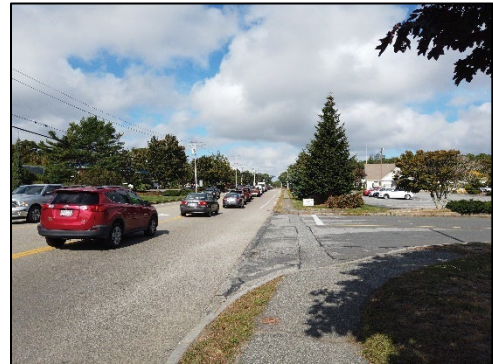
The RSA team noted during the site visit that there are several issues related to turn lane storage and lane widths. At this intersection, the crashes observed were rear-end (53%), angle (27%), or sideswipe, same direction (20%). Participants noted that these crashes may be due to short storage lengths and smaller lane widths. Both approaches on Station Avenue seem to have insufficient turn lane storage lengths, as well as on the White's Path approach. On the northbound approach of Station Avenue, northbound vehicle queues regularly block the left and right turn lanes. Additionally, the southbound left turn lane is regularly blocked by Station Avenue southbound through vehicles.

**Image 1: Left lane is blocked by the queues in the through travel lane on Station Avenue northbound.**

- Evaluate extending the storage length of the exclusive left lane on the northbound and the southbound approach of Station Avenue.
- Evaluate extending the storage length of the channelized right turn lane on the northbound approach of Station Avenue.
- Construct larger pedestrian refuge islands in the existing striped gore areas to reduce the amount of space available at the stop lines.
- Evaluate measures to tighten intersection geometry (e.g., removing slip lanes, reducing curb radii, alignment) to reduce the overall footprint of the intersection.
- Add wider shoulders on Station Avenue, adding room from emergency services.
- Evaluate the possibility of formally converting the northbound right turn only lane on Station Avenue to a shared through-right lane (note that this improvement would require coordination with any work done at the Route 6 interchanges).

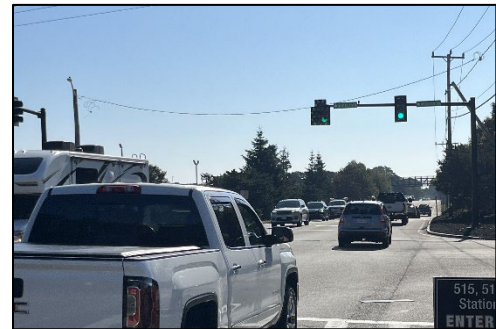
**Image 2: Signal head have LEDs burned out and are missing retroreflective backplates.**

RSA participants noted that some of the signals had several LEDs out, making the green lights less visible. The emergency pre-emption at the intersection appeared to be functioning during the site visit as the RSA team watched an ambulance make use of the system heading northbound on Station Avenue. The emergency pre-emption system, however, is missing the white flashing confirmation.

- Install a secondary signal head on the mast arm pole in both Station Avenue northbound and southbound directions.
- Replace the broken LEDs in the signal heads.

- Add retroreflective backplates to the signal heads at the intersection.

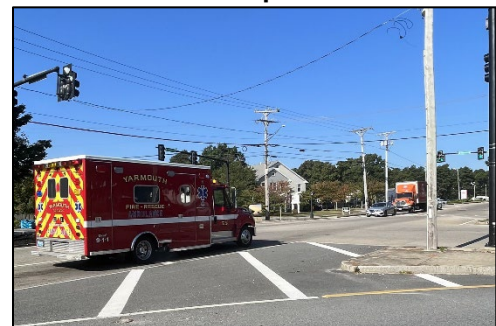
**Image 3: Ambulance observed during the RSA utilizing the emergency pre-emption system without a confirmation beacon.**

- Install missing flashing white indicator beacon for the emergency pre-emption system.
- Review and update signal timings, including clearance intervals and the pedestrian phase, to conform with latest standards.

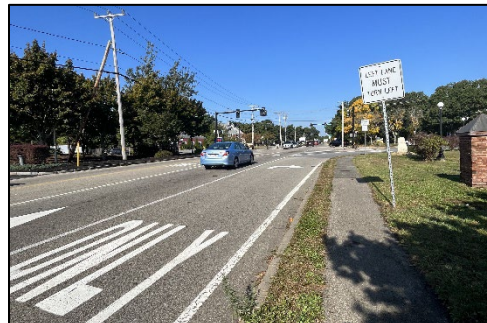
Pavement markings and signage were another noted issue for the travel lane assignments on Station Avenue. Drivers headed both north and south on Station Avenue experience some confusion as to lane assignments.

**Image 4: “Left Lane Must Turn Left” sign on Station Avenue northbound.**

- Conduct a signage inventory on current signage to assess if correct in location or if needs removal or replacement.
- Consider installing an MUTCD R10-12 "Left Turn Yield on Green" sign overhead on the signal mast arms to inform users of the left turn lane signal phasing on Station Avenue.

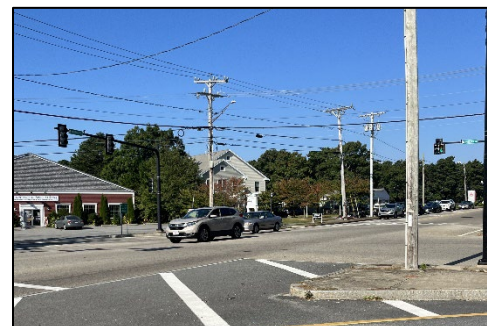
During the site visit, participants witnessed a through vehicle that had gotten stuck in the southbound left turn only lane. The vehicle then proceeded to cut off vehicles in the through-right lane when the light changed to merge back into the correct lane on Station Avenue southbound. While in the northbound direction, a vehicle was noted to travel straight using the right turn only lane that transitions into a striped gore area. The pavement markings do not extend far enough for them to make an effective decision on selecting the appropriate travel lane for their desired movement. The team noted during the site visit that existing turn lane regulatory signage (R3-7 series) were either too close to the intersection to be effective or in was in the wrong location. On Station Avenue, the northbound “Left Lane Must Turn left” (R3-7) sign and the northbound “Right Lane Must Turn Right” signs are two of the signs that were noted to be ineffective based on position as there are often lengthy vehicle queues. Crashes # 1, 9, 11, and 13 show that drivers must make last minute decisions to change what lane they are in due to lack of advanced notice and driver confusion.

**Image 5: Vehicle cutting off vehicles in the through-right lane attempting to merge in from the southbound left lane.**

- Extend the current pavement markings for the storage lanes on Station Avenue.
- Add lane markings for the right turn only lane on White's Path.
- Mark auxiliary lanes in the northbound direction on Station Avenue where there is an existing lane drop sign.

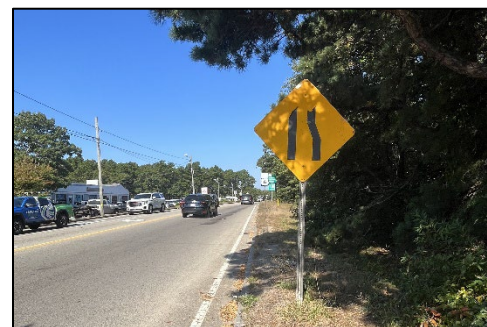
During the RSA field visit, it was observed that there was existing W4-2 lane drop warning signs that were inadvertently located on Station Avenue immediately north of the intersection in both directions. These signs may cause confusion to drivers who may think that two through lanes are allowed on Station Avenue approaching or departing the signalized intersection from the north. The southbound W4-2 sign

**Image 6: Existing W4-2 lane drop signs that were inadvertently located on Station Avenue.**

(coming from the Route 6 interchange ramps) is not supported as the road opens to two lanes as motorists approach the intersection. The southbound W4-2 sign may cause drivers to inadvertently switch into the left turn only lane, thinking the right lane is ending. The roadway width where the northbound W4-2 is located (north of the White' Path intersection) is wide enough to support a small section of two through travel lanes, however there are no formal lane markings.

- Remove the existing W4-2 lane drop sign in the southbound direction on Station Avenue (north of White's Path).
- Evaluate existing lane assignments for Station Avenue approaches and consider modifications as needed, including the potential for two through lanes.

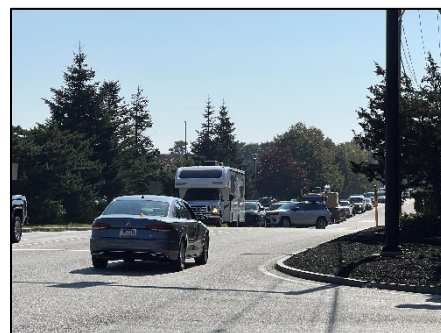
Near the intersection there are two curb cuts for the Mobil gas station at the southwest corner of the intersection. These curb cuts cause conflict when vehicles take left turns out of the gas station. Vehicles using these curb cuts resulted in two of the observed crashes, # 9 and 11. The curb cut for Mitsubishi and the Mid-Cape Pet Supply store on Workshop Road is difficult to enter in and out of given its proximity to the intersection. The uniqueness of this curb cut can also provide issues for trucks taking right turns from Station Avenue into this driveway as the turn radius needed is small.

**Image 7: Vehicle attempting to merge into the through lane after making a left from the Mobil station.**

- Coordinate with the Mobil gas station to revise the site driveway(s) to restrict movements only due to proximity to the signal.
- Encourage Mobil Gas to install signage encouraging patrons to use the driveway that exits onto Workshop Road to make left turns heading north on Station Avenue.

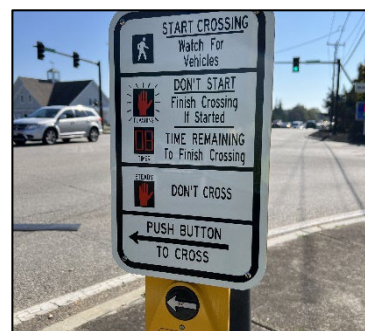
**Image 8: Push button sign mentioning countdown timers, which are not present.**

During the site visit, the RSA team noted that the pedestrian push button signs that are present do not correspond with the current pedestrian equipment that is present at the signal. The signs mention countdown timers, which are not present. There are also no pedestrian push buttons or pedestrian signals for pedestrians trying to cross the two channelized right turn lanes in the northeast or southeast quadrants. Pedestrians crossing the channelized right turns must wait for vehicles to yield in order to enter the marked crosswalk. During the site visit, the RSA team noticed that there was sand as well as debris built up on the existing sidewalks and curb ramps around the intersection.

- Widen the existing sidewalks at the intersection to meet current standards.
- Install sidewalks on the west side of Station Avenue, providing a connection to the existing northern sidewalk.
- Add missing crosswalks and pedestrian signal equipment for all approaches at the intersection.
- Reconstruct existing curb ramps at the intersection to meet current ADA standards.
- Install pedestrian countdown timers to be consistent with signage.
- Consider removing the channelized right turns or incorporating the channelized right turns into the signal operations to increase pedestrian safety for the northeast and southeast crosswalks which do not operate under the exclusive pedestrian phase.
- Maintain the existing sidewalk facilities to keep them clear of sand and debris.
- Evaluate installing bike boxes at the intersection.
- Add pavement markings for the bicycle detection loops.

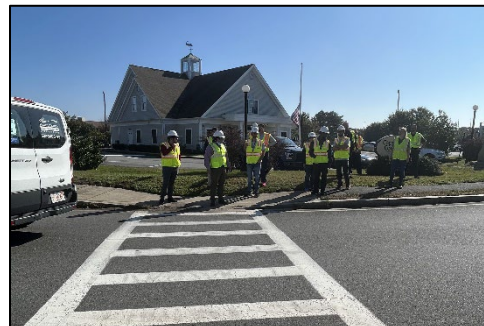
6 eastbound ramp and White's Path. At the signal, crosswalks are not present in all directions, leaving pedestrians with challenges crossing Workshop Road and the northbound approach on Station Avenue. The crosswalks that do exist at the signal are not in compliance with current ADA standards.

**Image 9: No pedestrian equipment on the sidewalk in the southeast quadrant to allow pedestrians to start the pedestrian phase.**

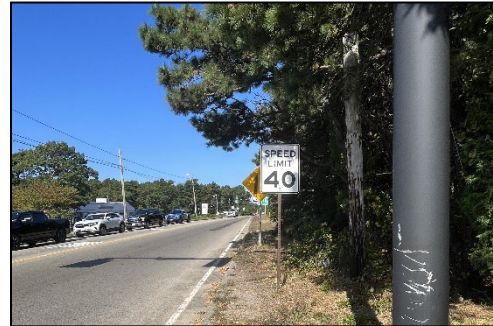
Station Avenue is a significant north-south connector and White's Path as well as Workshop Road provide access to important industrial and commercial areas. Posted speed limits through this intersection are rather high which may be a contributing factor to the number of rear ends observed. The straight roadway alignment and proximity to the Route 6 interchange could be contributing to higher speeds on Station Ave. Audit members also noted this is a transition area between differing roadway types and between a residential and commercial area. Drivers going faster during the offseason may contribute to the higher percentage of crashes occur outside of the summer season as the congestion is lower. There is also a significant number of crashes with a contributing factor of inattention at this intersection, distracted driving as well as drivers unfamiliar with the intersection's layout could be the cause of this. It was also observed in the field that drivers take the northbound right turn from Station Ave to White's Path at high speeds.

**Image 10: 40 mile per hour speed limit sign to the immediate north of the intersection.**

- Evaluate existing speed regulations and consider revising speed regulations for Station Avenue in the vicinity of the intersection, once other countermeasures related to speed reduction have been implemented.
- Coordinate with Yarmouth Police Department to enforce distracted driving laws including the hands-free law.
- Consider implementing traffic calming measures to encourage slower speeds through the intersection. Evaluate the current vehicle speeds along Station Ave to use as a baseline in selecting potential speed management countermeasures.
- Consider adding speed management countermeasures in the vicinity of the interchange (markings, flex posts temporary median).
