ROAD SAFETY AUDIT

Route 134 at the Route 6 Ramps

Town of Dennis

August 2009

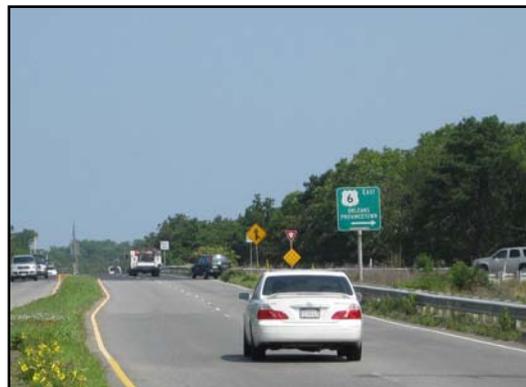
As stated above, 90% of the crashes at the Route 134/Route 6 interchange were rear-end crashes. Police noted that most crashes here occur when the second or third driver in the queue does not verify that the first driver completed his/her maneuver onto Route 134 before proceeding. Field observations indicated that uncertainty about the configuration of the merge lanes may result in driver confusion about how to maneuver from Route 6 to Route 134. Additionally, the steady flow of vehicles on Route 134 that reduces the number of available gaps, combined with the lack of a clear message regarding the merge condition, may lead a driver to take advantage of a smaller gap than is safe to enter Route 134.

Looking northbound on Route 134 toward Route 6 interchange.

1. Review operations and the feasibility of adding adequate acceleration and deceleration lanes at the interchange of Route 134/Route 6.
2. At the Route 6 eastbound off-ramp to Route 134 southbound, lengthen the solid white channelization line from the end of the delta island to reinforce the separation between the ramp and Route 134 southbound, and to delineate the additional lane. Replace the merge sign with an “add lane” warning sign. In conjunction, review the distance between the Route 6 eastbound ramps and the mall signal for appropriate weave distance.
3. Provide adequate turning radii to accommodate larger vehicles in a single lane on the Route 6 eastbound ramp to Route 134 southbound and on the Route 6 westbound ramp to Route 134 northbound.

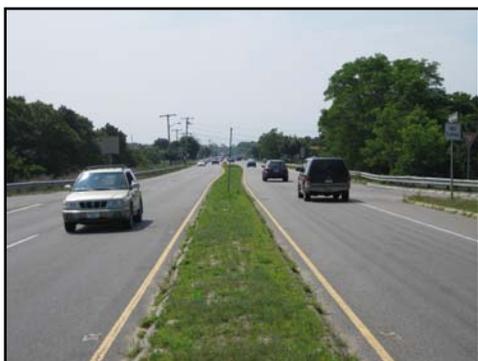
Looking southbound on Route 134 toward Patriots Square Mall.

lane. The perceived short distance to weave to access the retail areas and Main Street further complicates the travel patterns. The team observed that many motorists exiting from Route 6 eastbound to Route 134 southbound are destined for Patriot's Square Mall, requiring them to weave across two lanes. Motorists on Route 134 southbound who wish to access Main Street, located on the west side of Route 134 south of the Route 6 eastbound off-ramp, must also weave across two lanes in a short distance to access their destination.

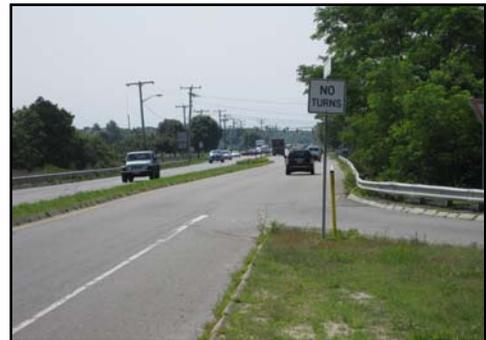
The Route 134/Route 6 interchange has worn or missing pavement markings. However, the pavement markings on the bridge over Route 6 have recently been re-striped in conjunction with the repaving of the bridge deck.

Worn pavement markings at the interchange of Route 6/Route 134.

1. Re-stripe and maintain durable pavement markings at the interchange of Route 134/Route 6.

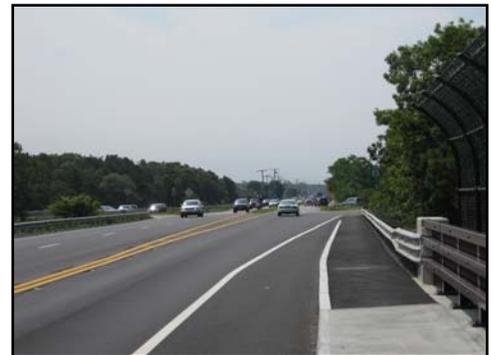
The RSA team members noted that several nearby residents walk to the commercial areas. A sidewalk is provided only on the west side of the Route 134 bridge over Route 6. Prior to the bridge, no sidewalks or crosswalks are provided across the on- and off-ramps.

The sidewalk on the Route 6 bridge.

1. To accommodate pedestrians, a continuous sidewalk should be provided along Route 134. Additionally, crosswalks and appropriate control would be needed at the intersections of Route 134 and the Route 6 ramps.

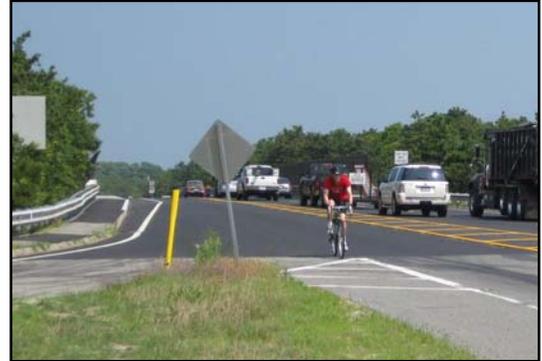
During the field visit, the RSA team observed several bicyclists traveling along Route 134. The team noted that bicycle accommodations on Route 134 are limited, with a 6-foot shoulder along Route 134 southbound on the Route 6 bridge. South of the interchange of Route 134/Route 6, a multi-use path is provided (see **Figure 1**). Ideally, the Town of Dennis wants to provide bicycle accommodations along Route 134 so bicyclists can connect to the multi-use path and commercial-use destinations. RSA team members noted that, because Route 134 is one of only two north-south corridors in Dennis, bicycle accommodations are needed.

A bicyclist maneuvers through the Route 134/Route 6 interchange.

1. Provide bicycle accommodations along Route 134 and bicycle connections to the multi-use path south of Route 6.
