# Wellfleet: Route 6 Safety Study

December 2012

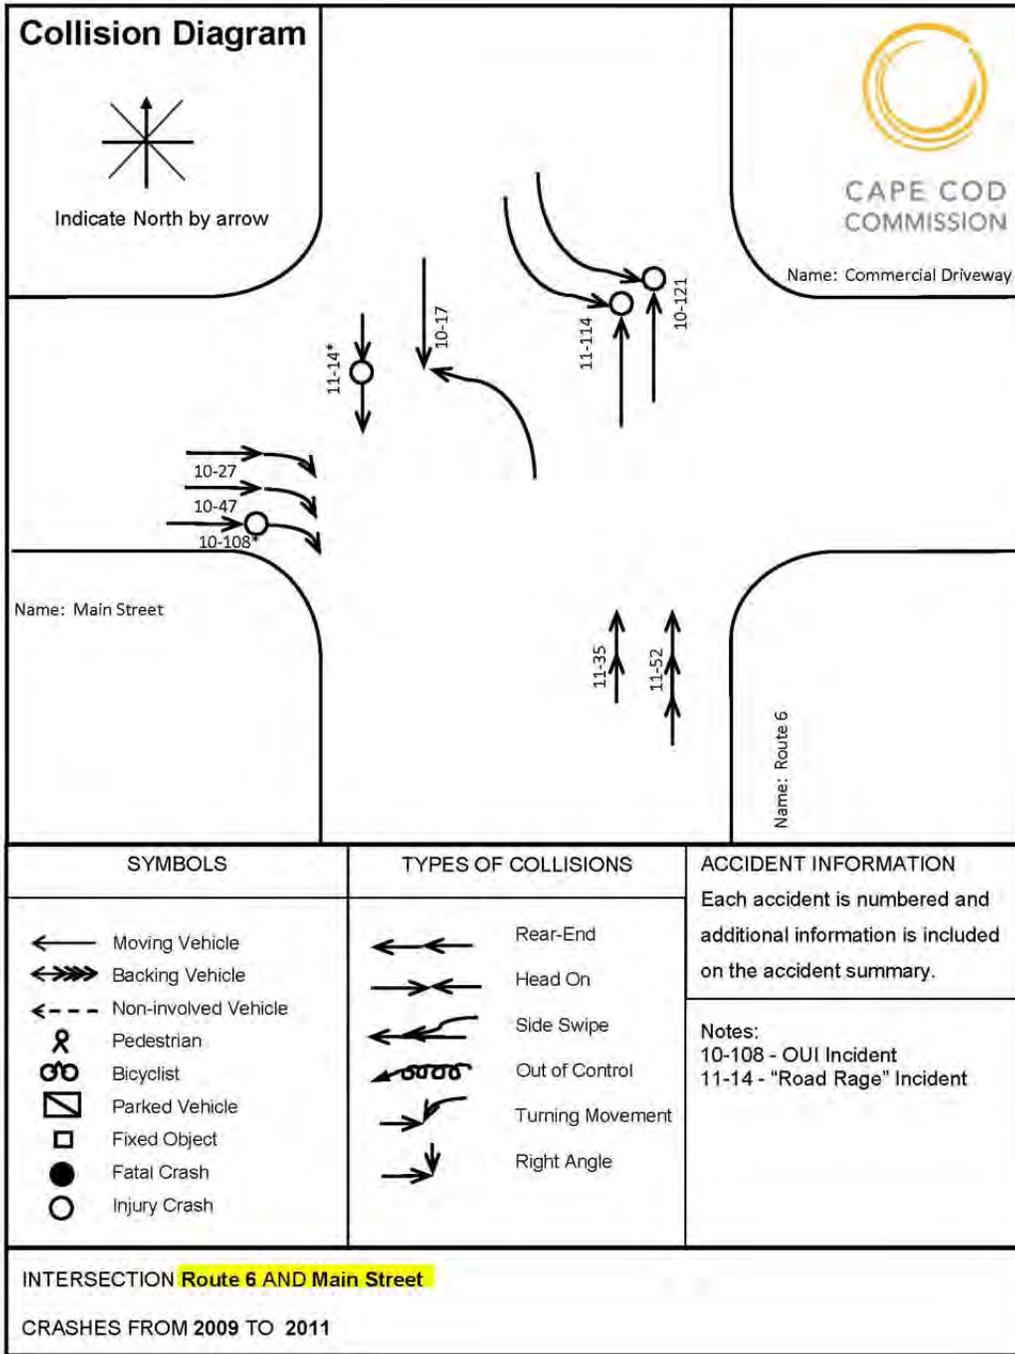
FIGURE 3 - ROUTE 6 AND MAIN STREET CRASH DIAGRAM

The diagram below indicates that there were four injury crashes out of the nine recorded from the years 2009-2011. The most prevalent crash type, rear end, included three occurrences from the Main Street approach (with right turning vehicles) and two crashes of northbound Route 6 vehicles. Two of the injury crashes occurred between southbound Route 6 vehicles turning left into the commercial property colliding with northbound Route 6 vehicles.

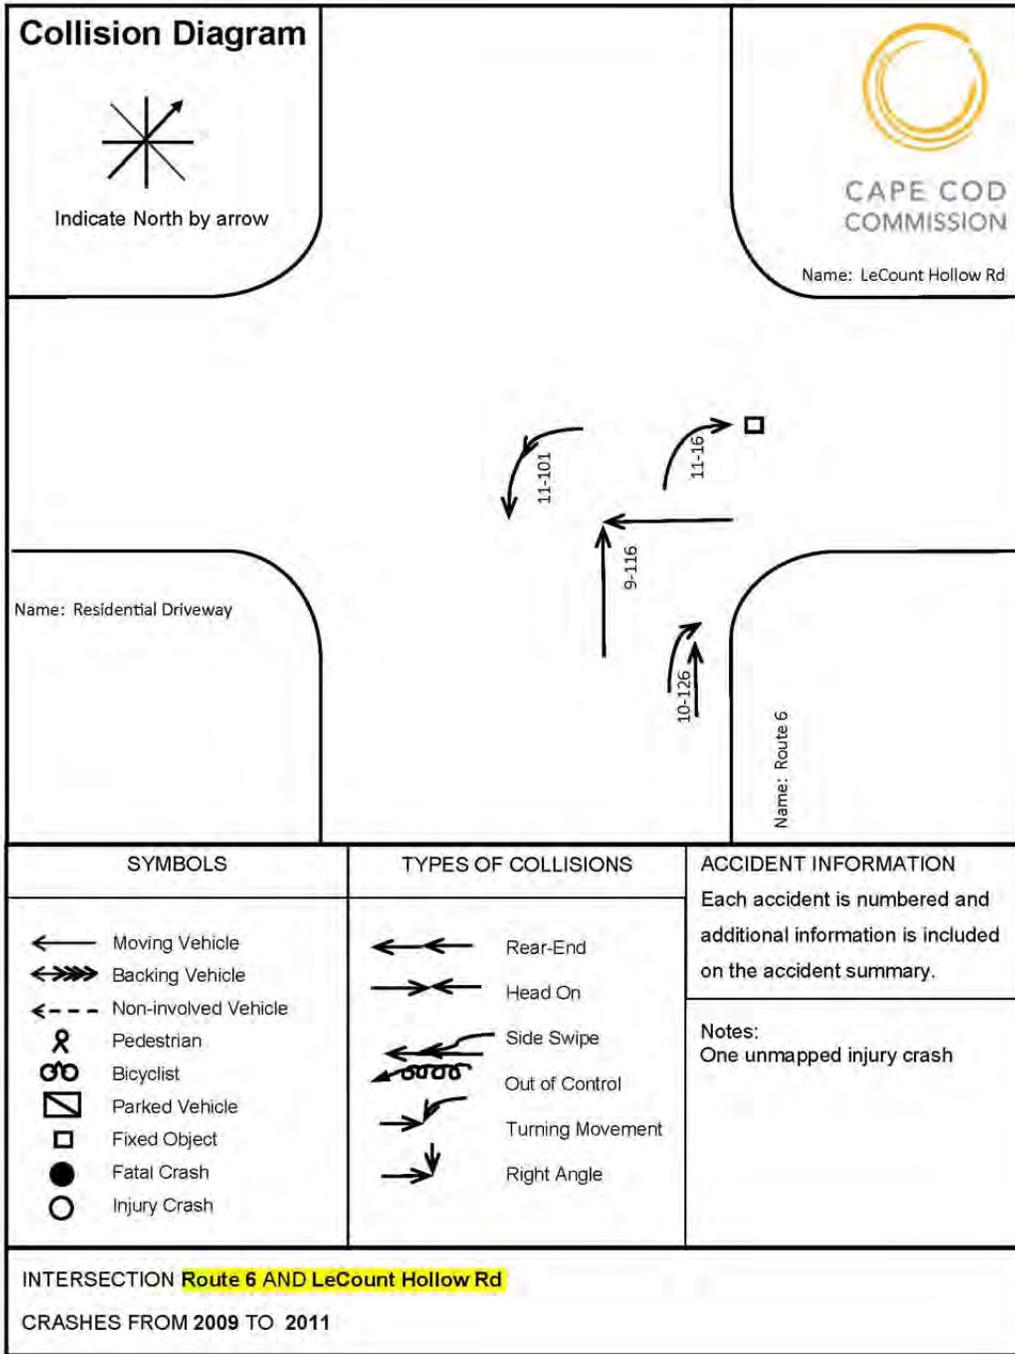
FIGURE 5 – ROUTE 6 AND LECOUNT HOLLOW ROAD CRASH DIAGRAM

There were four (property damage only) crashes recorded at the intersection for the years 2009-2011. All four related to vehicles turning into or out of LeCount Hollow Road with vehicles traveling northbound to the south on the southern approach of Route 6.

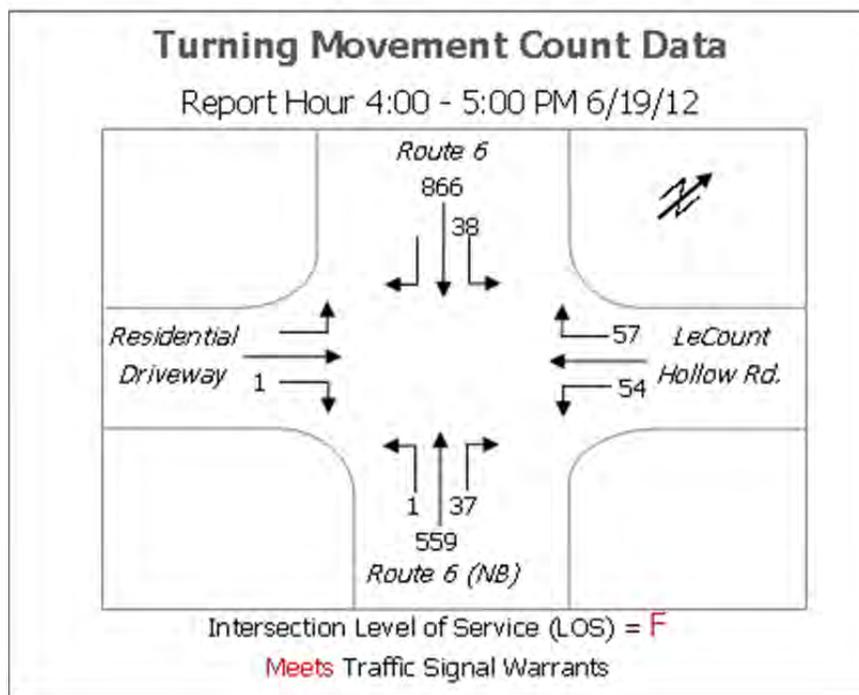
FIGURE 6 - ROUTE 6 AT LECOUNT HOLLOW ROAD TRAFFIC VOLUMES

Turning movement counts collected by Cape Cod Commission staff in June of 2012 are presented in the following figure. An analysis of operations using the methodology recommended by the *Highway Capacity Manual* shows that the intersection operates as Level of Service F (very high delay for vehicles on the LeCount Hollow Road approach).

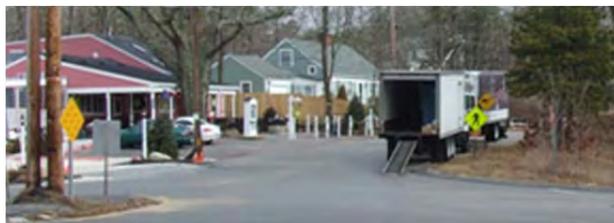
FIGURE 8 - LIMITED DELIVERY FACILITIES AT PB BISTRO ON LECOUNT HOLLOW ROAD

- Heavy traffic and high speeds of Route 6 traffic are traveling on a curve in the vicinity of the intersection. This traffic is particularly difficult and dangerous for left-turning vehicles out of LeCount Hollow Road.
- Delivery operations for a local business occur in the operational area of the intersection.
- Access to the adjacent commercial area occurs in the operational area of the intersection.
- A utility pole is in the middle of the LeCount Hollow Road approach
- Sight distances are somewhat affected by vegetation.
- Lack of bicycle and pedestrian accommodations.

- Discuss removal of the utility poles on the splitter island with the utility company.
- Consider a breakaway Stop Sign on the splitter island to increase visibility to motorists.
- Evaluate alternative parking and delivery options for the PB Bistro (see photo below).
- Consider the installation of a traffic signal or roundabout understanding that the signal warrants are met based on the June 21, 2012 traffic volumes, but such a treatment is not necessitated in the offseason.
- Consider possible relocation of the old Route 6 layout/LeCount Hollow Road intersection to add separation from the Route 6/LeCount Hollow Road intersection.
- Evaluate bicycle and pedestrian accommodations relative to such demands

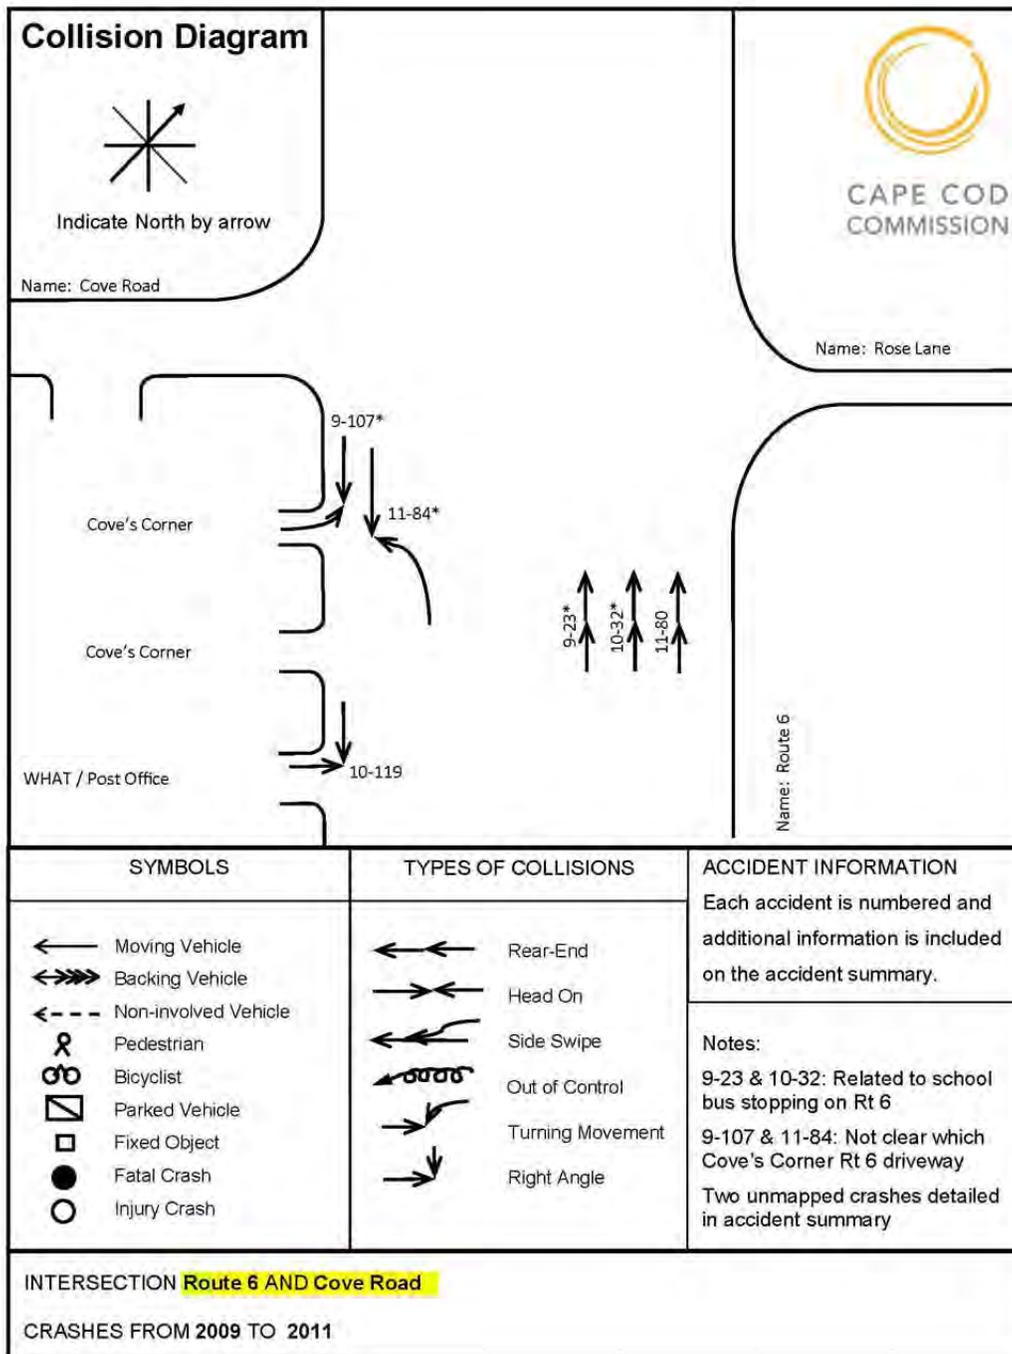
FIGURE 10 - ROUTE 6 AND COVE ROAD CRASH DIAGRAM

There were six crashes (all property damage only) recorded for the vicinity of the intersection for the years 2009-2011. None of these crashes were recorded directly at the intersection. Three of the crashes included rear-end collisions of northbound Route 6 vehicles. The remaining three correspond to crashes of vehicles accessing the commercial area to the south of Cove Road with through vehicles on Route 6.

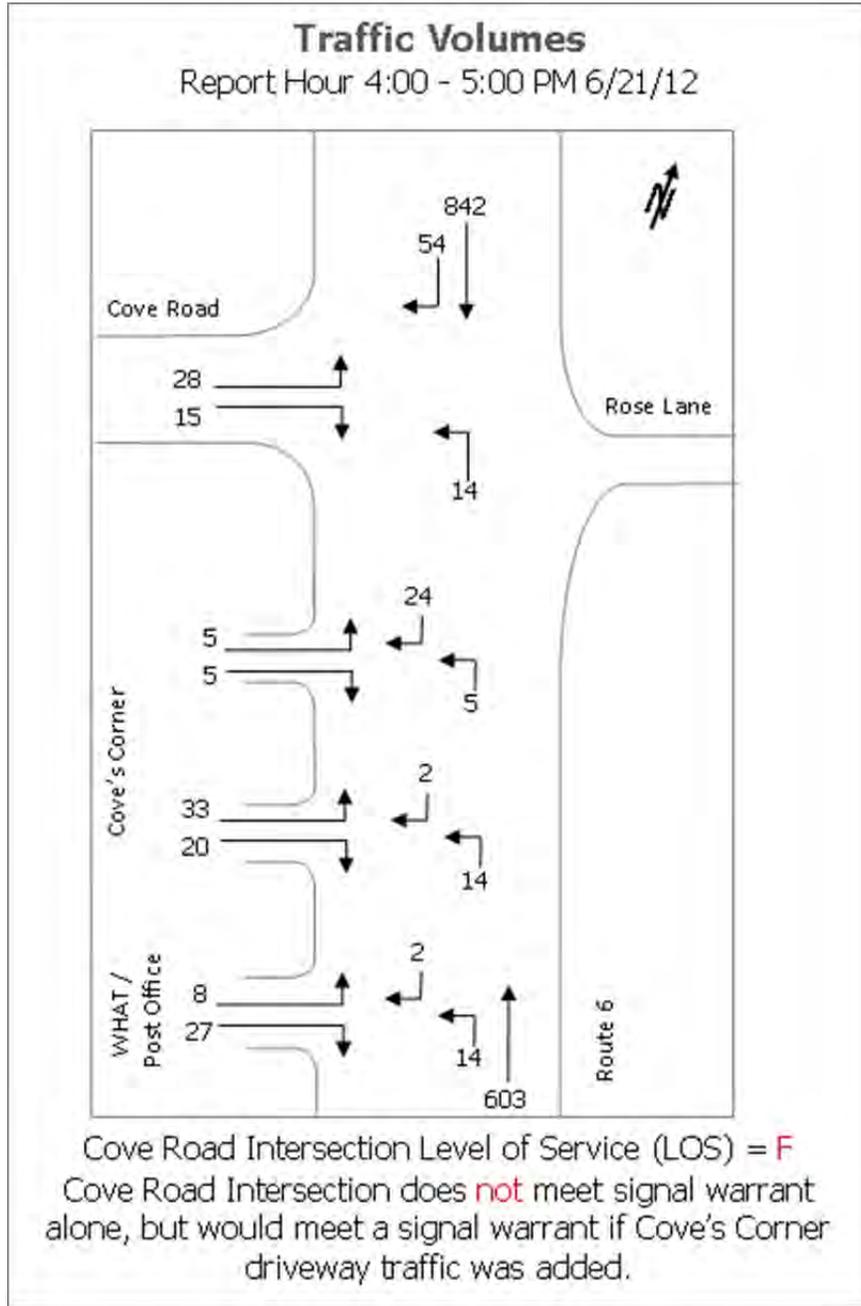
FIGURE 11 - ROUTE 6 AT COVE ROAD TRAFFIC VOLUMES

The Cape Cod Commission staff collected turning movement data in June 2012 as shown in the figure below. The Cove Road intersection operates at Level of Service F (very high delay for vehicles on the Cove Road approach). Traffic Signal Warrants are only met if adjacent turning movements are included.

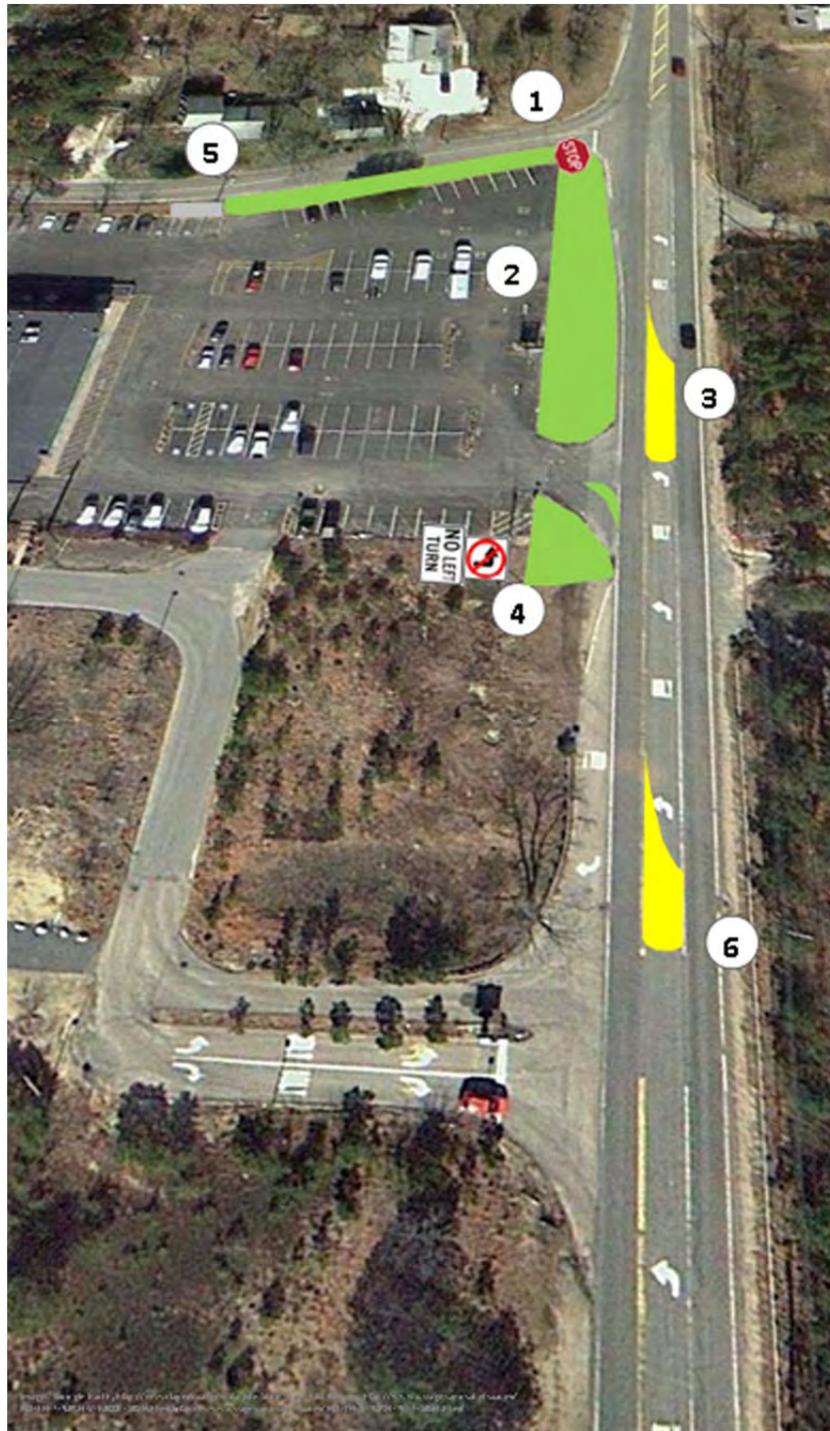
FIGURE 13 - ROUTE 6 AT COVE ROAD - POTENTIAL IMPROVEMENT AREAS

- Drivers accessing Route 6 from Cove Road or the commercial area face uncertainty of Route 6 northbound vehicles using the left turn lane. It is often unclear which driveway the Route 6 traffic is intending to use.
- The left turn lane on Route 6 is excessively long and may be used by northbound vehicles to pass.
- Lack of bicycle and pedestrian accommodations.

1. Install a new stop sign at the end of Cove Road (current sign shown below)
  2. Close northern Cove’s Corner / Rt. 6 driveway
  3. Mark turn pocket for Cove Road left turns instead of long turn lane

4. Restrict left turns from southern Cove’s Corner / Rt. 6 driveway
  5. Align Cove’s Corner / Cove Road driveway with the parking lot flow lines
  6. Mark turn pocket for Cove’s Corner left turns instead of long turn lane (optional)

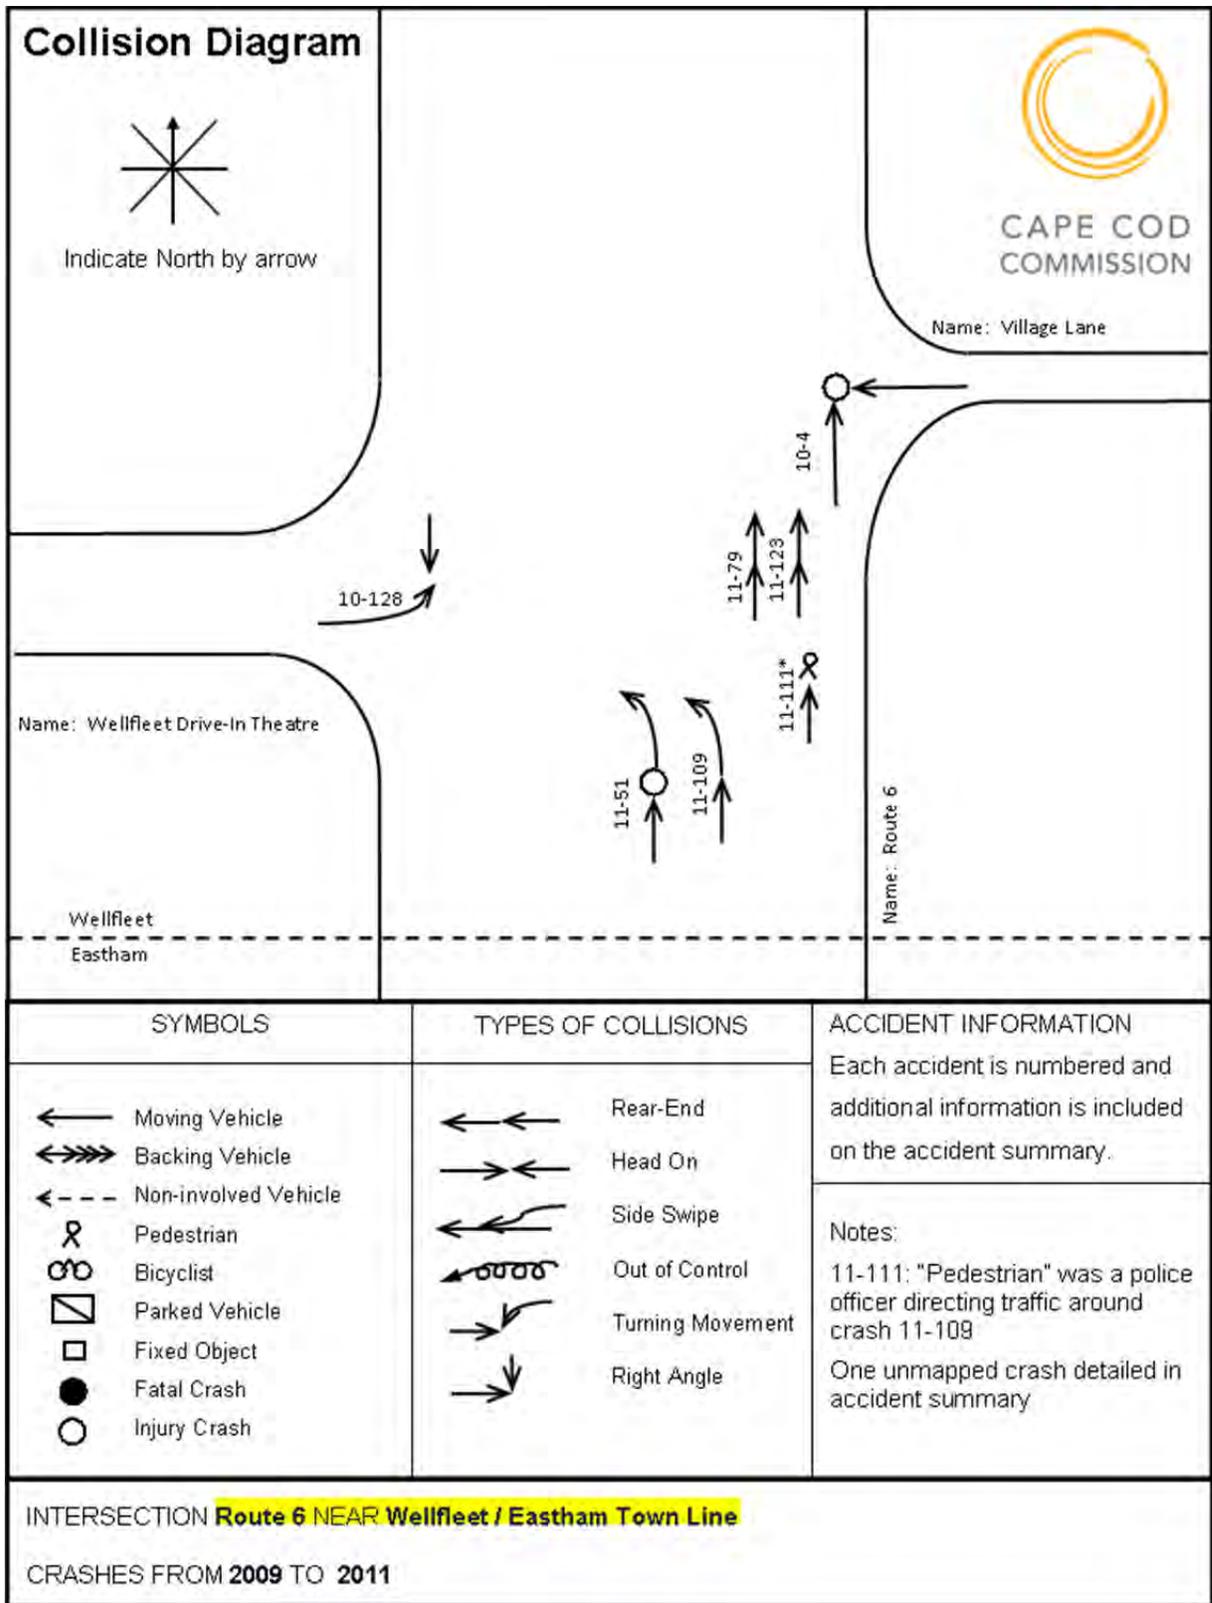
FIGURE 15 - ROUTE 6 NEAR EASTHAM TOWN LINE CRASH DIAGRAM

There were seven crashes recorded for the years 2009-2011. These included one fatality (This should be categorized as an injury crash between a northbound Route 6 vehicle and a vehicle exiting Village Lane. The driver from Village Lane was undergoing cardiac arrest before the crash; the Route 6 driver was injured), one injury crash (a rear-end crash between a northbound Route 6 vehicle and a vehicle turning left into the Wellfleet Drive-In). There were two northbound rear-end crashes and a northbound pedestrian crash (an uninjured police officer).

The merge of Route 6 from four to two lanes is complicated by the location of the driveway to the Wellfleet Drive-In. Northbound through vehicles are often jostling for position to avoid being trapped behind slower traffic while at the same time coping with vehicles turning into or out of the drive-in. There are two basic traffic flow issues at this location:

- Add/ update signage indicating lane drop
- Add pavement markings to indicate lane drop
- Continue dialogue with the Town of Eastham regarding the possibility of moving the Route 6 northbound merge back into Eastham and dedicating the left lane to vehicles turning left in Wellfleet Drive-In Theatre with additional guidance signage.
