ROAD SAFETY AUDIT

Route 28 between Bourne Rotary and Otis Rotary

Town of Bourne

April 2013

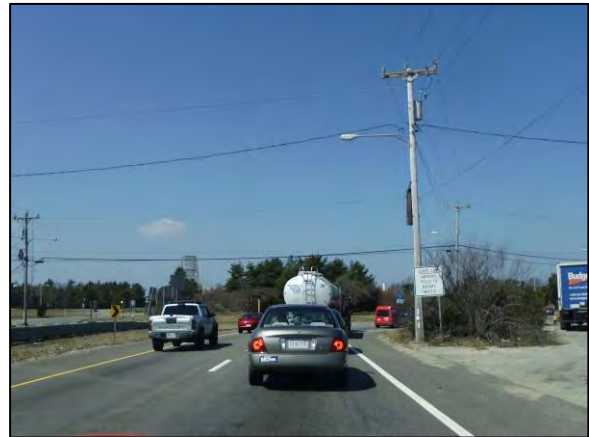
The RSA team noted that there is very little advance guide signage indicating the street names route numbers, and/or destinations of the available exits from the rotary. The only guide signage for exits to the rotary are within the rotary itself. This can create confusion, especially among drivers that are unfamiliar with the rotary, since motorists may not know when their exit is approaching until they read a sign located at the exit itself. There is no existing signage that indicates which lane a vehicle should be in if it is exiting the rotary or continuing to circulate. This lack of direction can cause angle crashes between vehicles exiting the rotary from the inside lane and vehicles remaining in the rotary in the outside lane. Twenty-nine crashes occurred between vehicles exiting the rotary onto Route 28 southbound from the inside lane and vehicles continuing around the rotary in the outside lane. Three similar crashes involved vehicles exiting to Sandwich Road, and one similar crash occurred involving a vehicle attempting to exit to Route 28 northbound occurred.

There is no advanced guide signage indicating the possible exits from the rotary.

2. Remove the guide signage from the center island of the rotary.
3. Remove guide signage that is too small for circulating traffic to read. Replace with MUTCD-compliant signage if the signage is deemed necessary. Ensure that all guide signage visible from the rotary or the approaches to the rotary is useful and necessary.

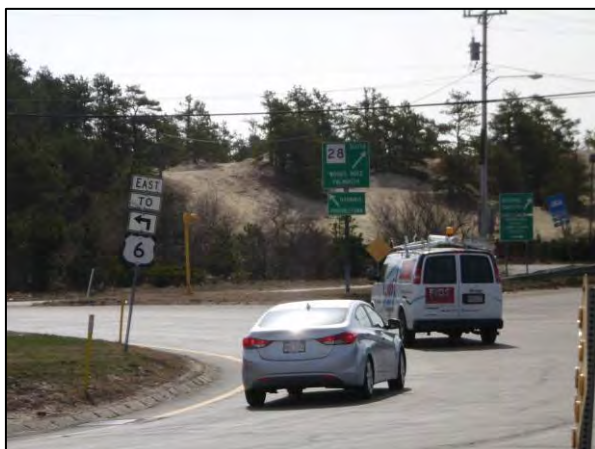
Guide signage for Route 6 eastbound is misleading and poorly placed. Some signage is too small to read.

Team members also noted that some of the existing guide signage is too small to read, and that some motorists slow down unexpectedly to read guide signage.

Guide signage is located along the inside of the rotary, including a sign facing the Route 28 southbound approach to the rotary that indicates vehicles should enter the rotary to access the National Cemetery. This sign is not necessary, as any motorist close enough to read the sign would have no choice but to enter the rotary, and it may be distracting to motorists looking for other information.

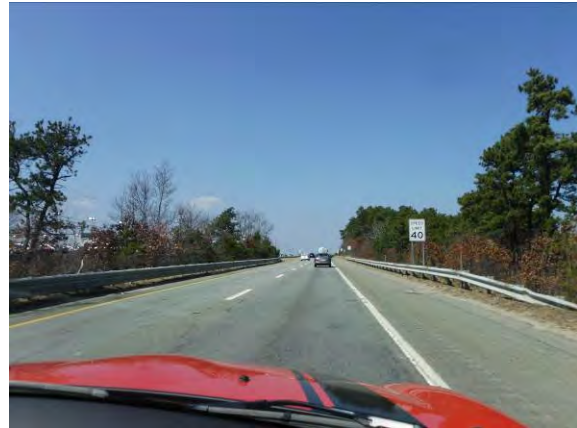
A second sign, located across from the Trowbridge Road eastbound entrance to the rotary, indicates vehicles should turn left for Route 6 eastbound. This sign is misleading; while continuing to circle the rotary will eventually allow for access to Route 6 eastbound, the sign implies that the turn is imminent, and entering Route 6 eastbound will require a traditional left turn, where in reality, motorists bear right to exit the rotary onto Route 6. The sign is visible to motorists entering the rotary from Trowbridge Road; this may lead to motorists that are unfamiliar with the area turning left into the rotary. Signage placed on the center island of the rotary distracts motorists from signage along the outside of the rotary.

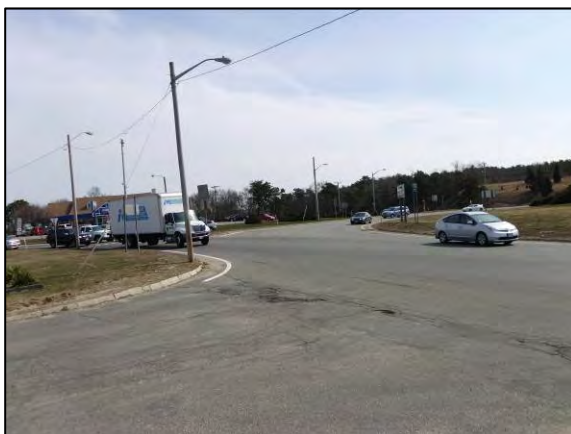
There are no longitudinal lane markings or arrow markings within the Bourne Rotary to guide vehicles through the rotary.

There are also no pavement markings within the rotary to indicate lane use. It is unclear as to whether exiting the rotary from the inside lane is permitted at any exit, at the Route 28 exits only, or not at all. As mentioned previously in the *signage* section, 33 crashes involved a vehicle exiting the rotary from the inside lane while a vehicle continued to circulate the rotary in the outside lane.

7. Consider the safety benefits of providing longitudinal markings and arrow pavement markings within the rotary, including dashed pavement markings to assist entering and exiting vehicles, as part of the upcoming Route 28 corridor resurfacing project.

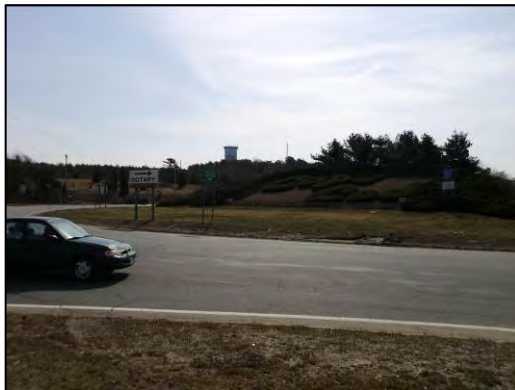
The vegetation in the center of the Bourne Rotary may be distracting, and may restrict sight lines of entering traffic.

RSA team members noted that the decorative vegetation facing Route 28 southbound traffic entering the rotary, spelling out “Cape Cod”, may be distracting for motorists. It was also noted that the height of the vegetation behind the Cape Cod topiary in the center of the rotary may make it difficult for motorists to judge the speed of circulating traffic. However, team members said anecdotally that the number and severity of crashes through the rotary has dropped dramatically since the mound was built.

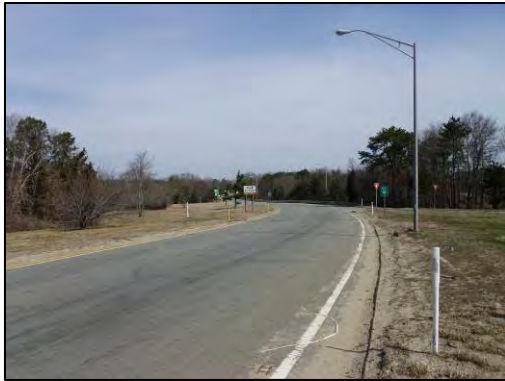
The oval shape of the Otis Rotary means that Route 28 through traffic may not need to slow down when traveling through the rotary.

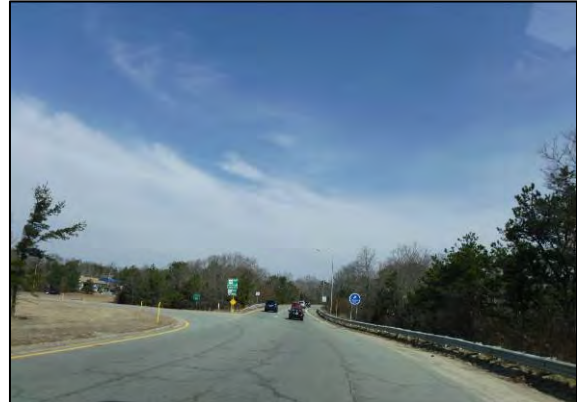
Similar to the Bourne Rotary, there are no pavement markings formalizing two travel lanes within the Otis Rotary. Four sideswipe crashes were reported within the Otis Rotary.

There are also no pavement markings that would indicate lane use within the rotary. Twenty-five crashes involved a vehicle exiting the rotary from the inside travel lane while a vehicle continued to circulate around the rotary in the outside travel lane.

There are no lane striping or lane-use arrows within the rotary.

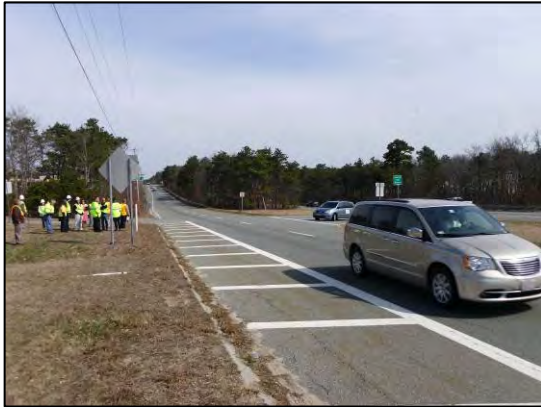
Sight lines to the north of the turnaround in the vicinity of Waterhouse Road are obstructed by vegetation in the median and a crest vertical curve.

Seven angle crashes, four of which resulted in personal injury, involved a vehicle traveling along Route 28 southbound and a vehicle crossing Route 28 southbound from the northbound-to-southbound turnaround onto Waterhouse Road. RSA team members noted that sight distance to the north of the turnaround is obstructed by overgrown vegetation. Sight lines to the north of the turnaround are also impacted by the crest vertical curve on Route 28 southbound. This may make it more difficult for vehicles in the turnaround area to judge the speed of traffic on Route 28, which, according to team members, often travels at speeds that exceed the 50 mph posted speed limit.

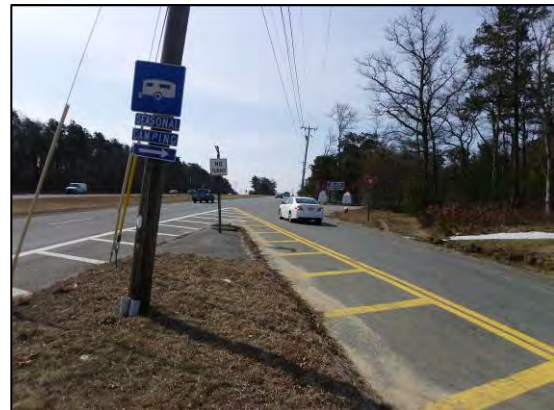
The Waterhouse Road eastbound approach intersects Route 28 southbound at an acute angle. Motorists waiting to merge onto Route 28 southbound must look over their left shoulder in order to see oncoming traffic. This makes it difficult to see and judge the speed of oncoming traffic, and may lead to rear-end crashes when a motorist assumes the vehicle at the front of the queue on Waterhouse Road will accept a gap, but does not. An RSA team member also stated that motorists often “piggyback” one another when merging onto Route 28, meaning two vehicles will often attempt to enter Route 28 at once. This may lead to rear-end crashes if the first vehicle unexpectedly decides not to merge.

Waterhouse Road intersects Route 28 southbound at an acute angle.

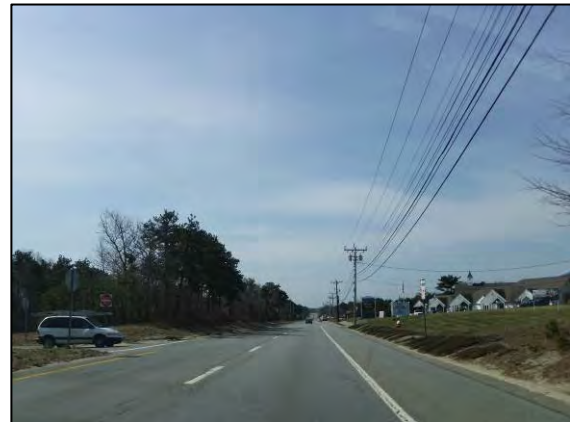
Nine turnarounds are located along the Route 28 corridor between the Bourne Rotary and the Otis Rotary. Five turnarounds allow Route 28 southbound traffic to turn to Route 28 northbound and four turnarounds allow Route 28 northbound traffic to turn onto Route 28 southbound. The northbound-to-southbound turnaround north of Clay Pond Road and the southbound-to-northbound turnaround just north of Otis Park Drive are the only turnarounds that provide acceleration lanes; vehicles using the other turnarounds must wait for an acceptable gap in Route 28 traffic, and then accelerate in the travel lanes. This can lead to rear-end crashes both within the turnaround and on the Route 28 mainline. It can also lead to angle crashes when vehicles attempt to exit a turnaround into the left, high-speed lane. Four crashes were reported involving vehicles exiting turnarounds at locations with no acceleration lanes.

Most turnarounds between the northbound and southbound directions on Route 28 do not provide an acceleration lane.

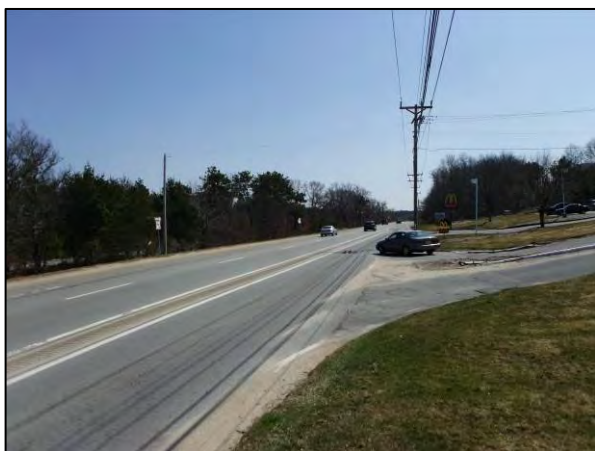
A flush concrete median separates Route 28 southbound through traffic and traffic entering and exiting commercial businesses in the vicinity of Clay Pond Road.

confusion could cause serious head-on crashes.

As part of long-term reconstruction efforts, consider replacing the flush concrete median with a raised median to prevent wrong-way travel along Route 28.	High	Long-term	High	MassDOT
	As part of long-term reconstruction efforts, repair or replace damaged drainage structures and ensure that all areas drain properly.	Medium	Long-term	High	MassDOT
	As part of long-term reconstruction efforts, consider providing pedestrian and bicycle accommodations, such as the planned shared-use path parallel to Route 28. Consider pedestrian/bicycle crossing infrastructure in conjunction with the proposed Route 28 parallel shared-use path.	High	Long-term	High	MassDOT
	Consider enlarging signs and sign legend/text, providing better lighting, and maintaining pavement markings to accommodate the rising population of older drivers on Cape Cod.	Medium	Short-term	Low	MassDOT
