CAPE COD
COMMISSION

Town of Harwich
Road Safety Audit
Route 39 (Orleans Road) at
Pleasant Bay Road

July 29, 2016

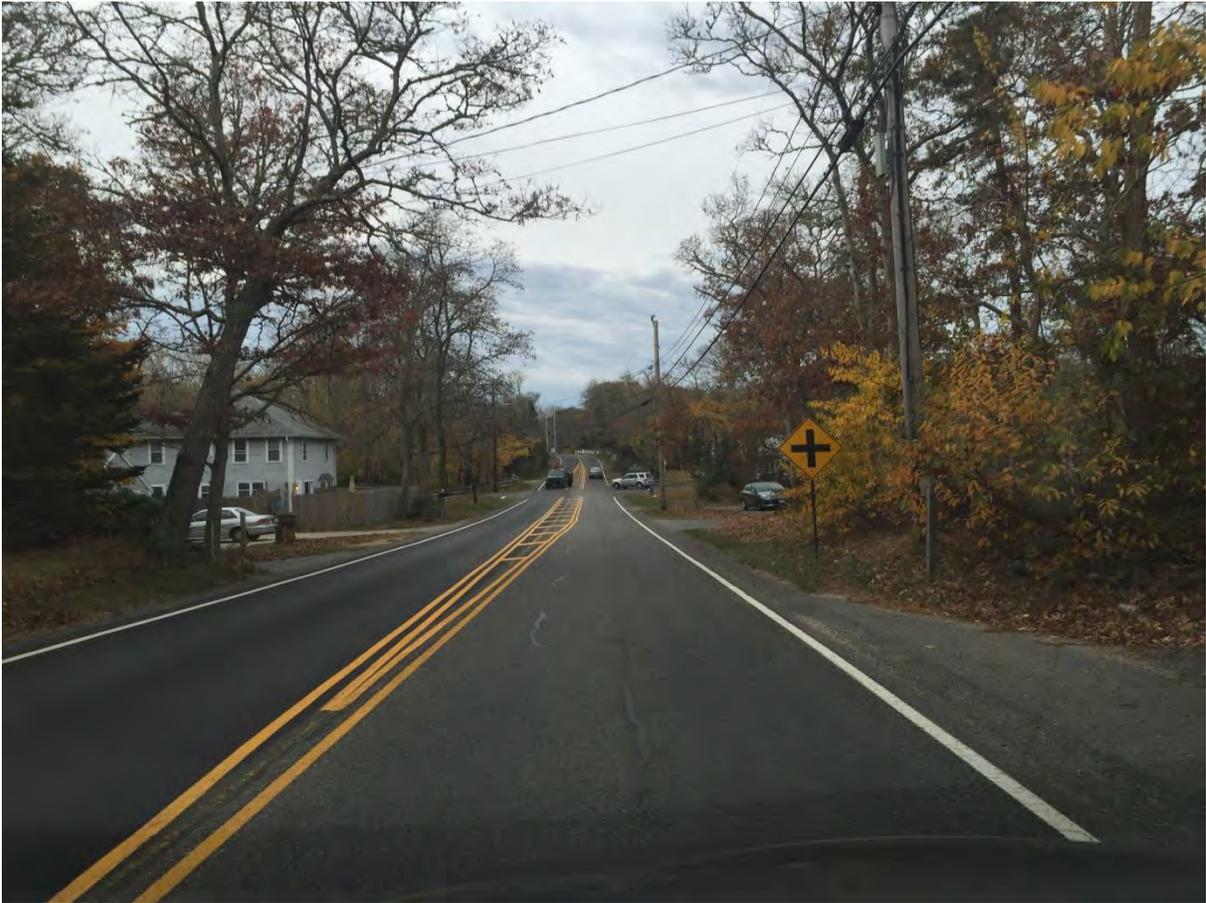
Figure 4 - View looking south, showing newly installed painted median

Team members also discussed the recently installed painted median, as shown in Figure 4 and Figure 9, and potential adjustments to it. Town staff noted that early feedback on the painted median (installed in November 2015) has been positive.

Replace painted median with mountable, raised median (maintain full access)

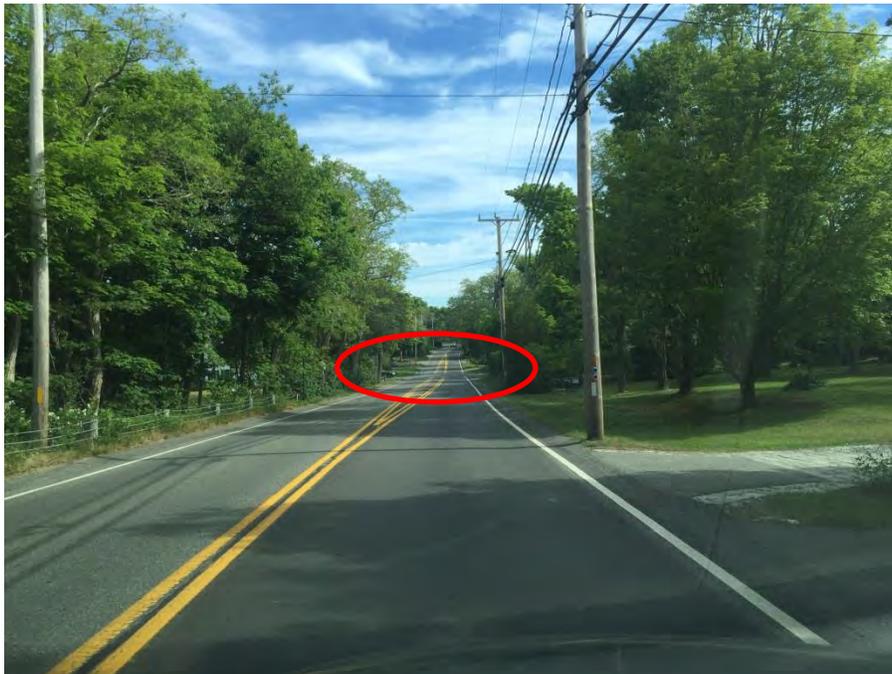
Obstructions on the southwest and southeast quadrant of the intersection are restricting the ability of drivers traveling north on Route 39 to see vehicles potentially crossing their path from Pleasant Bay Road. Figure 5 shows the view of a driver traveling northbound on Route 39 approximately 360 feet south of the intersection. This is the approximate distance required for a driver traveling 45 mph to identify a potential conflict and safely stop. Trees on the west side of Route 39 and hedges on the east side of Route 39 are **limiting drivers’ ability to see potential crossing vehicles.**

Figure 5 - View looking north from Route 39 approximately 360 feet south of the intersection (intersection circled in red)

Remove trees and hedges to the south of the intersection that are currently obstructing sight lines

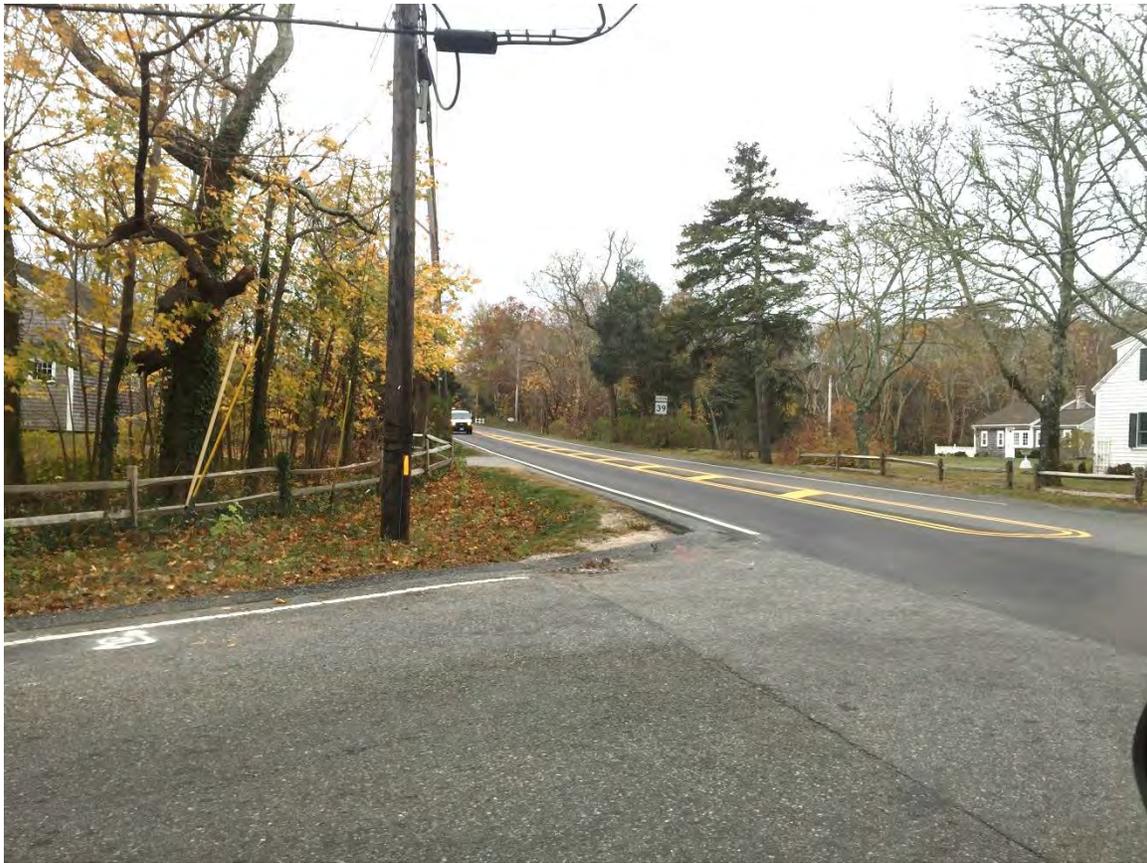
Figure 6 shows the view of a driver traveling westbound on Pleasant Bay Road looking south on Route 39. The hedges on the east side of Route 39 obstruct the view of oncoming traffic. Assuming vehicles on Route 39 are traveling 45 mph, a driver turning left out of Pleasant Bay Road should be provided clear sight lines to see vehicles 500 feet south down Route 39. The current available sight distance is less than 500 feet.

Figure 6 - View looking south down Route 39 from the Pleasant Bay Road eastbound

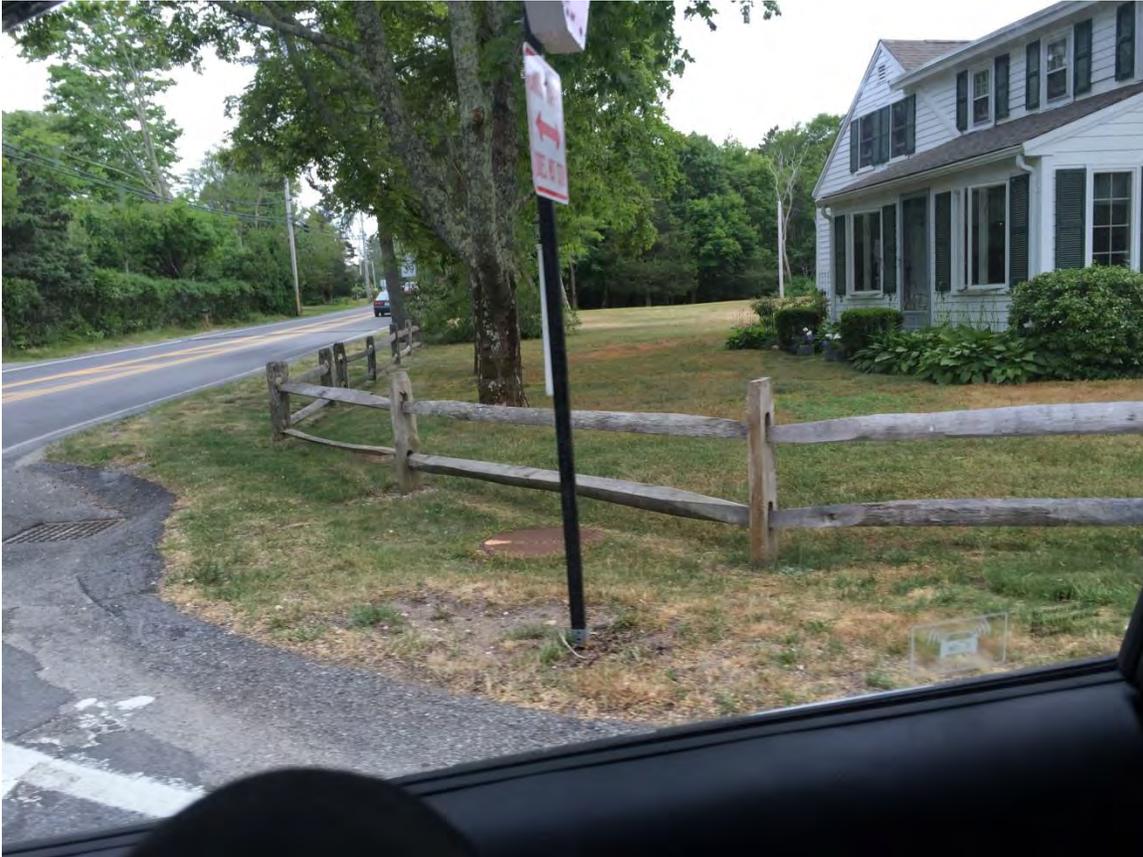
Figure 7 shows the view of a driver traveling eastbound on Pleasant Bay Road looking south on Route 39. The trees on the west side of Route 39 obstruct the view of oncoming traffic. Assuming vehicles on Route 39 are traveling 45 mph, a driver turning left out of Pleasant Bay Road should be provided clear sight lines to see vehicles 500 feet south down Route 39.

Figure 7 - View looking south down Route 39 from the Pleasant Bay Road westbound

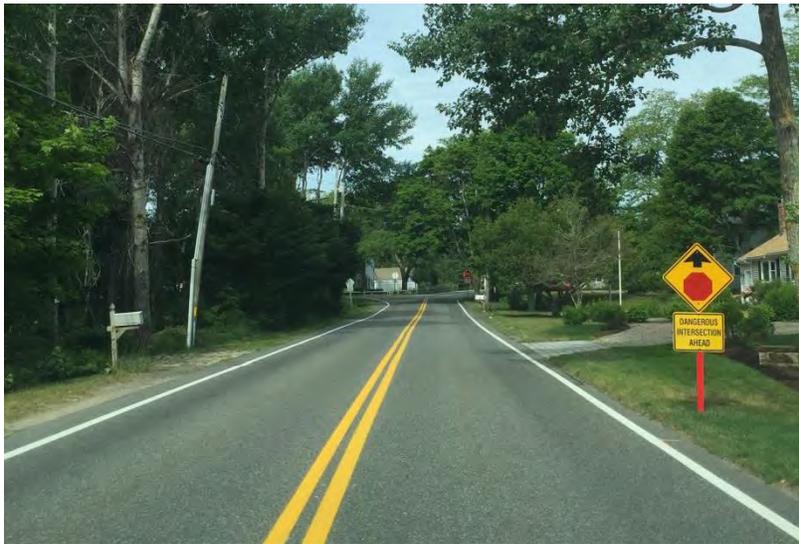
Another obstruction noted was a tree on the north side of the westbound Pleasant Bay Road approach partially blocking the view of the LED stop sign as shown in Figure 8. This obstruction partially obscures the LED stop sign when drivers are more than 300 feet from the intersection. From 300 feet in, the LED stop sign is fully visible. The advanced stop signage is visible from well beyond 500 feet of the intersection.

Given that the sign is visible well advanced of the intersection, censuses was that removing this tree would not have a significant safety benefit. Adding a supplemental stop sign on the left sign of the road, as discussed in the next section of the report, would likely have a greater safety benefit.

Figure 8 – Pleasant Bay Road westbound approach showing partially obscured stop sign

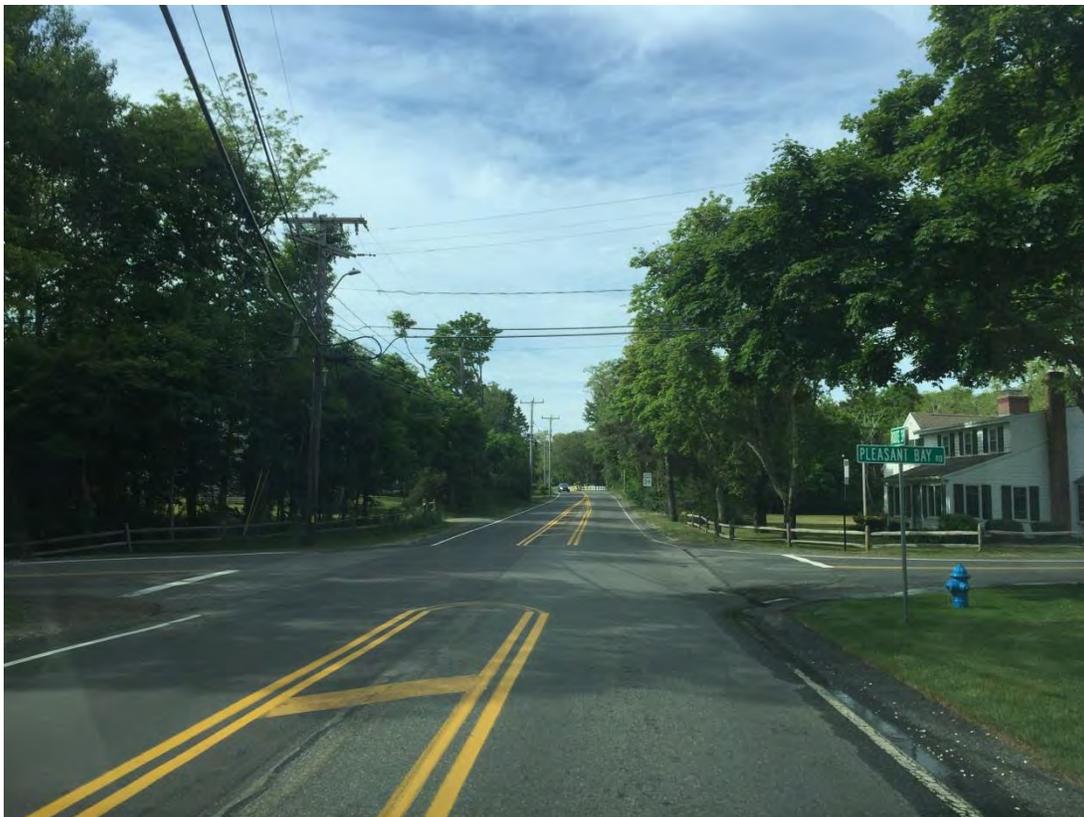
The placement of stop lines and stop signs at both Pleasant Bay Road approaches was discussed extensively by team members. Moving the stop lines closer to Route 39 encourages drivers to stop closer to Route 39 providing for better sight lines. However, moving the vehicles closer to Route 39 also presents issues for vehicles, particularly large trucks, turning onto Pleasant Bay Road.

Proper placement depends in large part on the degree to which vegetation is removed within the intersection sight triangles. As such, the placement of the stop lines and stop signs should be reassessed after such changes to the intersection are made.

Figure 9 – Looking south on Route 39, showing stop line placement on Pleasant Bay Road

Review stop sign and stop line placement

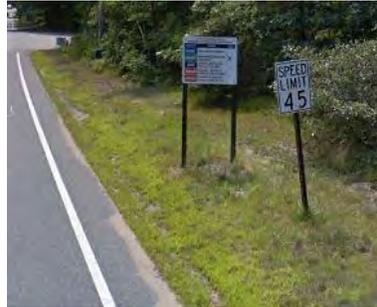
A team member noted a speed limit sign on Route 39, approximately ½ mile north of the intersection, was currently tilted as shown in Figure 10. There were also questions about the spacing of the sign with other in the area, the condition of the sign, and whether or not it is an appropriate location for the sign. A review of speed limit signs along the corridor, beyond the area of this project, may be warranted.

Figure 10 – Tilted speed limit sign on Route 39

Install cross road ahead sign (W2-1) on Rte 39 northbound and remove the damaged intersection ahead speed limit sign

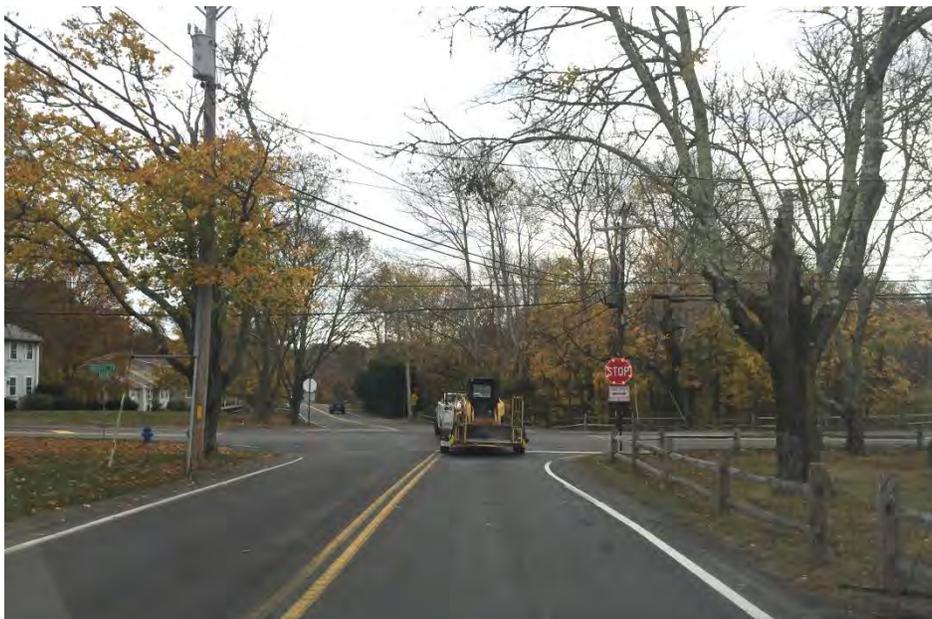
Team members discussed making improvements to the Pleasant Bay approaches to ensure drivers are aware that they will be required to stop at the intersection. Improvements to that end that have been completed by Town staff to date, include the installation of stop ahead signage and flashing LED stop signs as shown in Figure 11. Additional potential improvements discussed include installing a secondary (left side) **stop sign eastbound approach and installing “Stop Ahead” pavement markings on both Pleasant Bay Rd approaches**. It was noted that any pavement markings placed in the travel lanes should use an application technique designed to maintain skid resistance, particularly in consideration of motorcyclist and bicyclists.

Figure 11 – Looking east on Pleasant Bay Road, showing LED stop sign

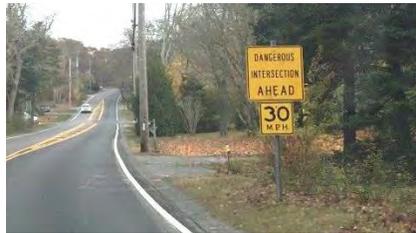
Team members discussed making improvements to Route 39 to improve advanced warning of the intersection. Figure 12 shows the current signage approaching the intersection from the south. Potential improvements discussed include installation of a cross road ahead sign (W2-1) on Route 39 northbound and adding street names to intersection ahead signs on both Route 39 approaches.

Figure 12 – Looking north on Route 39, showing current signage

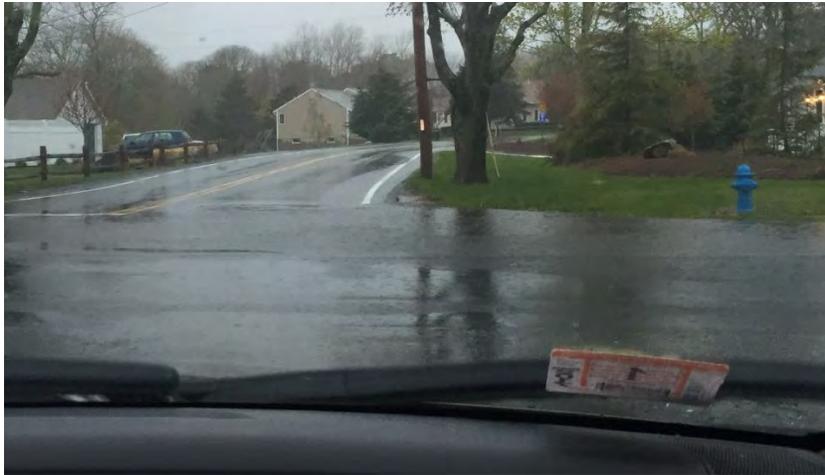
While the intersection appeared to generally be well-designed for drainage, a team member noted seeing some ponding during a recent heavy rain event. This ponding is shown in Figure 13.

Figure 13 - Looking west, showing ponding during heavy rain event

Clean/repair catch basin as necessary

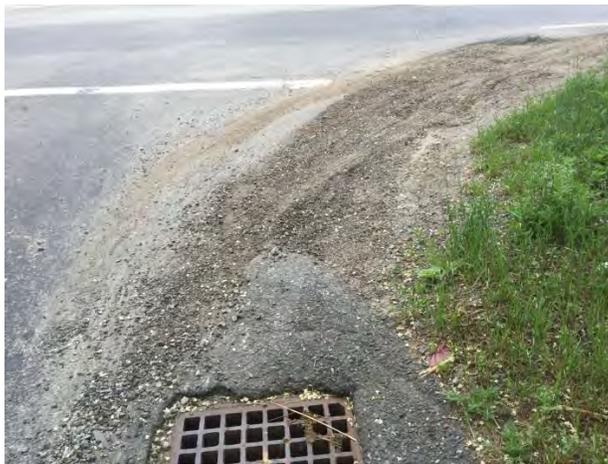
Team members observed vehicles tracking over the corners of the intersection as shown in Figure 14. This could cause damage to the edge of pavement and, potentially, the adjacent catch basin.

Figure 14 – Northeast corner of intersection, showing vehicle tracks over corner

Repair/reinforce corner

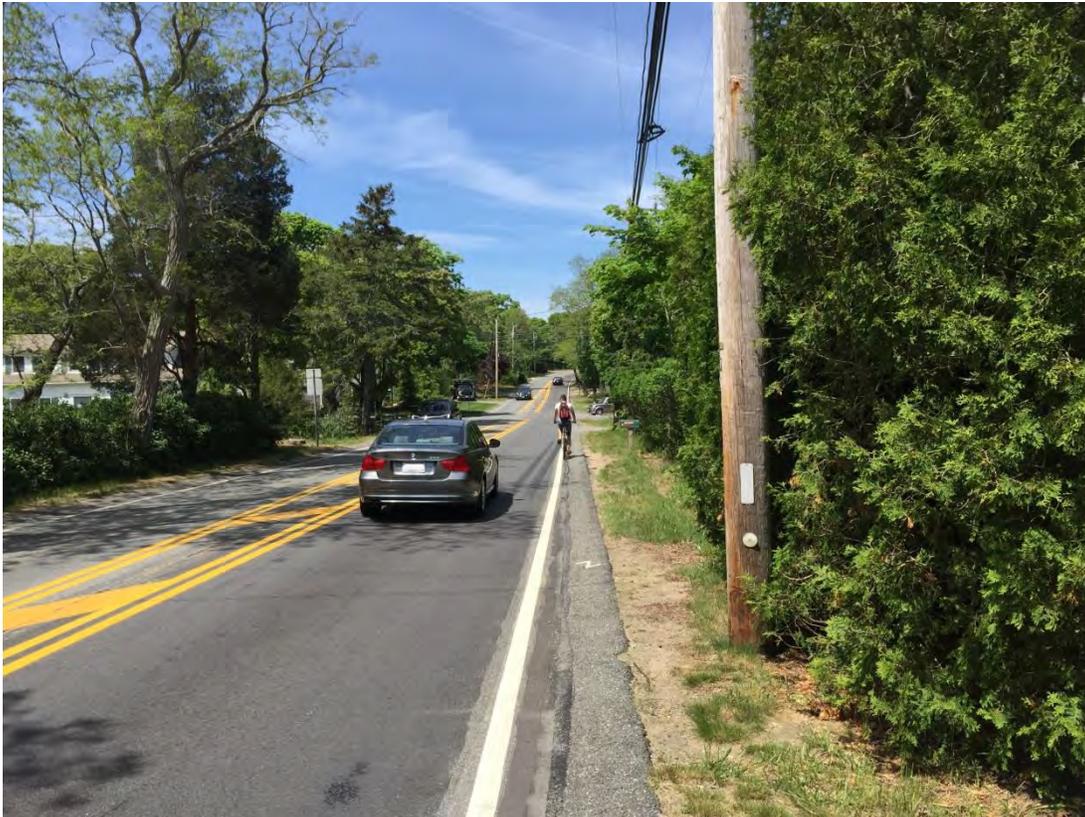
While this intersection does not typically experience a high level of pedestrian or bicyclist activity, it was acknowledged that it is an important route for some non-motorists. Figure 15 shows a bicyclist traveling north on Route 39.

Figure 15 – Bicyclist traveling north on Route 39

There is no dedicated accommodation for pedestrians or bicyclists at the intersection and very little shoulder on the approaching roadways. While many team members expressed a desire to safely accommodate non-motorists, they recognized that isolated improvements at this intersection may not be of particular value. In the event that a geometric change is made to this intersection, consideration should be given to improving bicycle and pedestrian accommodation.
