CAPE COD
COMMISSION

Town of Mashpee Road Safety Audit – Mashpee Rotary

FINAL August 2019

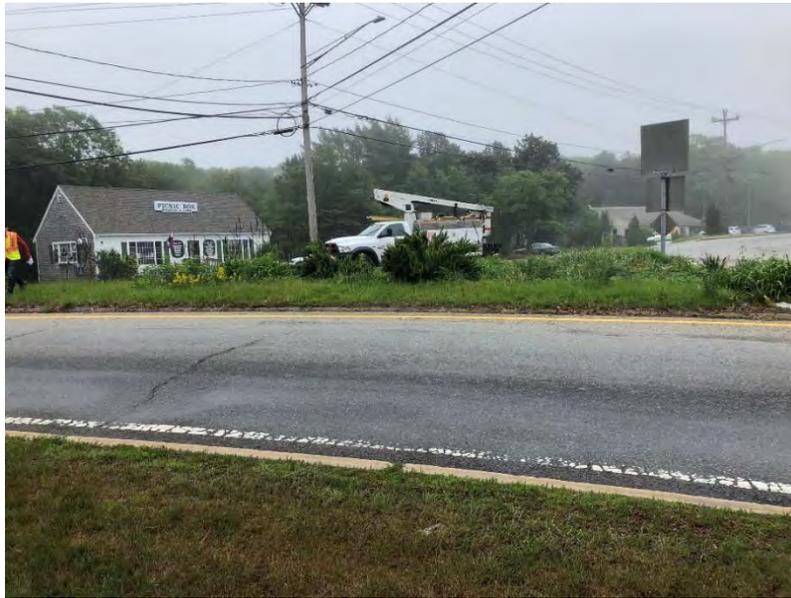
- Overgrown vegetation within the splitter island was noted as a potential sight distance issue on Route 28 westbound approach. Lack of sight distance would impact drivers' ability to determine when to enter the rotary and could contribute to rear-end crashes.

Figure 3 – Vegetation growth on Route 28 westbound approach

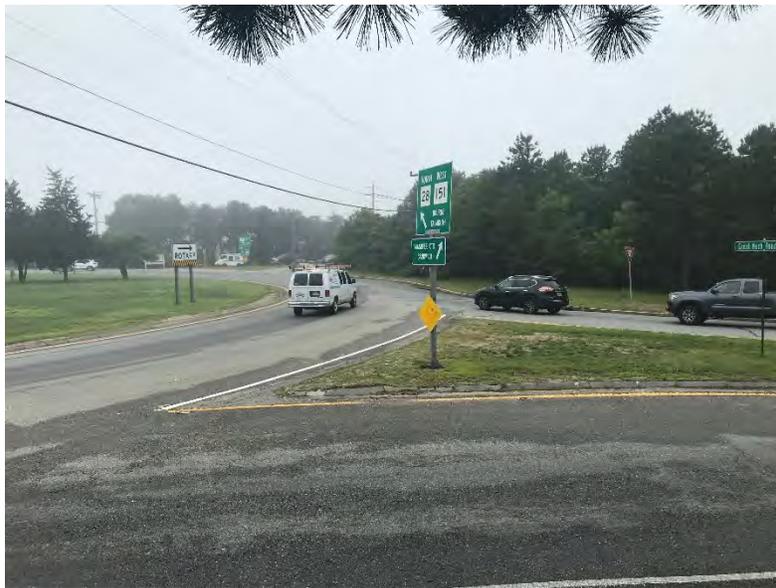
- Rotary splitter islands do not provide adequate deflection and do not provide adequate warning to drivers that a lower speed intersection is approaching. This leads motorists to enter the rotary in a straight line at high speeds and contributes to rear-end and angle crashes.

Figure 4 – Poor deflection on Great Neck Road North splitter island

- Evaluate the existing splitter islands and consider re-designing to improve deflection with advanced visibility and warning.
- Consider redesigning the rotary into a one- or two-lane modern roundabout.
- Consider installing diagonal pavement markings and/or flexible delineators to reduce the width of rotary and approach roadways to encourage lower speeds.
- Consider installing a truck apron or shifting the splitter islands forward to narrow the circulating width of the rotary.
- Ensure adequate sight lines are provided for all approach roadways with potential vegetation clearing.
- Evaluate the Route 151 approach to ensure there is adequate shoulder for emergency pull-offs.
- Investigate drainage issues in the northwest corner of the rotary

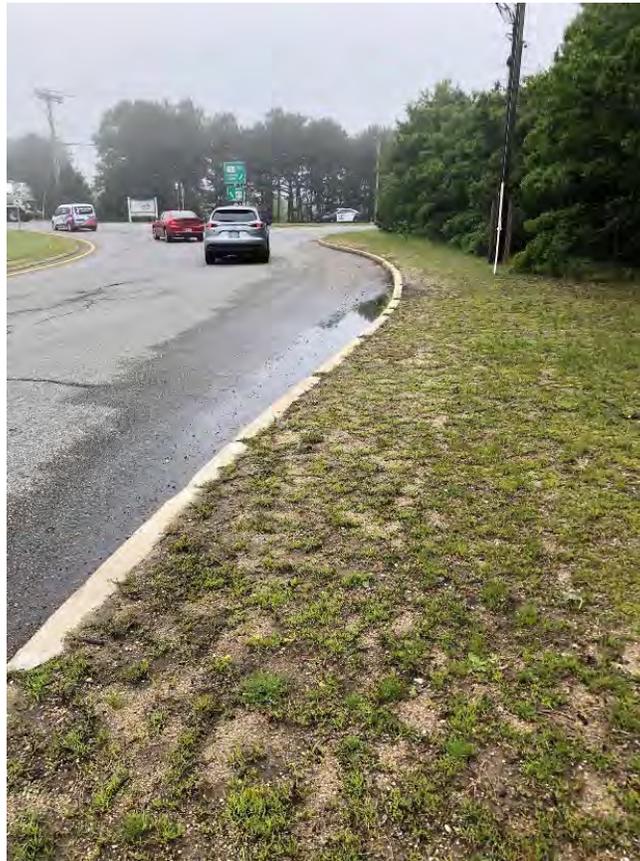
- Drainage issues were noted as a contributing factor to crash #50. Puddling was observed during the site visit in the vicinity of the catch basin in the rotary between Great Neck Road North and Route 151 where a crash due to icy conditions occurred.

Figure 5 – Drainage issues in the northwest corner of the rotary

Investigate drainage issues in the northwest corner of the rotary.	Medium	Medium	Medium	MassDOT
Traffic Operations	Evaluate the number of lanes needed within the rotary and the approach roadways to improve operations and queueing.	High	Mid-Term	Medium	MassDOT/Town of Mashpee
	Investigate long-term improvements to improve overall operations of the rotary, including rotary replacement.	High	Long	High	MassDOT/Town of Mashpee
	Confirm Route 151 westbound queue detection is working properly.	High	Short	Low	MassDOT/Town of Mashpee

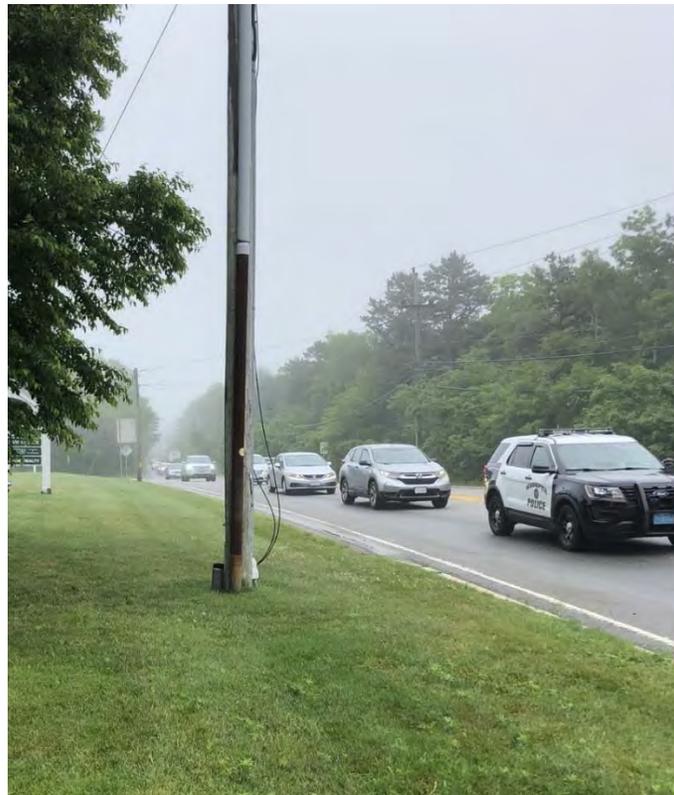
- Significant queues build up on the approach and departure roadways which contribute to rear ends on the approach roadways (See crash #46, 71).
 - It was mentioned that there is a queue detector installed on Route 151 which is connected to the traffic signal at Market Street to prevent westbound queues backing into the rotary.

Figure 6 – Route 28 westbound congestion approaching the rotary

- Evaluate the number of lanes needed within the rotary and the approach roadways to improve operations and queuing.
- Confirm Route 151 westbound queue detection is working properly.
- Investigate long-term improvements to improve overall operations of the rotary, including rotary replacement.

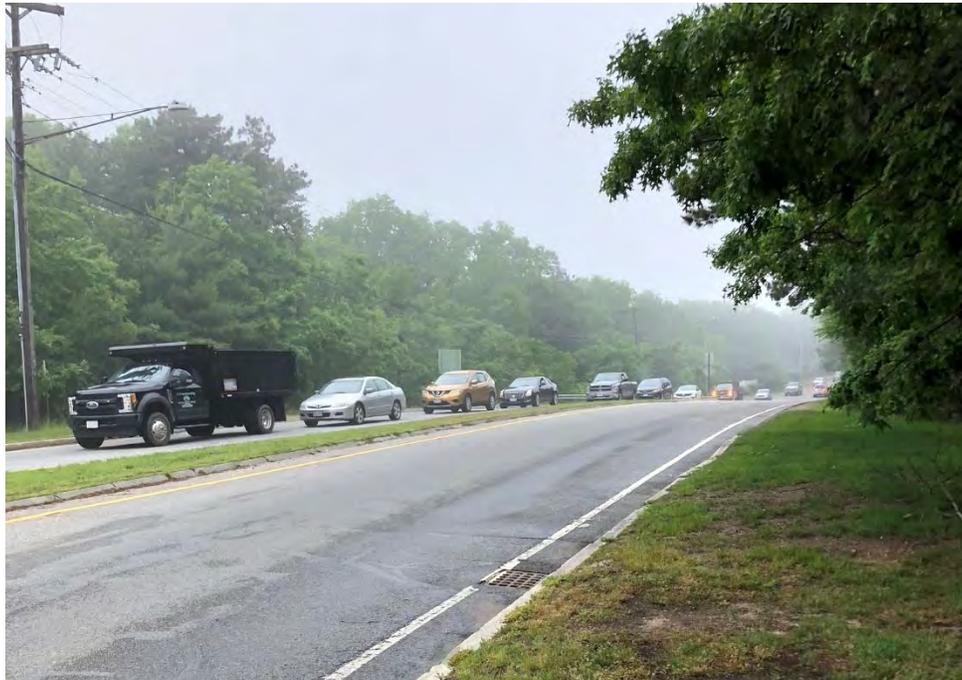
- High speeds and heavy traffic volumes prevent adequate gaps for vehicles to enter the rotary, specifically noted for Great Neck Road North where there is a heavy conflicting entering volume from Route 28 westbound. Lack of adequate gaps may contribute to the high number of rear-end crashes observed at the rotary entrances (i.e. crash #13, 57,62,72).

Figure 7 – Great Neck Road North congestion approaching the rotary

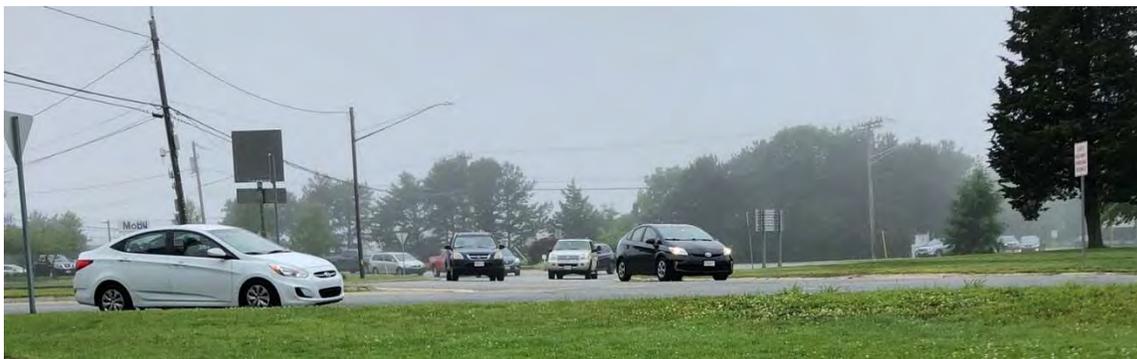
Figure 8 – Weaving vehicles entering and exiting the rotary

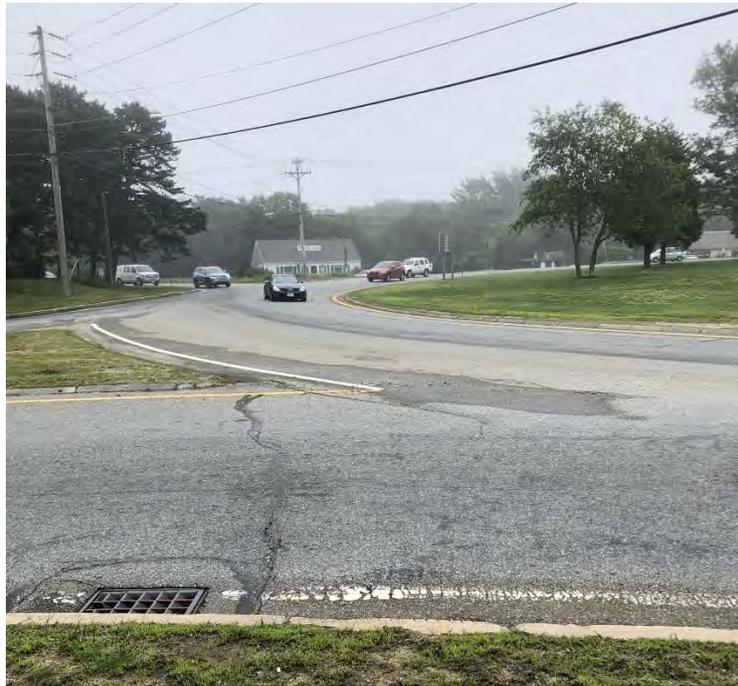
- Several "State Law" signs are dated and illegible to motorists.
- There is a lack of lane designation and pavement markings within the wide circulatory lane in the rotary and at the entrance points.

- With no lane assignment within the circulatory lane, many vehicles are seen weaving which may cause sideswipe crashes (See crash # 14, 30, 48).
 - Vehicles are confused if the entrance points are one or two lanes wide. (See crash #45, 68)

Figure 9 – Lack of pavement marking delimiting lane usage in the rotary

- Consider installing diagrammatic wayfinding signage in advance of the rotary.
- Replace deteriorated “State Law” signs.
- Clear overgrown vegetation to ensure all regulatory and warning signage is visible.
- Consider installing Reduce Speed Ahead signs on all of the approaches.
- Consider painting yield pavement markings and installing a second yield sign on the left-hand side at all approaches to reinforce right of way rules.
- Enhance existing signage to encourage motorists to use adjacent appropriate connector roadways to bypass the rotary.
- Consider installing diagonal pavement markings and/or flexible delineators to reduce the width of rotary and approach roadways to encourage lower speeds.
- Retrofit the rotary to include modern roundabout lane markings to provide a clearer sense of the rotary layout and provide traffic calming.

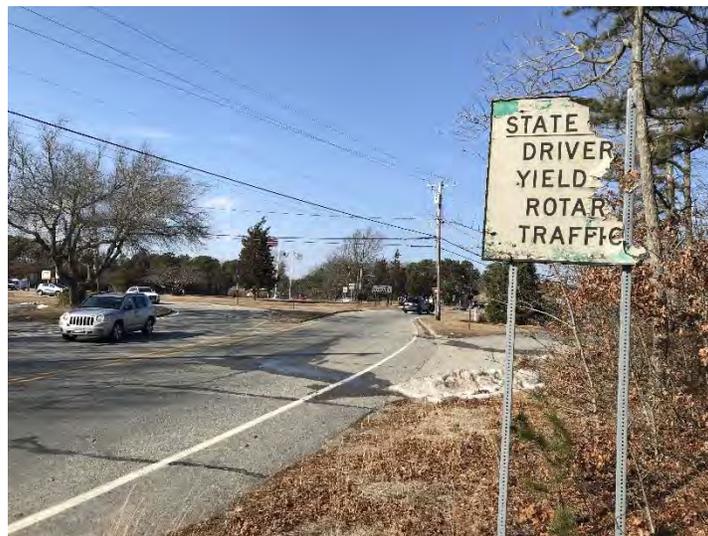
Figure 10 – Damaged and illegible 'State Law' sign on Great Neck Road South

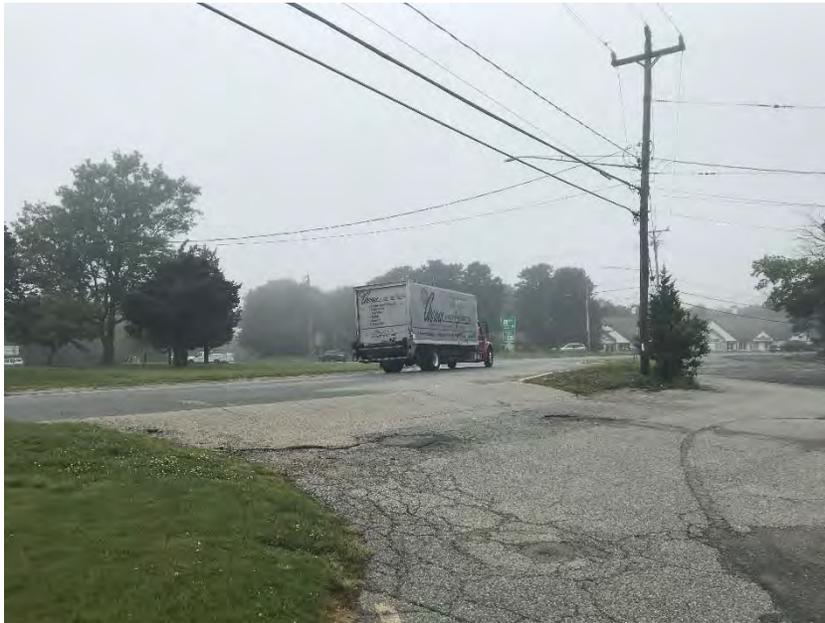
- The curb cuts and adjacent parking lots can encourage cut through traffic on Great Neck Road South to avoid congestion waiting to enter the rotary.
- The two curb cuts located to the east are very steep and hard to navigate for both entering and exiting vehicles.

Figure 11 – View of steep grade of business curb cut connecting to the rotary

- Analyze the existing MassDOT Access Permits for the curb cuts within the rotary. Investigate to see if curb cuts can be modified or consolidated to provide safer access.
- Remove the existing “Do Not Enter” sign within the Picnic Box curb cut.
- Install “No Left Turn” and chevron (R6-4b) signage to be installed across from each of the three curb cuts within the rotary.
- Install pavement markings on each of the curb cuts.

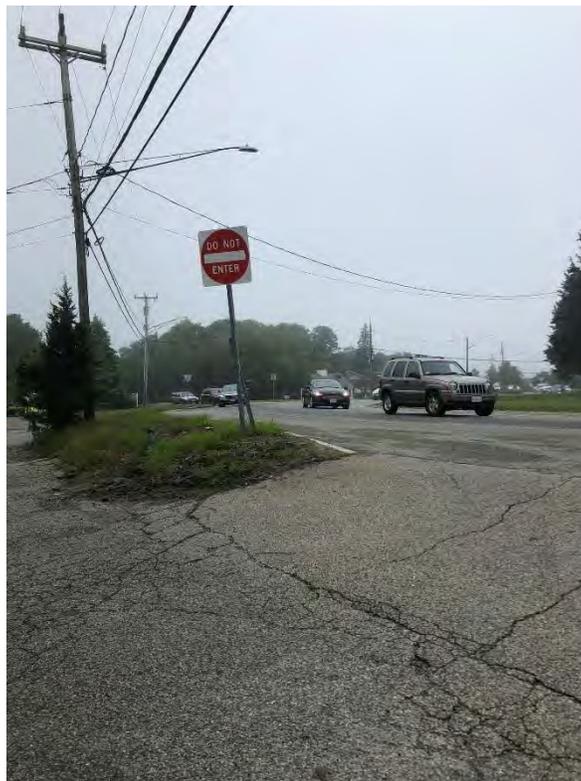
- There is a lack of general signage and pavement markings at the three existing curb cuts.
- There is an existing “Do No Enter” sign on the Picnic Box driveway which causes confusion and appears to be intended to reinforce the one-way circulation of the rotary and not to restrict exiting vehicles.

Figure 12 – View of confusing "Do Not Enter" sign at Picnic Box curb cut

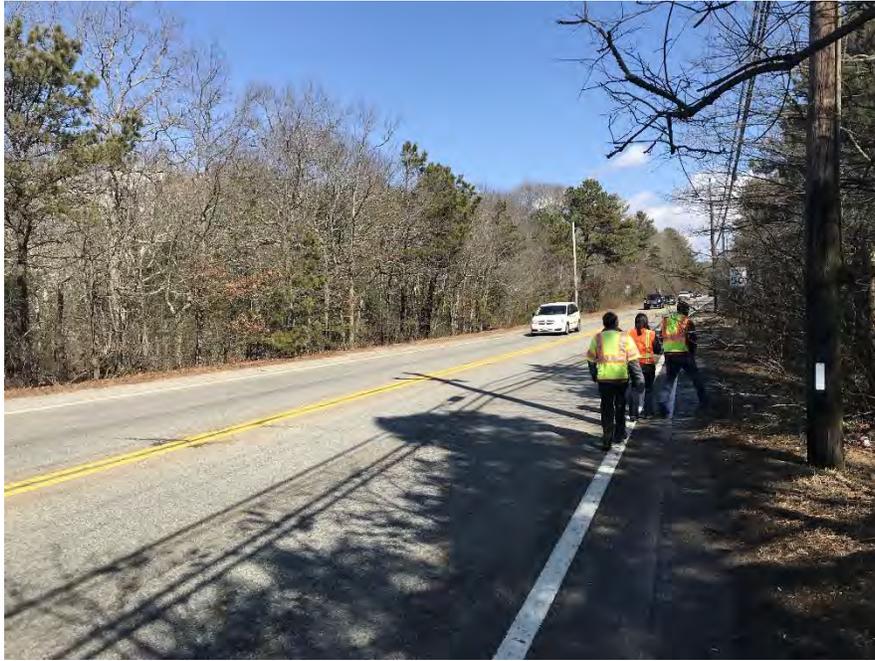
- No pedestrian accommodations (i.e. sidewalks) exist within the rotary or on any of the five approaches.
- Many of the approach roadways do provide sidewalks in the vicinity of the rotary but terminate at nearby retail establishments.

Figure 13 – Lack of pedestrian accommodations on Route 28 approaching rotary

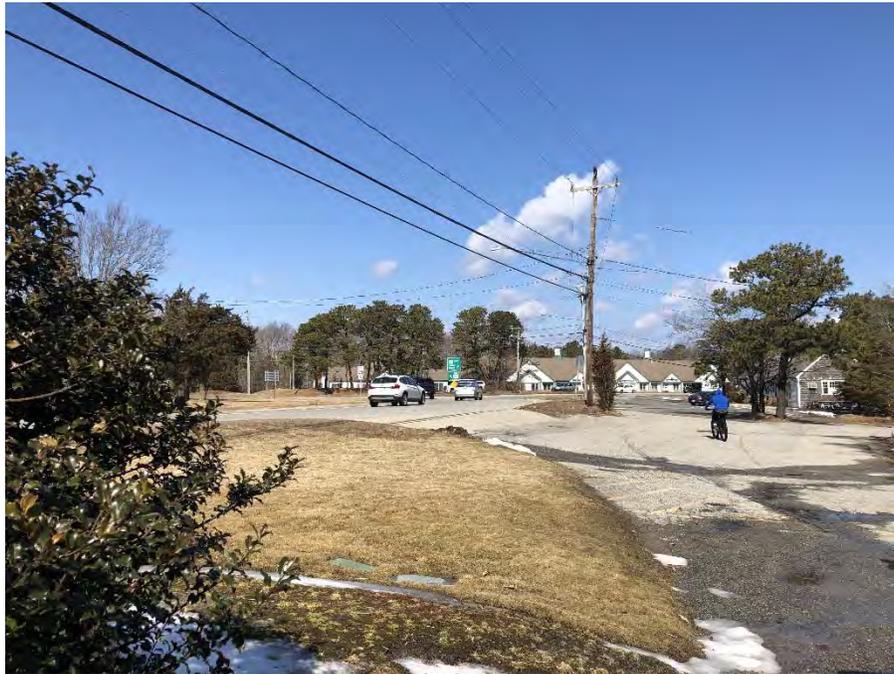
- There is an influx in bicyclists in and around the rotary during the summer due to seasonal workers.
- Many bicyclists use the businesses adjacent to the rotary as a cut through to avoid traversing the rotary itself.

Figure 14 – Cyclist avoiding rotary by utilizing business parking lots
