ROAD SAFETY AUDIT

West End Rotary

Barnstable, MA

June 30, 2021

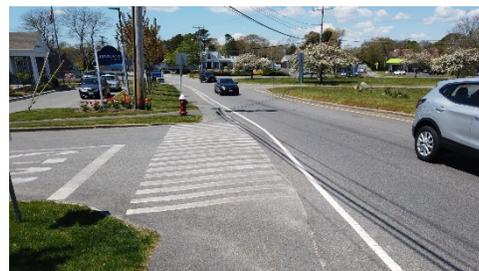
Image 1: Crosswalk across Rockland Trust driveway at the West End Rotary.

While three of the four approaches have sidewalks, with North Street as the exception, the pedestrian accommodations provided are confusing, incomplete and not useful. Expansive driveway crossings along businesses on the rotary are challenging to pedestrians and give the impression that the sidewalk is discontinued. The sidewalk on West Main Street and the sloped sidewalk between Main Street and North Street are in poor condition. Additionally, the sloped sidewalk between Main Street and North Street causes bikes and pedestrians to use the insurance business parking lot as a cut through, thereby creating conflicts in the parking lot. This bituminous sloped sidewalk transitions into a semi-driveway along the Main Street approach to the rotary with vehicles entering the parking lot quickly. This creates a difficult crossing for pedestrians. Historic images from the Google Street View of this sidewalk show yellow striped pavement markings present past the driveway.

- Install new sidewalks along the rotary and its approaches.
- Provide ADA-compliant crossings at all approaches with appropriate warning signage.
- Install crosswalks at all existing driveways where there are current sidewalk connections. (Currently only Rockland Trust driveways have crosswalks).
- Review ADA compliance and upgrade existing sidewalk connections as necessary. Improve sidewalk conditions where appropriate, in particular at the sloped sidewalk between Main Street and North Street.
- Evaluate providing bike accommodations where possible, such as consistent shoulder widths or a striped bike lane.
- Consider the installation of a shared-use path around the rotary.

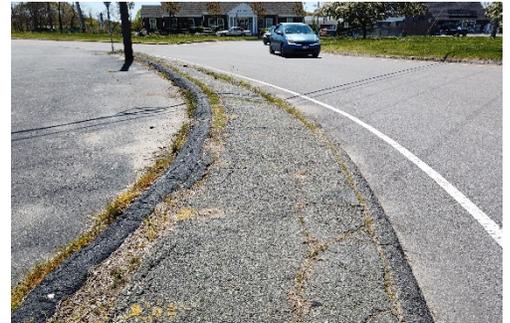
The rotary's design can also encourage indirect routes for pedestrians. For example, there is a short sidewalk segment that runs along the guardrail near North Street and leads into a crosswalk in the Subway Sandwich driveway entrance. The location of the crosswalk does not follow pedestrian desire lines and is likely unused. Also, there are no marked crosswalks at any of the approaches, creating a barrier for those walking through the rotary.

Image 2: Sloped sidewalk between Main Street and North Street

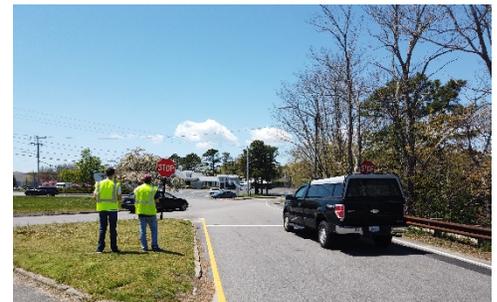
Image 3: North Street approach to rotary

The lack of deflection also contributed to crashes near the North Street and Scudder Avenue entry points, which offer near-straight alignments into the rotary (see crash #11). Drivers at the North Street approach have been observed blatantly running the stop sign or rolling through it. Most movements from North

Street are right turns onto West Main Street, which is a near-straight path for vehicles to make at any break in traffic. The previous switch from yield to stop control was likely an attempt to enforce yielding prior to entering the rotary.

- Consider reconstructing the rotary intersection into a modern roundabout with improved deflection, a smaller center island and smaller overall footprint.
- Evaluate the existing splitter island design and consider redesigning to improve deflection to slow entering and exiting vehicles.
- Relocate the existing utility pole on Scudder Avenue.
- Evaluate lighting conditions and implement improvements.
- Review lane assignments for entry lanes and modify as needed. Consider opportunities to use that space for sidewalks, bike lanes, or a shared use path.

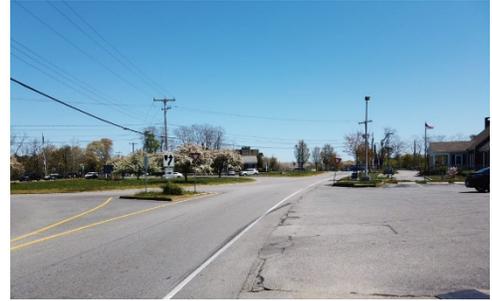
Additionally, several rear-end collisions occurred at the entry points where the second driver incorrectly thought the first driver had entered the rotary already (crashes #2, 5, 14, and 17). Other rear-end collisions were attributed to traffic queuing on Main Street exiting the rotary (see crashes #6, 18, and 19). Some of these crashes involved vehicles exiting the parking lots of Bank of America and Rockland Trust.

Image 4: Scudder Ave approach to rotary

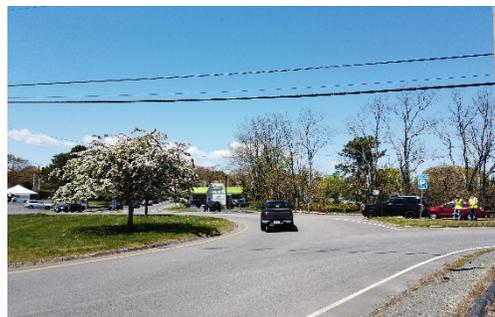
There is an overall lack of signage and pavement markings which lead to confusion for both motorists and non-motorists traveling within the rotary. Since speed regulations are not available for the roadways, speed limit signage is not present in the immediate area of the rotary. With the absence of pavement markings, signage and the wide roadway widths, vehicles tend to operate at a higher speed and not properly yield to circulating traffic, as noted in crashes #1,4,9, and 11.

Image 5: Wide circulatory lane with no pavement markings

- Retrofit the rotary to include modern roundabout signage and pavement markings to improve safety and reduce lane widths within the existing rotary layout.

- Narrow the rotary circulatory lane width with pavement markings or a truck apron to narrow lanes and slow speeds, but still allow space for emergency vehicles.

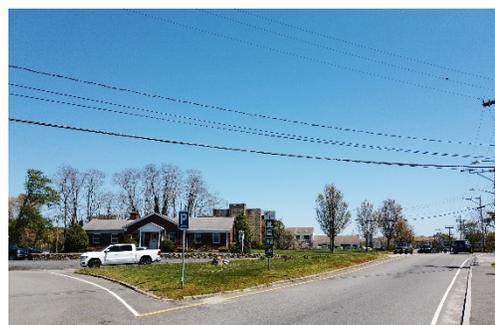
There was also observed to be minimal advance warning, regulatory, and directional signage at the rotary. All approaches lack advance rotary warning signage, except for the Main Street approach. There is also no signage within the rotary itself. Drivers unfamiliar with the area may be confused on how to navigate the rotary to their intended destination. On the North Street approach, where a horizontal curve is present, there is only a Stop Ahead sign, with no advance warning signage noting the rotary ahead. Additionally, there is inconsistency with the regulatory signage on the rotary approaches, as North Street is signed under stop control while the remaining approaches are signed under yield control. There is only one yield sign on Main Street, while the other approaches all have two signs. The Main Street yield sign and one of the Scudder Avenue yield signs are both placed far into the rotary and are not effective

Image 6: Lack of directional signage at exit points

- Install advance rotary warning signs on all approach roadways.
- Add yield lines to all entry legs.
- Add painted gore lines to all splitter islands.
- Develop a comprehensive signage plan for the rotary that includes chevrons for the center rotary island and supplemental directional signage at exit points.

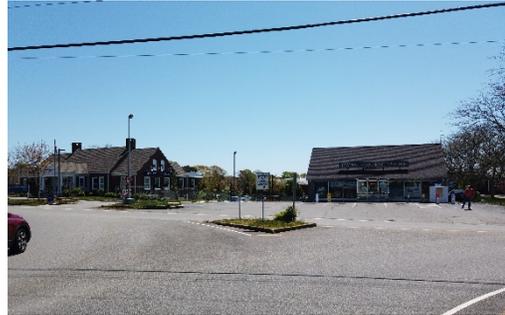
Many of the rotary driveways are wide, with little delineation which can cause confusion to motorists. For example, there appears to be a large driveway opening on Main Street to an office building with no pavement markings or delineation to motorists to inform motorists or non-motorists of the driveway operations. The liquor store driveway is also a large curb cut and it was noted that vehicles can enter the site from either side of the splitter island on Scudder Avenue, which can cause confusion to vehicles maneuvering the rotary in this area.

Image 7: Large driveway opening to Liquor Store

- Review and implement access management strategies for existing rotary driveways.
- Consider implementing turn restrictions on driveways within or near the rotary with appropriate signage or pavement markings.
- Consider striping driveways to narrow widths.
- Consider reconstructing rotary driveways to reduce widths by modifying curb lines.
- Modify the Scudder Avenue splitter island to restrict movement to the liquor store.
- Relocate Rockland Trust stop bar closer to roadway.
- Install missing left-turn restriction sign for West Main Street Subway driveway.

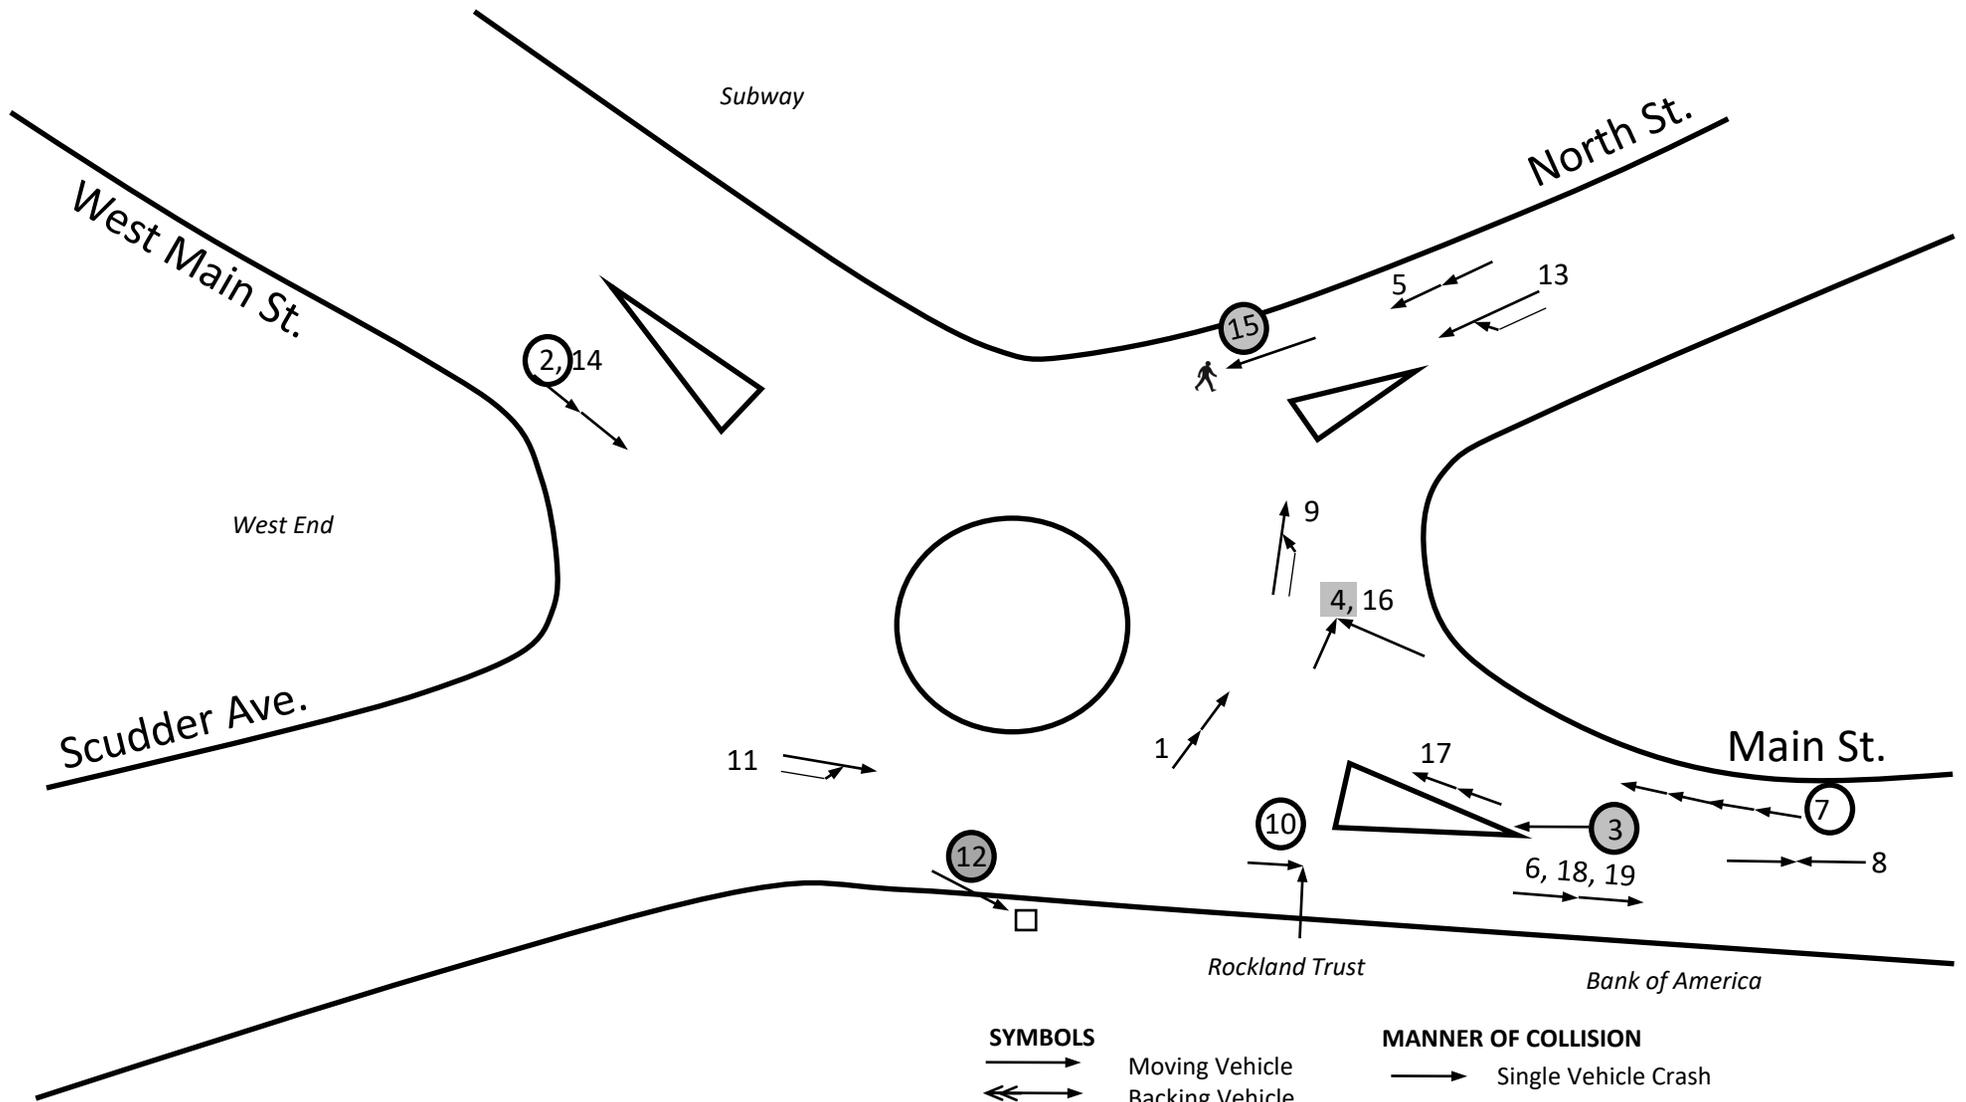
CRASH DIAGRAM

Total Crashes: 19 Injury Crashes: 6 Fatal Crashes: 0
