TOWN OF CHATHAM

- Town Map
- Chart of Site Characteristics
- Sites 1 to 7

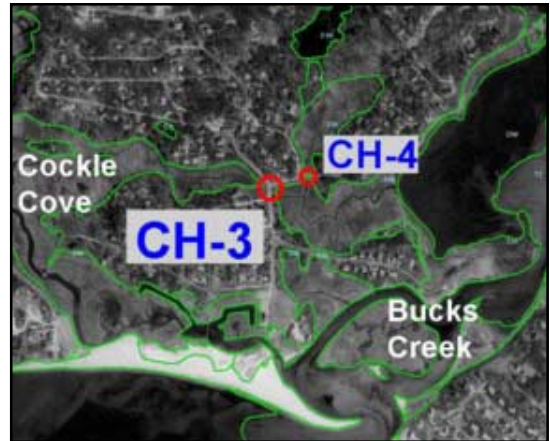
Upstream Affected Area (acres): SM – unable to determine.

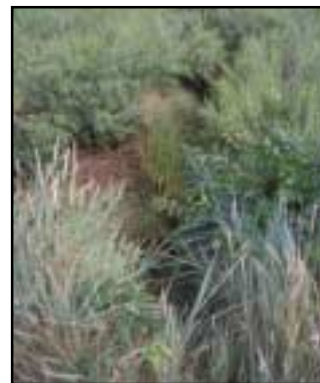
*The Wetlands Conservancy Program delineated salt marsh upstream of Cranberry Lane, but shrubs, *Phragmites*, cattails, and a dry creek channel were observed.*

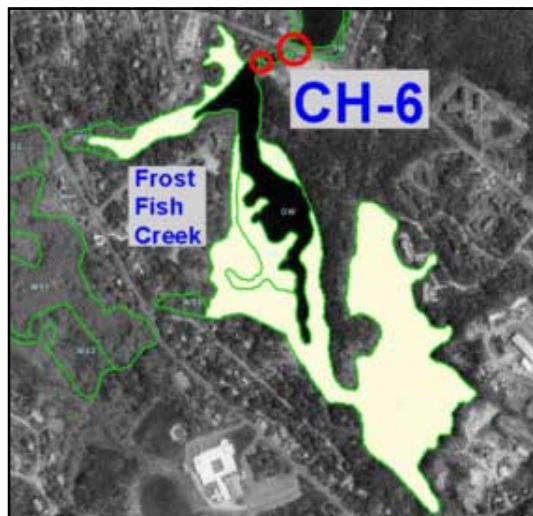
Upstream affected area (acres): SS – 31.69; M – 2.89.

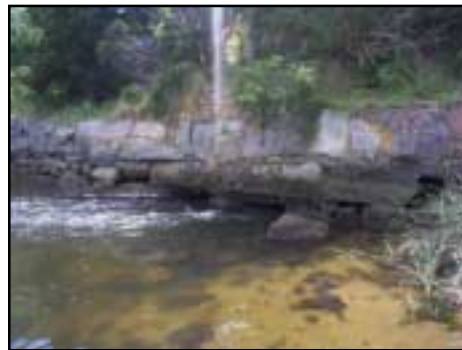
These 2 box culverts pass the flow of the Muddy River under Route 28. The stone slab retaining wall supporting the culverts appears to be in poor condition.

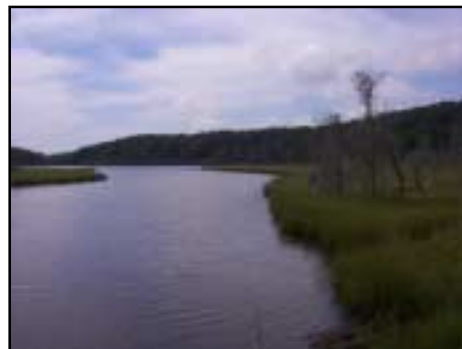
Upstream of Route 28 salt marsh exists along the banks of the Muddy River.
