ROAD SAFETY AUDIT

West Falmouth Highway (Route 28A) between Chapoquoit Road and Old Dock Road

Town of Falmouth

July 2023

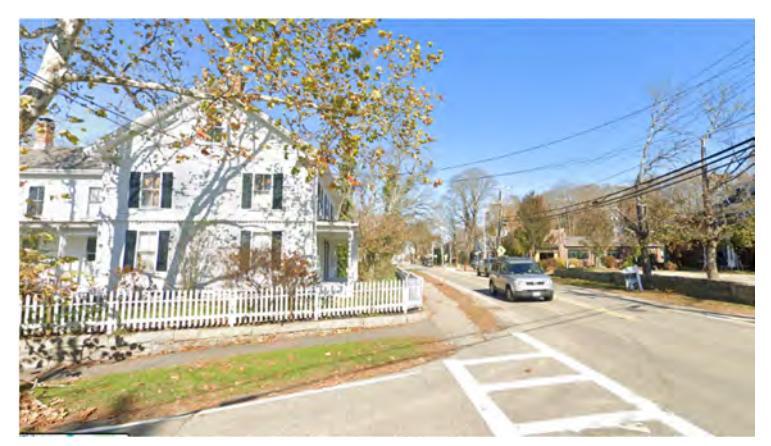
Multiple factors appear to obstruct driver visibility on the eastbound approaches of Old Dock Road and Chapoquoit Road at Route 28A, including roadside objects, vegetation, and horizontal and vertical curvature. Drivers turning onto Route 28A from both roads have vegetation blocking southbound visibility and a decline in elevation from north to south on Route 28A inhibits northbound visibility. Both of these conditions may obstruct a driver's view of cross-traffic on Route 28A until the driver is encroaching into the intersection and crosswalk (Chapoquoit crash #4, 6, 8). Although no crashes were reported, the audit team observed multiple drivers turning left and right from Old Dock Road onto Route 28A encroaching into the intersection to get a better view of oncoming traffic.

Image 1: View from Chapoquoit Road Looking North with Picket Fence Obstructing Visibility (Google)

- Consider consulting with abutters to remove visibility obstructions adjacent to the ROW but on private property such as fences and bushes.
- Make physical improvements to implement "daylighting" at intersections where parked vehicles may obstruct visibility. Daylighting is the practice of prohibiting parking near intersections to increase the visibility of roadway users. Examples of daylighting elements include paint, flexposts, curb extensions, and bioswales.

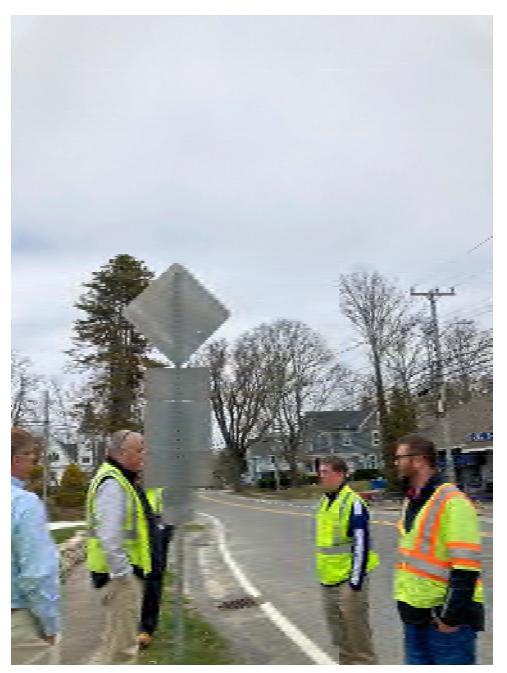
On Old Dock Road, the stone wall and regulatory signage on the northwest side of the intersection with Route 28A also block northbound visibility for drivers turning onto Route 28A and limits the visibility of drivers traveling south on Route 28A, who may not see people entering the crosswalks from Old Dock Road (Old Dock crash #6). There is a similar issue on Chapoquoit Road, where the picket fence on the northwest side of the intersection with Route 28A and uphill geometry block northbound

Image 2: Signs Blocking Sight Distance on Route 28A at Old Dock Road Facing North

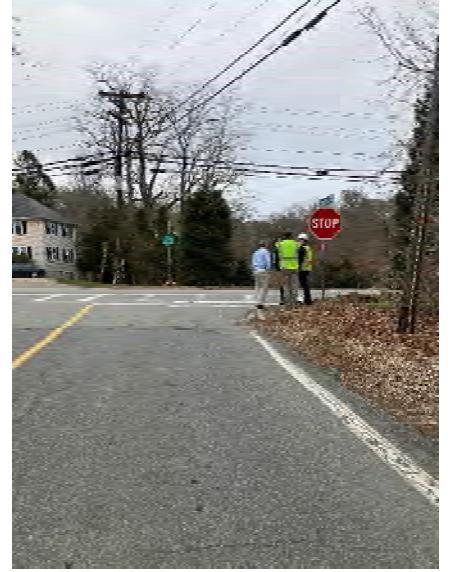
Image 3: Chapoquoit Road at Route 28A Has Visibility Concerns from all Approaching Directions

- Consider trimming overgrown vegetation, particularly on the southwest corner of Route 28A and Chapoquoit Road, at the Shining Sea Bikeway crossings with Old Dock Road and Chapoquoit Road, and along sidewalks.

- Evaluate the feasibility of removing the granite curb on the southwest corner of Chapoquoit Road and Route 28A so drivers turning right from Chapoquoit Road onto Route 28A do not have to take as wide of a turn, potentially into oncoming traffic.

- Evaluate Multi-Way Stop Control warrants on Route 28A at Old Dock Road and Chapoquoit Road.

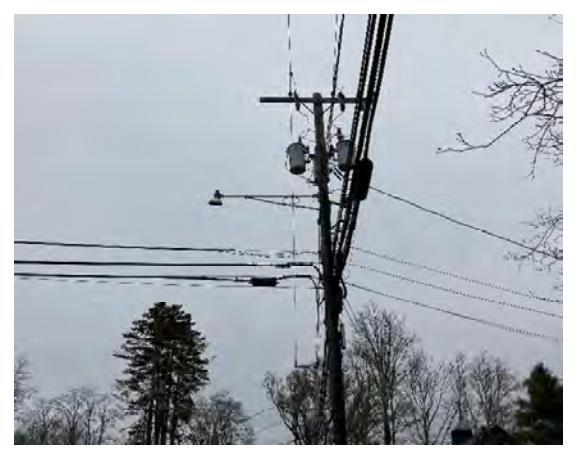
The audit team noted that the tree canopy along Route 28A limits natural light illuminating the roadway. Route 28A has several streetlights affixed to utility poles that are inconsistently placed. Local RSA participants noted that the streetlights are dim and do not currently use LED technology (Old Dock crash #1, 3; Chapoquoit crash #3, 4, 5). Streetlights, regardless of bulb technology, are not always effective in illuminating crosswalks. In addition, the crosswalk at the West Falmouth Library does not have a nearby streetlight. Local RSA participants indicated that the crosswalk at the Quaker Meeting House/West Falmouth Library is often used at night and that the parking lot lights at the West Falmouth Market may distract drivers, as the illuminated parking lot is much brighter than the road.

Image 4: Streetlight on Route 28A

• Consider upgrading existing streetlights in the Study Area to LEDs to improve roadway visibility.

- Consider installing additional streetlights as needed at intersections.
- Consider installing pedestrian-scale lighting at crosswalks.

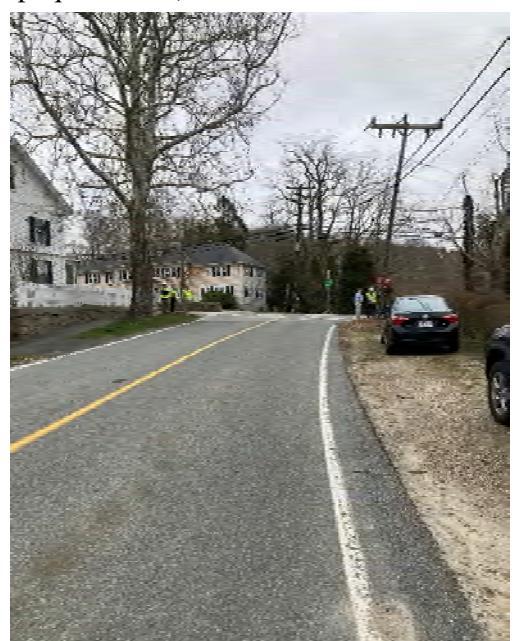
Image 5: Obstructed Stop Sign on Chapoquoit Road

- Consider adding object markers to features along Route 28A (such as utility poles) to increase their visibility to drivers.
- Relocate the stop sign on Chapoquoit Road at Route 28A that is blocked by a utility pole approaching the intersection.

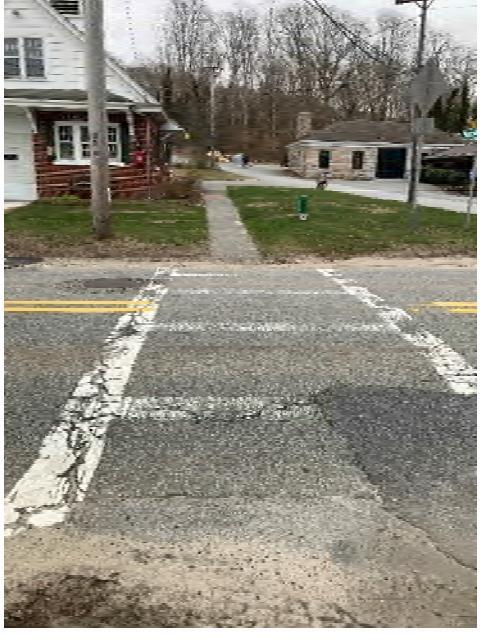
RSA participants noted that signage and pavement markings in the Study Area were not easy to see, which may be due to paint fading on the roadway, sign conditions such as retroreflectivity, sign locations, or obstructions from vegetation or other objects, such as utility poles. The intersections of Route 28A at Old Dock Road and Chapoquoit Road lacked sufficient signage such as intersection warning signs and flashing stop signs to warn drivers from all approaches of the upcoming intersections (Chapoquoit crash #4, 5). In addition, the stop sign on Chapoquoit Road approaching Route 28A is obstructed by a utility pole. Audit team members noted poor visibility of fixed roadside objects, such as utility poles, due to lack of roadway lighting and reflective markers; four crashes along the corridor involved a single vehicle crashing into a fixed object (Old Dock crash #5, 7; Chapoquoit crash #1, 3). From a driver's perspective, the audit team also noted that crosswalks across Route 28A are difficult to see (Old Dock crash #6).

Image 6: Crosswalk with Faded Striping on Route 28A at the Falmouth Fire Department Station 4

- Relocate the Old Dock Road street name sign at Route 28A closer to the intersection to improve wayfinding.
- Restripe Route 28A, particularly its mid-block crosswalks. Evaluate widening the crosswalk striping and using high visibility striping to improve visibility to drivers.

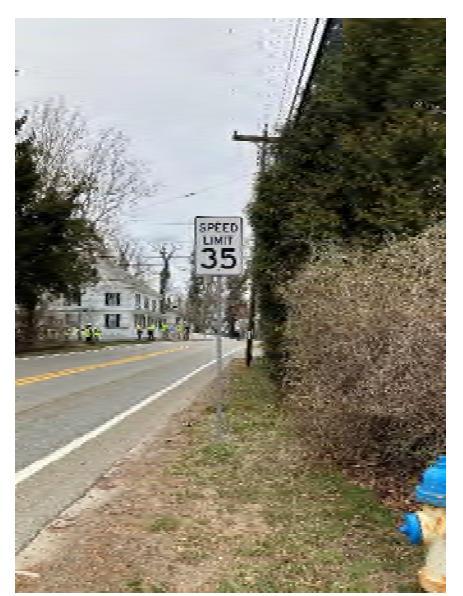
There are few posted speed limit signs in the Study Area, particularly on Route 28A southbound. RSA participants noted a lack of speed limit signs on Route 28A after Thomas B. Landers Road to the north and Brick Kiln Road to the south, which connect to exits at Route 28. Drivers arriving in the Study Area from Route

Image 7: Speed Limit Sign on Route 28A at Chapoquoit Road, Facing North. Vegetation Obstructs This Sign in Warmer Months

- Consider installing speed feedback signs to increase driver awareness of speeds along Route 28A.
- Consider installing confirmatory speed limit signs on Route 28A near highway interchanges to alert drivers of speed limits through the corridor.

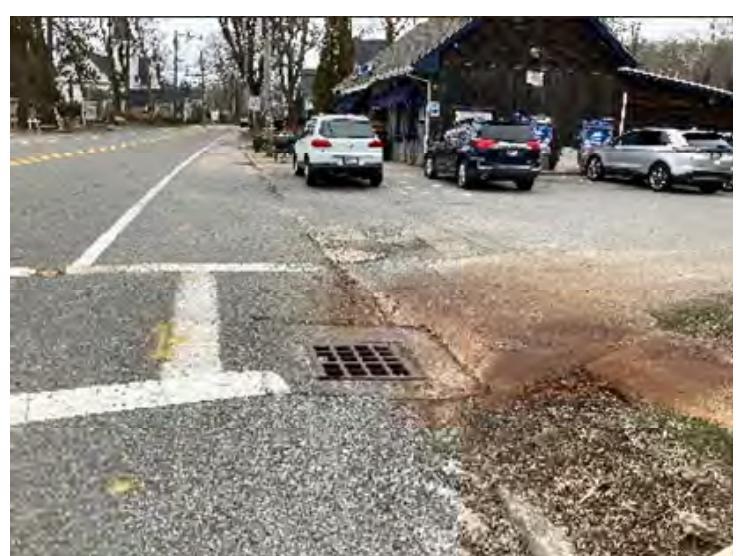
The RSA team observed that sidewalks on Route 28A in the Study Area are disconnected (primarily on the east side of the roadway, south of the Chapman Cole and Gleason Funeral Home), in poor condition, not compliant with the Americans with Disabilities Act (ADA), and narrower than the 5-foot width required by MassDOT's Engineering Directive E-20-001 for sidewalks in urbanized areas. Curb ramps (where available) and crosswalks were also

Image 8: Crosswalk at the West Falmouth Market with a Catch Basin in the Path of Travel

generally not ADA compliant. On some segments of Route 28A, utility pole placements are in the middle of sidewalks or placed adjacent to the roadway edge in the likely path of a potentially new sidewalk.

- Bring all crosswalks to ADA compliance, including the use of high-visibility markings and the installation of compliant curb ramps.
- Evaluate the feasibility of improving sidewalks on Route 28A between the West Falmouth Market and Chapoquoit Road to make them continuous and accessible within the rustic context of the corridor.

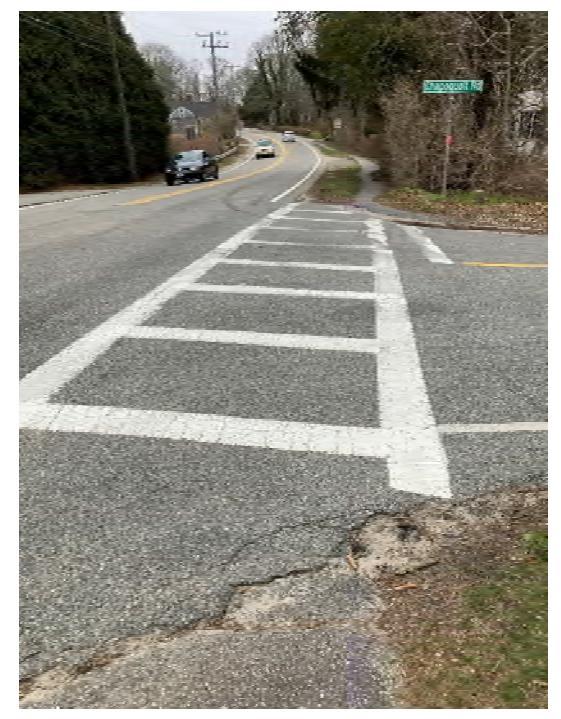
Image 9: Crosswalk at Chapoquoit Road Does Not Have Accessible Curb Ramps

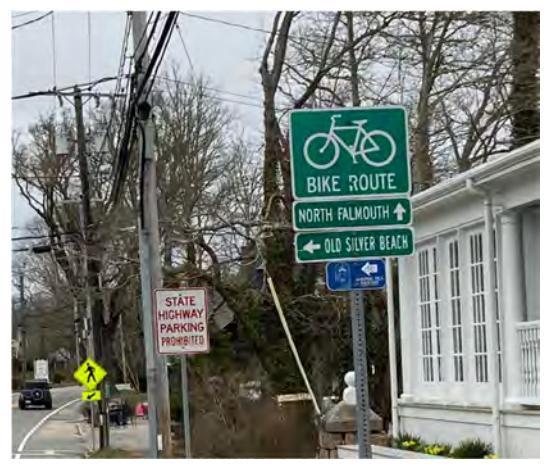
Image 10: Bike Route and Wayfinding Signs on Route 28A at Old Dock Road

- Consider initiating a bicycle safety campaign, possibly building on the Town's Safe Routes to School initiative.
- Consider off-street bike accommodations on Route 28A that complement the Shining Sea Bikeway.
- Evaluate installing additional traffic controls at the Shining Sea Bikeway crossings of Old Dock Road and Chapoquoit Road to make them more conspicuous.
- Consider installing bicycle pavement markings and Share the Road signs on Old Dock Road and Chapoquoit Road between the bikeway and Route 28A.
- Install Share the Road signs on Route 28A to alert drivers of the potential presence of bicyclists.
- Install additional wayfinding signage for bicyclists on Route 28A to direct bicyclists to the Shining Sea Bikeway and community destinations.

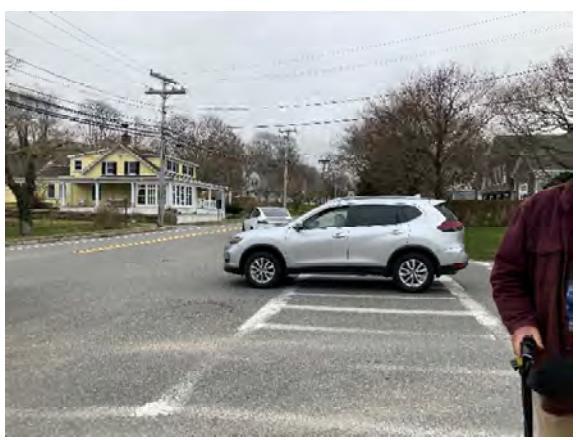
Blocked by an Encroaching Car

Dock Road to visit the West Falmouth Market (Old Dock Crash #4). Both sides of Route 28A in front of the market have posted No Parking signs, but they are routinely ignored.

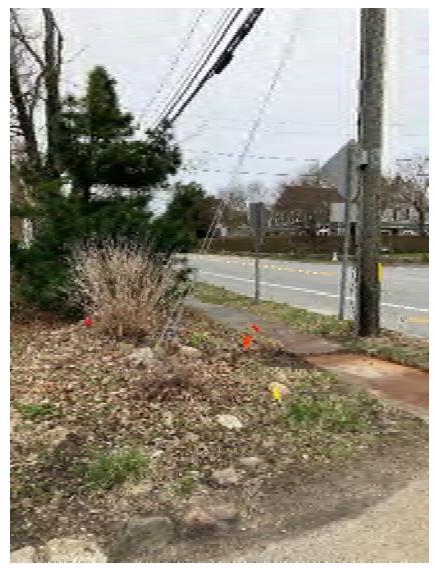
Vehicles parking on both sides of Route 28A in front of the West Falmouth Market inhibit the visibility of drivers turning into and out of the Market's driveway and Old Dock Road who may not see approaching vehicles, bicyclists, and pedestrians. RSA participants observed numerous vehicles turning from Old Dock Road onto Route 28A stopping past the stop sign and blocking the crosswalk to gain better visibility before proceeding. This is a common action for bicyclists as well.

Image 12: View from the West Falmouth Market Parking Lot **Facing South with Vegetation Obstructing Visibility**

- Coordinate with the owners of the West Falmouth Market and 631 West Falmouth Highway (Route 28A) to see if there is an opportunity to introduce one-way circulation for the market parking lot.

- Evaluate the feasibility of formalizing the edges of and narrowing the West Falmouth Market driveway apron with a reconstructed pedestrian curb ramp and reintroducing the landscaping that was removed between 2009 and 2011, and extending the sidewalk from the Market's front entrance south to the edge of a narrower driveway, with a striped crosswalk across the driveway.

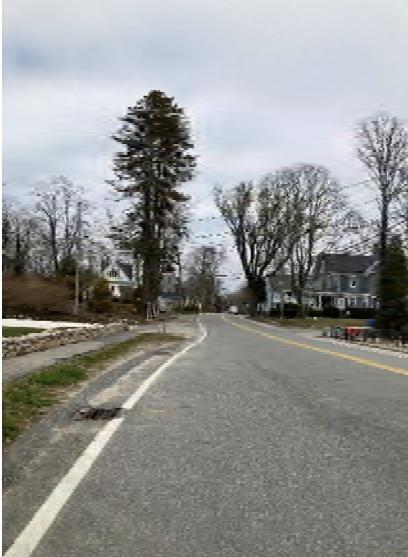
Image 13: Storm Drains on Route 28A As It Widens North of Old Dock Road

RSA participants noted drainage issues with blocked catch basins on the northwest side of the Old Dock Road intersection, which cause ponding (particularly in front of the West Falmouth Market driveway) and create a potential falling hazard for bicyclists. Along the Route 28A corridor, three crashes occurred during wet conditions (Old Dock crash #3,4; Chapoquoit crash #2), including one (Chapoquoit crash #2) where the driver hydroplaned.

• Clear sand out of the shoulders and catch basins on Route 28A and evaluate drainage grates to remove potential bicyclist falling hazards.
