# NATURAL RESOURCES INVENTORY

Cape Cod Commission Regional Policy Plan  
Technical Bulletin 92-002  
Developments of Regional Impact

Assessor's Map 27 Parcel 152  
Bourne, Massachusetts

## Atlantic Subaru

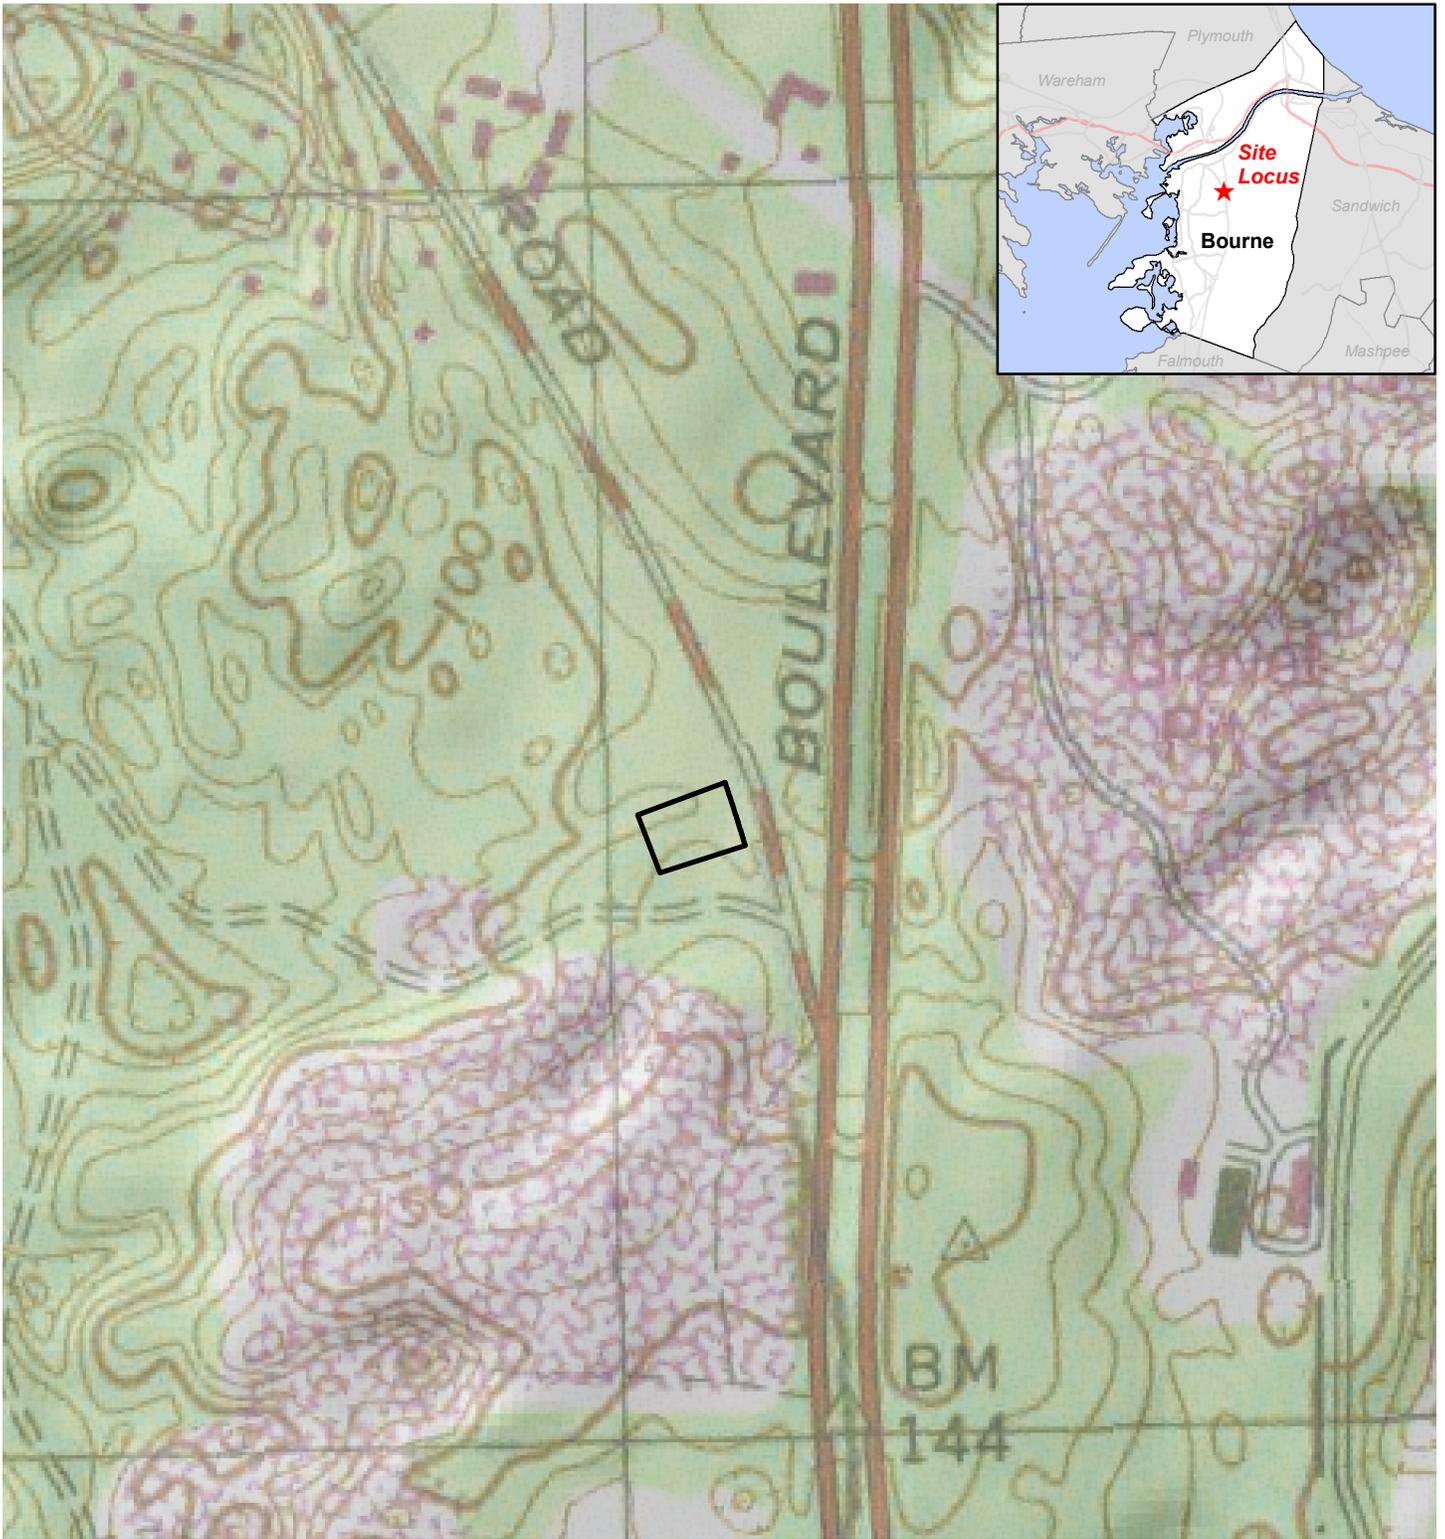
Figure 1

USGS Topographic  
Quadrangle  
122 Waterhouse Road  
Bourne, MA

The project area at 122 Waterhouse Road is on a 0.92 acre lot located along the west side of Waterhouse Road (latitude: 41° 43' 35.64"N, longitude: -70° 35' 8.70"W) (Figure 1). The property is defined by the Bourne Assessors Department as Map 27 Parcel 152 and is within the Business 4 zoning district under the Bourne Zoning Bylaw. The parcel is an undeveloped wooded parcel with a plant community indicative of a typical Cape Cod pine/oak forest habitat. The tree canopy is primarily composed of pitch pine (*Pinus rigida*) and mixed oak species (*Quercus* spp.), with a patchy understory that ranges from densely vegetated to sparse with very little groundcover. The terrain has slight, gently rolling hills, a few depressions, standing snags, fallen dead trees, and occasional boulders, with some evidence of past land-use activity.

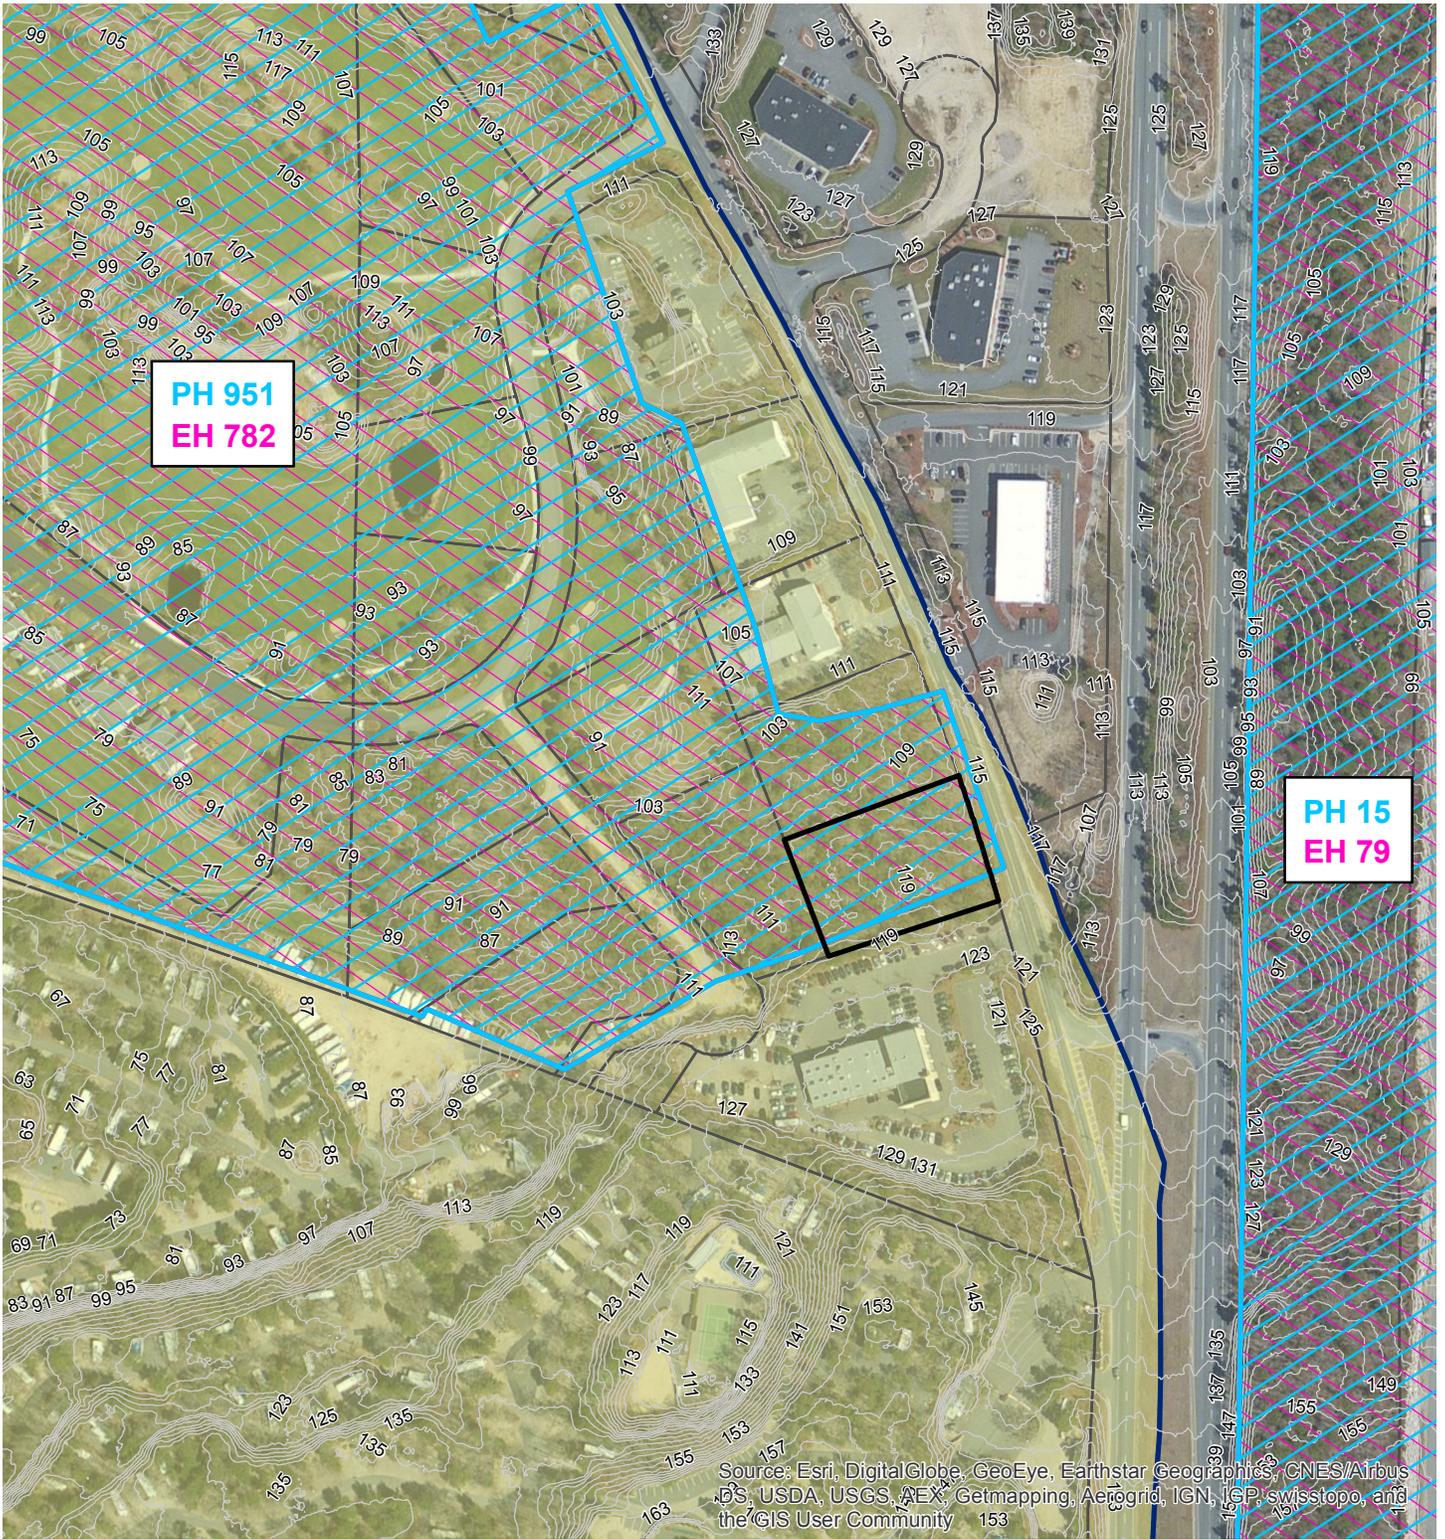
Figure 2

**Existing Constraints**  
 122 Waterhouse Road  
 Bourne, MA

The project locus abuts a vacant forested lots to the west and north (parcels 154 and 151, respectively); a developed lot (Atlantic Subaru) to the south (parcel 153); and a major paved road (Waterhouse Road) to the east. There is a 20-foot utility easement off the southern boundary, which includes gas and water service to Dornick Road. The general topography of the site slopes from south to north with the steepest grades along the southern and western boundaries. The elevation across the property project area varies from 119 to 103 feet above mean sea level (Figure 2).

The site is located within the Bourne Back River Area of Critical Concern (ACEC) (see Figure 2) and the project area is located entirely within the X-Zone as shown on the Federal Emergency Management Agency (FEMA) Flood Insurance Rate Map (FIRM) Community Panel Number 255210 0008F revised August 9, 1999 (Figure 3).

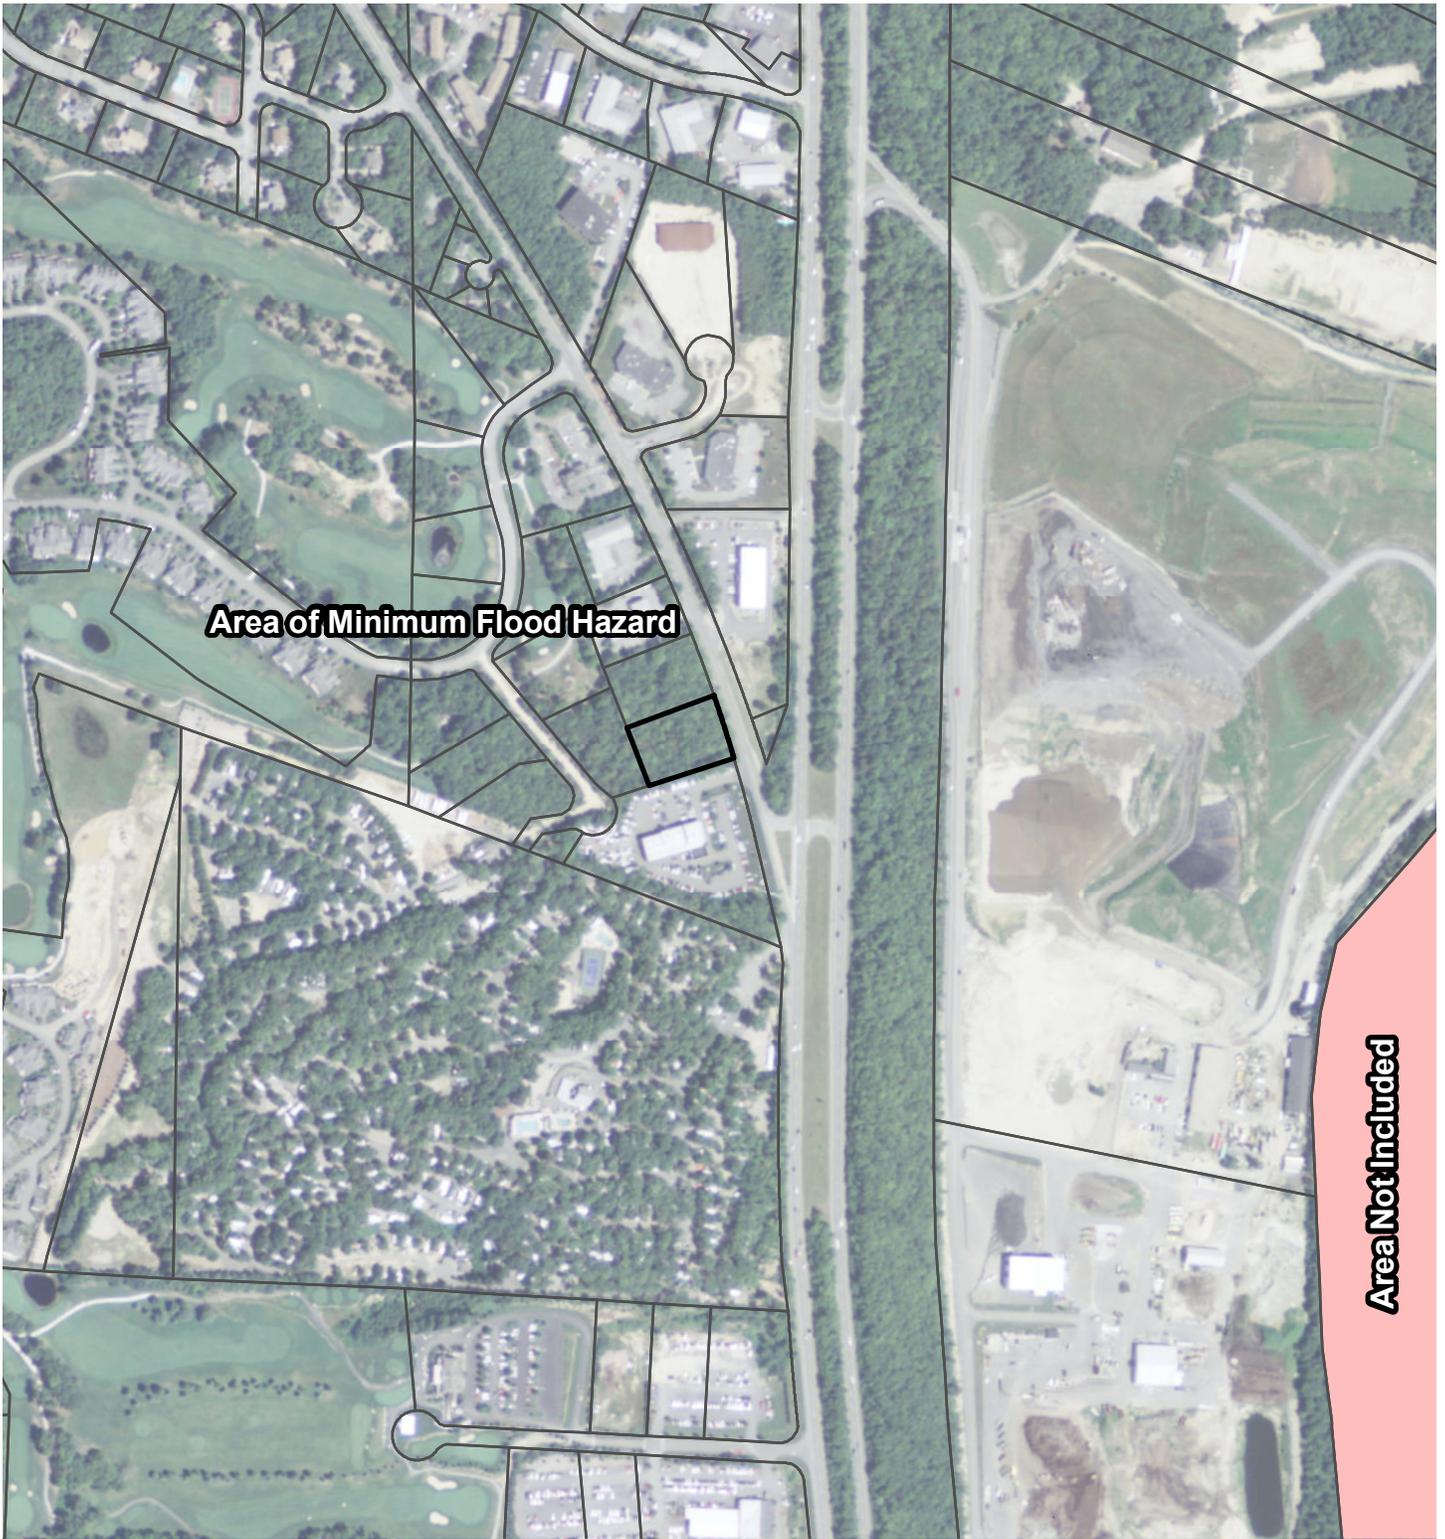
Figure 3

FEMA's National Flood Hazard Layer  
122 Waterhouse Road  
Bourne, MA

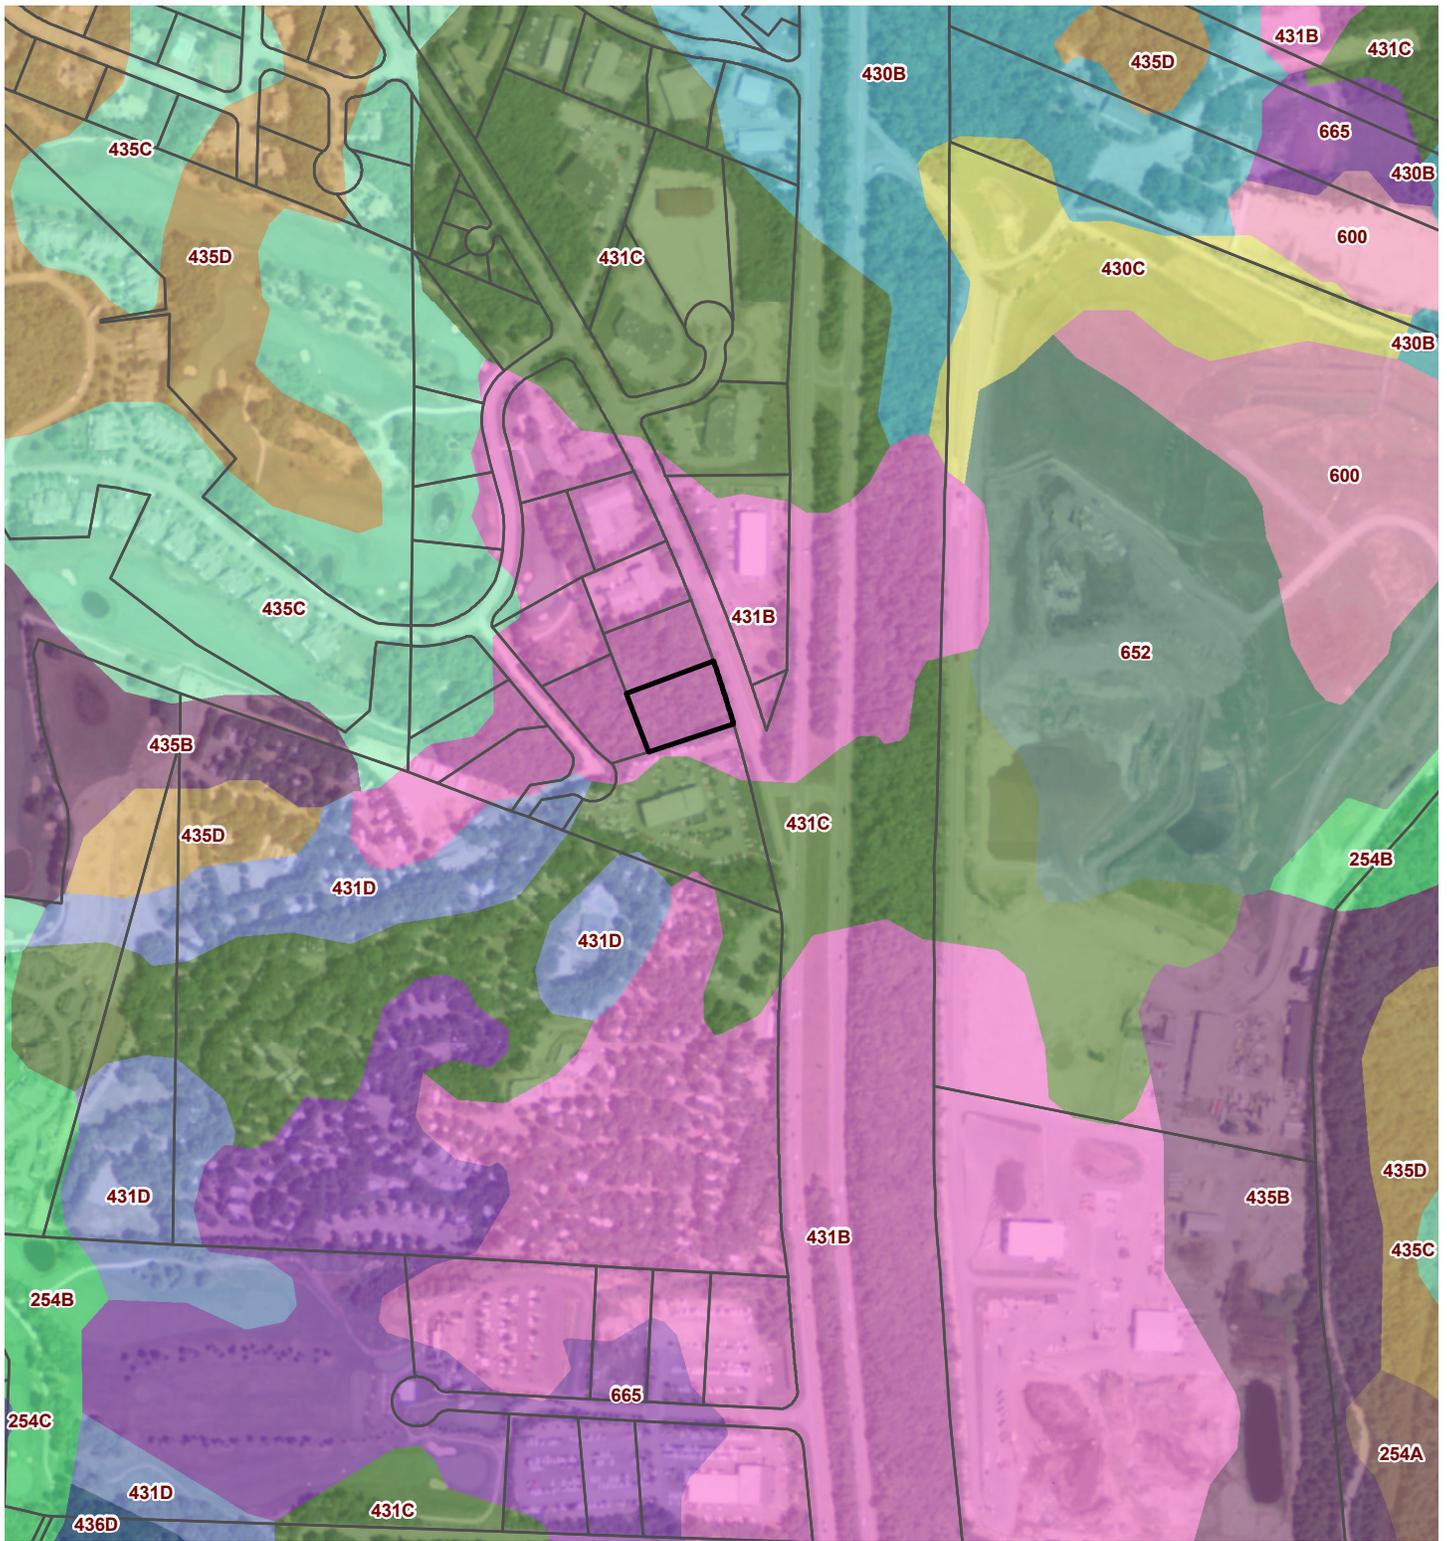
Barnstable County Soils  
122 Waterhouse Rd  
Bourne, MA 02532

The Natural Resources Conservation Service identifies this site as falling within one soil type, as described in the Soil Survey of Barnstable County, Massachusetts (March 1993). The soils underlying the site are classified as Barnstable sandy loam, Barnstable sandy loam, 3 to 8 percent slopes (431B), which are described as “very stony, moderately well drained soils formed in glacial fluvial deposits on outwash plains, delta, kames, and ice contact deposits” (Figure 4). HW’s site observations are consistent with the wide range of slopes, as topography at this site is somewhat undulating from nearly flat to more steeply sloped.

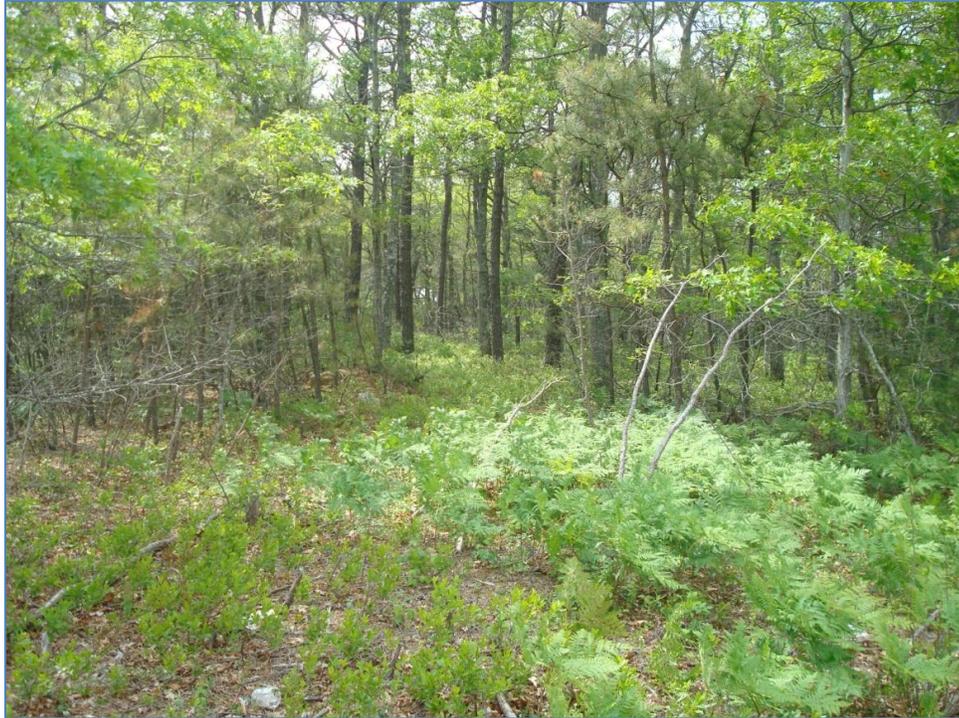
**Photo 1. Tree canopy of project site, looking northwest.**

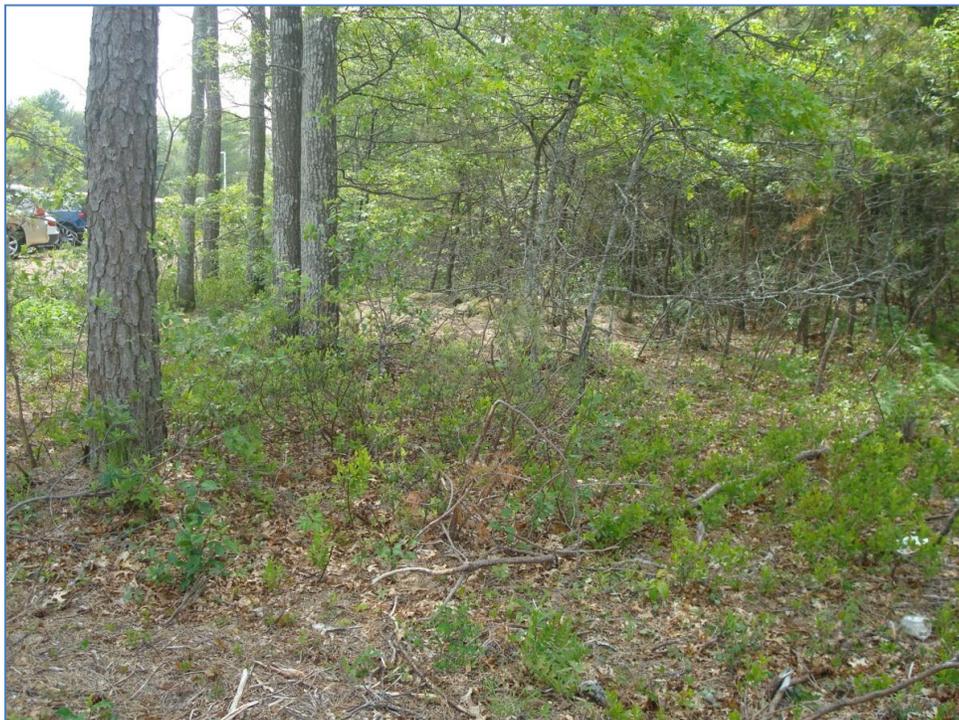
**Photo 2. Tree canopy of project site, looking west (Cars parked at Atlantic Subaru just visible on left).**

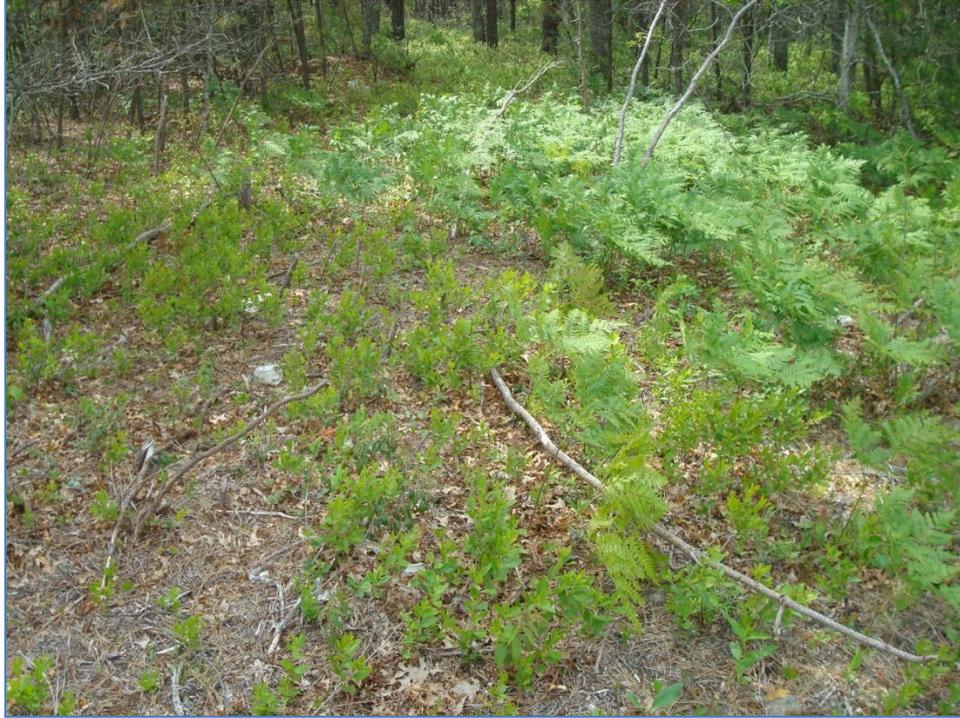
Photo 3. Understory plant species, looking northwest.

The understory plant community is shrub-dominated with sparse herbaceous cover. Commonly observed species include black huckleberry (*Gaylussacia baccata*), highbush blueberry (*Vaccinium corymbosum*), ink berry (*Ilex glabra*), patches of sheep laurel (*Kalmia angustifolia*), low bush blueberry (lowbush blueberry (*Vaccinium angustifolium*), and oak and sassafras seedlings. To a lesser extent, there are clumps and patches of nannyberry (*Viburnum lentago*). The invasive European buckthorn (*Frangula alnus*) was also present in small amounts.

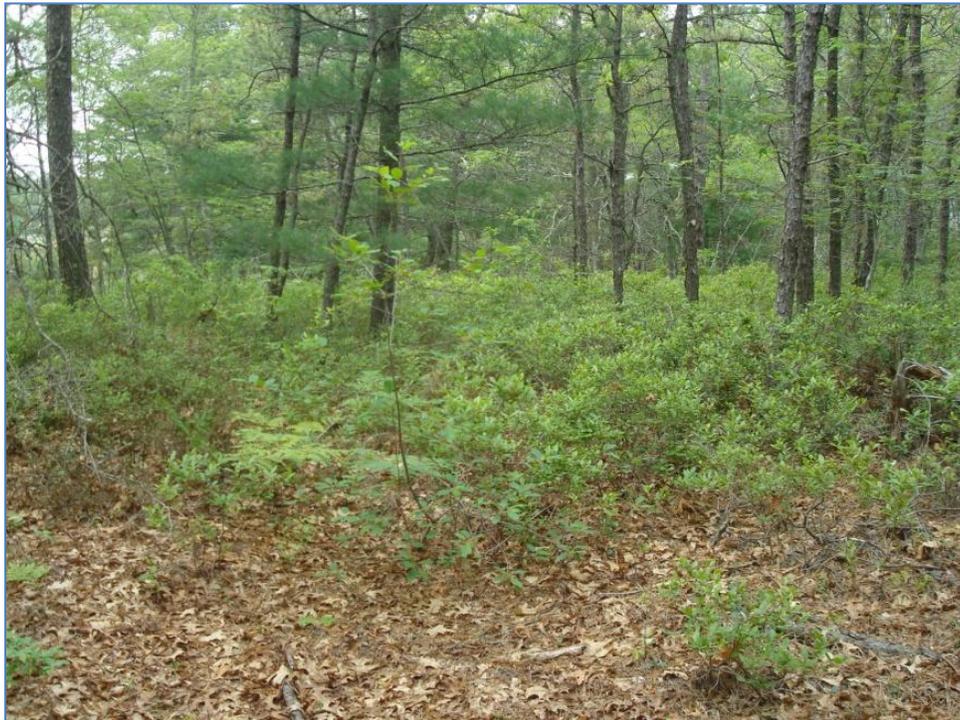
Photo 4. Ground cover of inkberry, lowbush blueberry, and leaf cover.

Groundcover consists of carpets of wintergreen (*Gaultheria procumbens*), tree-clubmoss (*Dendrolycopodium obscurum*), pipsissewa (*Chimaphila maculata*), bracken fern (*Pteridium aquilinum*), and mayflower (*Maianthemum canadense*). The understory is fairly consistent throughout the site. The floor of the forested upland habitats is a relatively thick (i.e., three to four-inch) layer consisting of oak leaf, pine needle, twig, and fibric organic matter.
