Provincetown Municipal Airport

2013 Wildlife Hazard Assessment

Prepared by
Jacobs Engineering

November 2014
Final

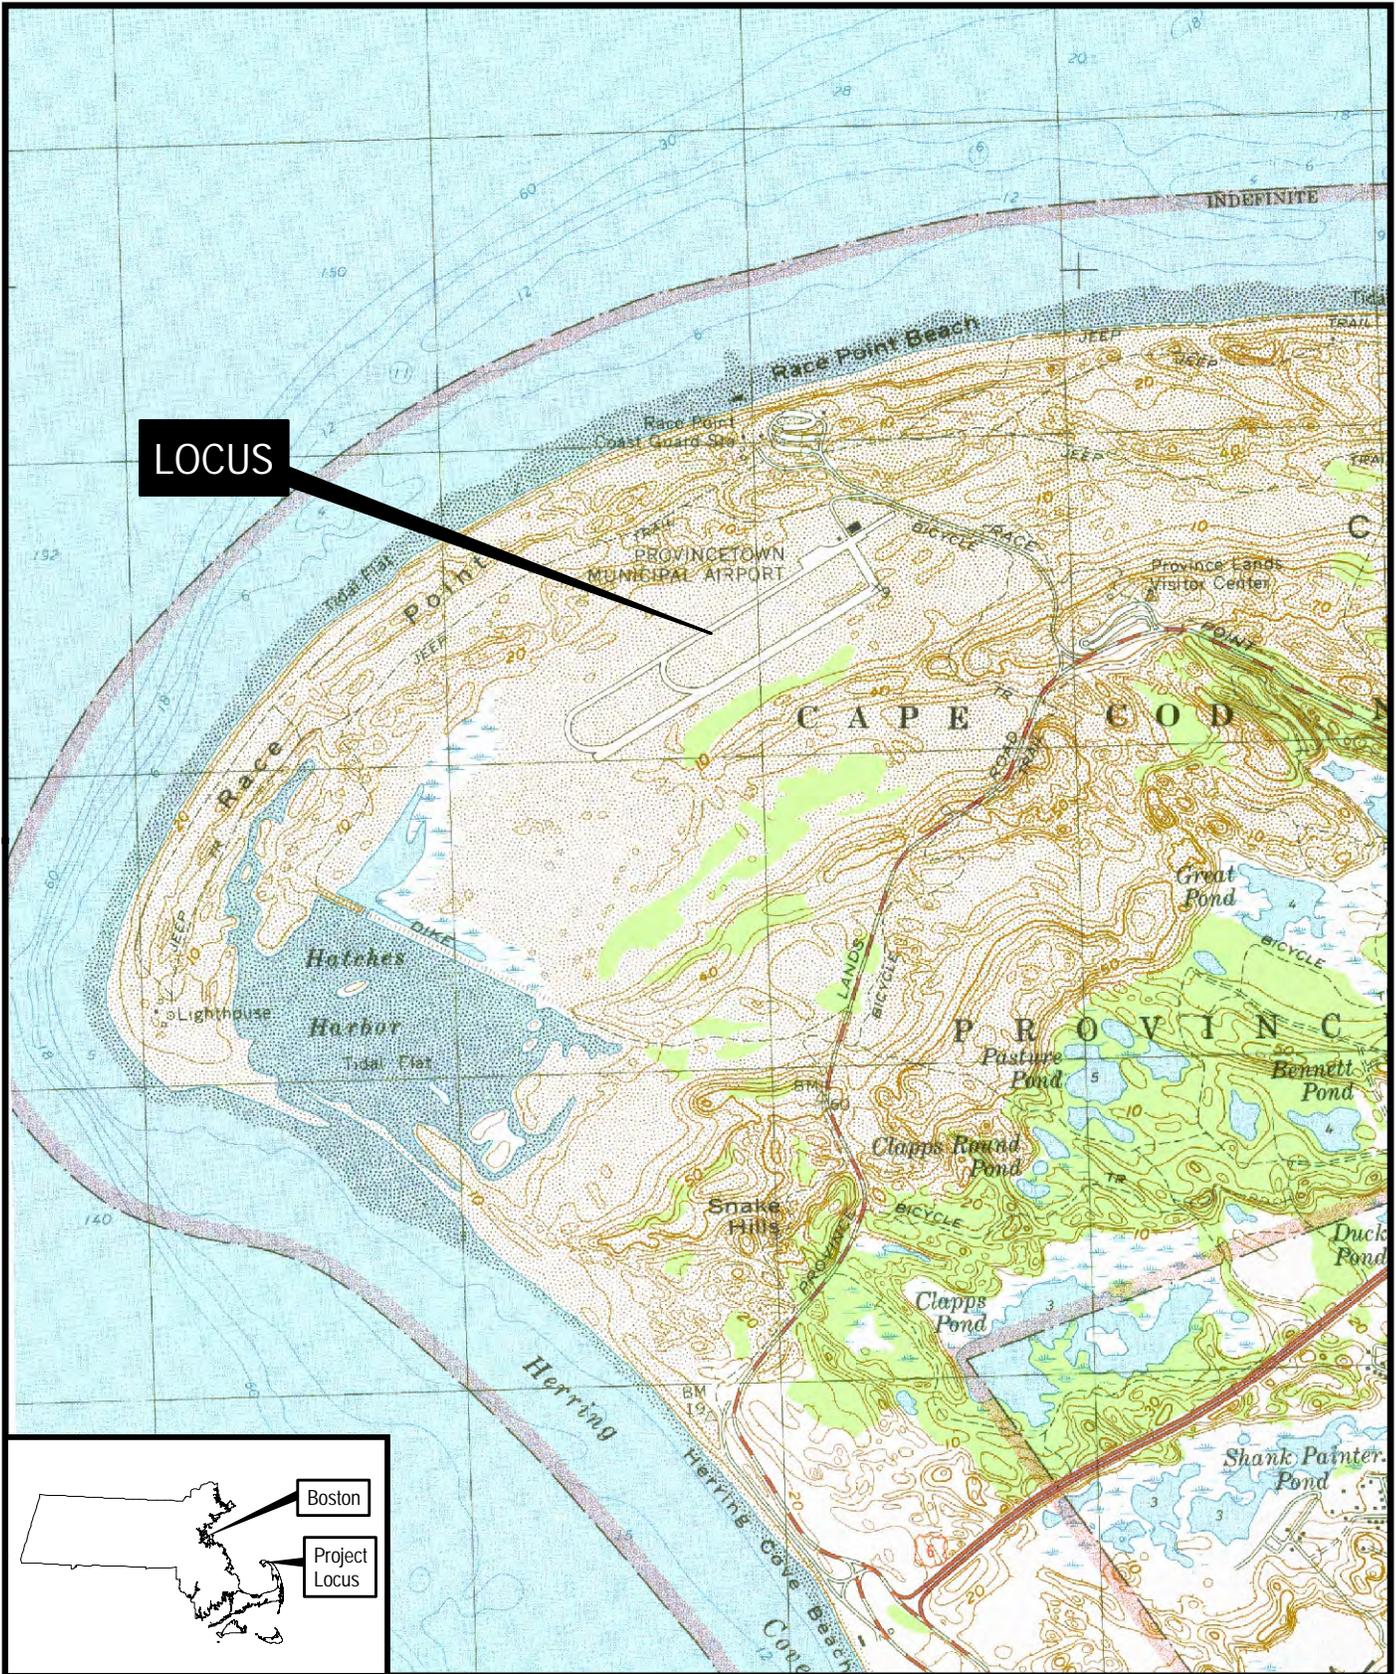
Figure 1

Provincetown Municipal Airport (PVC) is located in Provincetown, Massachusetts on the northern tip of Outer Cape Cod (Locus Figure 1). The Airport is sited within the Cape Cod National Seashore (CCNS), on approximately 322 acres of federally owned land administered by the National Park Service (NPS). The Airport pre-dates the formation of the CCNS. A Special Use Permit, between the NPS and the Provincetown Airport Commission, establishes terms under which airport operations and improvements are carried out.

USGS Project Locus
 Wildlife Hazard Assessment
 Provincetown Municipal Airport
 Provincetown, MA

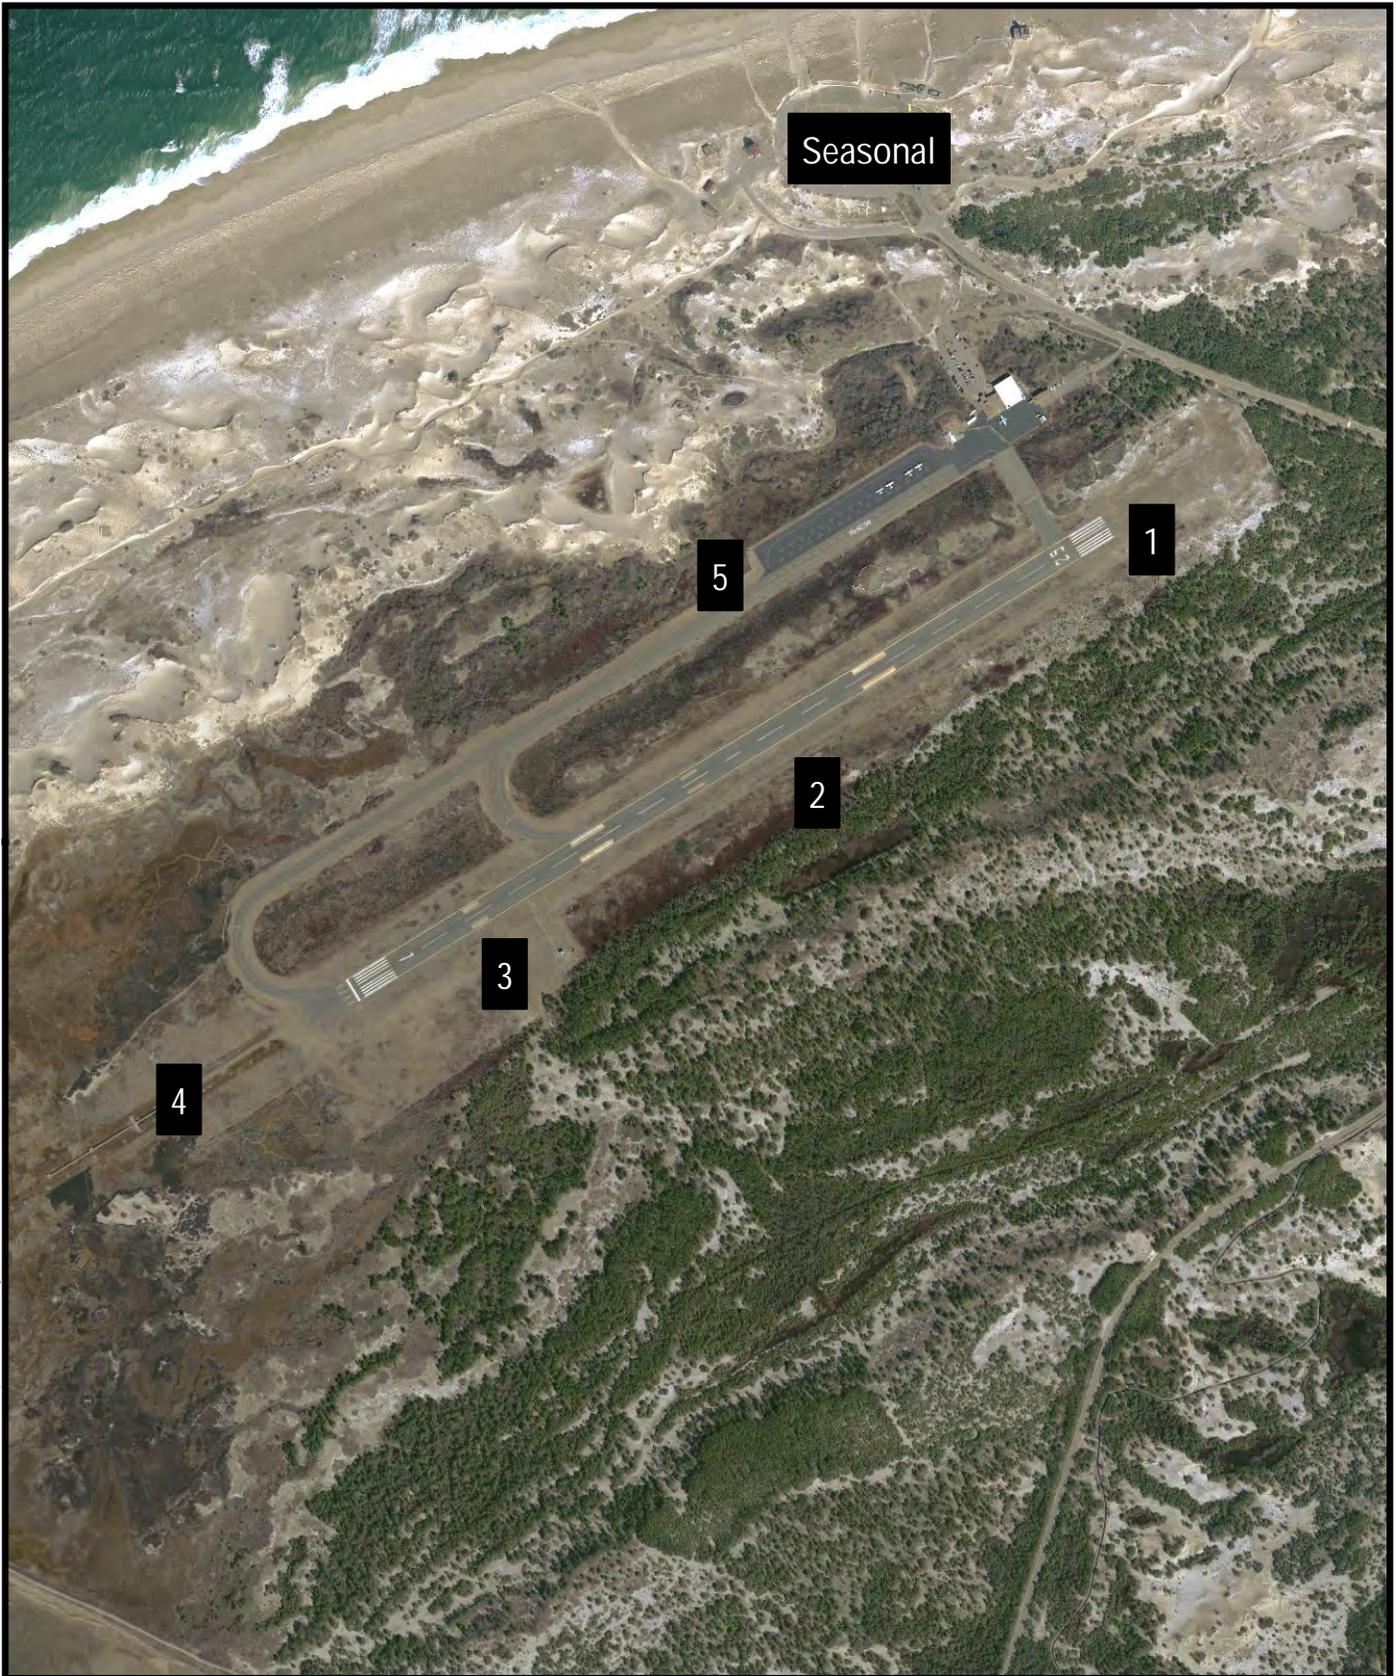
Figure 2

Five survey station locations were established on the airfield that allowed observation of the AOA. One off-site seasonal survey station was established at the CCNS Race Point Beach parking lot. The off-site station was selected to capture any seasonal attractant to gulls during the summer tourist season. The locations of the survey stations are shown on Figure 2. Photos of field conditions are provided in Appendix 1. The station locations were selected based on knowledge of the Airport, field work over several years, and previous habitat studies listed in the reference section.

Wildlife Hazard Assessment
Provincetown Municipal Airport
Provincetown, MA

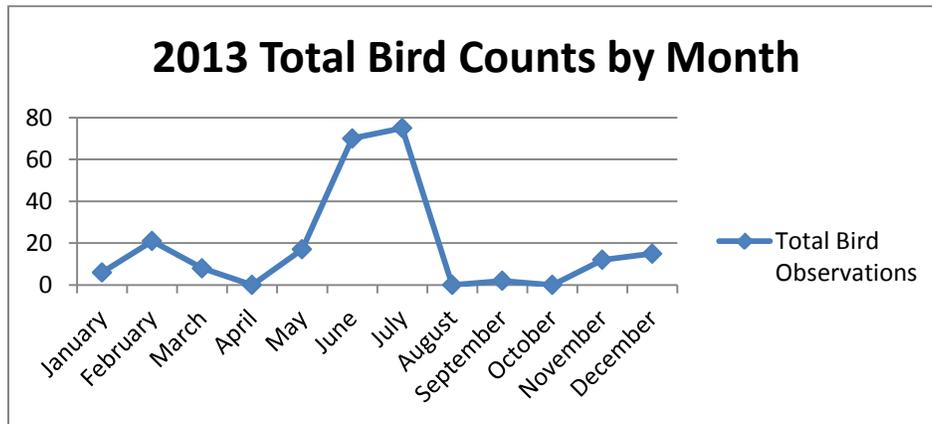
Figure 3 Total Survey Bird Counts by Assessment Month

Figure 3 shows the monthly total of bird counts during the standardized counts at the survey stations. The relatively low counts are due in some part to the fact that large flocks of gulls, geese, or starlings were not observed. During some surveys no birds were counted but this does not mean that birds were not observed at all during that time, just not within the standardized survey.

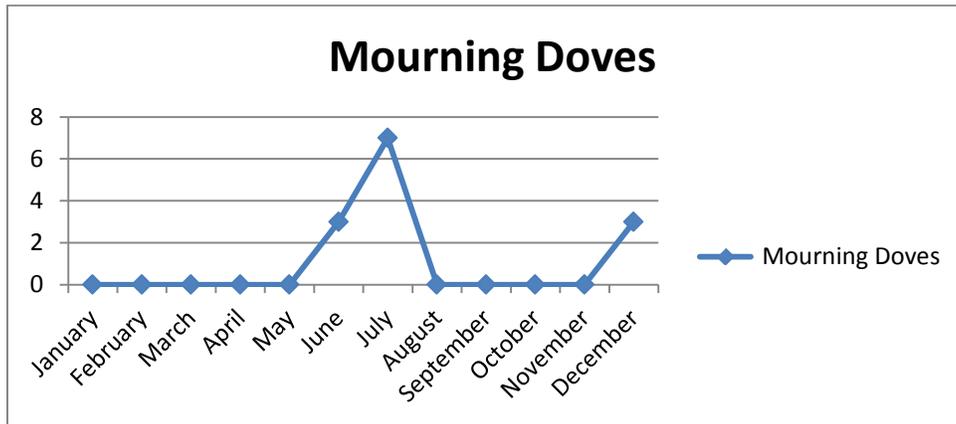
Figure 4 Total 2013 Mourning Dove Survey Counts

Mourning Doves were observed on occasion with a flock of about 10 observed on the taxiway near the GA Apron in July (Figure 4).

Mourning Doves have a relative ranking of 18 out of the top 25 hazardous wildlife. Habitat modification (turf management) is the most effective control measure along with removal of the feeder and clearing of brush. The hangar should be monitored for any nesting activity.

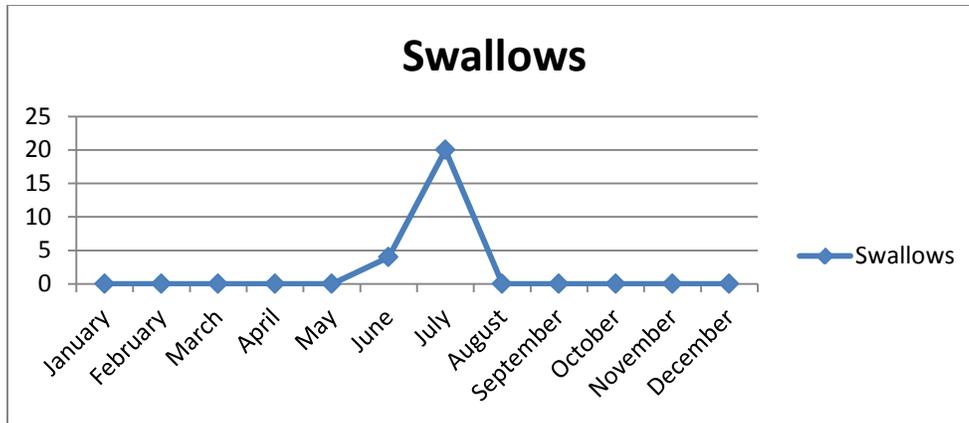
Figure 5 Total 2013 Swallow Survey Counts

Tree Swallows were observed on several occasions with a flock of about 20 observed on Runway 7 in July (Figure 5). Although not observed directly, swallows are known to flock in large numbers at the Airport. There are anecdotal reports of Cessna 402s striking flocks of swallows. Barn Swallows have been observed nesting in the hangar.

Swallows have a relative ranking of 23 out of the top 25 hazardous wildlife. Habitat modification is the most effective control measure. Northern Bayberry produces berries, which are a food source for tree swallows. Management of this shrub within the airfield may be effective.

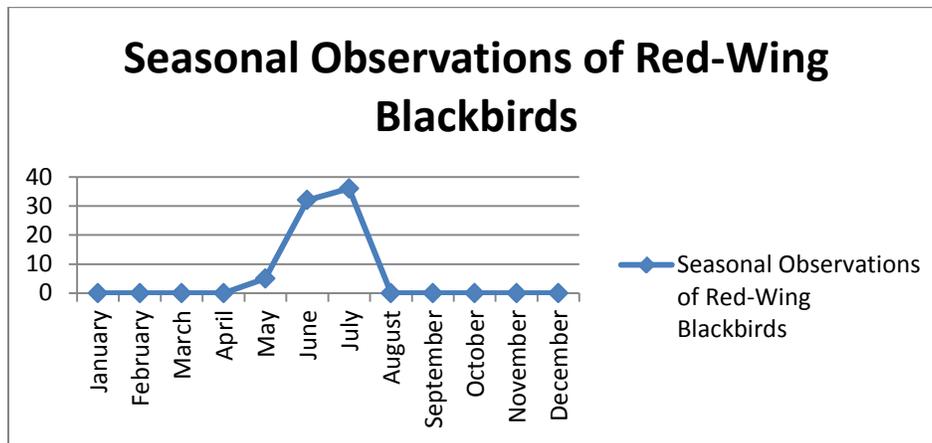
Figure 6 Total 2013 Red-Wing Blackbird Survey Counts

Red-winged blackbirds are present at the Airport during the summer months (Figure 6). Some flocks consisted of about 20 birds. They tend to stay in the wetlands but can be seen flying over the runway and roosting in the brush between the runway and taxiway.

Blackbirds have a relative ranking of 20 out of the top 25 hazardous wildlife. Habitat modification is the most effective control measure, especially grass height and removal of roosting trees.

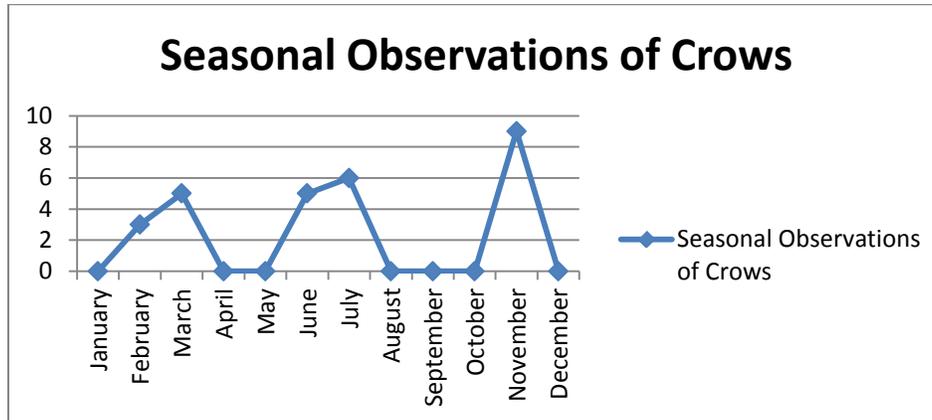
Figure 7 Total 2013 Crows Survey Counts

Crows are seen in small flocks throughout the year at the Airport (Figure 7). They generally are seen flying over the approach to Runway 25 or north of the parallel taxiway. They were not observed roosting in trees during the survey period.

Crows have a relative ranking of 16 out of the top 25 hazardous wildlife. Habitat modification is the most effective control measure, especially grass height and removal of trees.

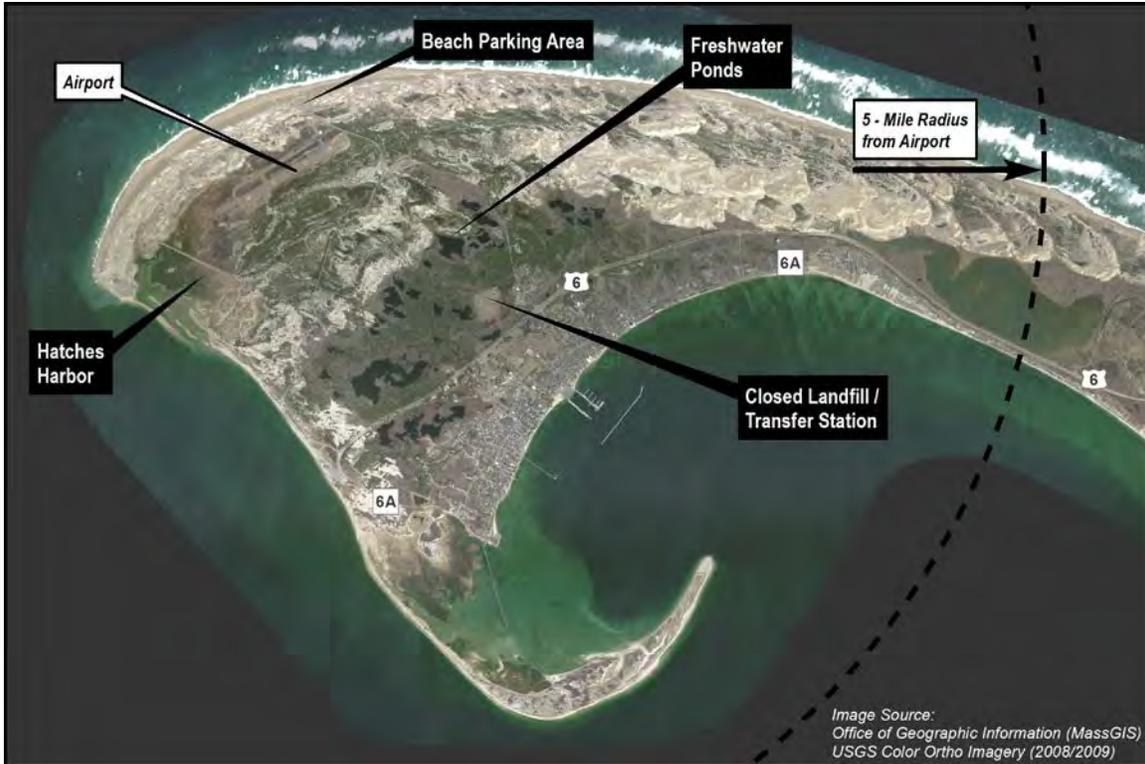
Figure 8 Attractants within 5 miles of PVC

The presence of natural and man-made wildlife attractants (ponds, landfills, water treatment lagoons, etc.) within 5 miles of the airfield was investigated. Off-site attractants within 5 miles of the Airport include large ponds, a municipal transfer/recycling center, and public beach/visitors areas within the CCNS. The Race Point Beach parking area (0.5 miles north) was observed on several site visits and no attractants such as open trash cans were observed. Provincetown Center is approximately 2 miles to the southeast. The site of the closed town landfill is now used as the transfer/recycling station. The transfer station is approximately 1.5 miles southeast of the Airport. The closest golf course is in North Truro, approximately 9 miles from the Airport.

The attractants of most concern would be the large freshwater ponds 1 mile to the south and open tidal waters of Hatches Harbor immediately to the west of Runway 7. Depending on the location relative to an airport, birds might fly across the runway to move from one open water area to another. At PVC, the freshwater ponds are all to the south of the Airport which minimizes the chance of an avian flight path crossing the airspace.

Hatches Harbor includes open tidal water, salt marsh, and coastal dunes. It is located in a highly critical and sensitive airspace off Runway 7, the predominant low visibility runway used for both approach and take-off operations. Ducks, gulls, Great Blue Herons, Red-Wing Blackbirds and other birds were consistently seen flying, heard in the *Phragmites* adjacent to the ILS, or on the water at high tide.

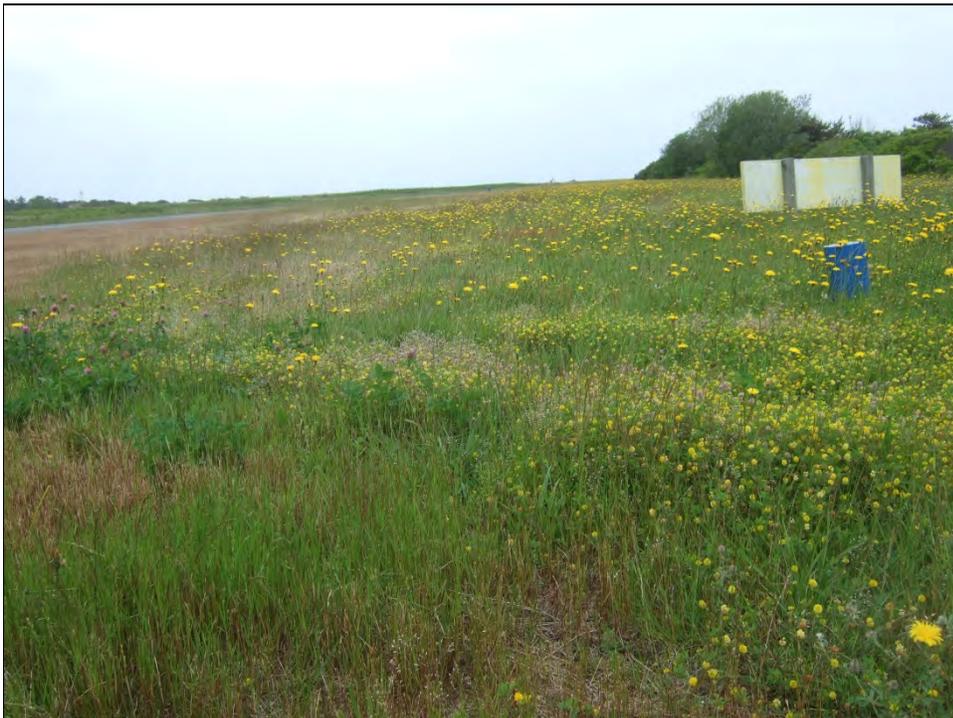
Photo 2 Summer Turf Conditions.

The schedule for mowing the grass areas should be reviewed to see if it is possible to cut the grass before it flowers and goes to seed. The general recommendation for turf at airports is to maintain mowed areas between 6 and 12 inches. The height of the cut at PVC should be evaluated before any change. Changing the height to discourage one hazard may result in better habitat for another hazard. At this time it is recommended that a schedule for the mowing be determined and records kept of the height at the time of the cut and the cutting height. More information over time is needed before any modification is made to avoid unintended consequences.

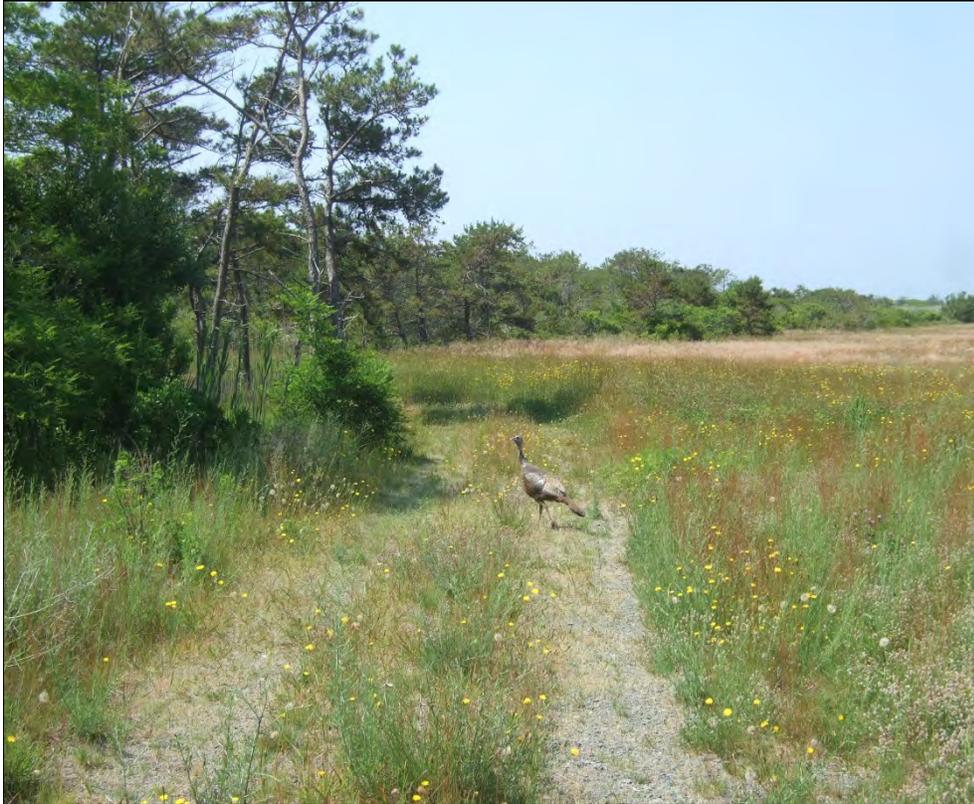
Photo 3 Turkey Near Glide Slope Area.

Turkeys have a relative ranking of 9 out of the top 25 hazardous wildlife. Habitat modification is the most effective control measure, especially grass height and removal of trees.

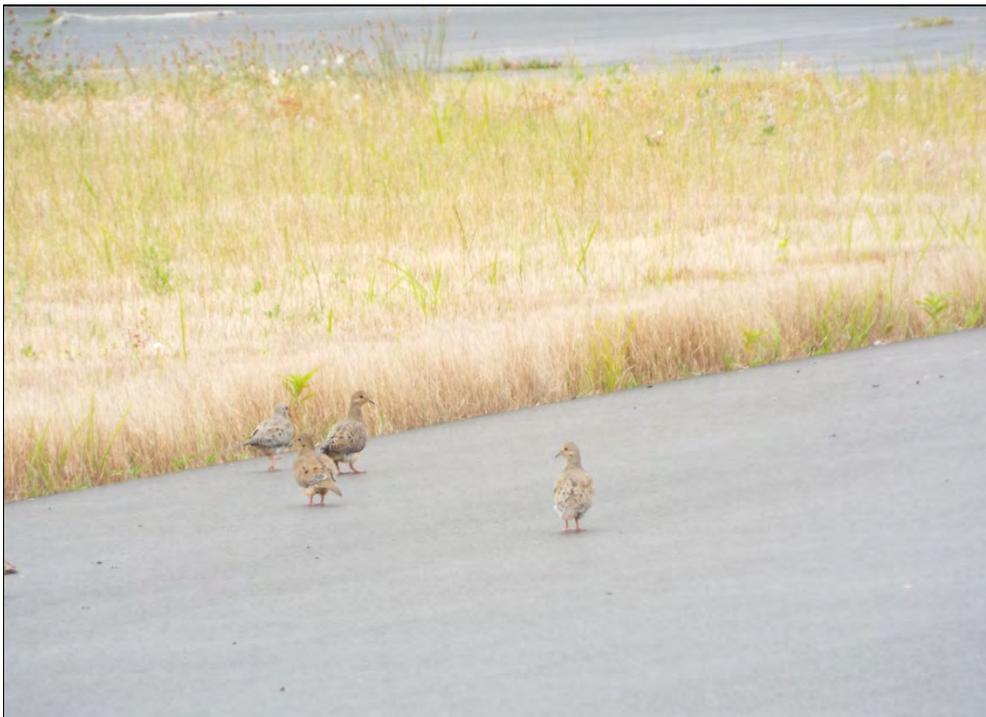
Photo 4 Mourning Doves on the Taxiway and GA Parking Apron.

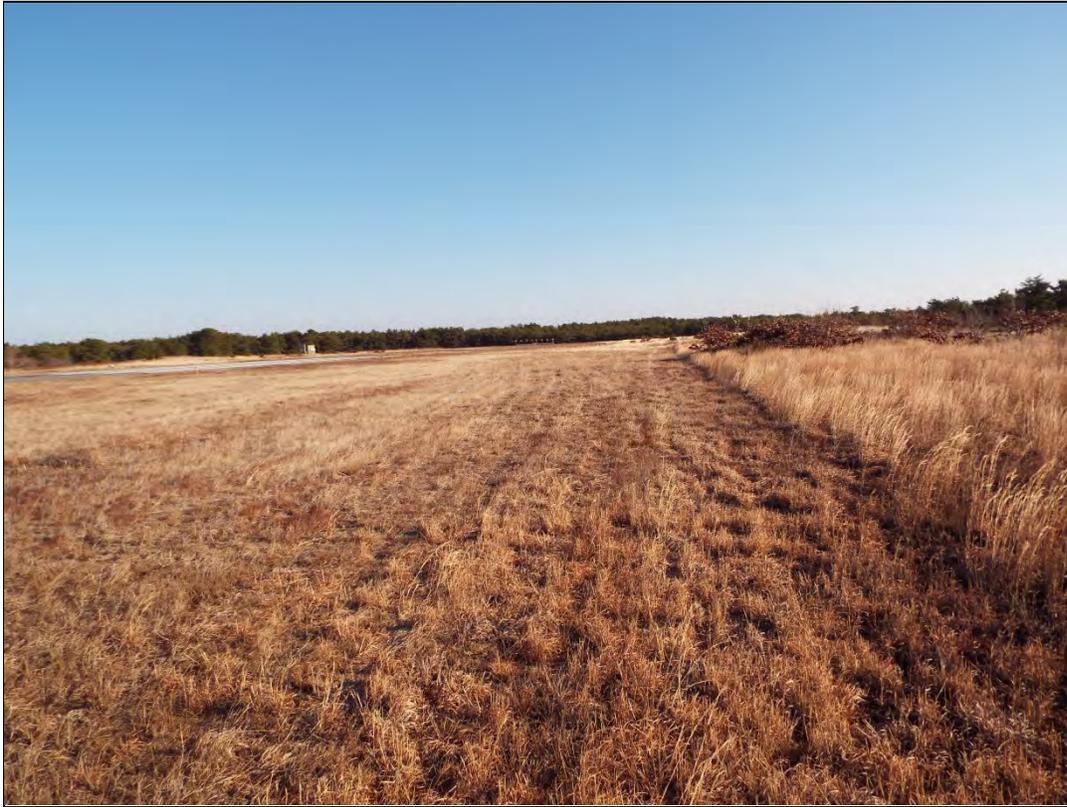
Photo 5 Winter Turf Conditions.

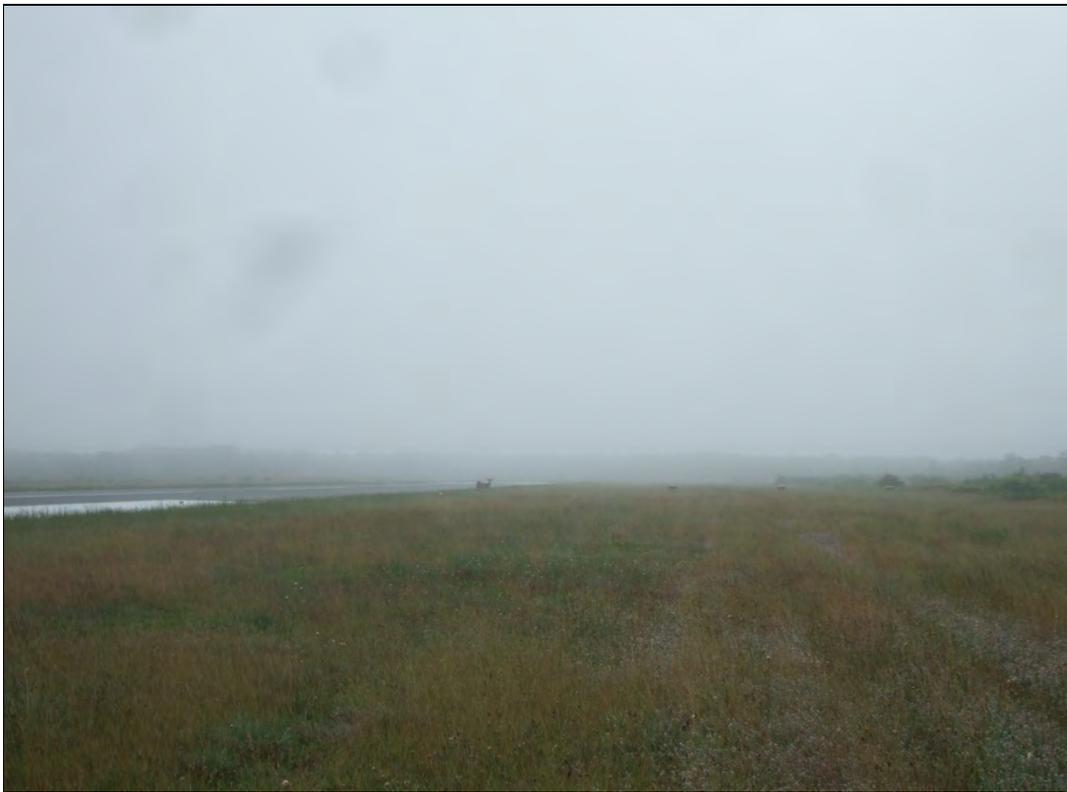
During the Assessment period, two deer were observed during the day feeding next to the runway. It was very foggy and the deer blended in with the VASI lights (see photo in Attachment). As a Cape Air flight prepared for take-off, the deer withdrew south to the shrub area. A deer strike that resulted in significant damage to the aircraft was reported in June 1997. There have been anecdotal reports of other deer strikes since 1997.

airfield. In foggy conditions, the deer are almost invisible as witnessed during the site assessment and illustrated in Photo 6 in Attachment 1.

Photo 6 Deer Blend in with the VASI lights during Fog Conditions.

The #1 wildlife hazard at PVC is deer and the most effective measure for keeping deer off the airfield is adequate fencing. FAA recommends a 10-12 foot chain link fence with 3-strand barbed wire outriggers. The Airport has very limited perimeter fencing. Environmental permitting for a perimeter fence project is in progress.

All of the above recommendations cannot substitute for the most effective control for deer and that is a perimeter fence. Without a fence, it is impossible to keep deer off the

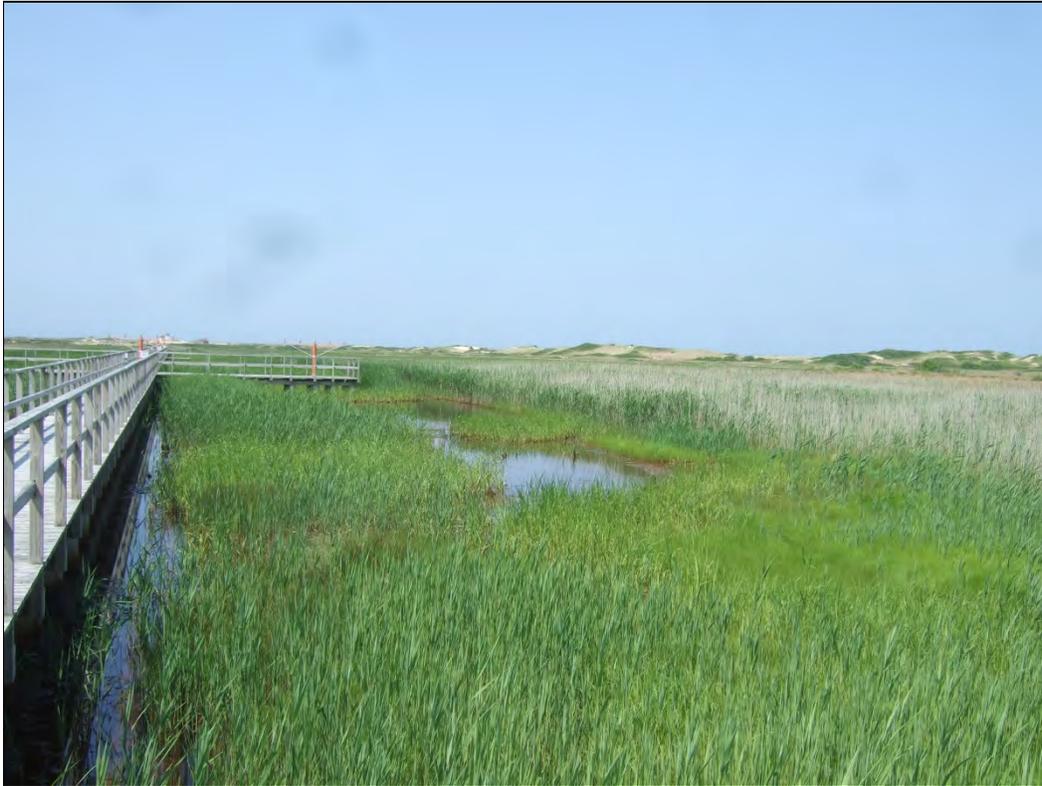
Photo 7 Standing Water at High Tide Attracts Ducks off RW 7

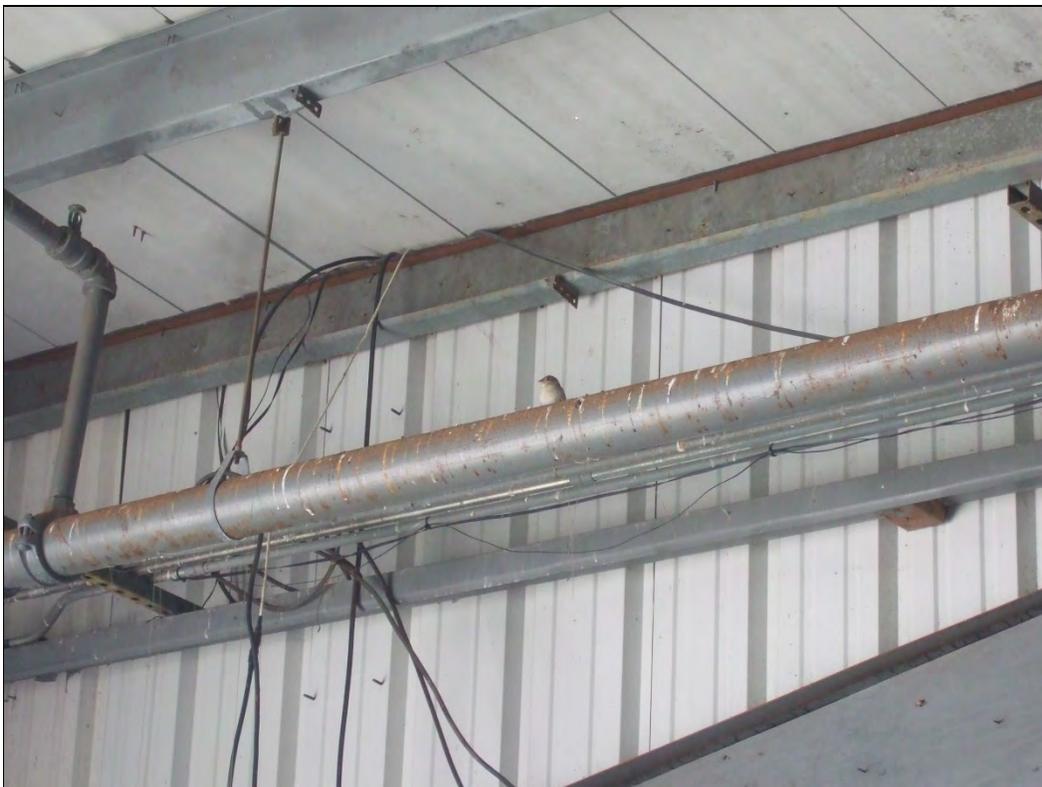
Photo 8 Sparrows and Swallows nest in the hangar.

Although it would be preferable to keep the hangar door closed, opening and closing the large bay door is impractical. Strip doors of vinyl plastic might be an effective deterrent. Strip doors consist of 6- to 16 inch wide strips of vinyl hung like a curtain. Strips overlap about 2 inches. Strip doors do not require opening and closing like conventional doors and are not damaged by passage of equipment.
