Lane Departure Road Safety Audit for Route 130 in Mashpee, Massachusetts

Prepared by
Cape Cod Commission
and
University of Massachusetts Traffic Safety Research Program

1.0 Introduction to Road Safety Audits & Lane Departure Crashes in Massachusetts

2.0 Background Material for Route 130 in Mashpee

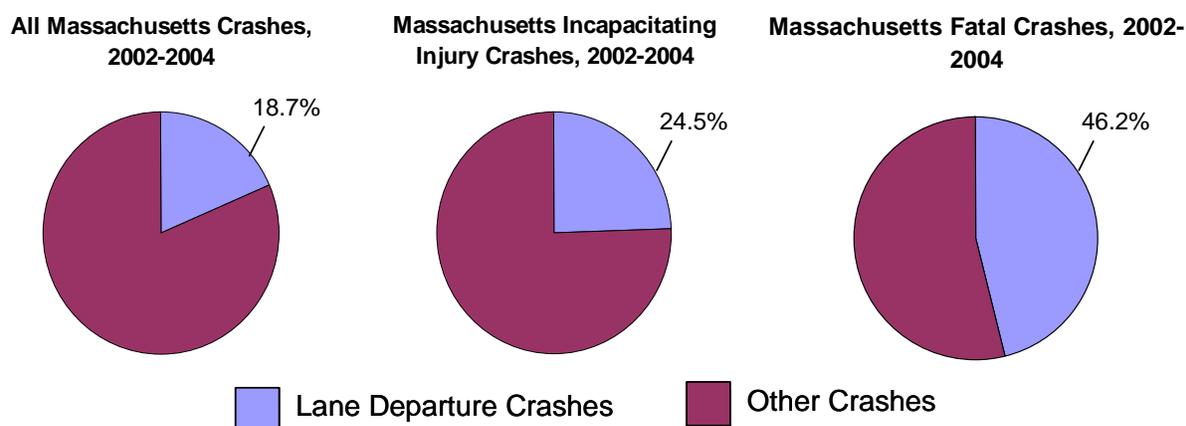
Figure 1. Relationship Between Lane Departure Crashes and Injury Severity

The RSA program in Massachusetts is being implemented in accordance with the Commonwealth's role as a lead state in preventing run-off the road (lane departure) crashes and in conjunction with the Strategic Highway Safety Plan (SHSP). Lane departure crashes are a notable problem area for Massachusetts, especially for crashes with high injury severities. Between 2002 and 2004, lane departure crashes accounted for nearly 20 percent of all crashes in Massachusetts and approximately one-quarter of crashes involving an incapacitating injury. Almost one-half of fatal crashes between 2002 and 2004 were lane departure crashes. As the crash severity increases, so too does the percent of crashes that are lane departures as shown in Figure 1.

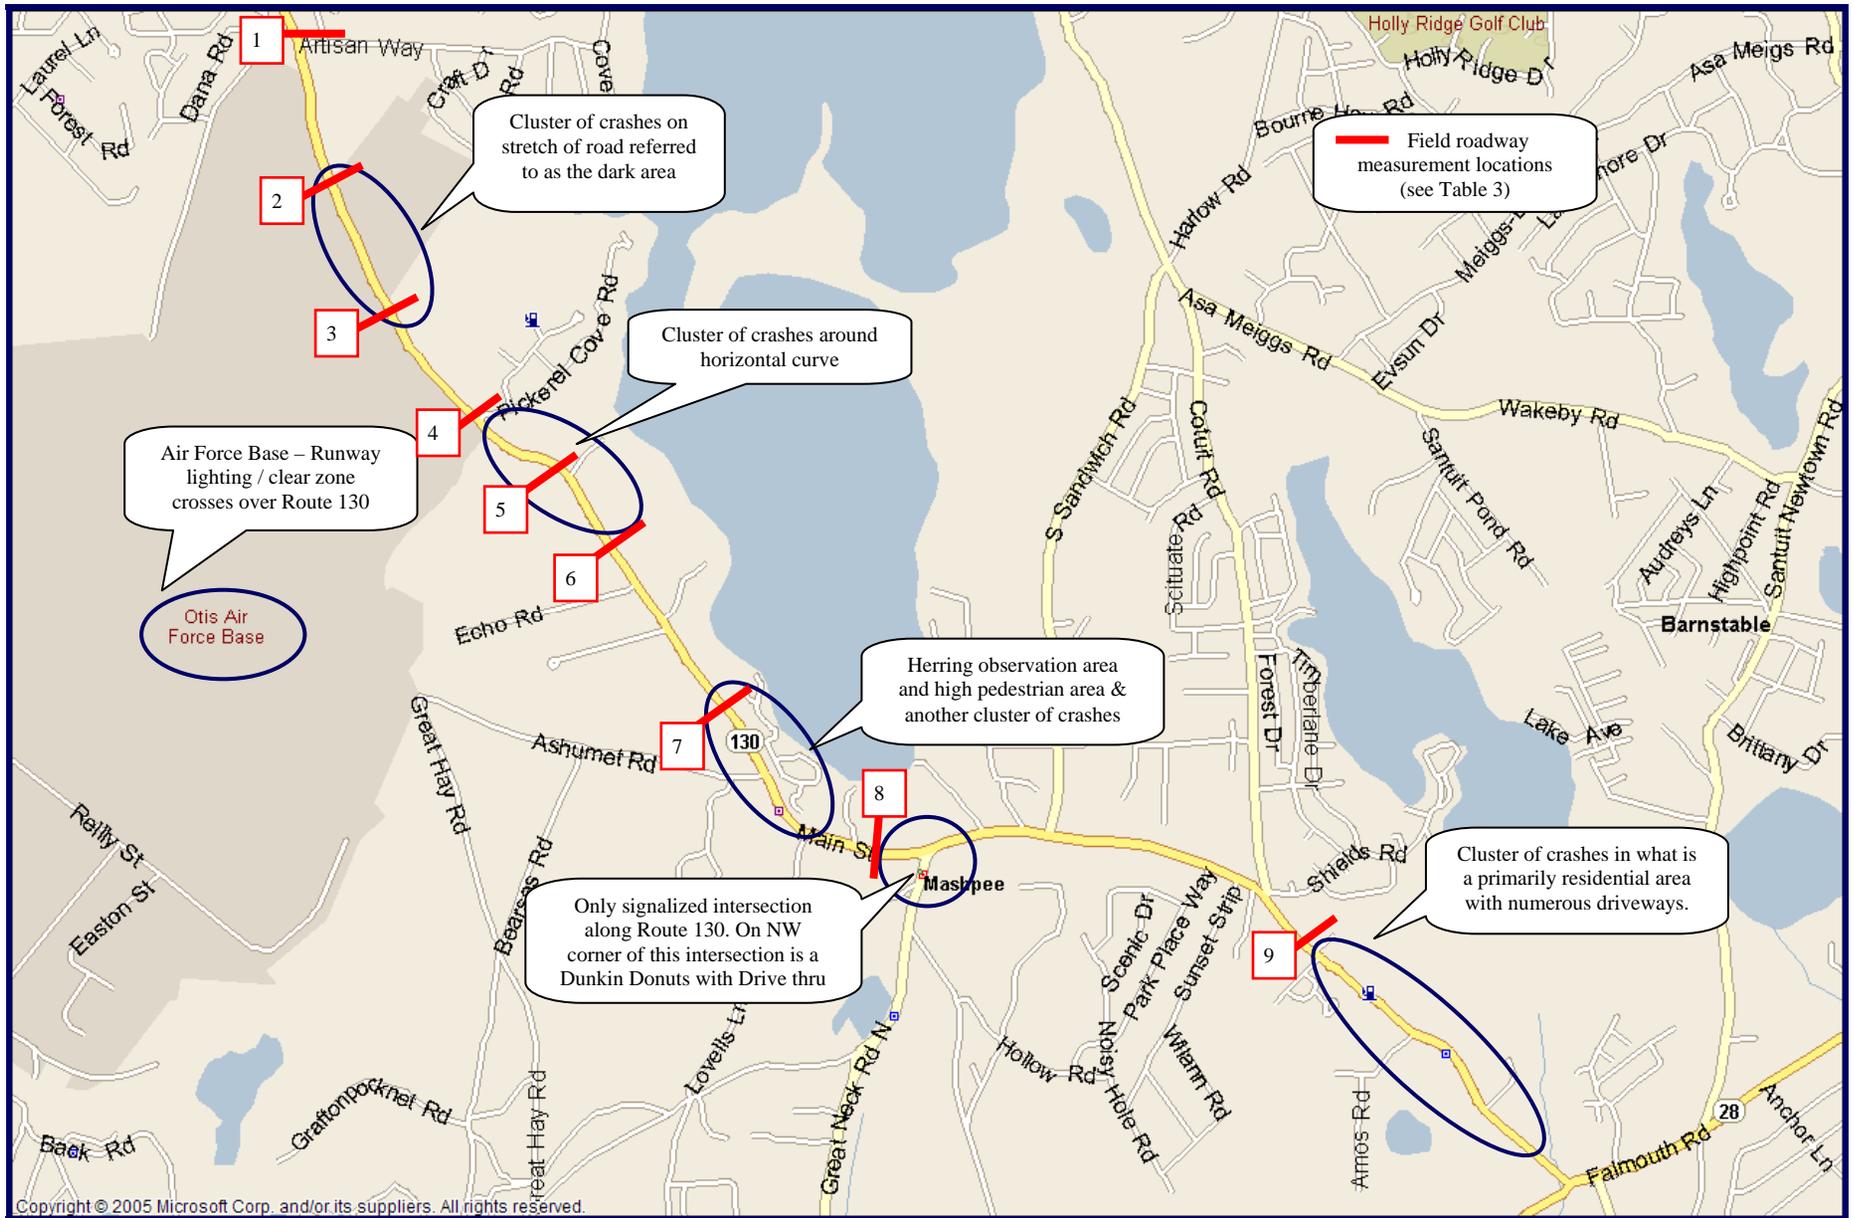
Figure 3. Characterization of Roadway Features for Route 130

- Between 8/25/03 and 9/21/06 there were 69 reported crashes consistent with the lane departure initiative. Sixty-five of those crashes were able to be geolocated and are presented in Figure 6. A complete summary of the 69 identified crashes over the 3-year period is included in Appendix A and was provided to participants prior to the audit meeting. Please note that this does not reflect all crashes along Route 130, but those deemed relevant to this initiative.

- As previously noted, the lane and cross-sectional widths varied slightly throughout Route 130. This information is critical as it impacts possible countermeasures. Table 3 provides measured lane widths provided by the Town of Mashpee, Department of Public Works.

Location Number (see Figure 3)	Lane Width ^a	Measured (Edgeline to Edgeline)
1	9' 10"	20' 8"
2	9' 10 ^{1/2} "	20' 9"
3	9' 10 ^{1/2} "	20' 9"
4	10' 1 ^{1/2} "	21' 3"
5	10' 4"	21' 8"
6	10' 1 ^{1/2} "	21' 3"
7	9' 10"	20' 8"
8	9' 1"	19' 2"
9	9' 3"	19' 6"

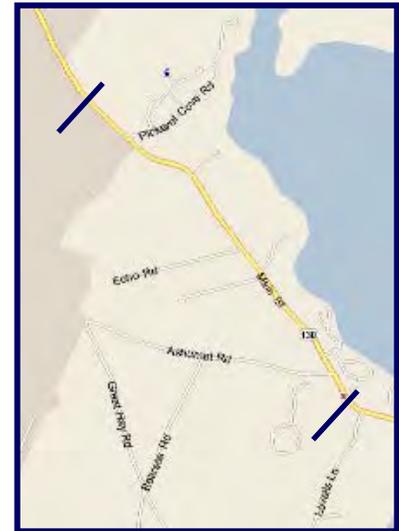
Figure 4. Speed Study Locations

- Similar to many roadways, the posted speeds vary along Route 130 in Mashpee. Route 130 has segments posted at 35, 40, and 45 mph. The official speed regulations for Route 130 in Mashpee are summarized below in Table 2. An available speed study at two locations (see Figure 4, inset) from December 2005 indicated that 95 percent of vehicles were exceeding the posted limit and 15 percent were exceeding the posted limit by greater than 10 mph. This separate report was shared with participants during the meeting and attached as Appendix B.

In total, nearly 40,000 vehicle trips were recorded. The posted speed limit of 40 mph in three cases and 35 mph in one case was exceeded by 95% of the vehicles. In addition, 5,943 (15%) of the vehicles exceeded the speed limit by more than 10 mph. There were 715 (2%) vehicles exceeding 55 mph. Speeds were recorded between 61 and 75 mph for 116 vehicles. These speeds were noted at all times of day. There were no accidents during this period.

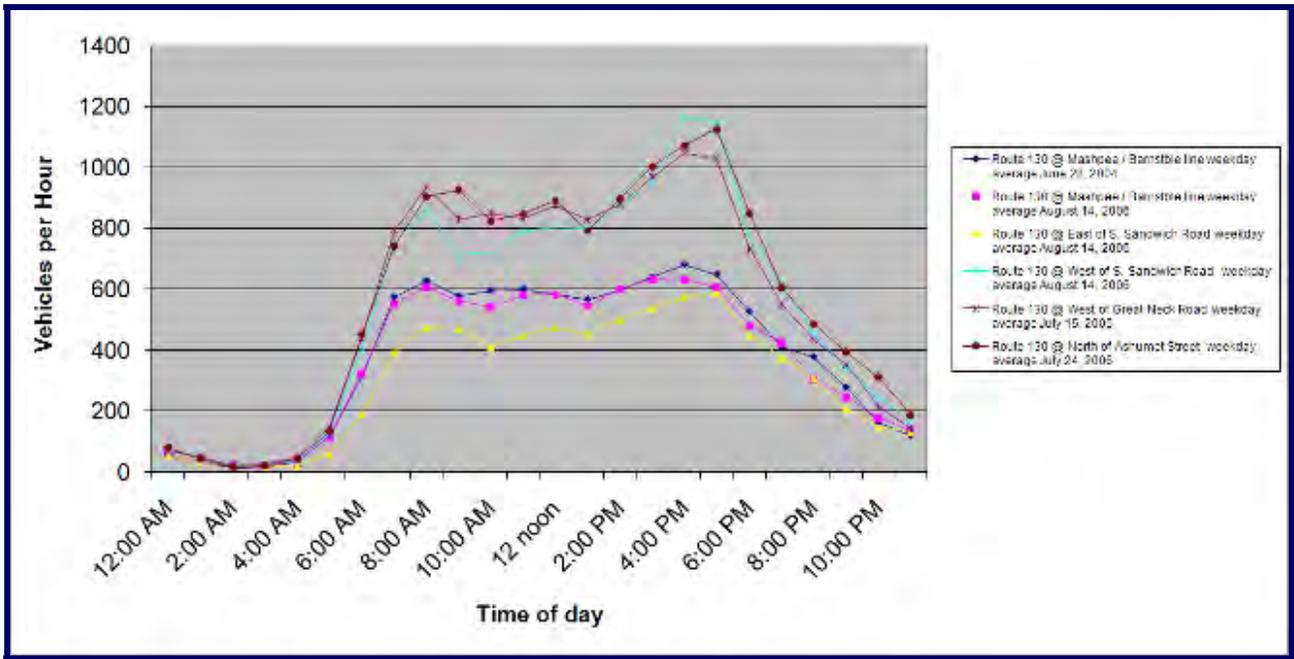
Figure 5. Hourly Distributions of Volumes for Route 130

- Figure 5 presents an hourly distribution of traffic volumes along Route 130 at various locations for several summer month observation periods. From the compiled data collection that are part of the Cape Cod Commission traffic counting program the maximum average daily traffic (ADT) was 13,654 (7/24/06) with approximately equal directional splits.

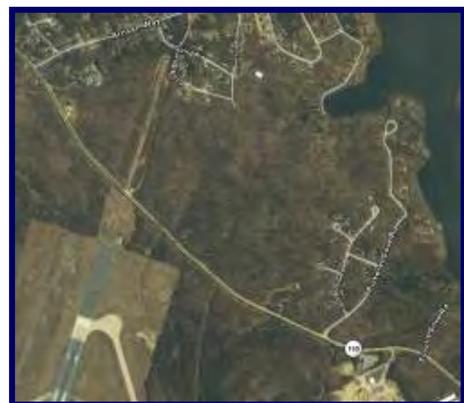
Figure 7. Dark Area of Route 130

- A second major characterization of the crashes along Route 130 involved distracted and/or drowsy drivers. Given the constrained cross-section there is little room for error. Related to this discussion was the lack of significant lighting, coupled with the cover provided by trees on the northwest portions of Route 130 which has horizontal curves, little light, and is a typical route for drivers working varied shifts. This particular stretch of road was referred to as the dark area of Route 130 (see Figure 7). Recessed reflective markers installed in the roadway centerline assist in this area without electrical service, but additional solar powered lights or signs may prove beneficial.

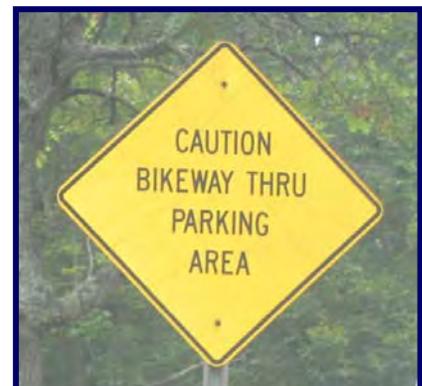
Figure 8. Small Font Signs

- There are several signs (see Figure 8) located near the Mashpee-Barnstable line adjacent to the bike path which feature a nearly illegible message based upon the small font size. It is recommended that these signs be revised or removed as drivers may spend an increased amount of time fixated away from the roadway attempting to read the signs.

Remove/change warning signs located near the Mashpee-Barnstable line adjacent to the bike path with small font requiring significant driver attention for comprehension.	Short Term & Low Cost	Low

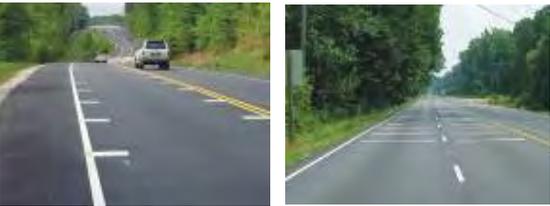
Speed-related issues along entire Route 130 corridor	Investigate and explore possible low-cost speed-related strategies such as optical speed bars.	Short Term & Low Cost	Experimental

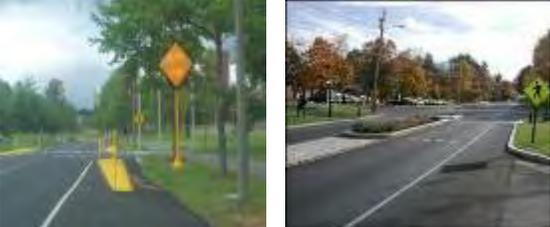
Implement established traffic calming measures to meet specific needs. A candidate location would be bulb outs in the vicinity of the midblock pedestrian crossing.	Long Term & Mid/High Cost	High

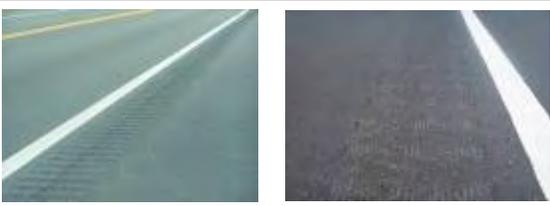
Distracted or drowsy drivers	Consider rumble strips/stripes in future reconstruction for non residential areas along roadway in the vicinity of the Air Force Base.	Long Term & High Cost	Mid

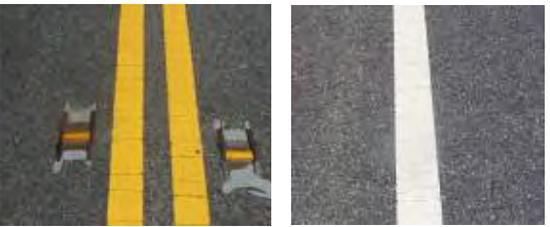
Pavement markings	Maintain pavement markings for continued visibility.	Short Term & Mid/High Cost	Mid

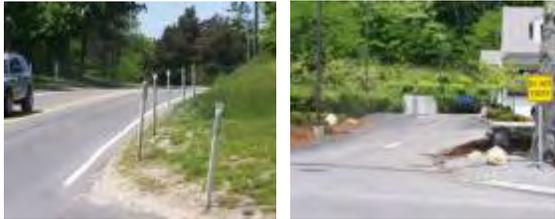
Potential Safety Issue	Possible Countermeasures	Implementation Timeframe & Cost	Potential Safety Payoff	Photos
Sight distance turning from Dunkin Donuts site drive	Install warning sign for SB traffic.	Short Term & Low Cost	Low

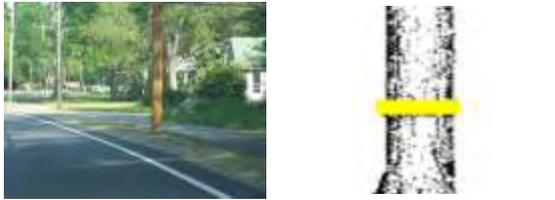
Roadway modifications to improve sight distance (i.e. cut back crest vertical curve inhibiting sight to west).	Long Term & High Cost	High	
Presence of utility poles within the roadway clear zone	Reflectorize utility poles.	Short Term & Low Cost	Low

- Utility poles are in close proximity to the traveled way along Route 130. While longer term strategies are considered for possible relocation of the most hazardous poles, it is recommended that the poles be reflectorized to add conspicuity. Specific locations may include the utility poles at the following addresses 84 (struck 3 times), 223, 520, 544, and 621 Route 130. All utility poles along the corridor, however, should be considered.

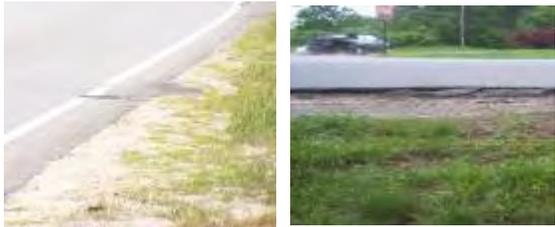
Add guard rails for particularly hazardous utility poles (see address locations listed in Section 4.0).	Mid Term & Low/Mid Cost	Low	
	Work with utility company to remove utility poles from clear zone.	Long Term & Mid/High Cost	Mid	
Edge drop-off at roadside	Maintain and fill roadside as needed to prevent edge drop-off.	Short Term & Low Cost	Low

- Continue to maintain level surface along roadside edges. At the time of the audit several spots of edge drop-off were observed north and west of the Great Neck Road North intersection which may in turn accelerate the impacts of lane departure crashes as motorists are unable to return to the roadway.

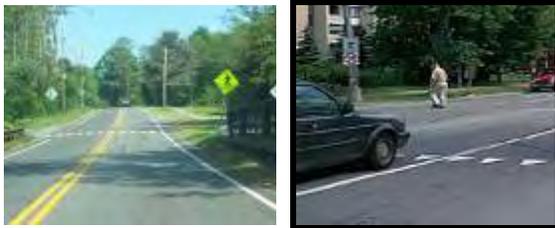
Safe crossing opportunities for pedestrians	Install advance yield line with accompanying sign (R5-1) for existing midblock crosswalk location.	Short Term & Low Cost	Low/Mid

- It is recommended that advance yield lines (see MUTCD Figure 3B-14) and accompanying sign (R5-1 – Yield Here to Pedestrians) be installed on both approaches to the existing midblock crosswalk along Route 130.

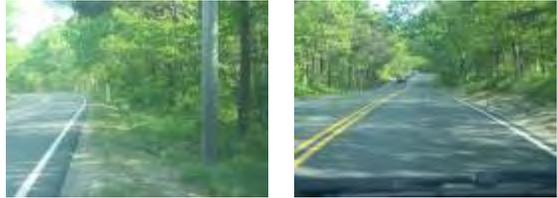
Potential Safety Issue	Possible Countermeasures	Implementation Timeframe & Cost	Potential Safety Payoff	Photos
Guard rail opportunities	In areas with insufficient clear zone, guard rail installation should be considered, including but not limited to embankments and utility poles. Specific locations include the dark area in the vicinity of the runway clear zone.	Mid Term & Mid/High Cost	Mid

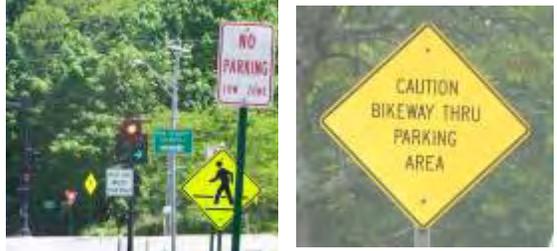
Sign efficiency	Identify unnecessary signs in heavily signed areas (i.e. signalized intersection) that can be moved/removed to prevent sign clutter. A specific example is the pedestrian warning sign on the approach to a signalized intersection, as pedestrians would be expected.	Short Term & Low Cost	Low
