CAPE COD
COMMISSION

Pavement Management Report 2012 Status Report

November 2012

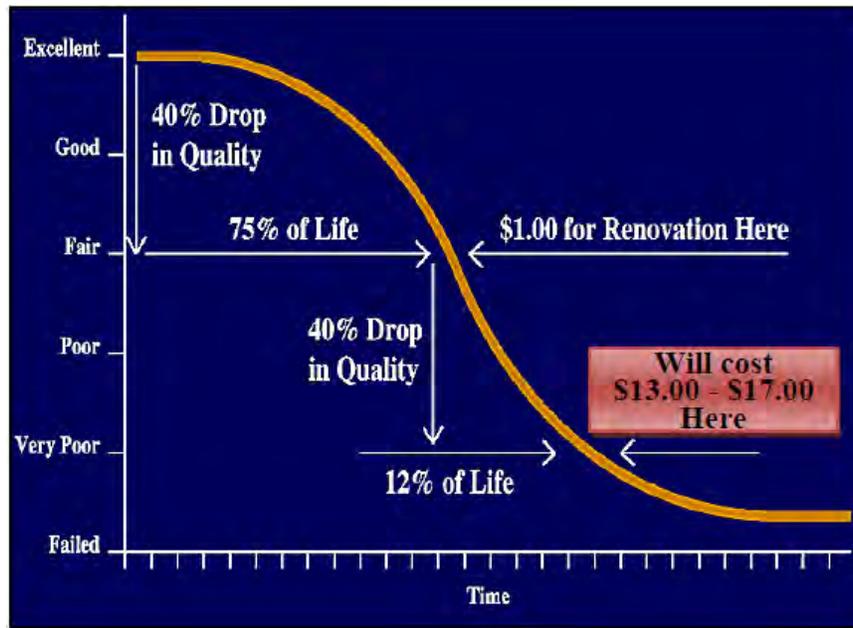
Figure 1 - Pavement Deterioration Curve

Below is a model of how a street’s pavement deteriorates over time. Interpreting the curve, a street starts out in excellent condition when it is newly constructed. Midway through its life, a low cost repair such as crack seal and full depth patch will cost approximately a dollar a square yard. It takes only a few years for the window of opportunity to perform this low cost maintenance to pass after which the road would need an overlay costing \$13 - \$17 per square yard. By performing timely maintenance, road conditions can be improved today thereby extending the life of the road.

A strategy is required to responsibly allocate available funding to maintaining and improving pavement condition on Cape Cod. As can be observed by the costs listed above and also demonstrated in Figure 1, allowing pavement to deteriorate to the lowest condition requires a significantly magnified cost to improve. To get closer to the MPO’s ultimate goal, resources spent on improving “Fair” pavement would result in far more miles of resulting “Excellent” pavement than directing resources to “Poor” pavement. Nevertheless, “Poor” pavement cannot be ignored. Therefore, the strategy of the Cape Cod MPO is to evenly divide investment across the lower two categories. Based on expected resources identified in the RTP, the following table lists the resulting totals of each category:

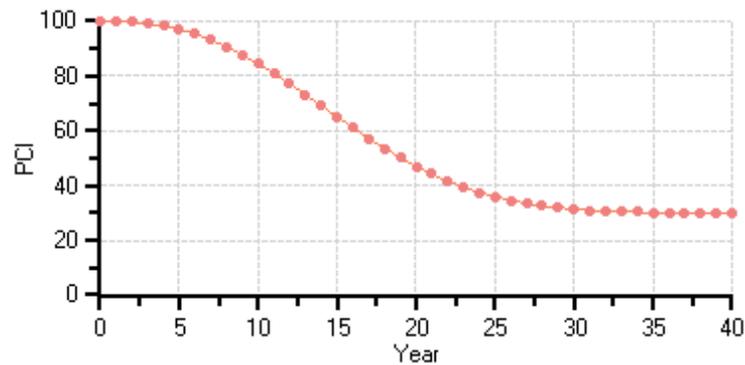
Figure 2 - Sample Deterioration Curve

In order to properly plan for future repairs, the budget analysis feature of the pavement management system uses deterioration curves. The deterioration curves estimate the rate at which the pavement condition decreases over time. These pavement deterioration curves depict two major categories of functional classification - arterials

and collectors in one curve and local roads in the other. An example deterioration curve is presented in the following figure:

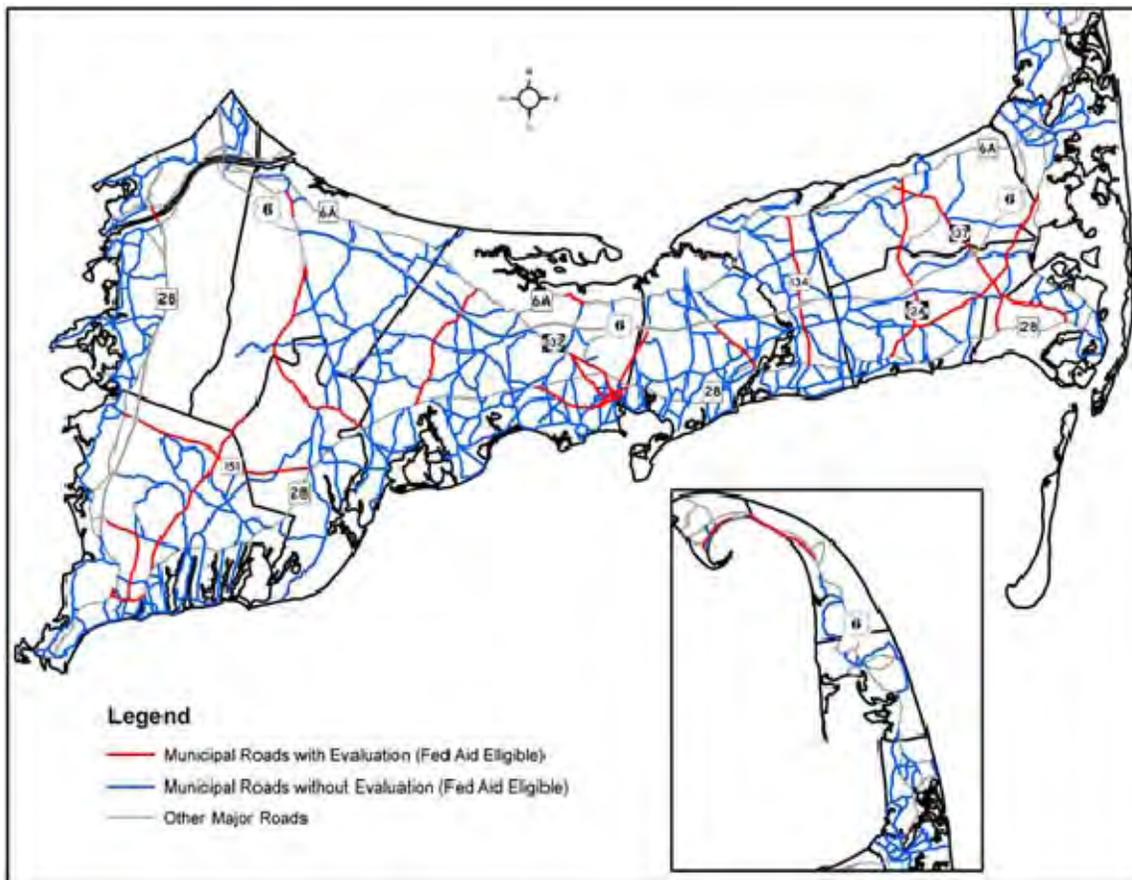
Figure 3 - MassDOT Evaluation of Municipal Roads

The following map identifies the roadways that have been evaluated (shown in red) and those that lack evaluation (shown in blue).

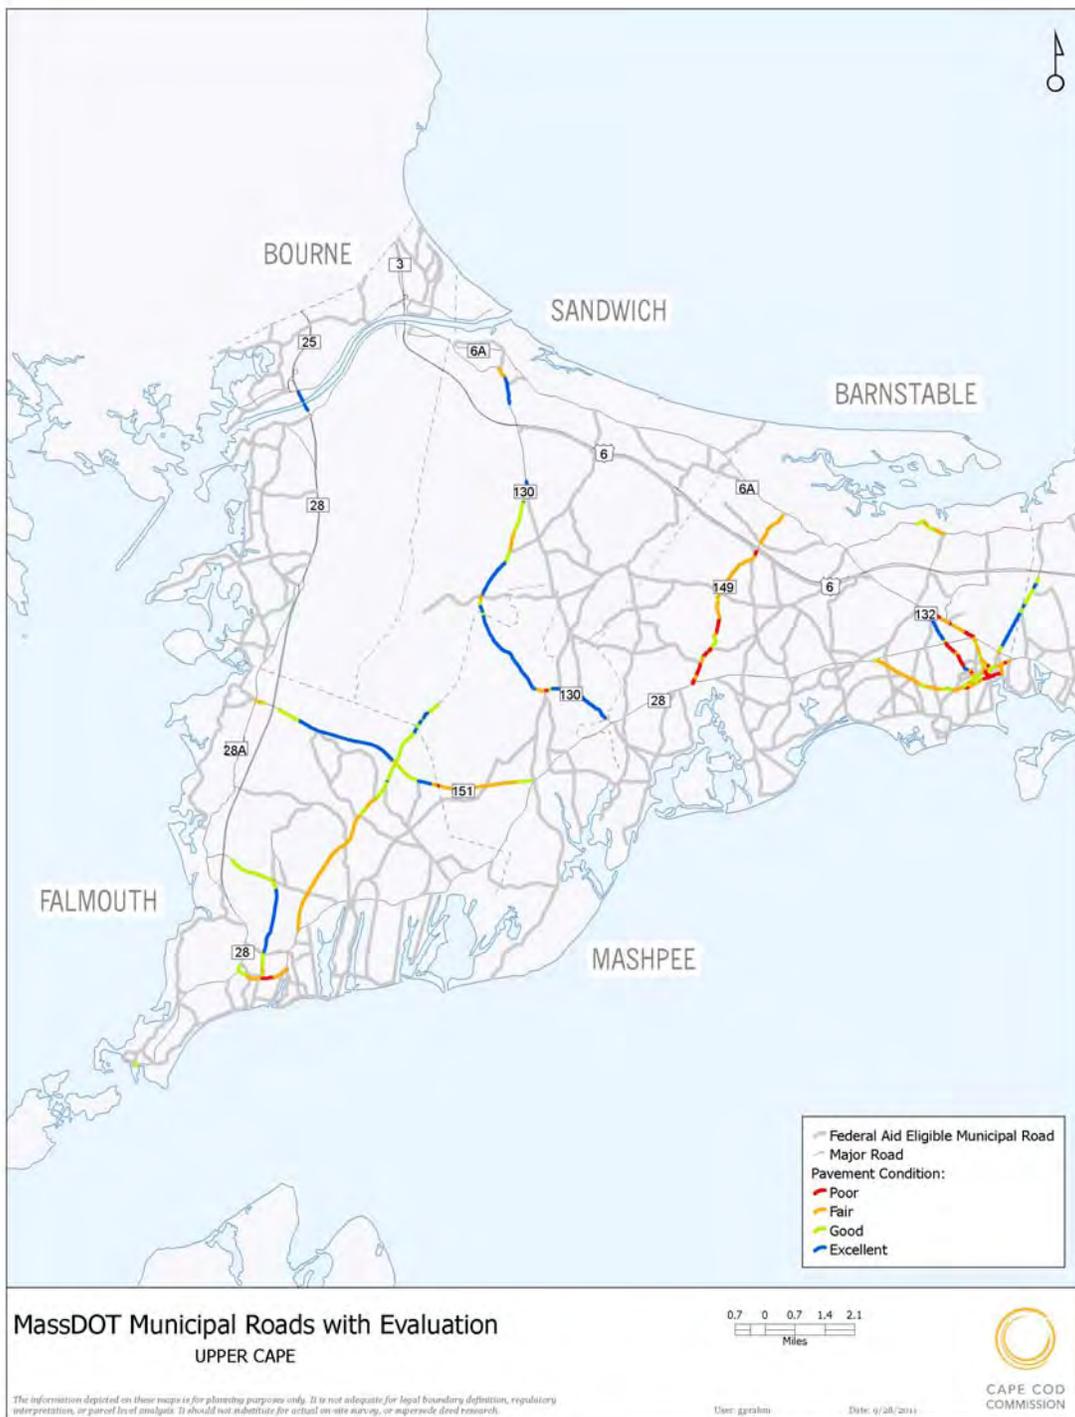
**Figure 4 - 2006-2009 MassDOT Evaluation of Municipal Roads:
Upper Cape**

The maps in the following figures shows the four categories of pavement condition(see Table 5) on the MassDOT-evaluated roadways available in a series of three maps (Upper Cape, Mid-Cape, and Lower Cape). The MassDOT evaluations are shown as thick solid colored lines ranging from Blue (Excellent) to Red (Poor).

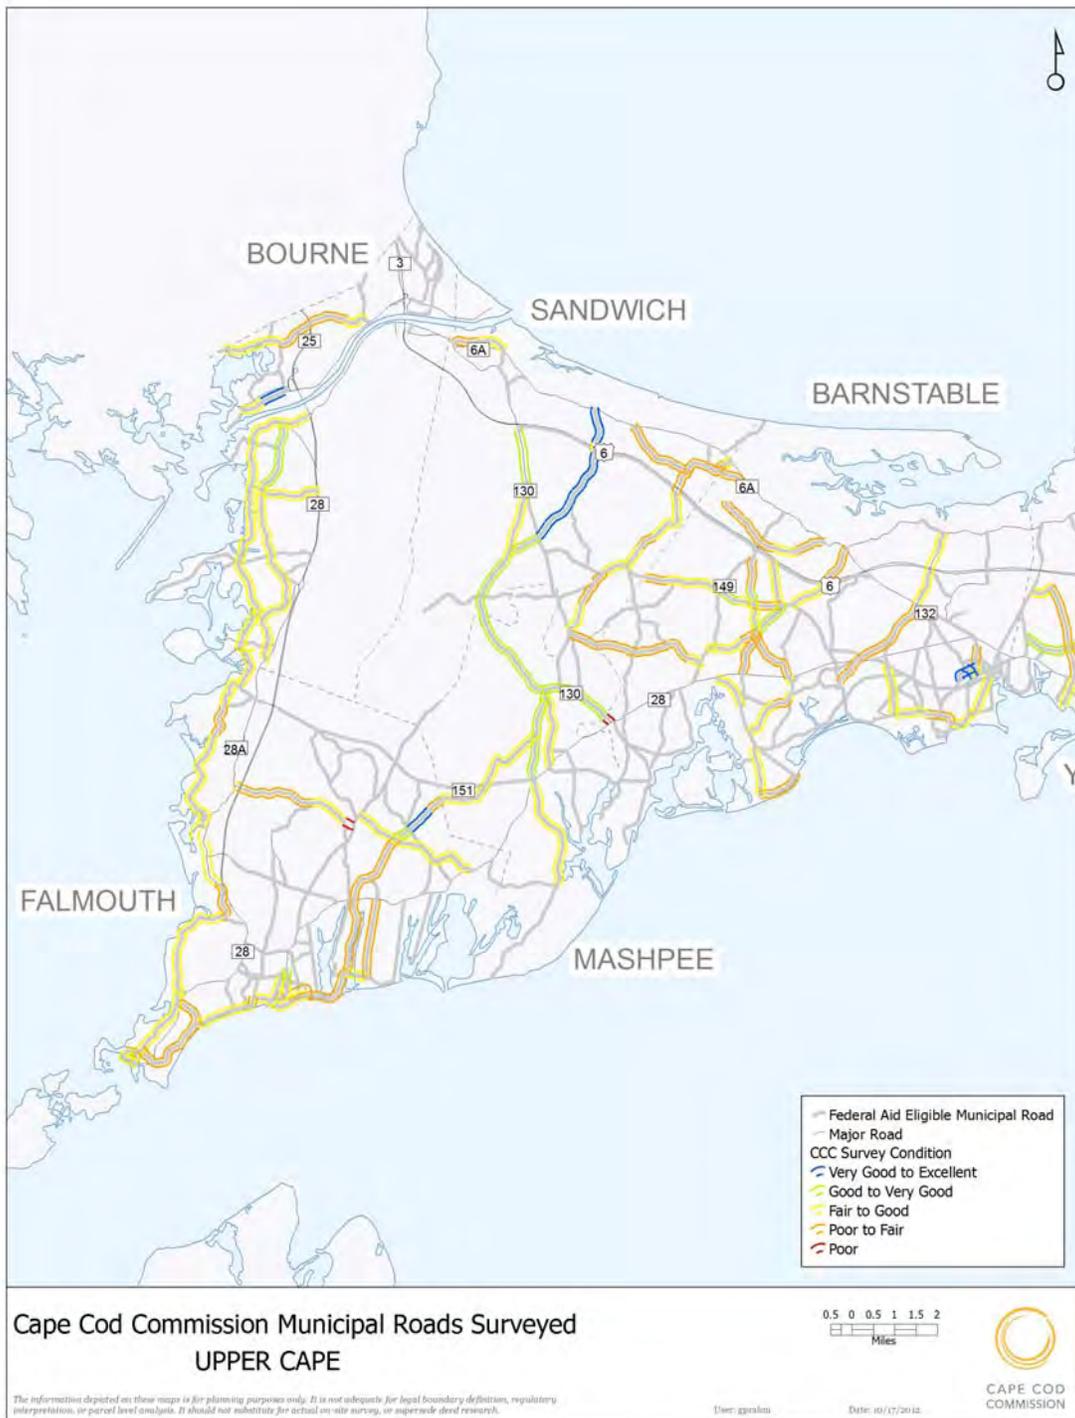
Figure 7 - 2011-2012 CCC Pavement Condition Surveys: Upper Cape

The following figures provide a graphic of the CCC survey data in a series of three maps (Upper Cape, Mid-Cape, and Lower Cape). The CCC evaluations are shown as colored parallel lines ranging from Blue (Very Good to Excellent) to Red (Poor).

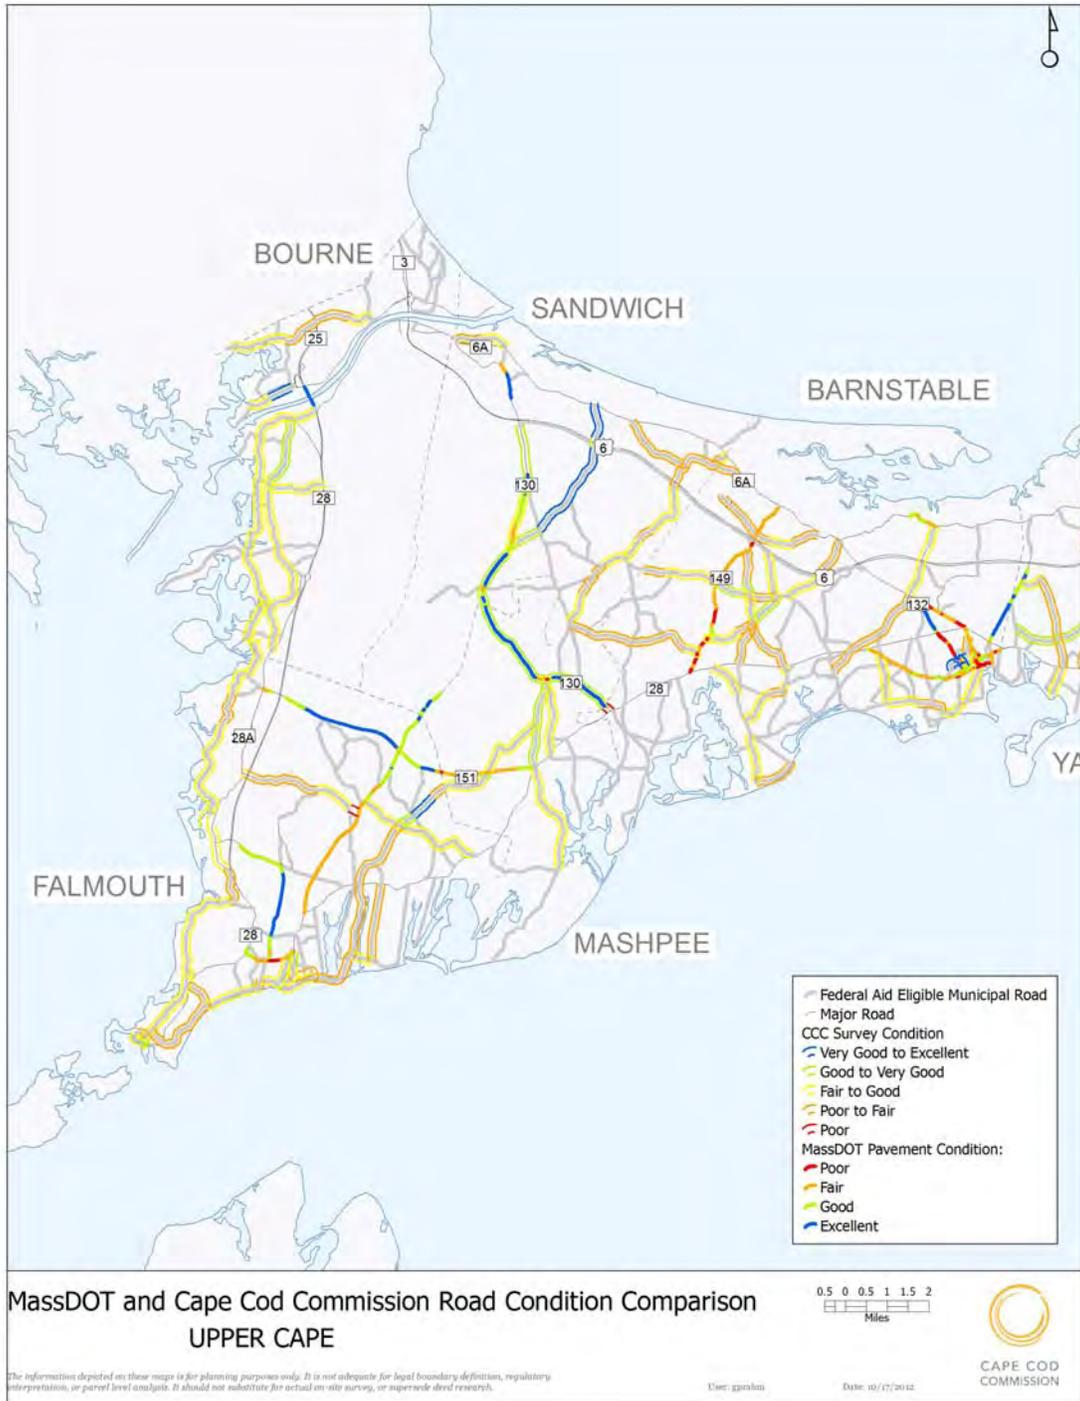
Figure 10 - MassDOT & CCC Evaluations (2006-2012): Upper Cape

When combined with MassDOT's "Municipal Roads with Evaluation" information, the following figures represent conditions of many of the County's Municipal Roads. In some cases CCC evaluations were made on sections of roads also evaluated by MassDOT. The figures are presented geographically (Upper Cape, Mid-Cape, and Lower Cape) and show the combined evaluations by colored lines. For MassDOT evaluations, the colors of the thick solid lines range from Blue (Excellent) to Red (Poor). For the CCC evaluations, the colors of the parallel lines range from Blue (Very Good to Excellent) to Red (Poor).

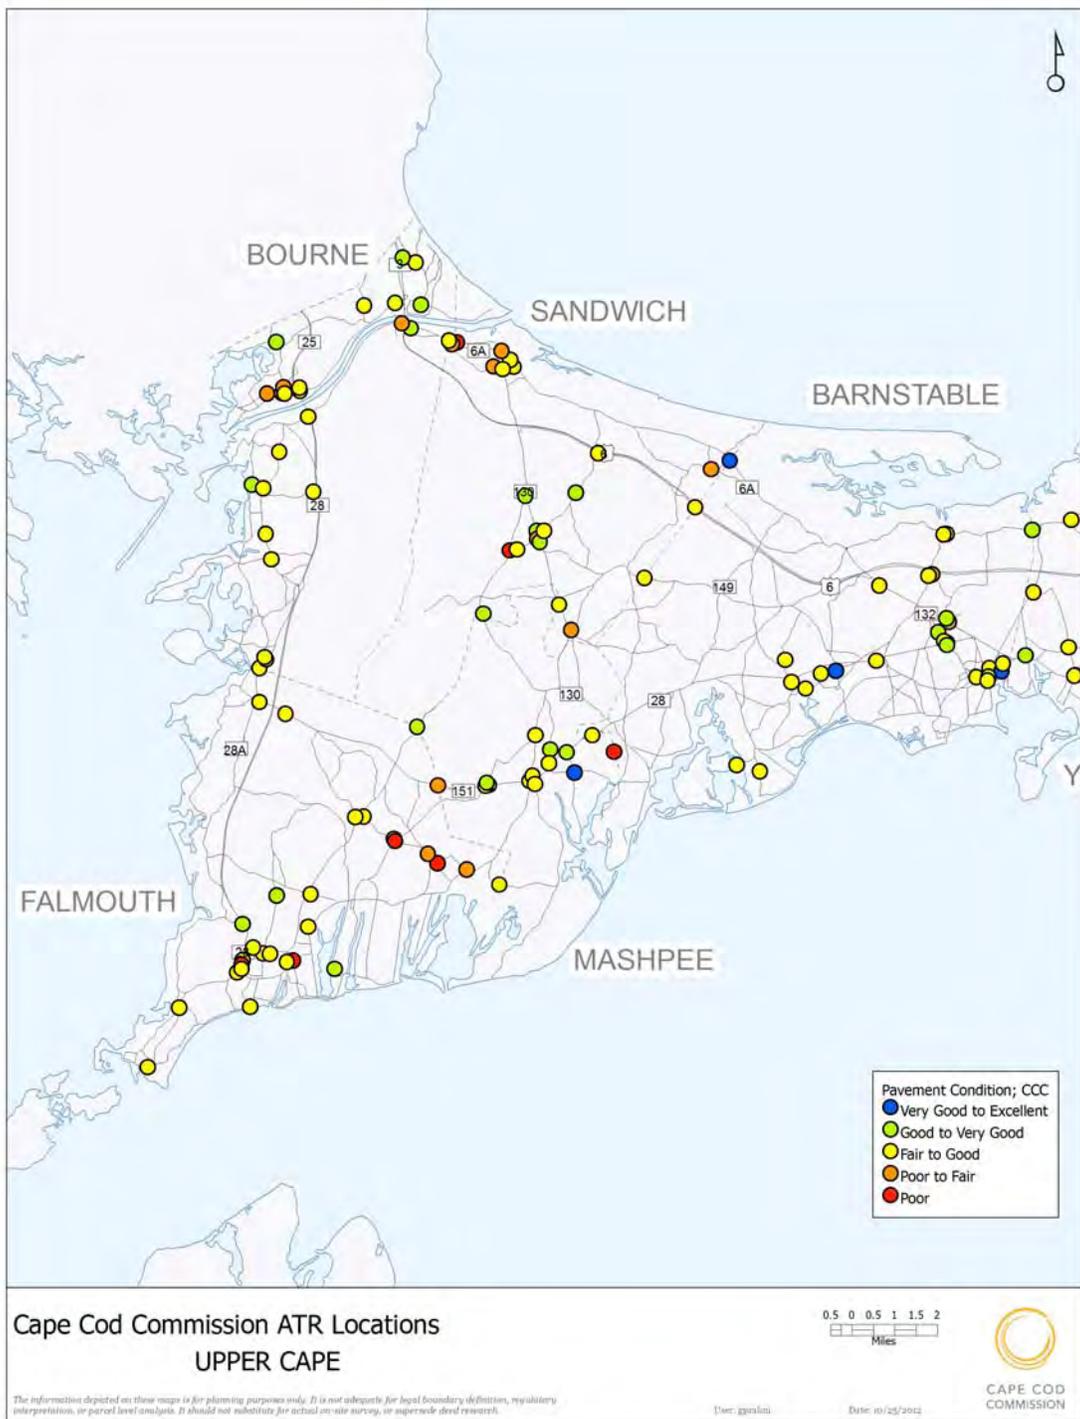
Figure 13 - 2011-2012 Pavement Conditions at ATR Locations: Upper Cape

See Table 1 for descriptions of pavement conditions (ranging from “Excellent” = 1 to “Poor”=5). Pavement conditions including comments and other ATR data for each of the 250 collection sites are presented in the appendix. The following figures are a graphical display of the individual site data for sections of Barnstable County (Upper Cape, Mid-Cape, and Lower Cape). The pavement condition at each ATR site is shown as a colored circle ranging from Blue (Very Good to Excellent) to Red (Poor).

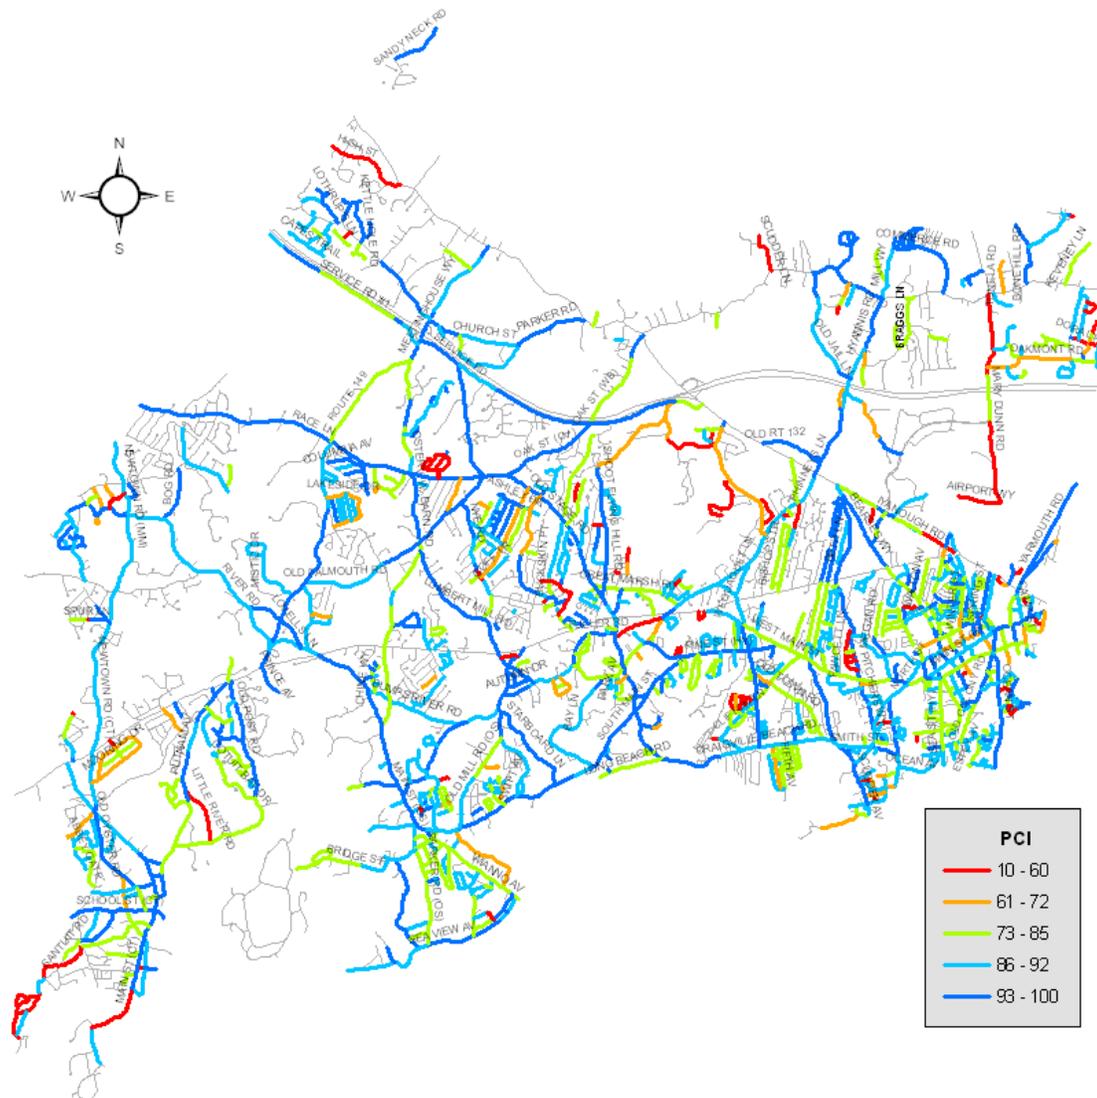
Figure 16 - Barnstable PCI Map

Several communities have active PMS and have provided examples of pavement condition reporting. Two of these towns (Barnstable and Sandwich) have submitted maps showing roadways with evaluations of pavement conditions. The color-coding is based on the average “Pavement Condition Index” (PCI) as described in Section 1.4.1.1, with the pavement in the best condition (highest PCI) shown in blue and the poorest condition (lowest PCI) shown in red.
