TOWN OF BREWSTER

- Town Map
- Chart of Site Characteristics
- Sites 1 to 7

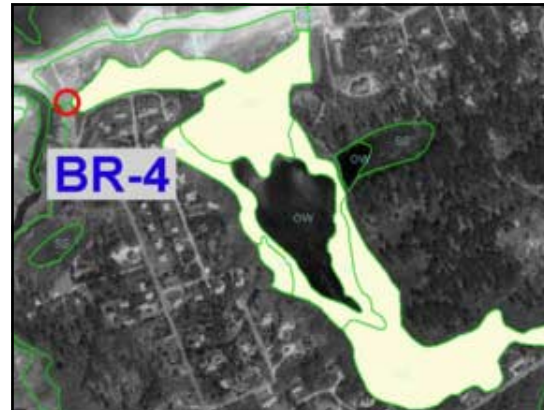
Upstream Affected Area (acres): SM – 8.39;
M – 4.36; SS – 8.54.

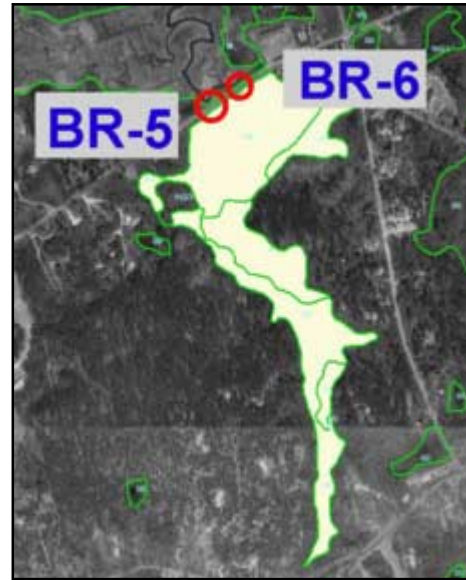
Upstream Affected Area (acres): SM – 12.25;
SS – 13.12; M – 6.19.

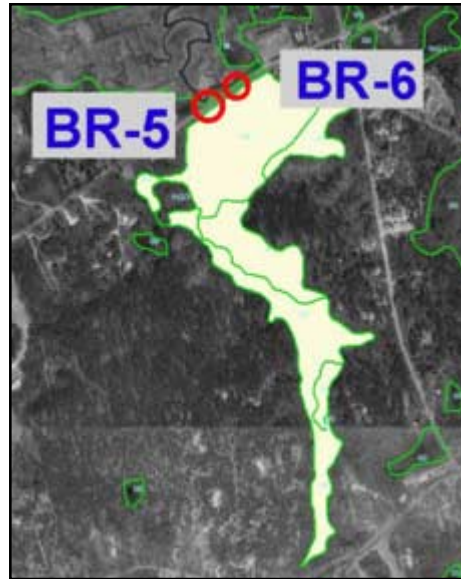
Upstream Affected Area (acres): SM – 12.25;
SS – 13.12; M – 6.19.
