# **TOWN OF EASTHAM**

## Location of Selected Salt Marsh Restrictions

## Dyer Prence Road restriction of Rock Harbor Creek

### Site EA-1

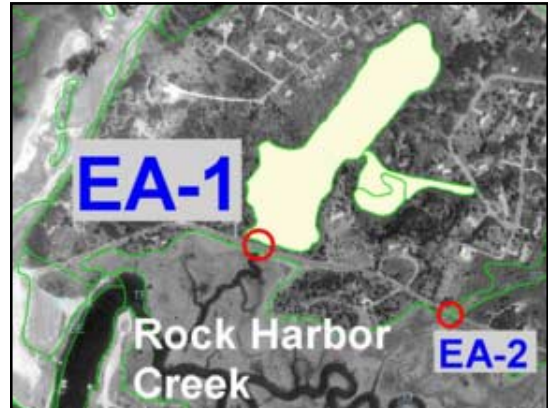
Upstream Affected Area (acres): SM – 9.71;  
SS – 1.11; M – 0.74.

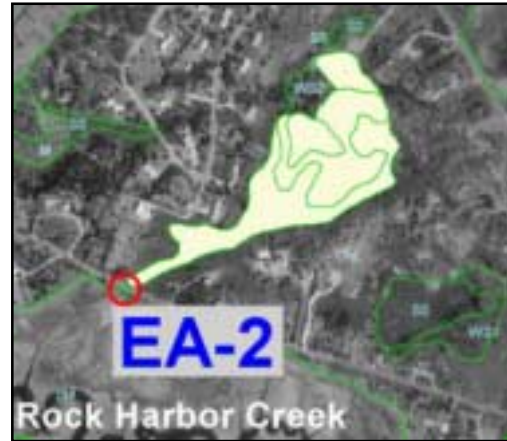
Upstream Affected Area (acres): SM – 0.72;  
SS – 3.65; M – 2.50.

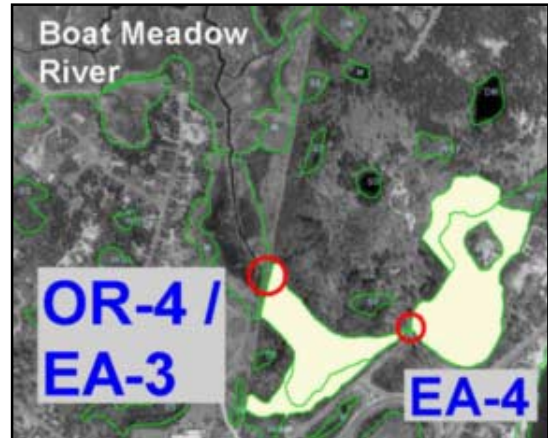
Upstream Affected Area (acres): SM – 5.20;  
SS – 2.31; M – 9.43.

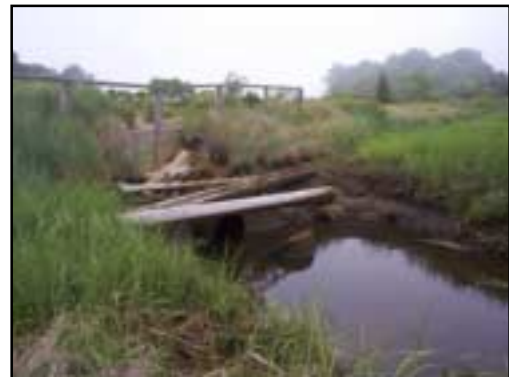
Seaward of this site the river channel is approximately 15 feet wide, narrowing to approximately 5 feet upstream. Visual indicators of a restriction are severe and include major scouring and erosion both seaward and upstream. Vegetation die off and ponded water are significant in the adjacent seaward marsh area. The vegetation changes noticeably from the seaward to upstream sides of the bike path with minor *Phragmites* growth seaward, becoming significant on the fringes and in the rear of the upstream affected area. An exposed length of seaward pipe is broken off in several sections. The opening is jammed by large logs, pieces of docks, and other debris that have collected at this site.

Debris marks the seaward opening of this culvert under the bike trail. Pieces of the pipe have broken off and lie in the deep scour pool in front of the opening.

An Environmental Notification Form (EOEA file number 12421) for Cape Cod Rail Trail Safety Improvements was filed in January 2001, stating that the pipe is a tidal restriction reducing critical upstream habitat for fish and invertebrates and that the vegetative community suffers as well. Massachusetts Coastal Zone Management (MCZM) has examined this site as part of the US Environmental Protection Agency sponsored Salt Marsh Assessment Project. This project calls for replacement of the existing pipe with a 6 by 4-foot precast concrete box culvert. Restoration work at this site has now been funded by the Massachusetts Wetlands Restoration Program's Corporate Wetlands Restoration Partnership, the National Fish and Wildlife Federation, the Department of Environmental Management and MCZM. At this time all permits have been approved and construction bids received.

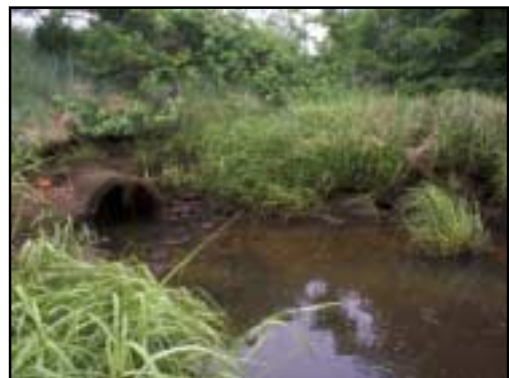
Upstream of the bike trail the bank has eroded away from this 36-inch pipe. Scour and erosion scar the area.

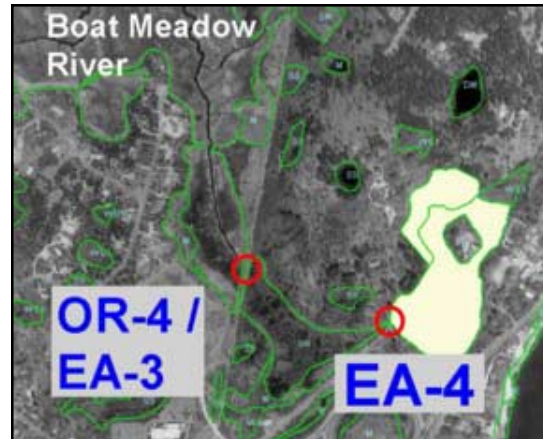
Upstream Affected Area (acres): SS – 2.31; M – 7.87.

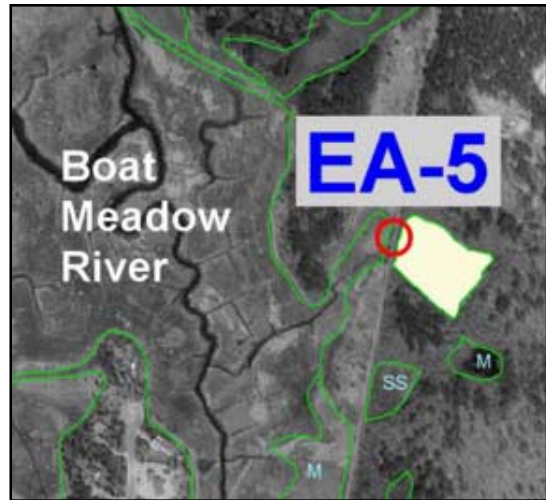
Upstream Affected Area (acres): SM – 1.13.

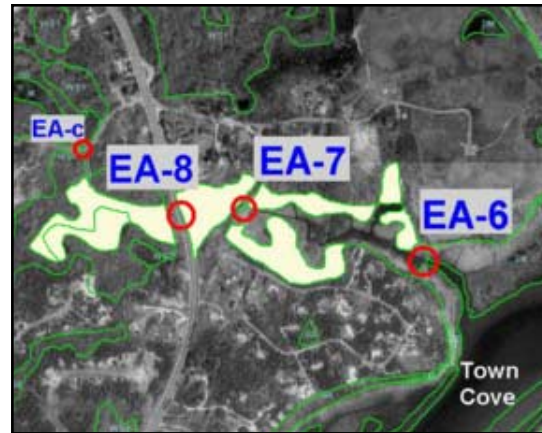
Upstream Affected Area (acres): SM – 7.71; M – 11.03. The SM acreage between EA-6 and EA-7 is estimated at 6 acres. Not all of the SM is highlighted in this image.

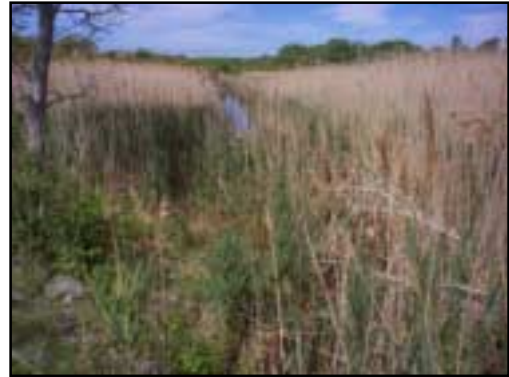
*Phragmites visibly dominates the Marsh Chase Salt Marsh, an area of approximately 2.42 acres of shallow marsh between Governor Prence Road and Route 6.*

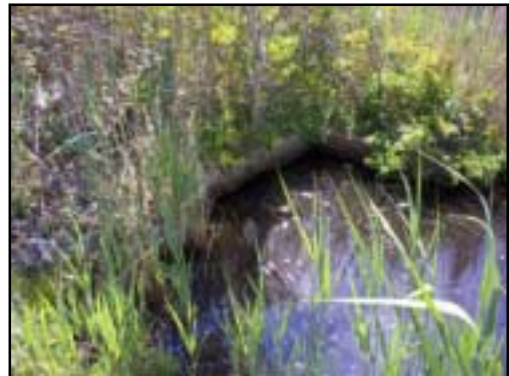
*This concrete headwall houses the upstream opening of the 30 inch pipe passing under Route 6. Stagnant water obscures the submerged pipe.*

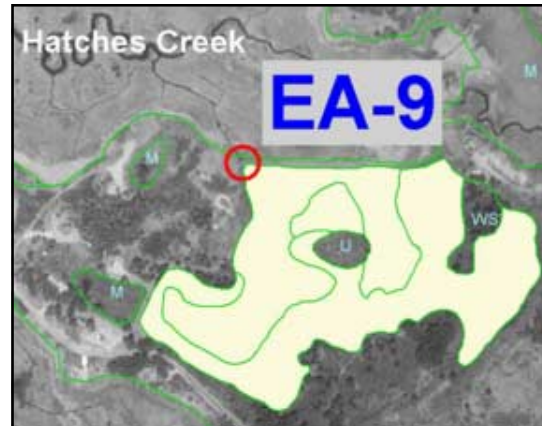
Upstream Affected Area (acres): SM – 6.31; SS – 9.43; M – 0.77.
