TOWN OF MASHPEE

- Town Map
- Chart of Site Characteristics
- Sites 1 to 6

Location of Selected Salt Marsh Restrictions

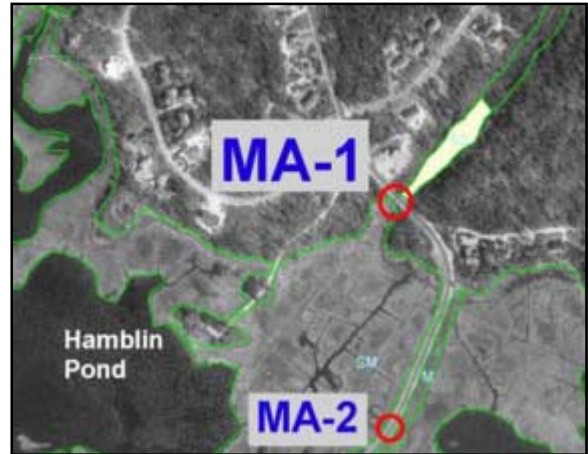
Upstream Affected Area (acres): SS – 0.73.

The seaward and upstream channels measure 2 and 3 feet respectively. Because both are smaller than the 1-foot opening, natural flow is restricted. Salt marsh extends to the seaward opening. *Phragmites* and cattails are present in the seaward marsh. Scour and erosion are minimal in the channels. The upstream affected area contains only shrub swamp.

- Restriction width – 1 foot
- Restriction length – 45 feet
- Upstream salt marsh – 0 acres

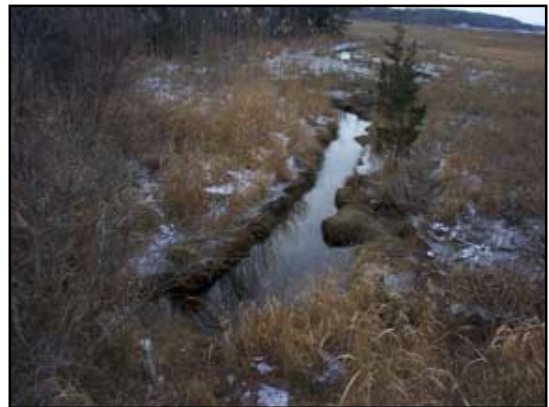
Phragmites and shrubs are taking hold in the salt marsh near the seaward opening of the pipe.

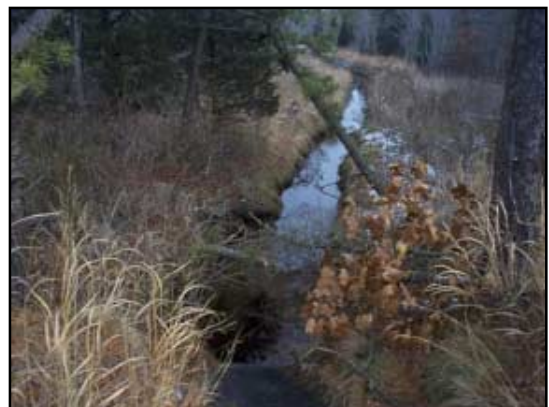
View into the 0.73 acres of shrub swamp located upstream of site MA-1.

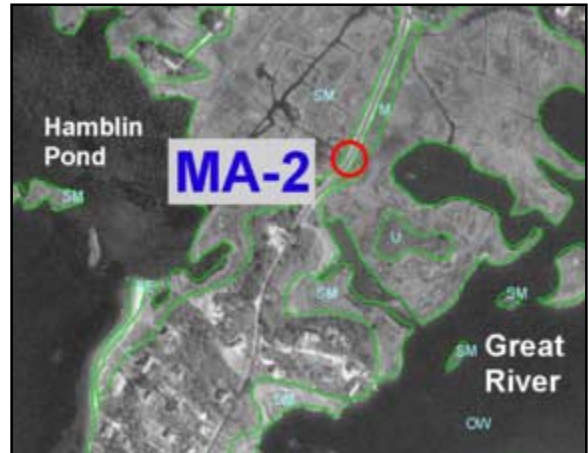
Upstream Affected Area (acres): SM – unable to determine.

Local officials have observed incoming tidal flow entering this pipe from both the east and the west depending upon the prevailing winds. Therefore, seaward and upstream “sides” are not appropriate labels for this location. The channel extending to the road from Hamblin Pond is approximately 2 feet wide. The channel extending to the road from the Great River is approximately 4 feet wide. There is minor bank erosion and small scour pools near both ends of the pipe. *Phragmites* grows along the eastern side of the road.

- Restriction width – 2 feet
- Restriction length – 35 feet
- Upstream salt marsh – unable to determine

The town replaced this pipe in 1999, and therefore no work is likely to be undertaken at this site in the near future. No hydrologic study was conducted to determine the appropriate size for this pipe; rather the reconstruction replicated the previously approved engineering specifications from the 1950's. This was done in order to expedite replacement of the collapsed pipe. To redesign and resize the pipe would have involved extensive permitting, an endeavor that the town was not willing to undertake at that time.

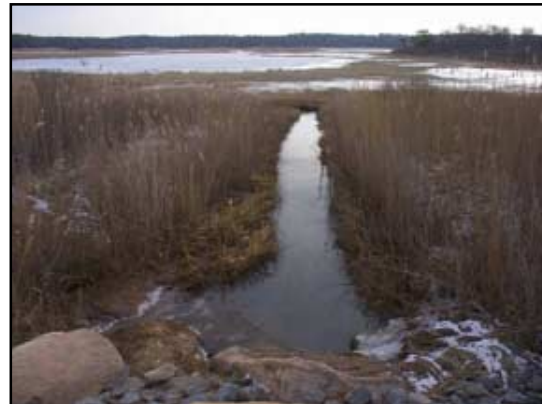
Phragmites grows in the marsh east of the road near this 4-foot channel connecting to the Great River.

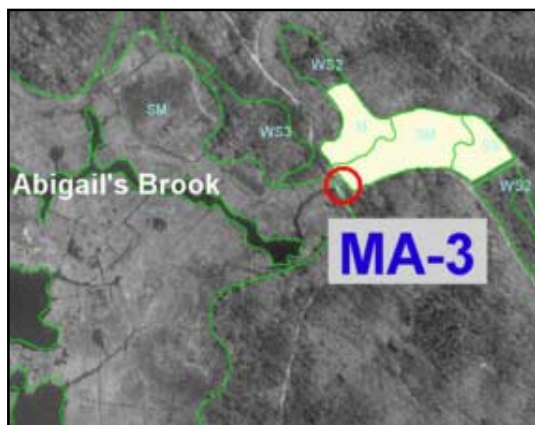
Upstream Affected Area (acres): SM – 2.26; SS – 0.91; M – 1.21.

The 10-foot wide seaward channel flows through salt marsh in the upper reaches of the Great River to this culvert. *Phragmites* and cattails are scattered in this marsh area. Adjacent to the seaward pipe opening, a significant scouring basin and severe bank erosion scar the channel. Vegetation has begun to die back at its edges. The upstream channel is only 5 feet wide, half the seaward width. It also exhibits significant bank scouring and erosion. *Phragmites* growth is significant in the upstream affected area and shrubs are visibly taking hold.

- Restriction width – 30 inches
- Restriction length – 17 feet
- Upstream salt marsh – 2.26 acres

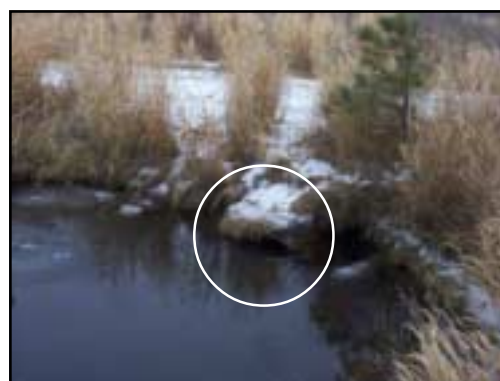
Seen during mid, incoming tide water flows over the channel banks and pools at the roadway berm; the top of the pipe is barely visible under a clump of grass (opening circled in photo above).

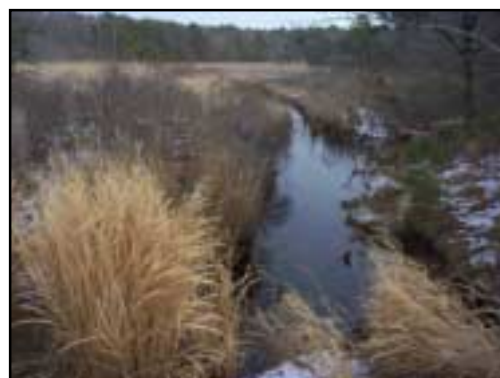
Upstream of the Great Hay Road restriction the land is part of the Mashpee National Wildlife Refuge. *Phragmites* growth is extensive toward the rear of this affected area.

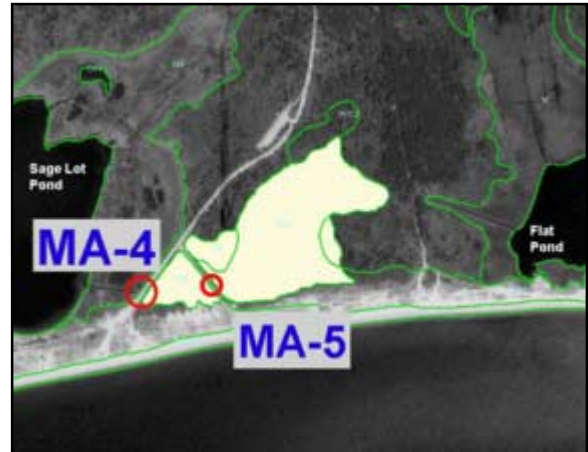
Upstream Affected Area (acres): SM – 14.68; SS – 1.75.

The seaward and upstream channels are approximately 10 feet wide. Stream flow is partially dammed by the roadway berm as water tries to flow through the 4-foot diameter pipe. The upstream channel flows approximately one-eighth of a mile before reaching upstream site MA-5, where flow is again restricted. Minor scour basins are present on either side of the pipe. *Phragmites* growth in the vicinity of this site is minor.

- Restriction width – 4 feet
- Restriction length – 45 feet
- Upstream salt marsh – 14.68 acres

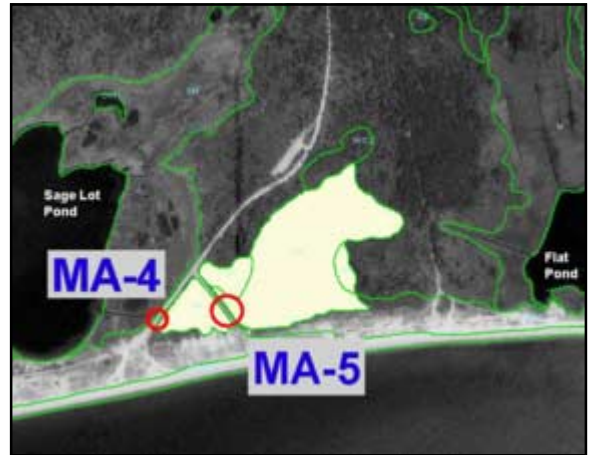
Upstream Affected Area (acres): SM –12.62; SS – 1.75.

The seaward channel varies between 5 and 10 feet and small scour pools and minor bank erosion are visible near the pipe opening. The seaward opening becomes submerged at mean high tide. The upstream channel is approximately 5 feet wide. The storm water drainage from a paved parking lot adjacent to this site appears to be directed straight into this channel. *Phragmites* growth is minimal in the upstream affected area.

- Restriction width – 4 feet
- Restriction length – 32 feet
- Upstream salt marsh – 12.62 acres

This unnamed tidal channel continues east from this site into Flat Pond by first crossing site MA-d (see Appendix B). The three infrastructure crossings along this unnamed channel must be considered jointly in any remediation discussions. The Massachusetts Wetlands Restoration Program is currently studying this site for potential future restoration.

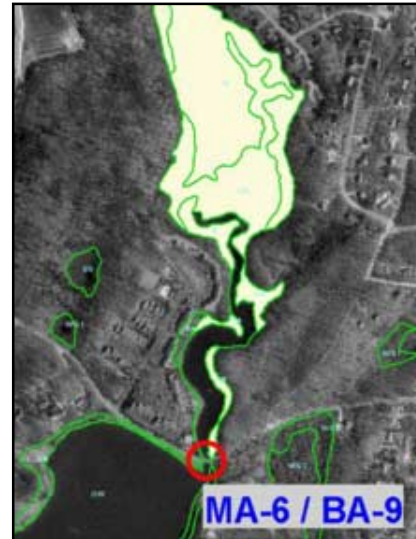
Upstream Affected Area (acres): SM – 11.07; SS – 1.19; M – 17.51.

The seaward side of the bridge parallels the northern extent of Shoestring Bay, therefore a channel measurement is not relevant. The Santuit River begins on the upstream side of the bridge and is approximately 100 to 150 feet wide – clearly wider than the 45-foot bridge span. Long bridge abutments were built out from the natural banks to decrease the need for construction of a wider span – obvious contributors to the tidal restriction. Minor scour is visible in the river and bay near the opening. Cattails (seaward and upstream) and *Phragmites* (seaward only) are present along the riverbanks.

- Restriction width – 45 feet
- Restriction length – 25 feet
- Upstream salt marsh – 11.07 acres

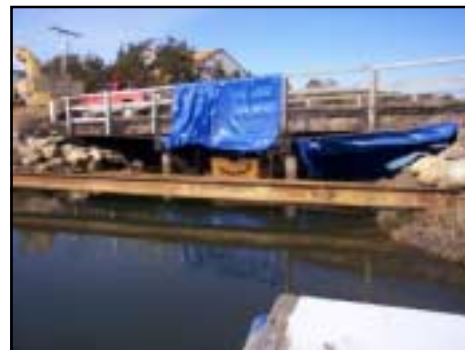
Reconstruction of the bridge began in the fall of 2000. The project is intended to widen the bridge and increase its height above the Santuit River. Unfortunately, reconstruction did not include increasing the width of the span to allow increased tidal flow.

Construction underway on the Santuit River bridge to widen and raise the roadway; unfortunately plans do not include alleviating the restriction.

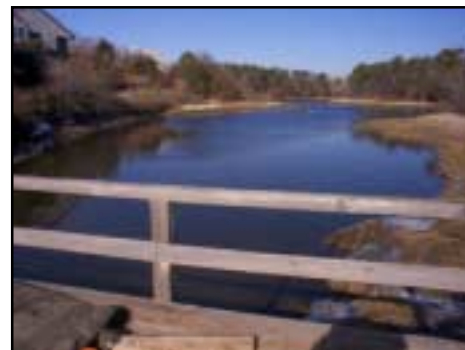
Upstream of the bridge salt marsh lines the eastern riverbank while development is visible on the western bank.
