# **TOWN OF ORLEANS**

- Town Map
- Chart of Site Characteristics
- Sites 1 to 7

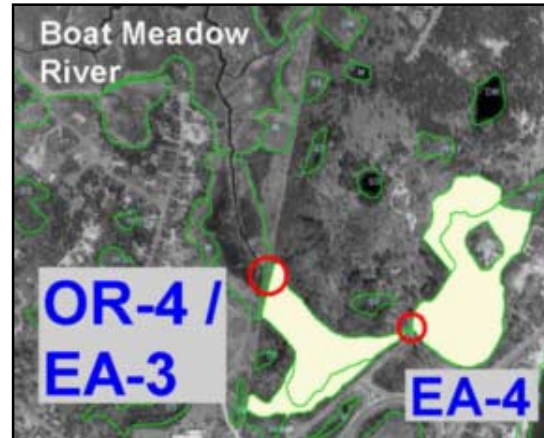
Upstream Affected Area (acres): SM – 5.20;  
SS – 2.31; M – 9.43.
