# TOWN OF PROVINCETOWN

## Location of Selected Salt Marsh Restrictions

## Province Lands Road/Route 6A restriction of unnamed channel

Site PR-1

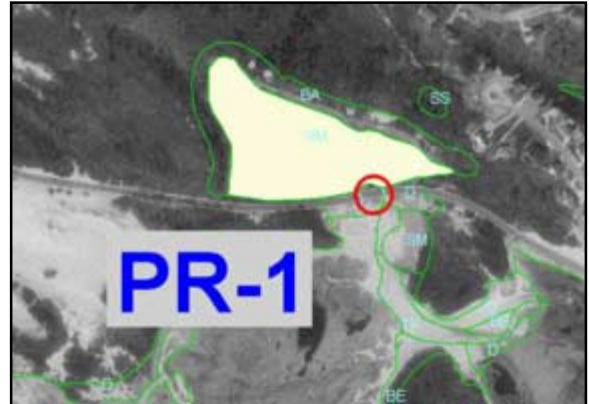
Upstream Affected Area (acres): SM – 5.22 acres.
