Town of Barnstable Road Safety Audit

Iyannough Road (Route 132) at Cape Cod Community College/Cape Cod Conservatory Intersection

August 2014

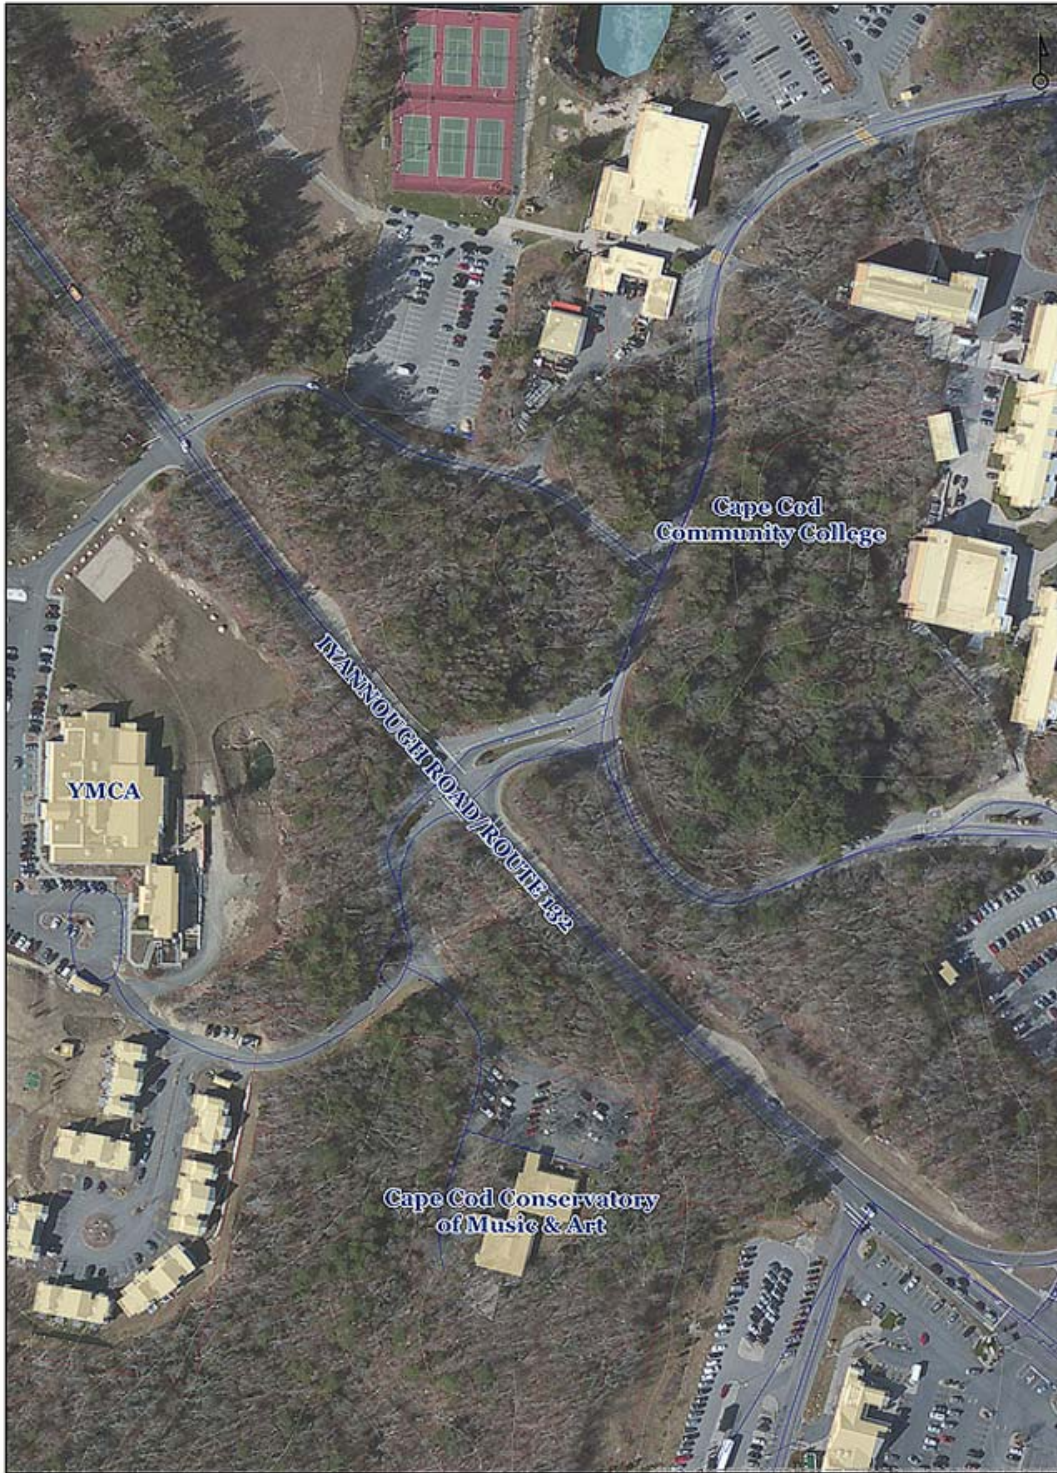
Figure 2 - Figure 1. Iyannough Road/Route 132 at Cape Cod Community College/Cape Cod Conservatory of Music & Art intersection

The intersection of Route 132 at Cape Cod Community College/Cape Cod Conservatory in the Town of Barnstable is a four-way unsignalized intersection, with the roadways crossing at a right angle. Route 132 is functionally classified in this section as an urban minor arterial and consists of two travel lanes and a sidewalk on the southwest side. Both minor street approaches to the intersection are stop-sign controlled. The Conservatory drive consists of a one-way lane in each direction separated by a median. The College drive includes a single lane entrance lane separated by a median from a two-lane exit.

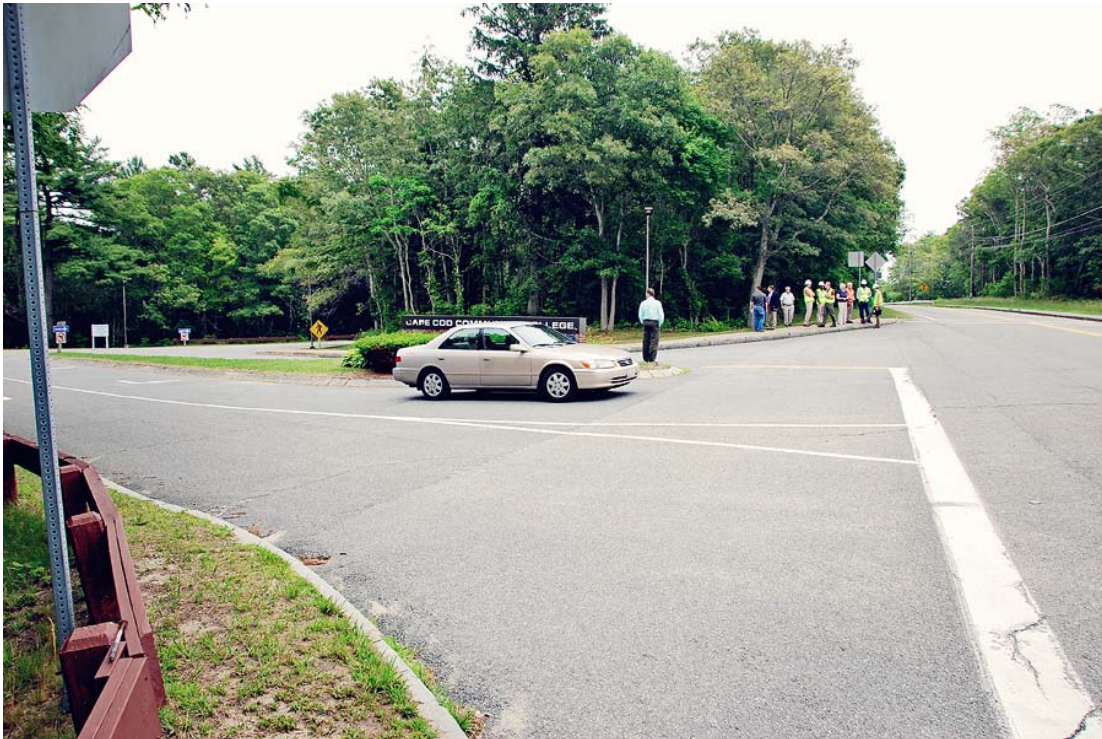
The eastern leg approach from the college includes a left-turn marked lane and a right-turn marked lane. There is no consideration given for through traffic traveling across to the destinations on the western side of the intersection. Vehicles in the right-turn lane are guided to a skewed-angle approach, requiring motorists to turn their heads far to the left (while trying to see past vehicles in the left lane waiting to turn left).

The curb radius on the southeastern quadrant is large – allowing northbound Route 132 vehicles to travel at high speed while turning into the college.

Heavy traffic volumes on Route 132, traveling at high speeds make it difficult for vehicles entering the intersection from the minor road approaches, especially for left-turning vehicles. During busy college times, vehicle queues may cause driver frustration – leading to less-experienced motorists (college students) to enter shorter (unsafe) gaps in the traffic stream.

Figure 3 - View of the Cape Cod Community College entrance

Provide more control and definition at the intersection. This may include a right-turn lane on northbound Route 132. Modify pavement marking to allow for through-traffic exiting the college driveway.

For traffic calming and to reduce vehicle conflicts, consider installation of a modern roundabout.

To reduce left-turning vehicle conflicts, consider installation of a traffic signal.

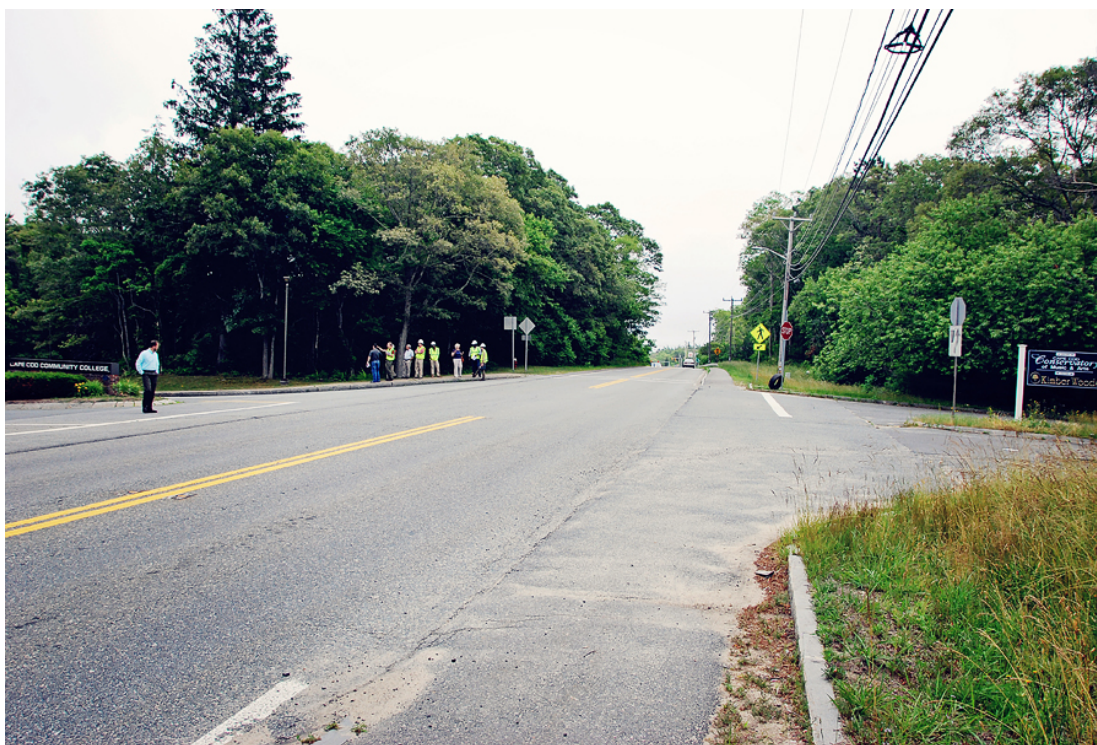
Figure 4 - View of Route 132 traveling southbound

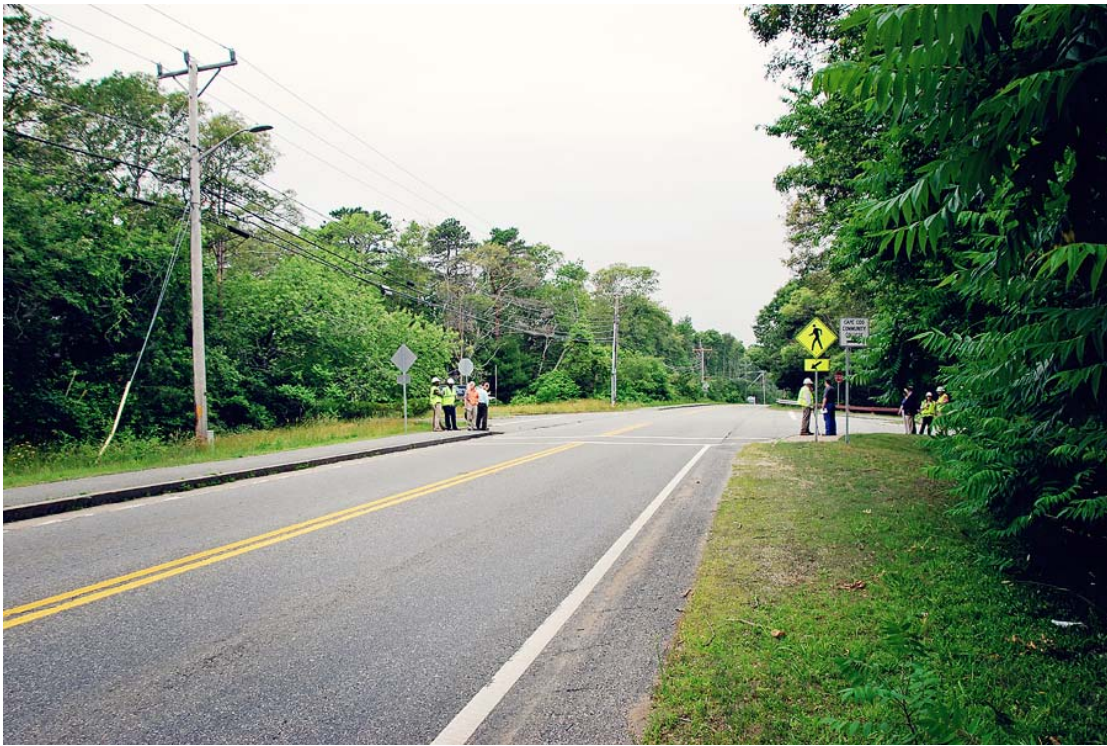
The team observations on sight distance and vegetation were related, and therefore, the issue categories are combined. Vehicles entering from the eastern leg (college) have difficulties seeing northbound Route 132 vehicles.

Vegetation obscures the view of the college entrance and signage for vehicles traveling north on Route 132

Figure 5 - View of Route 132 northbound toward the entrances to the Cape Cod Community College and the Cape Cod Conservatory of Music & Art

Trim vegetation to increase available sight distance and signage visibility.

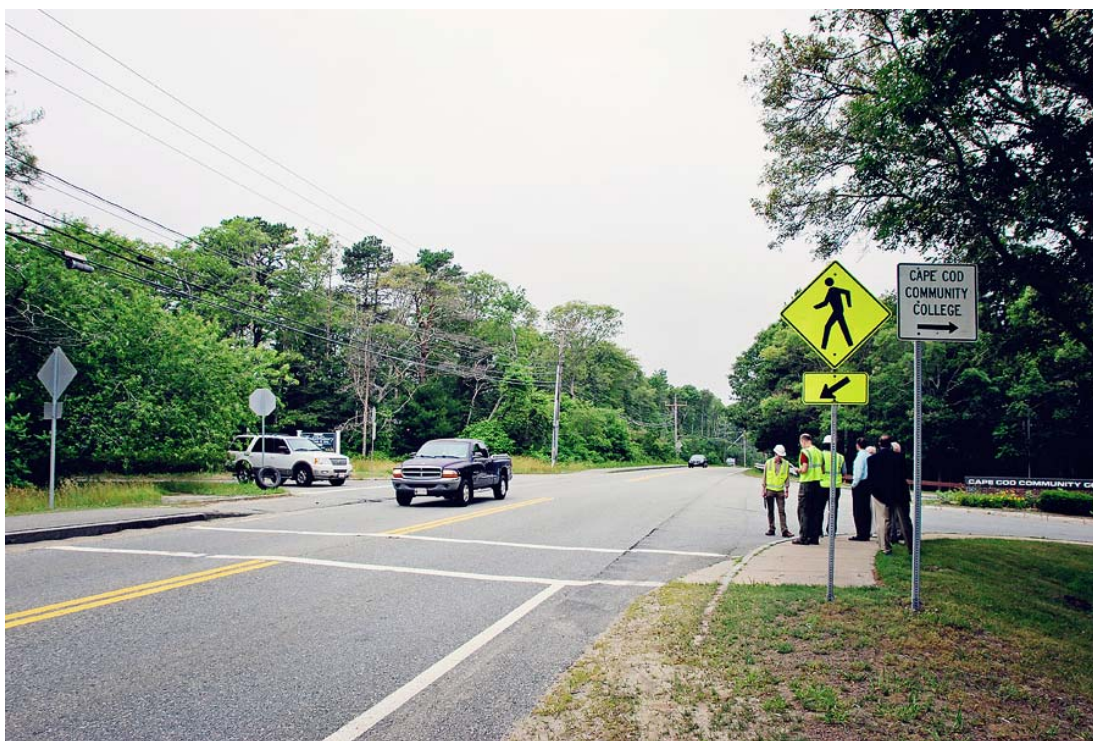
Signs in the vicinity of the intersection are generally sufficient but do need to be brought up to date with requirements for retro-reflectivity.

It was mentioned that drivers looking for the entrance to the college may have difficulty. Signage on northbound Route 132 near the entrance is obscured by vegetation.

There is no overhead lighting at the intersection. The splitter island on the eastern leg includes an internally illuminated sign for the college.

Figure 6 - View northbound of Route 132 near the Cape Cod Community College entrance

Upgrade (replace) signs to improve retro-reflectivity.

Add a white on green sign in advance of the intersection with “Cape Cod Community College next right”.

Consider installing overhead lighting at the utility pole on the northwest quadrant of the intersection.

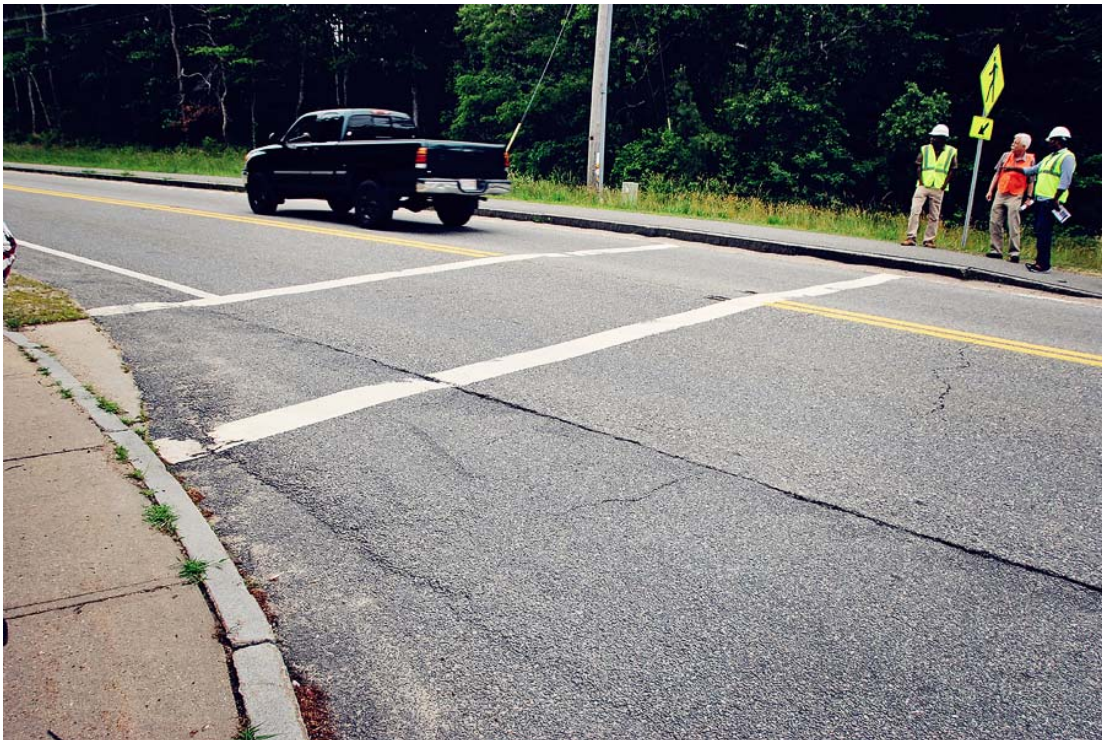
Pavement condition and markings are in poor to fair condition.

There are signs of wear including cracking, potholes, and rutting.

Pavement markings are partly worn through such as the stop bars on the minor leg approaches from the college and conservatory.

Figure 7 - View looking southbound of the pedestrian crosswalk crossing Route 132 depicting no accessible ramp for pedestrians on the opposite side of the street

With intersection improvements the pavement condition and markings should be improved, as feasible.

Install an accessible ramp on the western side of the Route 132 crosswalk.

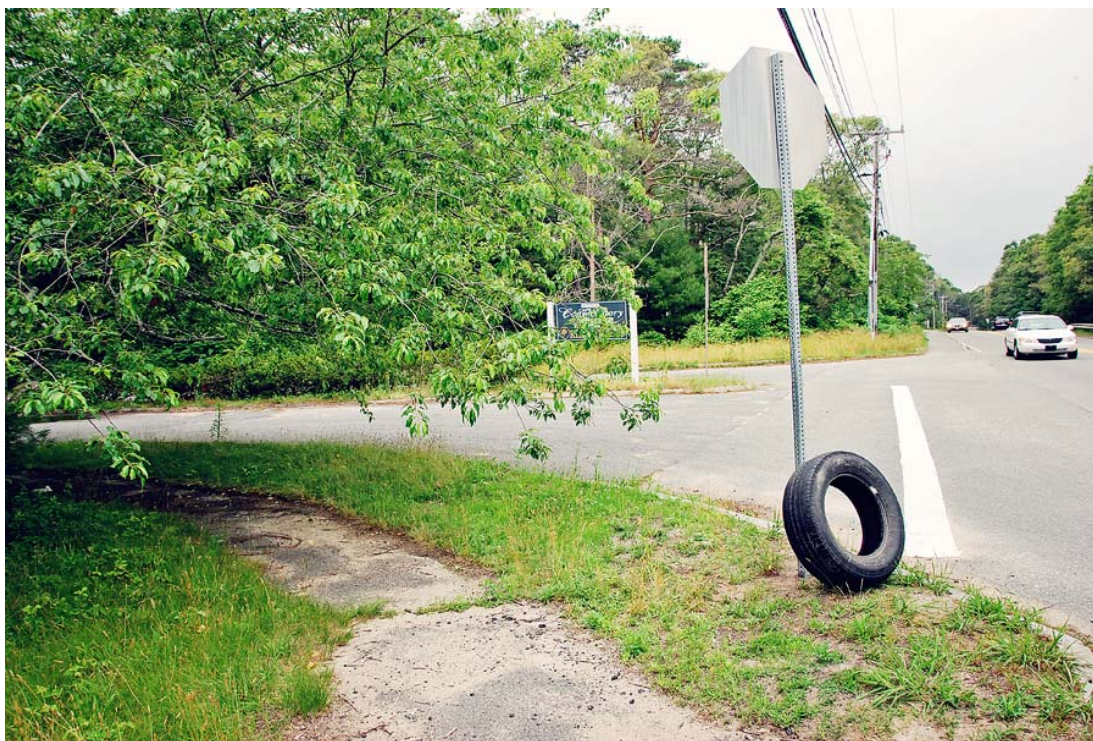
There is no crosswalk connecting the sidewalks on either side of the Conservatory driveway on the western leg of the intersection.

There is no accessible ramp from the crosswalk to the Conservatory driveway.

Figure 8 - View of sidewalk turning into the Cape Cod Conservatory of Music & Art. This view also depicts the evidence of no crosswalk and no accessible ramps for pedestrians

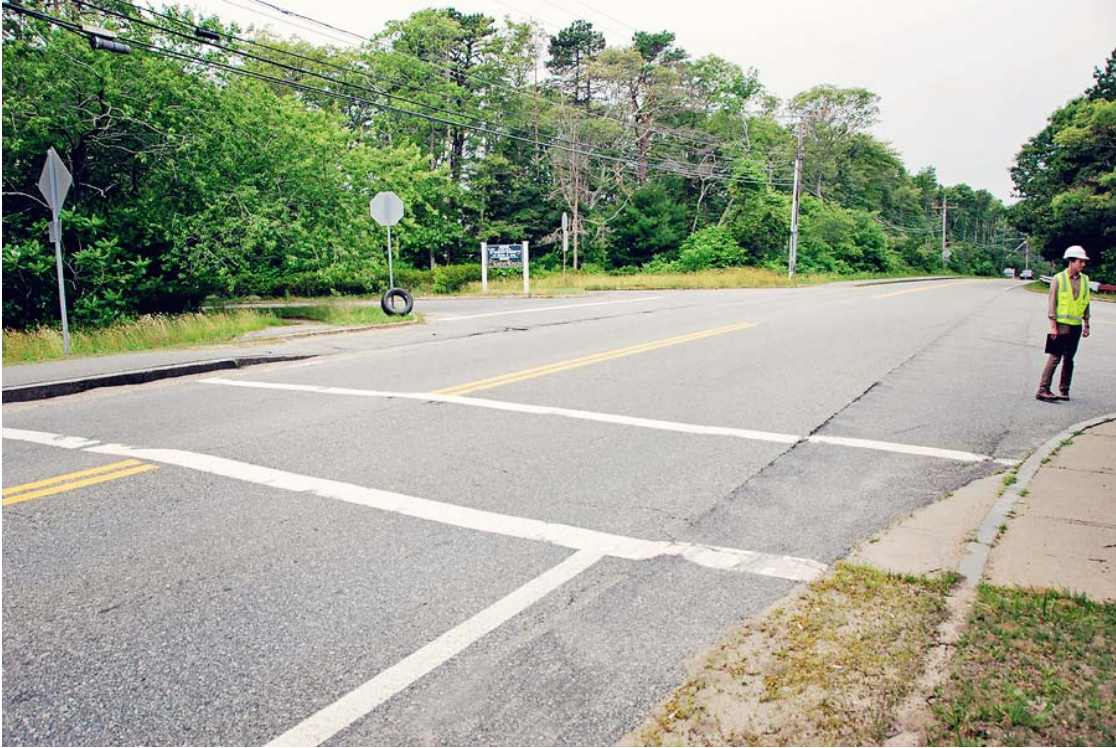
Pedestrian traffic has increased between the Community College and the businesses and bus service at the Exit 6 Park and Ride Lot. A sidewalk exists along the west side of Route 132 connecting Route 6A in the north along the entire length of the roadway to Route 28. Access to the Community College is provided by a crosswalk on the southern leg of the intersection.

Figure 9 - View of crosswalk markings across Route 132

Provide advance warning signage notifying motorists along Route 132 of the upcoming crosswalk.

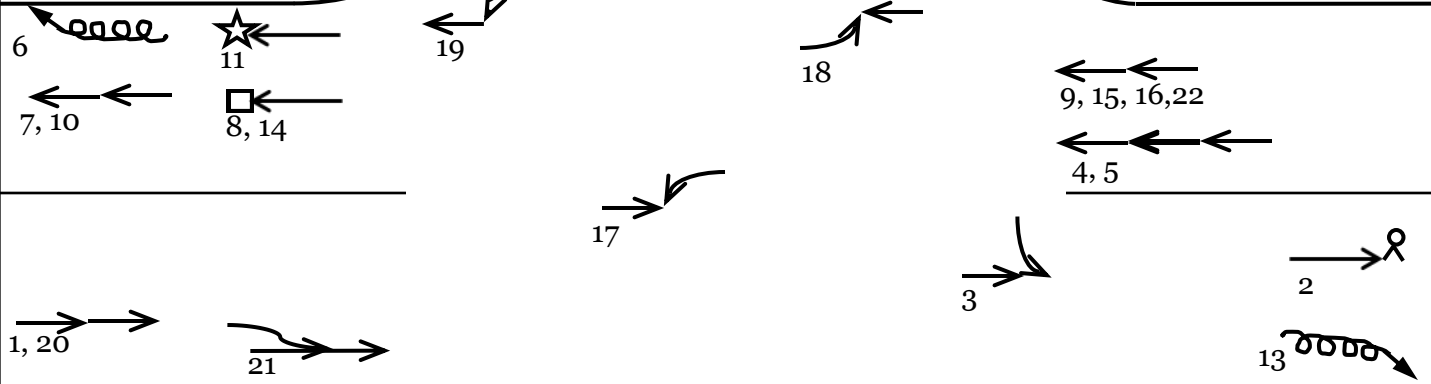
Collision Diagram

LOCATION Along Iyannough Road (Route 132) at the entrances of Cape Cod Conservatory of Music & Art/Cape Cod YMCA and the Cape Cod Community College Campus

CRASHES FROM 04/05/2011 TO 03/07/2014
