ROAD SAFETY AUDIT

Route 151 Corridor

Town of Falmouth

June 8, 2018

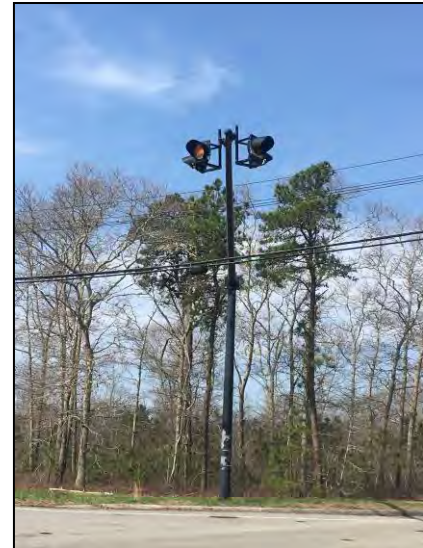
Currently, the northbound and southbound approaches of Currier Road are under stop control, and the eastbound and westbound approaches are free-flowing. An audit team member noted that vehicles on the northbound and southbound approaches to the intersection have significant delays during the peak hours due to the high vehicular volume and travel speed along Nathan Ellis Highway (Route 151). There is an overhead flashing beacon at the intersection; however, audit participants noted that the indicators are not L.E.D., reducing visibility by motorists. This issue is exacerbated as the stop sign is missing on the southbound Currier Road approach and the stop bars on both the northbound and southbound approaches are either faded or missing.

Image 1: Overhead flasher at Route 151 / Currier Road intersection

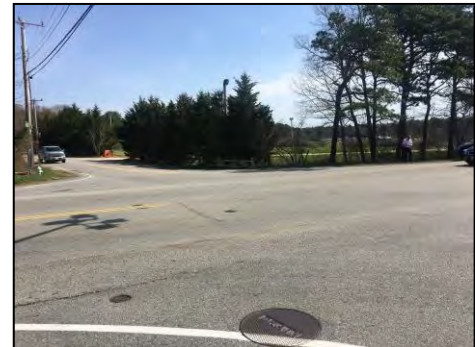
The intersection of Nathan Ellis Highway (Route 151) / Currier Road is situated on a large expanse of asphalt pavement, with large corner radii on all four corners of the intersection. During the audit, vehicle operators were observed performing right turn movements at high rates of speed due to the intersection geometry. An audit participant noted that wide corner radii are not necessary since trucks and heavy vehicles do not use Currier Road.

The wide corner radii also create a wide area for vehicles to turn from Currier Road. There were six (6) sideswipe crashes at this intersection that involved a vehicle attempting to pass a vehicle traveling in the same direction due to the wide curb radii and intersection geometry. Audit participants noted that vehicles attempting to turn right onto Nathan Ellis Highway from northbound Currier Road pull far to the right, allowing vehicles desiring to turn left or continue straight to also approach the stop bar, further restricting sight lines for both vehicles. The slight vertical curve of Route 151 to the west of the intersection also restricts the sight lines of the northbound vehicles looking left to exit Currier Road.

Image 2: Wide intersection geometry

1. Consider reducing the corner radii of all four corners of the intersection to reduce travel speeds for turning vehicles and reduce the potential crossing distance for pedestrians. Evaluation of required large vehicle turning radii must be considered with this recommendation.

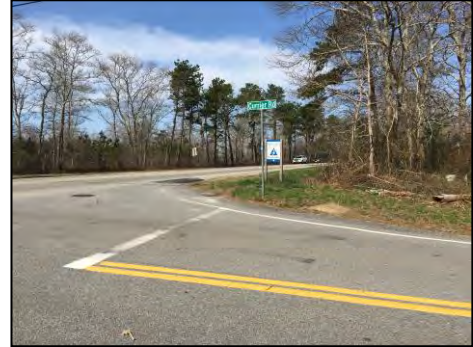
Audit participants noted that the existing pavement markings and signage at intersection are faded. The stop bars of northbound and southbound Currier Road are set far back from the intersection, which indicates a stop location to vehicles where foliage and trees restrict sightlines. Furthermore, the Currier Road southbound approach lacks a stop sign.

Image 3: Faded stop bar and missing stop sign on Southbound Currier Road

1. Reapply all existing pavement markings, including stop bars and centerlines, to improve motorist and pedestrian safety.
2. Consider replacing existing pavement markings with thermoplastic markings which will last longer against snow plow damage and improve visibility during inclement weather.

4. Replace all existing signage at the intersection that are currently faded, damaged or non-compliant with MUTCD-compliant signs to provide clear and concise regulatory and warning messages. Consider adding an additional stop sign to the left side of Currier Road.

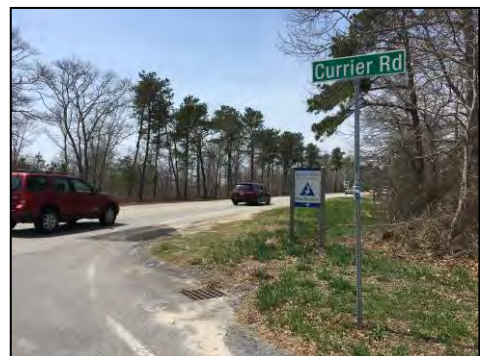
Sightlines – Audit participants noted that due to the curvature of Route 151 and vegetation at the corners of the intersection of Nathan Ellis Highway (Route 151) / Currier Road, vehicles attempting to turn onto Route 151 from Currier Road encroach

Image 4: Restricted sightlines looking east from Southbound Currier Road

into the intersection in attempt to regain sightlines past the vegetation. The “Ashumet Holly Wildlife Sanctuary” sign located on the northwest corner of the intersection limits the sight distance of the vehicles travelling southbound on Currier Road.

Visibility	Maintain corner sight lines by continuing to trim the vegetation within the intersection sight triangles.	Medium	Continuous	Low	Town
	Consider relocating the “Ashumet Holly Wildlife Sanctuary” sign located on the northwest corner of the intersection outside of the intersection sight triangle.	Medium	Short-Term	Low	Town
	Consider installing additional overhead luminaires at the intersection.	Medium	Long-Term	Medium	Town
Sub-Standard Multi-Modal Accommodations	Construct ADA/AAB compliant accessible curb ramps in future conditions with the addition of pedestrian infrastructure.	Medium	Long-Term	Medium	Town
	Consider placing portable lights and signs at the intersection during events at the Fairgrounds.	Medium	Short-Term	Medium	Town

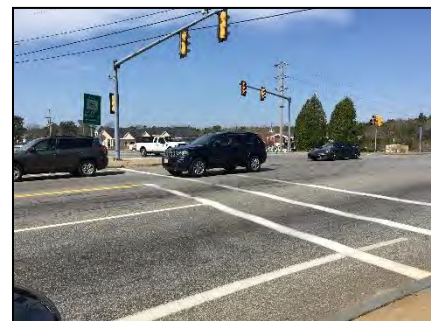
The Nathan Ellis Highway (Route 151) eastbound and westbound through travel lanes are currently offset, with the eastbound approach providing a shared through / left turn lane and a shared through / right turn lane and the westbound approach providing a dedicated left turn lane and a shared through / right turn lane. With this alignment, vehicles do not have a direct path to access the

Image 5: Vehicles traveling through Eastbound Route 151 in two lanes

available receiving lanes. Audit participants noted that the inconsistent approach geometry can be confusing to motorists. Further, vehicles travelling eastbound are able to use both lanes to perform a through movement, however, there is only one wide receiving lane, which can cause conflicts for two eastbound vehicles traveling through at the same time.

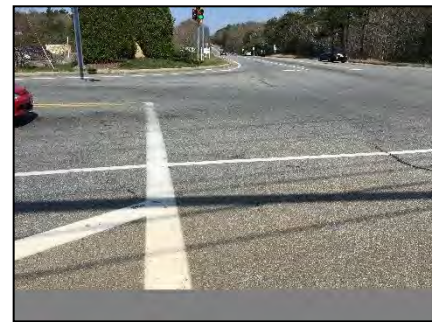
The northbound approach of Sandwich Road provides a shared through / left turn lane and a wide (18-foot) channelized right turn lane. Audit participants noted that northbound through vehicles will use the striped gore area for the channelized right turn lane to bypass left turning vehicles, rather than wait within the left turn queue. This movement is unexpected by vehicles making southbound left turn movements, causing conflicts between turning vehicles. A total of three (3) crashes during the five-year period are angled crashes between vehicles northbound on Sandwich Road and vehicles turning left from southbound Sandwich Road.

Image 6: Sight distance along Eastbound Route 151 from Northbound Sandwich Road

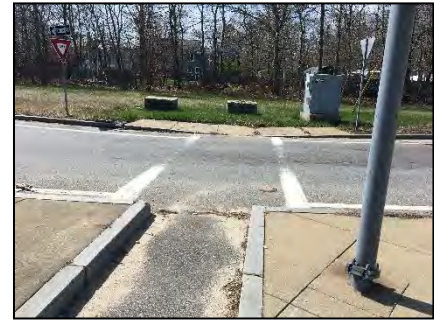
Audit participants noted that some of the existing pavement markings at the intersection, especially the northbound approach, are faded and difficult to see. Poor pavement markings can mislead motorists and cause unnecessary confusion. Audit participants noted that the stop bar on northbound Sandwich Road is faded. Three yield signs were provided for the channelized right turn lane; however, no yield pavement markings are provided. Further, the westbound approach stop bar appears to be too close to the crosswalk.

Image 7: Lack of yield markings on northbound right turn

3. Consider installing a MUTCD-compliant “No Turn on Red” sign for the southbound right turning vehicles due to the high vehicle speeds on Route 151.
4. Consider replacing existing pavement markings with thermoplastic markings which will last longer against snow plow damage and improve visibility during inclement weather

5. Ensure the westbound stop bar is located at least four feet away from striped crosswalk to reduce the potential for pedestrian collisions.
6. Replace all existing signage at the intersection that are currently faded, damaged or non-compliant with MUTCD-compliant signs to provide clear and concise regulatory and warning messages.

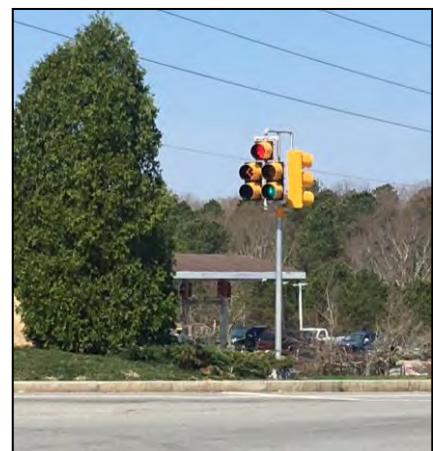
Audit participants observed during the RSA field visit that the traffic signal at the southwest corner of the intersection shows a red ball indication with the left turn yellow arrow indication and green ball indication, which is not the correct display and is confusing to motorists. This may indicate a wiring conflict. Currently, the intersection utilizes loop detectors. An audit participant noted that there can be a high volume of motorcycles during the summer months in Falmouth. Motorcycles travelling through the intersection

Image 8: Faulty traffic signal indications at the southwest corner of the intersection

cannot be detected by the loop detectors causing motorcyclist and motorist frustration. Motorcycles tend to run red lights when the detectors do not confirm a vehicle is present.

1. Repair the traffic signal at the southwest corner of the intersection to provide correct signal indications during the left turn protected phase to eliminate driver confusion.
2. Evaluate the need to include a protected/permitted or fully protected eastbound/westbound left turn phasing with any proposed changes in geometry to provide standardized signal timings for motorists.
3. Evaluate installing video detection cameras at the intersection to provide a more efficient detection than loop detection.

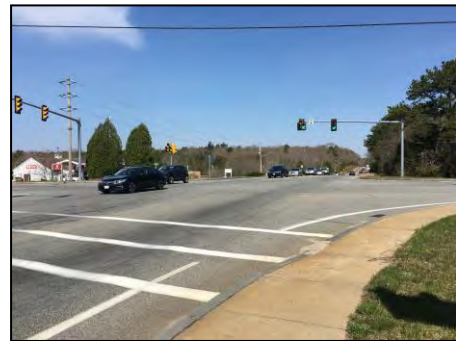
Pedestrian Accommodations – There is a crosswalk striped across the Route 151 westbound approach. The crosswalk lacks pedestrian signals, pedestrian push buttons, pedestrian phasing and ADA/AAB-compliant access ramps. Without pedestrian signal equipment at this signalized intersection, there is no safe way for pedestrians to utilize this crosswalk and cross Nathan Ellis Highway. No pedestrian crashes were recorded at this intersection.

Image 9: Crosswalk across the westbound approach with no ADA ramps or pedestrian signal equipment

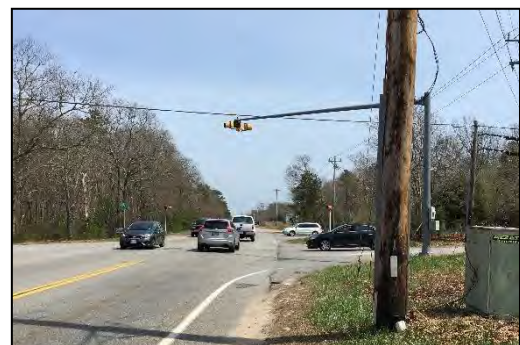
Currently, the northbound and southbound approaches of Sam Turner Road, Cloverfield Way and Boxberry Hill Road are under stop control, and the eastbound and westbound Nathan Ellis Highway (Route 151) approaches are free-flowing. There is an overhead flasher and post-mounted flashers present for the approaches to the intersection cluster. Audit participants noted that the red flasher on the post for Cloverfield Way can be seen from the Route 151 eastbound approach, causing driver confusions. Furthermore, the post-mounted flasher for the Nathan Ellis Highway (Route 151) / Boxberry Hill Road is not ideally located, as the flasher heads for eastbound and westbound approaches are far from the road and are currently covered by the overgrown vegetation

Image 10: Red post mounted flasher seen from two directions

along Route 151. Audit participants noted that the indicators are not L.E.D., reducing visibility by motorists. Two (2) crashes during the five-year study period involved vehicles not stopping at the stop signs.

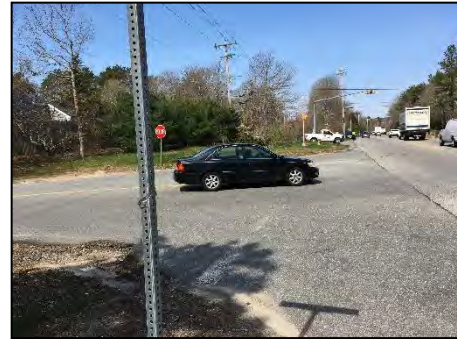
Boxberry Hill Road intersects Nathan Ellis Highway (Route 151) approximately 125 feet to the east of the Sam Turner Road / Cloverfield Way intersection. Audit participants noted that the close proximity of the two unsignalized intersections causes conflicts between turning vehicles. Vehicles will attempt to make turning movements from both Boxberry Hill Road and either Sam Turner Road or Cloverfield Way at the same time to use one of the few gaps in traffic along Route 151, potentially conflicting with each other. Further, motorists using their signal indicators prior to turning into the side streets from Route 151 can cause confusion as to which side street they are turning into. Nine (9) angled crashes during the five-year study period involved left turns exiting Sam Turner Road and colliding with through vehicles along Nathan Ellis Highway. An audit participant noted the significant number of crashes at the intersection that are under the reporting threshold but attended by the Falmouth Police Department.

Image 11: Vehicles at both northbound approaches waiting to make left turns

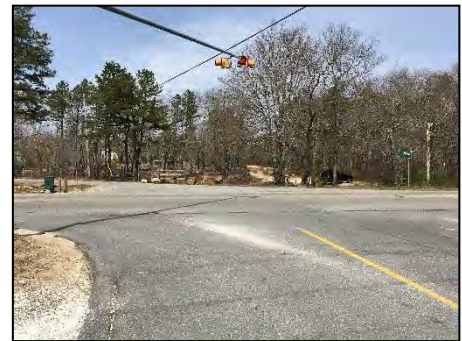
Image 12: Wide intersection approaches

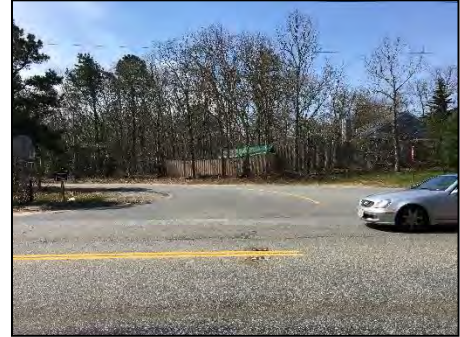
Pavement Markings – Audit participants noted that the existing pavement markings at the intersection cluster are faded especially on Sam Turner Road, Cloverfield Way and Boxberry Hill Road. All three side street approaches lack stop bars.

Image 13: Missing stop bar on Northbound Sam Turner Road approach

1. Reapply all existing pavement markings, including stop bars and centerlines, to improve motorist and pedestrian safety.
2. Reapply stop bars at Sam Turner Road, Cloverfield Way and Boxberry Hill Road approaches to define vehicle stop locations and provide adequate sight distance.
3. Replace the “Stop Ahead” word sign on the northbound Sam Turner Road approach with a “Stop Ahead” symbol sign (W1-3) to provide consistent signage.
4. Trim the vegetation from the existing stop sign locations to maximize visibility.
5. Replace all existing signs within the vicinity of the audit area that are currently faded, damaged or non-compliant with new MUTCD-compliant signs to provide clear and

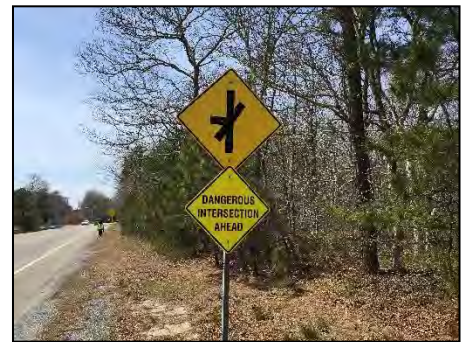
The “Stop Ahead” sign on Sam Turner Road is not consistent with current MUTCD standards and differs from the sign on Boxberry Hill Road. The “Intersection Ahead” signs on the Nathan Ellis Highway eastbound and westbound approaches are located approximately 350 feet in advance of the intersection cluster. It was noted by an audit participant that this sign should be placed approximately 1000 feet in advance of the intersection cluster. At the time of the RSA, a “Dangerous Intersection” sign was located on the westbound approach of the intersection cluster. It was noted by a MassDOT representative that this sign is not a standard MUTCD sign.

Image 14: Dangerous Intersection sign on Westbound Route 151

Remove the “Dangerous Intersection” sign from the westbound approach.	Low	Short-Term	Low	Town
Sub-Standard Multi-Modal Accommodations	Construct ADA/AAB compliant accessible curb ramps in future conditions with the addition of pedestrian infrastructure.	Medium	Long-Term	Medium	Town
	Evaluate the opportunity to construct dedicated bicycle lanes along Nathan Ellis Highway or multi-modal pathway adjacent to the roadway. With any future bicycle facilities, and should a signal be warranted, bicycle accommodations to facilitate crossing of Currier Road and Route 151 should be provided, such as bicycle detection or dedicated signal.	Medium	Long-Term	High	Town

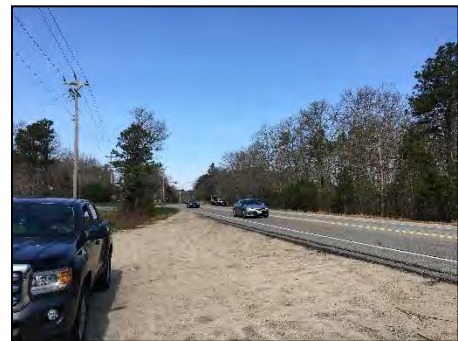
Pedestrian and Transit Accommodations – Immediately to the north of the intersection along Cloverfield Way is an access driveway to a parking area for the Frances Crane Wildlife Management Area on the northeast corner of the intersection. Audit participants noted that this parking area is heavily used seasonally. Further, audit participants noted that a dirt shoulder area along eastbound Nathan Ellis Highway is used as a parking area by visitors to the Wildlife Management Area seasonally as well, with pedestrians crossing Nathan Ellis Highway at the intersection.

Image 15: Dirt parking area on eastbound Nathan Ellis Highway

Audit participants observed this dirt area being used as a bus pick-up and drop-off location by area residents. No bus stop signage is provided at the intersection. No pedestrian crashes were recorded at this intersection.
