ROAD SAFETY AUDIT

Route 28 Corridor High Crash Locations

Town of Falmouth

December 15, 2017

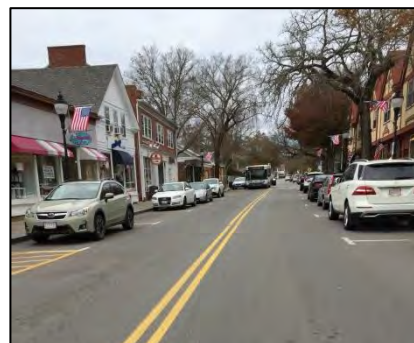
On-Street Parking (Both Sides) – On-street parking is provided consistently along both sides of Main Street for much of its length; including the segment identified as a high crash cluster. The proximity of the on-street parking and numerous curb extensions (bump-outs) at intersections provides a significant narrowing effect on the corridor segment. A narrowing effect can typically lower the speed of the roadway; however, the narrowing effect could also contribute to the increase of sideswipe crashes, not only with parked vehicles but with side-by-side vehicles traveling along Main Street as well. Furthermore, the vehicles that park along Main Street tend to park close to the crosswalks. The most substantial contribution to crashes within this short segment of roadway was related to crashes involving parked vehicles. Fifty (50) crashes within this short segment during the four-year study period involved a parked vehicle. This includes vehicles attempting to park, leaving a parking space, or being sideswiped by a vehicle within the travel lanes.

Image 1: On-street parking along Main Street.

On-street parking along the corridor is essential to the tourist commerce within the central business district; however, it has decreased the potential for other amenities such as bus turn-outs and bicycle racks. The above picture depicts a Cape Cod Regional Transit Authority (CCRTA) bus stopped within the travel lane and vehicles attempting to go around the bus, causing congestion and driver frustration.

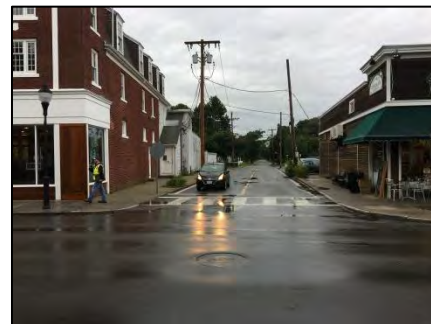
Generally, sightlines from side-streets entering the Main Street corridor have been maintained by the previous construction of curb extensions (bump-outs) and other pavement markings to shift on-street parking back from each side-street intersection. However, some locations along the corridor experience sight distance challenges. The sight distance looking east and west of Walker Street at the intersection of Main Street / Walker Street are restricted by the building structures at the corners of the intersection. The sight distance at the Post Office Road

Image 4: Intersection of Main Street / Walker Street.

intersection is restricted by heavy parking turnover and typical congestion between the Palmer Avenue intersection and Town Hall Square. Pedestrian safety at this intersection is limited due to the blind building corners. Additionally, bump-outs along Main Street are utilized as snow dumping areas during snow plowing which further inhibits the sight distances; as well as planters at several intersections that restrict sightlines during the spring and summer seasons. One (1) crash during the study period occurred at this intersection as a result of limited sight distance where a vehicle exiting Walker Street struck a Main Street vehicle.

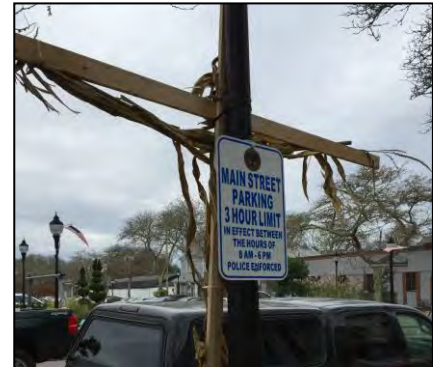
Faded, Damaged, and/or Mislocated Signage - Audit participants noted that some of the existing signs along Main Street are faded, or damaged, detracting from their effectiveness or cluttered. Additionally, an audit participant noted that the street name signs are difficult to see especially during low light conditions due to their color. In addition, some signage, such as the parking turnover signage, is temporarily misplaced for fall decorations.

Image 6: Street decorations on the sign/light posts with turned signage.

1. Complete a full sign inventory along Main Street to determine accurate placement, condition, and possible replacement of existing signs.
2. Replace all existing signs along Main Street within the audit area that are currently faded, damaged, or non-compliant with MUTCD-compliant signs to provide clear and concise regulatory and warning messages.

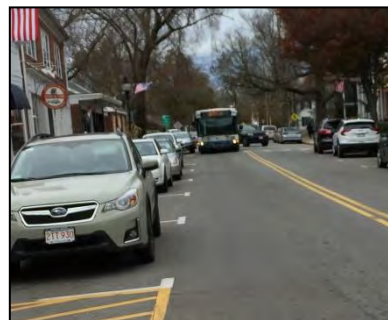
Overall, the Town of Falmouth street network does not provide for prominent alternate routes east-west separate from the Route 28 corridor. This permits heavy commercial vehicles to travel along the corridor in order to access not only the central business district; but access to Woods Hole, the retail centers, the beachfront, and other prominent municipal locations. Due to the narrow roadway nature of Main Street, heavy vehicles, buses, and trucks tend to cross over the centerline and drive in the middle of the road. In addition, CCRTA buses tend to stop within the travel lane in order to allow for riders to enter and exit the vehicle. It is not uncommon for vehicles trailing the bus to by-pass the vehicle by utilizing the opposing travel lane. Five (5) crashes within the Main Street segment involved a heavy vehicle or delivery vehicle. Additionally, due to the small size of the loading areas, the delivery trucks for the business along the corridor have to find parking and loading areas elsewhere, block multiple parking spaces, or block traffic.

Image 7: Vehicle by-passing CCRTA bus along Main Street.

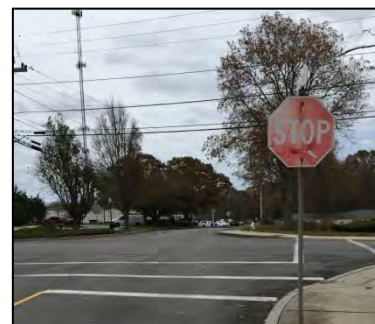
Currently, the eastbound and westbound approaches of Spring Bars Road are under stop-control, and the northbound and southbound approaches are free-flowing. It was noted during the Audit meeting that the traffic volumes along the roadways may suggest that both Spring Bars Road and Worcester Court are equally the mainline. Drivers sometimes misinterpret the traffic control as a result, assuming that their approach has the right-of-way at the intersection. This issue is exacerbated as stop-signs at the intersection are faded, and the sightlines along the corridor are extensive. Approximately 88 percent (15 of 17) of the crashes at the intersection of Spring Bars Road / Worcester Court were angled crashes. Ten (10) of the 15 crashes involved a vehicle traveling eastbound or westbound colliding with a vehicle traveling northbound or southbound. Six (6) of the crashes at the intersection were the result of a vehicle along Spring Bars Road disregarding the stop-sign by not stopping. Two (2) additional crashes at the intersection were the result of vehicles along Spring Bars Road assuming that the intersection was a four-way stop-controlled intersection and proceeding into the intersection when oncoming traffic did not stop.

Image 8: Faded stop-sign along the Spring Bars Road eastbound approach.

1. Install new MUTCD-compliant stop-signs along the Spring Bars Road approaches.
2. Consider installing an overhead flasher at the intersection of Spring Bars Road / Worcester Court to supplement the existing traffic control condition.

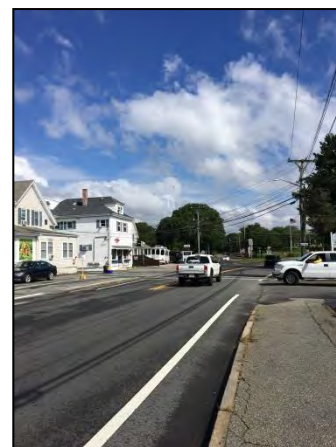
Commercial Driveways - Audit participants expressed significant concerns over the access management along the Teaticket Highway corridor. The Teaticket Highway corridor, between Stop & Shop to the south and Sandwich Road to the north, has an abundance of retail, restaurant, and commercial buildings. Each property has at least one, if not multiple, curb-cuts accessing the corridor. In addition to the number of curb-cuts, many driveways are excessively wide; do not provide visual differentiation to parking areas, with multiple curb-cut driveways; and do not provide visual differentiation to the mainline roadway. Fifty (50) of the 150 crashes along the corridor segment involved a vehicle turning into or out of a driveway. Many other crashes involved a vehicle turning into or out of one of the side-street approaches, which in many cases are indistinguishable from the commercial driveways. Finally, the corridor experienced a large number of rear-end crashes, of which many may have been a result of upstream queuing and turning movements related to the numerous corridor driveways.

Image 11: Numerous curb-cuts along Teaticket Highway.

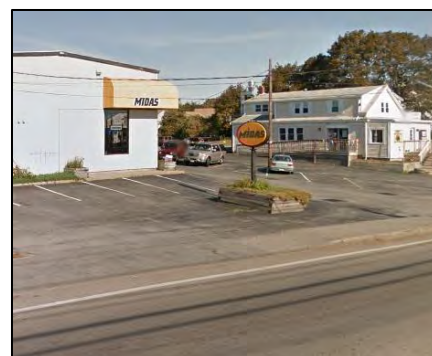
Pedestrian Accommodations – This Teaticket Highway corridor segment experiences a high pedestrian volume. Audit participants noted that pedestrians tend to cross Teaticket Highway at non-crosswalk locations to access locations on the opposing side of the roadway. This occurs mostly between Stop & Shop and the Admiralty Inn; as well as between the Falmouth Mall and the Teaticket Apartments. Throughout the corridor segment, there are numerous locations where pedestrian space is not defined between parking lots, driveways, and the general travel way. At crosswalk locations, there is a lack of advance pedestrian crossing warning signage and ADA/AAB-compliant accessible ramps. The reported crash data indicates four (4) pedestrian related crashes along the corridor within the audit area.

Image 12: Open undefined pedestrian space along Teaticket Highway.

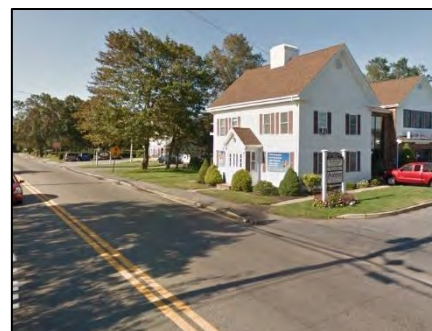
Bicycle Accommodations – Formalized bicycle accommodations are not provided along Teaticket Highway. It was observed during the RSA that cyclists travelling along the audit area were riding on the sidewalk. Audit participants noted two specific cross-section ‘choke’ points along the corridor segment where the shoulders narrow; including just north of Maravista Avenue and immediately adjacent to Town Fair Tire. The reported crash data indicates 12 bicycle related crashes along the corridor within the audit area. Nine (9) of these cyclist crashes involved a vehicle entering or exiting a side-street or driveway, both of which are numerous along the corridor. Six (6) of the bicycle related crashes involved a cyclist travelling the incorrect direction along Teaticket Highway where drivers may be unaware or not expecting the cyclist to be travelling illegally.

Image 13: Bicycle and shoulder choke point north of Beagle Lane.

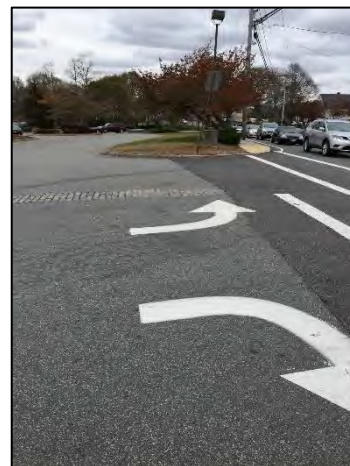
Courtesy Crashes – The crash data indicated two (2) crashes for vehicles exiting the Stop & Shop Driveway directly related to a mainline vehicle extending “courtesy” to the drivers exiting the driveway, where one driver with the right-of-way waves the side street driver to proceed even when the right-of-way may not be with that driver.

Image 14: Short exiting area from Stop & Shop Driveway.

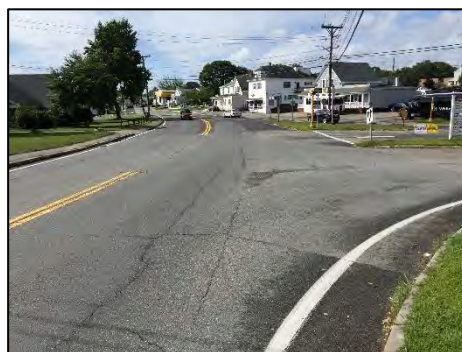
Excessive Teaticket Highway Cross-section – Adjacent to the island separating the entrance and exit of Sandwich Road, the Teaticket Highway southbound approach widens unnecessarily which promotes higher travel speeds for vehicles traveling through the intersection. In addition, it provides a longer conflict area for northbound vehicles attempting to turn left onto Sandwich Road and eastbound vehicles attempting to turn left onto Teaticket Highway. Three (3) crashes at the intersection resulted from vehicles exiting Sandwich Road and vehicles travelling southbound along Teaticket Highway.

Image 15: Open Teaticket Highway cross-section adjacent to Sandwich Road,
