ROAD SAFETY AUDIT

Falmouth Rd (Rte 28) at Iyannough Rd (Rte 132)

Barnstable Airport Rotary

May 2019

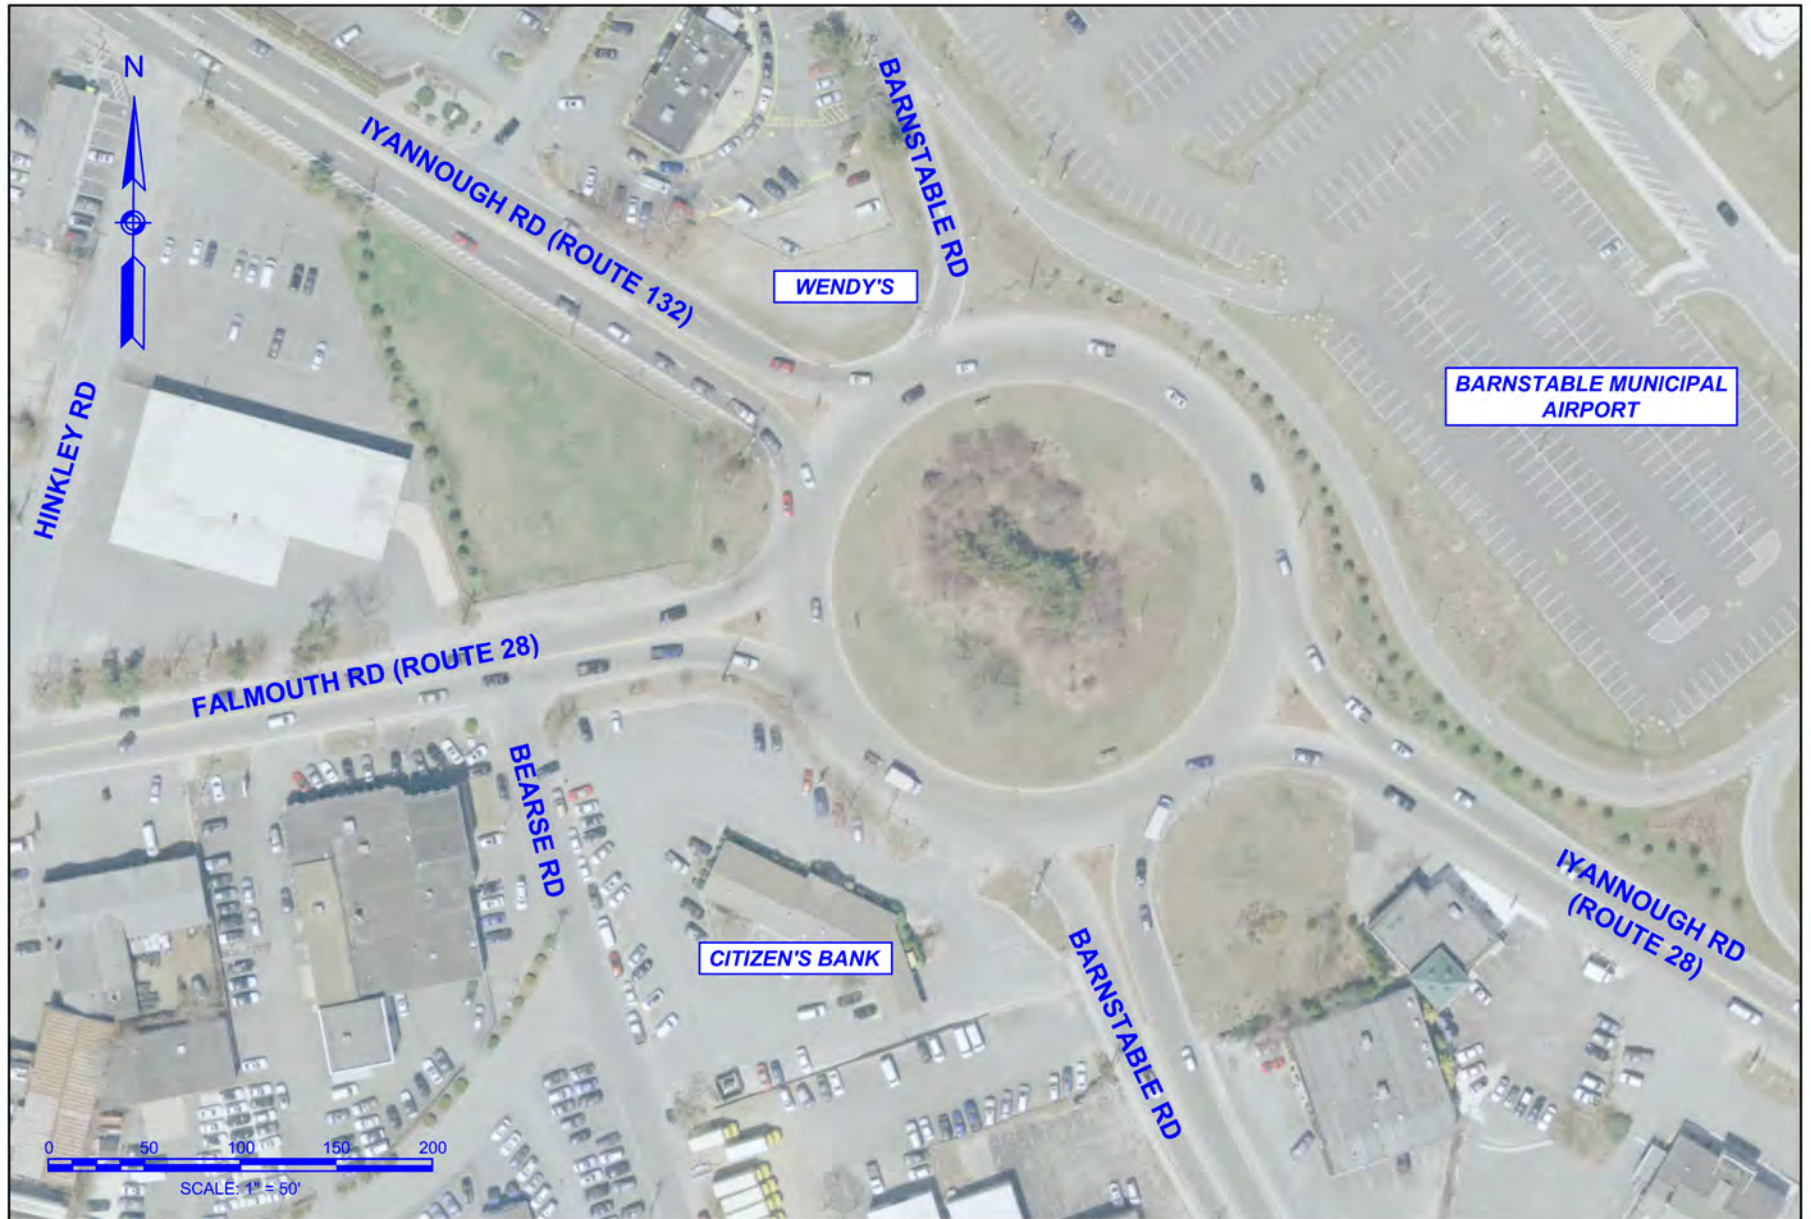
FIGURE 1
FALMOUTH RD (RTE 28) AT IYANNOUGH RD (RTE 132)
ROAD SAFETY AUDIT - AIRPORT ROTARY
BARNSTABLE, MASSACHUSETTS

As shown in Figure 1, the Barnstable Airport Rotary is a large rotary, which serves as an intersection of the following roadways:

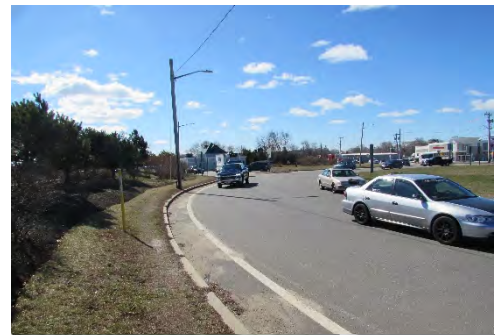
During the audit meeting, the group discussed the lack of clear lane designation and/or markings both approaching and within the rotary. In particular, Iyannough Road (Route 132) is striped as two lanes to approximately 50 feet before the rotary; at the rotary, a wide lane with no striping is provided, creating confusion on whether the lane should operate as one or two lanes. Within the rotary, there is also a lack of clear lane designation, which may contribute to vehicles exiting from the inner lane creating confusion for vehicles entering the rotary. Based on the crash data, 27% of the crashes were sideswipe in nature, which may be attributed to the lack of clear lane designation and/or markings.

Image 1: Lack of Lane Definition within Barnstable Airport Rotary

- Evaluate existing signage within the study area and consider removing unnecessary signage.
- Evaluate the existing lane and arrow pavement markings in the study area and consider alternative markings within the rotary and at approach roadways to provide clear lane designation.

- Evaluate the number of lanes needed within the rotary and provide modern roundabout markings to clarify operations and reduce the likelihood of unexpected maneuvers.

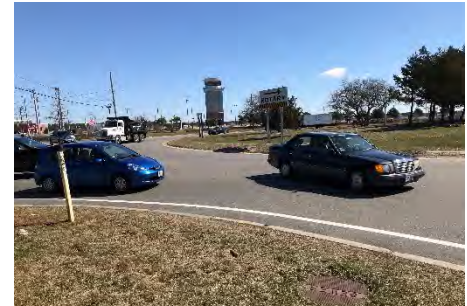
Due to the skew and/or asymmetric layout of the rotary, there are short segments where vehicles are maneuvering between entrances and exits, specifically the segment between Iyannough Road (Route 132) and Falmouth Road (Route 28) and the segment between Barnstable Road and Falmouth Road (Route 28). The high crossover volume presents a safety concern at these locations. Based on the crash data, there were 20 crashes (26%) at this crossover area between the Iyannough Road (Route 132) entrance and Falmouth Road (Route 28) exit. The majority of these crashes were angle and sideswipe in manner, and there were also several rear-end crashes as well, which may be attributable to the inter-circle vehicular crossover. There were also 4 crashes (crash numbers 5, 50, 60, 61) in the inter-circle segments between Barnstable Road and Iyannough Road (Route 28), which may be attributable to the inter-circle crossover as well.

Image 2: Inter-circle Crossover between Falmouth Road and Barnstable Road

- Evaluate the feasibility of realigning the approach roadways to eliminate the short rotary segments between approaches.
- Evaluate providing grade separation to reduce the number of roadways intersecting the rotary as recommended in the Hyannis Access Study Implementation report.

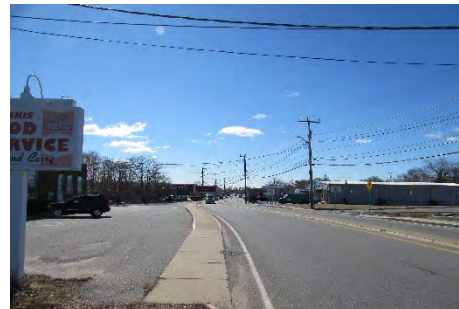
During the audit meeting, the attending emergency response personnel explained that the available width on the southern segment of Barnstable Road is restrictive and does not provide adequate space for vehicles to pull over when emergency vehicles are responding. There is a concrete median with sloped curbing in the center of the roadway and vertical curbing on the side of the roadway. The physical obstructions in conjunction with the narrow single lane width restrict access for emergency vehicles in either direction. This condition is exacerbated when queueing within the rotary is present, as noted earlier. The group identified the Airport Rotary as a major intersection connecting to Cape Cod Hospital and is frequented by emergency personnel.

Image 3: Barnstable Road Median

- Consider coordination with emergency response personnel on any potential geometric improvements to ensure that accommodations are made to facilitate emergency vehicle operations.
- Evaluate the pull-off areas along all approach roadways to ensure that there is adequate clearance for emergency vehicles to pass.

- Consider installing diagonal pavement markings within the right shoulder of the rotary, similar to the treatment on Iyannough Road (Route 132), to provide pull-off areas.
- Consider re-designing the median on the southern segment of Barnstable Road to make it traversable for emergency vehicles.
- Consider the feasibility of emergency pre-emption strategies and/or signals that could help facilitate emergency vehicle operations through the rotary.

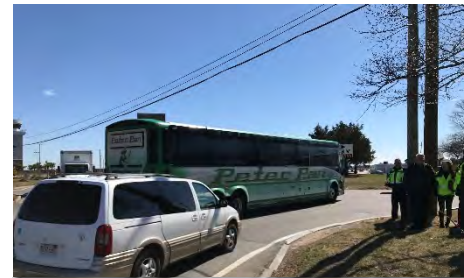
During the audit field visit, it was observed that heavy vehicles tended to encroach on the adjacent lanes while entering the rotary in order to navigate the turn. Audit participants noted that heavy vehicles tend to utilize the full width of the circulator road to navigate within the rotary. The crash data supports these tendencies as the majority of the crashes where a tractor trailer was identified (crash numbers 26, 36, 64, & 77) were sideswipe in manner, indicating that lane encroachment may be a contributing factor. The group identified that the nearby Steamship Authority Hyannis Terminal generates heavy vehicle traffic that exacerbates these issues. During the audit, tire tracks were observed in the grass area behind the curb on the corner of Iyannough Road (Route 132) at the rotary entrance, which indicates that truck encroachment is present.

Image 4: Heavy Vehicle Encroachment

- Evaluate potential alternative truck routes to divert heavy vehicles away from the rotary.
- Consider installing truck aprons or shoulders to accommodate heavy vehicle turning movements.
- Consider truck lane use guidance signage and/or pavement markings (i.e. “Trucks Use Inner Lane”) to provide clear guidance for heavy vehicles.
- Evaluate turning paths at all approaches to determine if geometry is adequate.

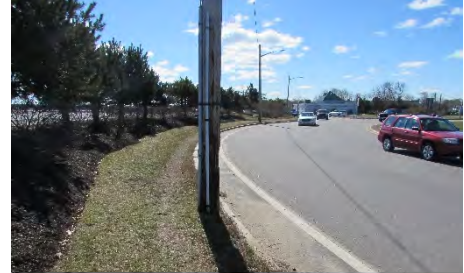
During the audit field visit, it was observed that there are no pedestrian or bicycle accommodations around the rotary, with the exception of a walkway on the Citizens Bank site between the southern segment of Barnstable Road and Iyannough Road (Route 28) approaches. There are some worn paths in grassy areas, specifically between the Iyannough Road (Route 132) and Falmouth Road (Route 28) approaches, which may indicate a pedestrian desire line. The group mentioned that there are seasonal workers in the area that walk and/or bike to work, as well as some anecdotal observations of people parking off-site and walking to the Airport. Additionally, there was a mention that bicyclists currently avoid the rotary and seek alternative routes because of uncertainty as to whether bicyclists can safely navigate the rotary. Although there were no crashes within the study area involving a pedestrian or bicycle, the desire lines should be evaluated to determine whether adequate amenities are in place.

Image 5: Lack of Pedestrian Amenities

- Evaluate the pedestrian and bicycle desire lines and consider appropriate amenities, such as sidewalks, crosswalks, rectangular rapid flashing beacons (RRFB), etc. to improve bicycle and pedestrian facilities around the rotary.
- Consider the needs of seasonal cyclists while evaluating guidance and wayfinding signage within and adjacent to the rotary to provide clear guidance.
- Consider organizing an educational campaign with handouts and suggested routes for cyclists, which would involve coordination with employers, retail shops, etc.

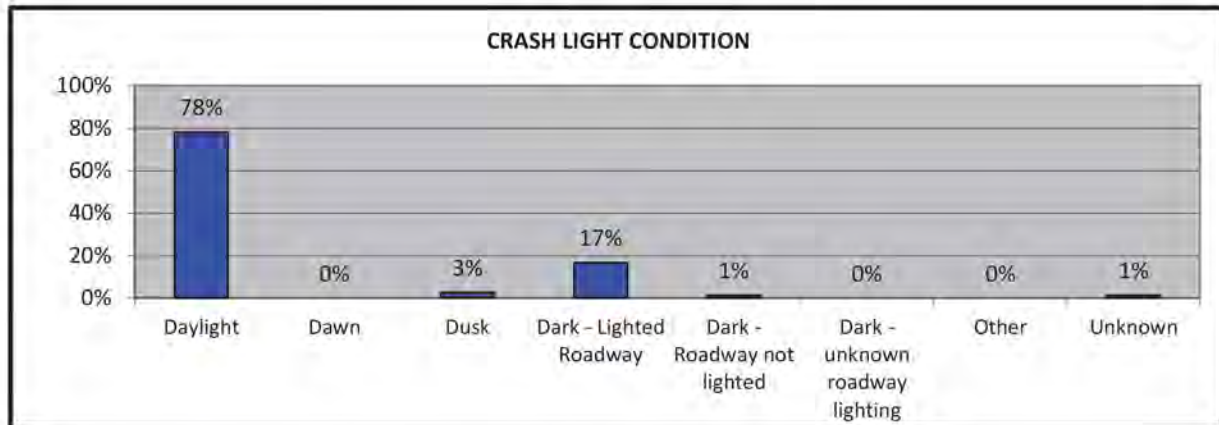
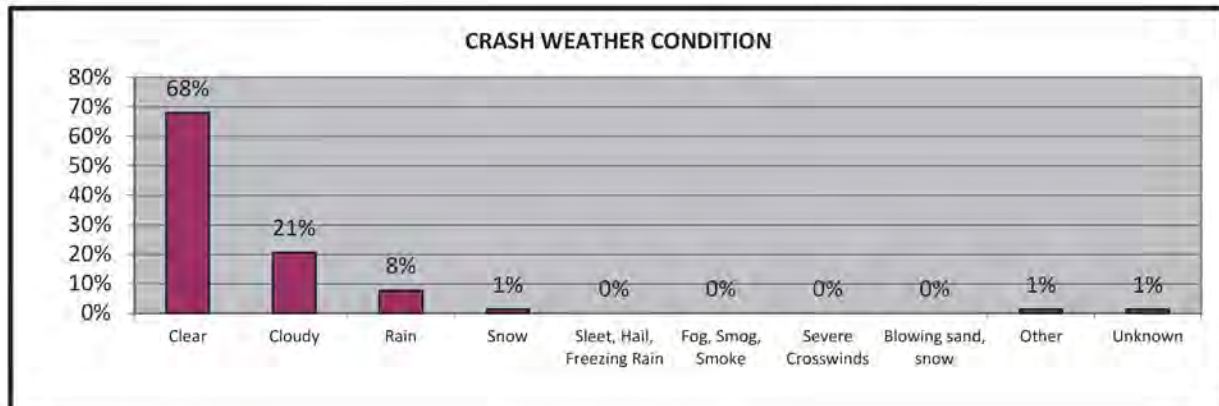
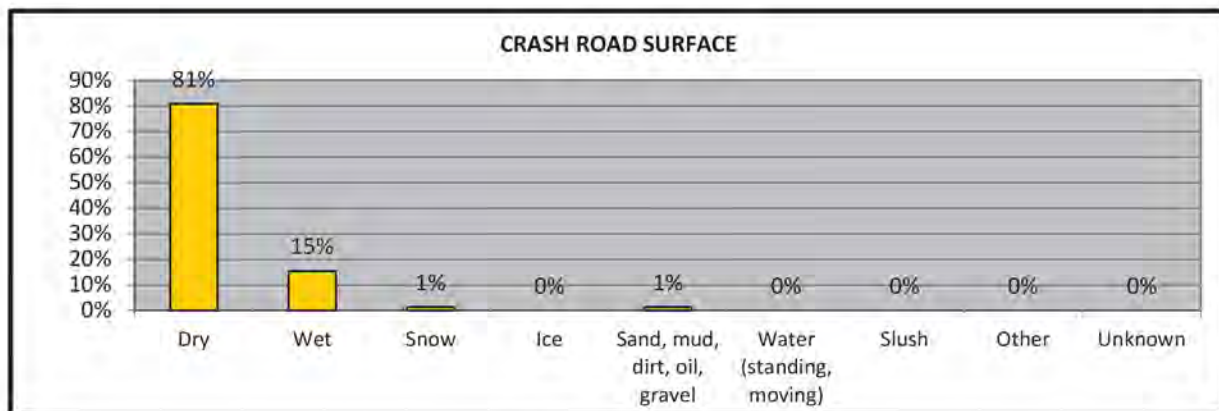
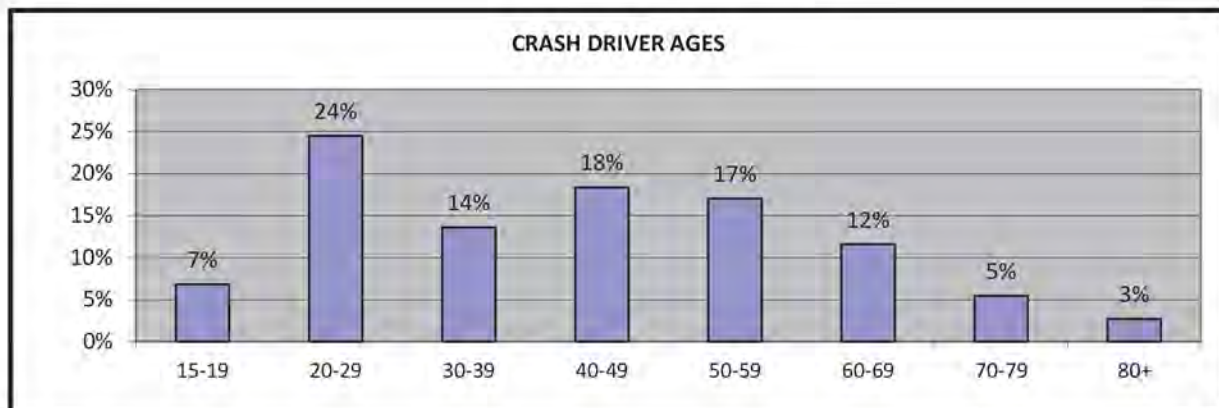
Crash Data Summary Tables and Charts

Based on the reported data, there is a decrease in crashes during the winter and spring months of December through April and then an increase from 6% to 14% in May when there is likely an increase in tourism-related traffic. The highest time period for crash activity is during the midday period between 10:00 AM and 12:00 PM when traffic volumes are heavier in the nearby retail areas and potentially due to traffic generated by Cape Cod Hospital and the Steamship Authority ferries. Based on the crash data, the 20-29 driver age group had the highest involvement in crashes (24%).
