**Route 28 Walk Audit
Yarmouth, MA**

June 28, 2018

*Sponsored by the Massachusetts Executive Office of Public Safety and Security
Planning Initiative for High-Fatality Communities*

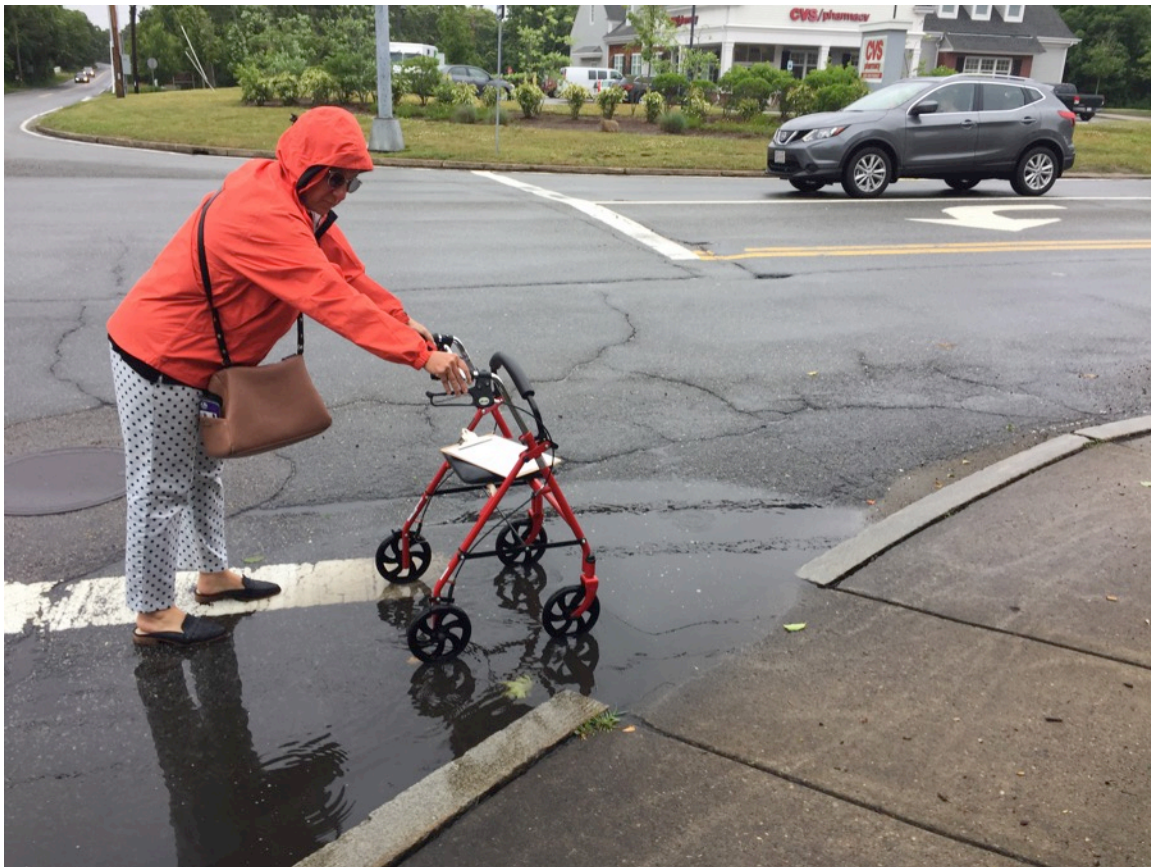
The weather conditions during the walk audit were challenging with heavy rain showers and minor flooding. These conditions provided the opportunity to see the difficulties walkers face in the rain which include pooling of water along curbs and at curb ramp locations, splash zones where water ponds on the travelway and moving vehicles splash it into the sidewalk zone, and lack of shelter from trees, awnings or bus shelters along the walking route.

Ponding at curb ramps impede access.

- Widen sidewalks based on analysis of expected number of pedestrians using the corridor. Minimum of 5 feet wide with a maximum of 10 feet wide in high pedestrian traffic zones.
- Separate the sidewalk from the curb-line where possible given right of way limitations to provide a safer, more enjoyable walking experience along Route 28. May require narrowing of travel lanes to provide more space for people walking.
- Install code compliant curb ramps with detectable warning strips at all driveways and road intersections. Ensure rainwater drains away from curb ramp entrances to eliminate ponding.

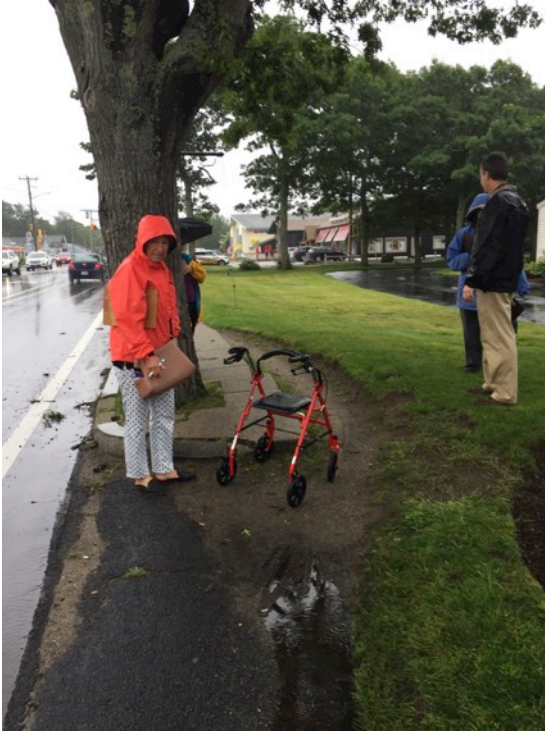
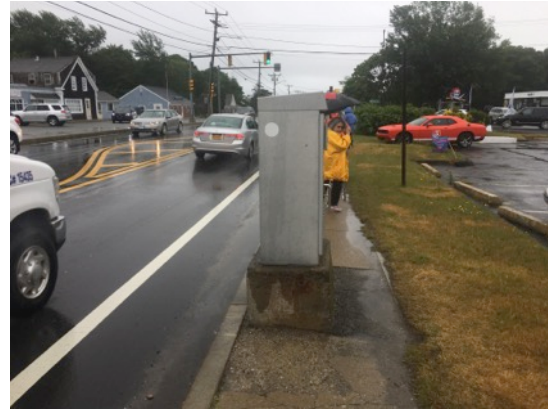
The sidewalks along Route 28 vary in width, quality and material in the study area. Sidewalks run along both sides of the walking route except on the north side of Route 28 from the Higgins Crowell intersection to the CVS driveway (approx. 76'). In general, the sidewalks average 4 to 5 feet wide and are directly adjacent to the travel way with little or no separation from the curb. Sidewalks were made of either asphalt or concrete. Concrete tends to be associated with more recent development or property renovation. Some sections of the sidewalk have obstacles

including uneven pavement, tree roots, and trees narrowing the already minimal sidewalk width.

Trees and utility boxes limit sidewalk width.

- Build a sidewalk from the Higgins Crowell intersection to CVS complete with compliant curb ramps and detectable warning panels.
- Replace heaving concrete panels and patch uneven or cracked asphalt to improve sidewalk surface smoothness.

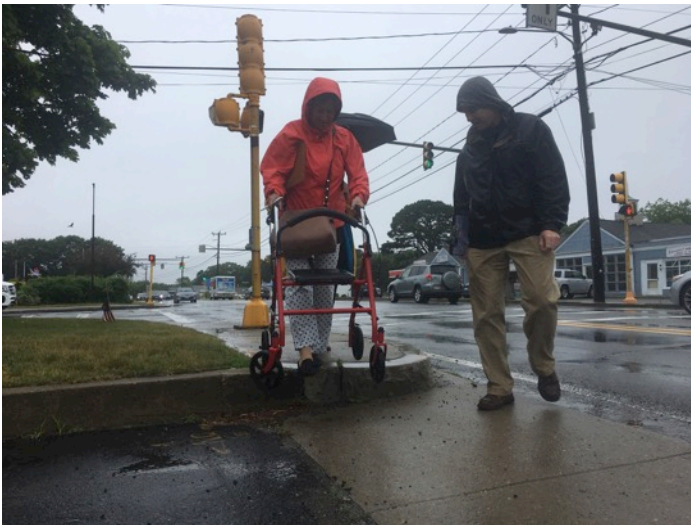
Curb ramps are not accessible (don't meet ADA requirements), if in place at all. They are missing at the signalized intersections along the walking route, such as at Route 28/South Sea Ave and Route 28/Winslow Gray Road, as well as many of the cross streets. MassDOT recently repaved and repainted a section of Main Street (Route 28) without bringing the curb ramps up to code. While this may be technically allowable, it is not a best practice. Rain was collecting in front of many of the ramps, which would force someone in a wheelchair to traverse deep puddles or stay in the roadway. Detectable warning strips were missing throughout the corridor.

Example of a typical curb condition along Route 28.

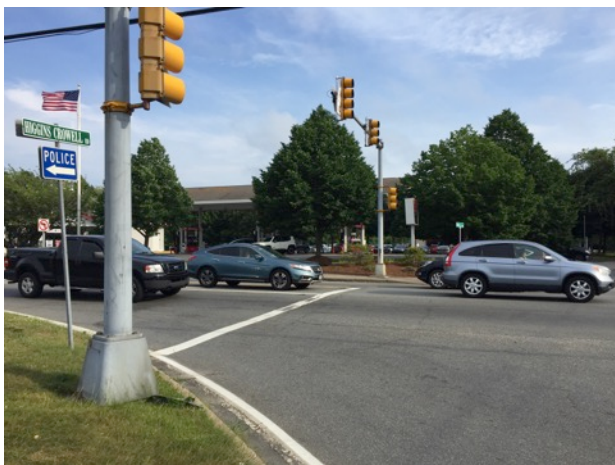
Crossing Route 28 on foot is challenging. Within the study area (which is 1.1 miles long), there were only 2 signalized intersections. Both were equipped with pedestrian signal heads, but crosswalks were missing across some approaches in both locations. At the Higgins Crowell/Route 28 intersection, the crosswalks are missing across the north side of Higgins Crowell and the east side of Route 28. This is most likely due to the incomplete sidewalk network in this area. The Winslow Gray Rd and South Sea Ave signals seem to be designed as one intersection despite the fact that the roads are offset with crosswalks approximately 325' away from each other. While this design may be acceptable for vehicular travel, it reduces the number of opportunities people have to cross and may promote risky pedestrian behavior.

No crosswalk across Route 28 at the Higgins Crowell intersection.

- Install crosswalk markings and appropriate ramps at all approaches at signalized intersections.
- Consider painting crosswalks at un-signalized intersections, particularly those that have (or could have based on destinations) high volumes of pedestrians crossing.

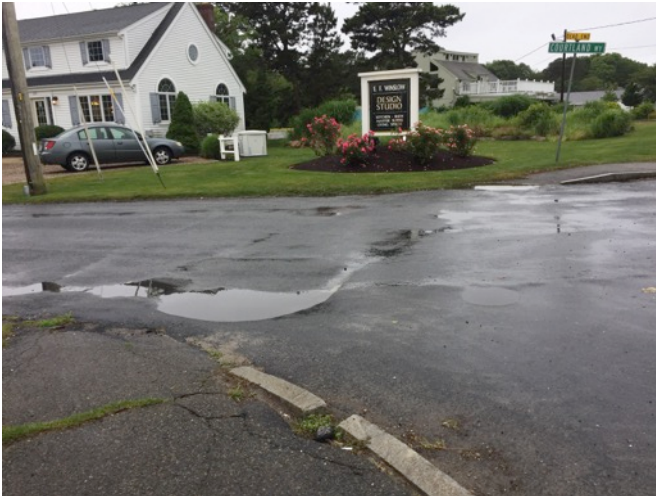
Crosswalks are not painted across the town-owned streets that intersect Route 28. Although more crosswalks require more maintenance, their presence would show a commitment to the safety of people walking. Yarmouth does not control the right-of-way at these intersections and, therefore, it does not have jurisdiction or funding to paint additional crosswalks. The town could extend sidewalks from the intersections down the street and install curb ramps and crosswalks, but at their expense and dependent on MassDOT approval.

Crosswalks are not painted across town-owned streets that intersect Route 28.

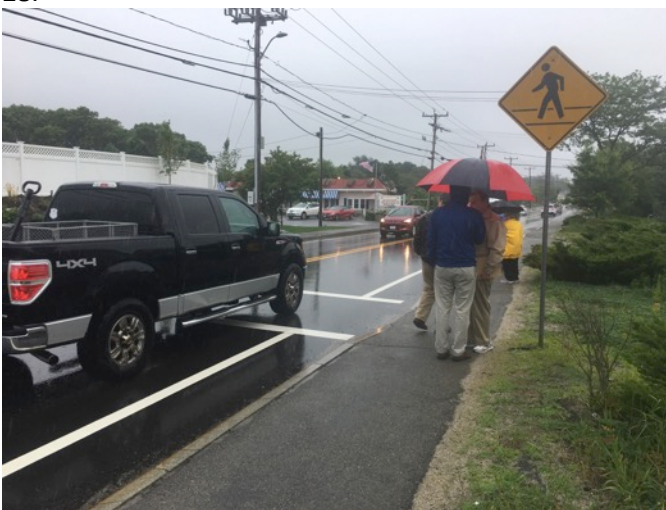
The lack of mid-block crossings on Route 28 promotes the dangerous practice of crossing between gaps in traffic. There is one mid-block crosswalk located in front of the Inflatable Water Park. It is left over from a previous development pattern that facilitated crossing to a Dunkin Donuts. The Inflatable Water Park asked to move the crosswalk to its entrance, but was denied due to a permit infraction. Property ownership and destinations will change over time. A regular pattern of mid-block crossings, complete with appropriate signage based on both destinations and distance, would provide safer crossings at more regular intervals across Route 28.

Mid-block crossing in a location that no longer connects destinations.

- Evaluate the Route 28 corridor and determine locations of additional mid-block crosswalks to safely link destinations across Route 28. Establish a rhythm of marked crossings that provide safer access and increase driver awareness of people wanting to cross the road.
- Consider installing Rapid Rectangular Flashing Beacons (RRFBs) at key mid-block crossings along Route 28 to maximize visibility of pedestrians.

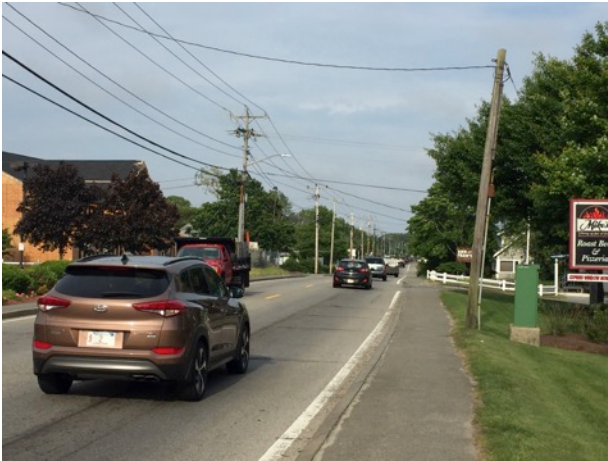
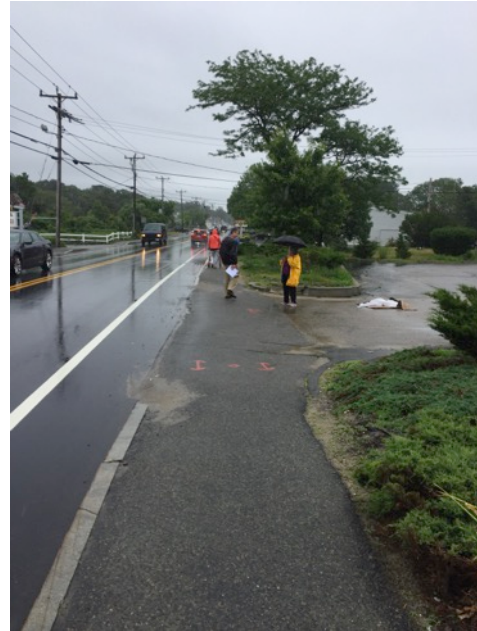
The travel lanes are wide along Route 28 (approximately 28' wide from curb-to-curb). Fog (or edge) lines are painted up against the curb or within a foot of the curb throughout the corridor. Pavement markings indicate a passing lane along some portions of the stretch (dashed yellow centerline). Consistent fog lines could be used to narrow travel lanes to 10 or 11 feet without moving curbs and drainage.

Examples of different fog line treatments.

- Repaint dashed yellow centerline with double yellow lines assuming passing is not allowed in this zone.
- Paint consistent fog lines to delineate narrower travel lanes (between 10 to 11 feet).

- Evaluate width right of way to determine if bike lanes can be added to further narrow the travel way and encourage cyclists to use the roadway rather than the sidewalks.
