CAPE COD
COMMISSION

Route 6 Hydroplaning Crash Analysis and Alternatives Development

Bourne, Sandwich, Barnstable, Yarmouth,
Dennis, Harwich, Brewster and Orleans

October 2013

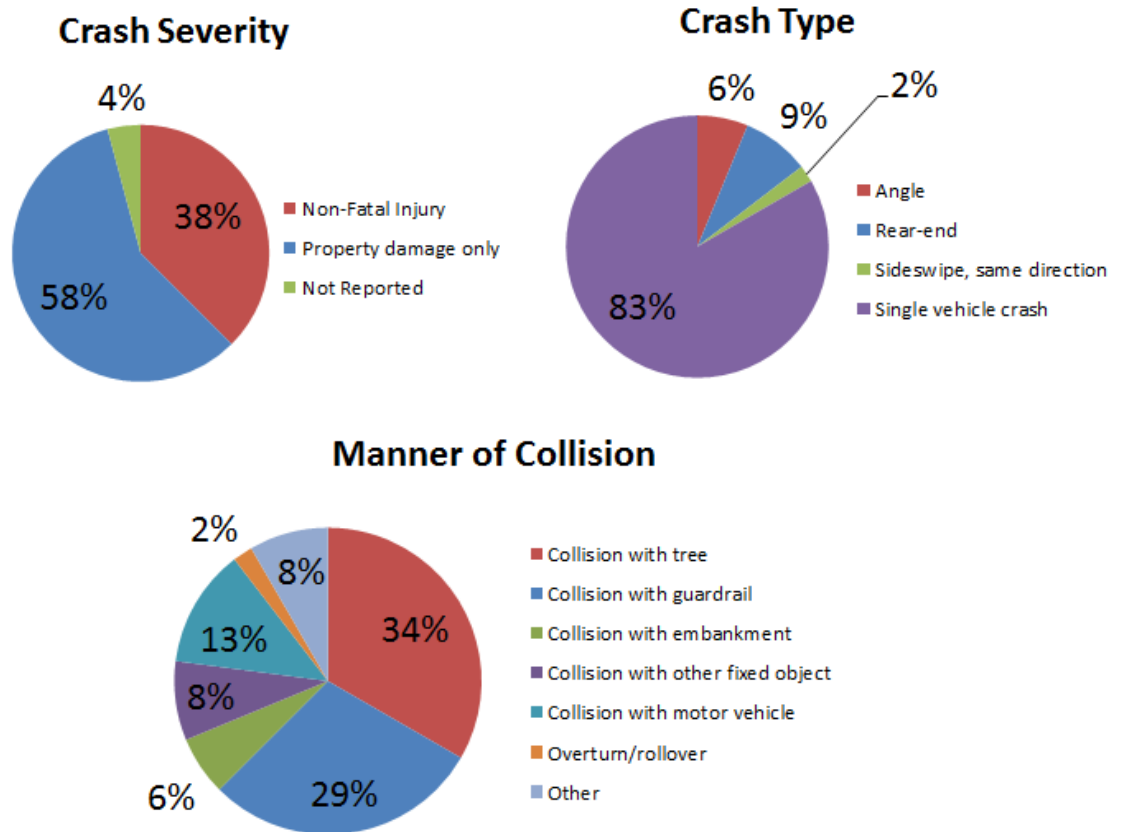
FIGURE 3: ANALYSIS OF WET WEATHER CRASHES UNRELATED TO RAMP TRAFFIC

The most common crash type among the 48 crashes not occurring near ramps was a single vehicle run-off-the road crash that resulted in a collision with a tree, guardrail, embankment, or other roadside feature. Key characteristics of these crashes are shown in Figure 3. Of great concern is the high number of injury crashes among this set of crashes.

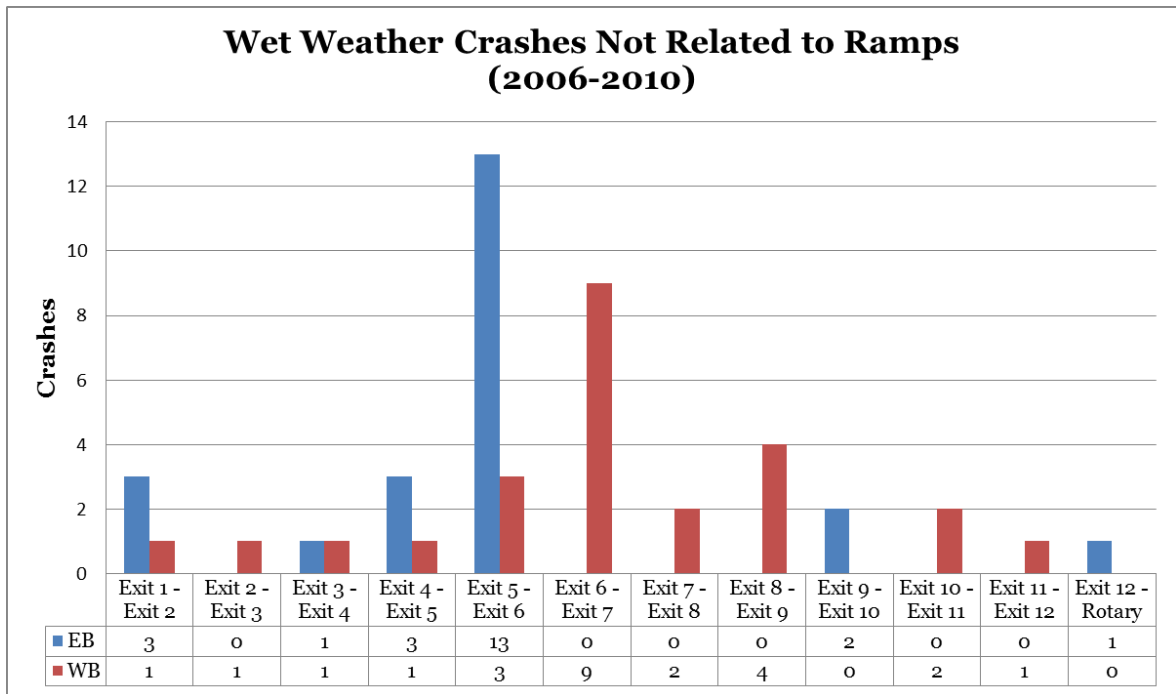
FIGURE 4: LOCATION OF WET WEATHER CRASHES UNRELATED TO RAMP TRAFFIC

Looking at the locations of the wet weather crashes not related to on or off ramps a number of high crash segments are clearly identifiable. As shown in Figure 4, the segment of Route 6 eastbound between Exits 5 and 6 has the highest number of crashes with 13 crashes, and the eastbound segment of Route 6 between Exits 6 and 7 being the next highest with nine crashes. It should be noted that the lack of crashes on a segment does not necessarily suggest there is not a hydroplaning problem on the segment of Route 6. Factors such as design elements of the specific roadway could result in drivers being able to recover from hydroplaning incidents without ever being involved in a crash.

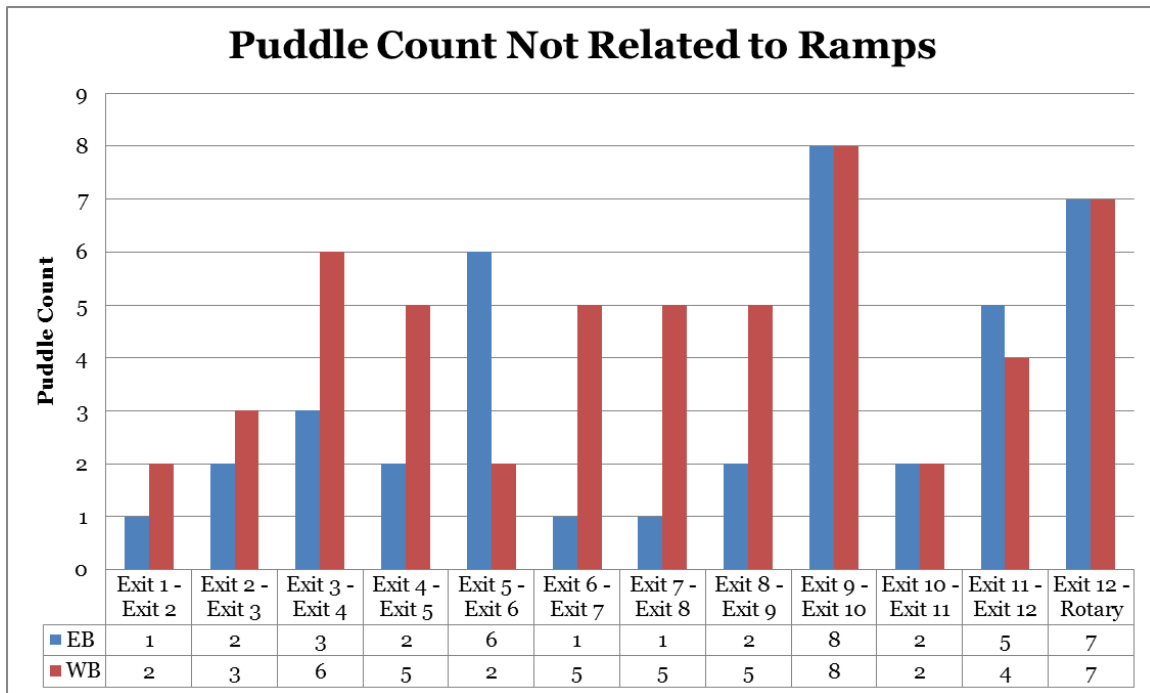
FIGURE 5: PUDDLE COUNT DURING RESEARCH STUDY PERIOD (JUNE – AUGUST, 2013)

To further investigate locations where hydroplaning may be resulting in unsafe locations, a field investigation of ponding conditions during rain events was conducted during the summer of 2013. The intent of this “puddle inventory” was to identify locations where there may or may not be a documented crash history, where ponding is resulting in conditions that could result in hydroplaning incidents. A complete description of puddle inventory methodology is provided in Appendix B of this report. The degree to which ponding is present in the roadway is a function of both the duration and the depth of rain that falls in a specific period of time, also referred to as intensity. The puddle inventory covered rain events varying in both duration and intensity. Overall, the puddle inventory was developed during rain events that resulted in 0.6 to 2.8 inches over a 24 hr. period of storm event. Figure 5 and Figure 6 present a summary of results for the puddle inventory considering the eastbound and westbound direction of Route 6 between each exit.
