Emblem-Hyannis Restoration Plan Barnstable, Massachusetts

December 8, 2022

Prepared By: ILEX Environmental, Inc.

Prepared For: Quarterra 99 Summer Street, Suite 701 Boston, MA 02110

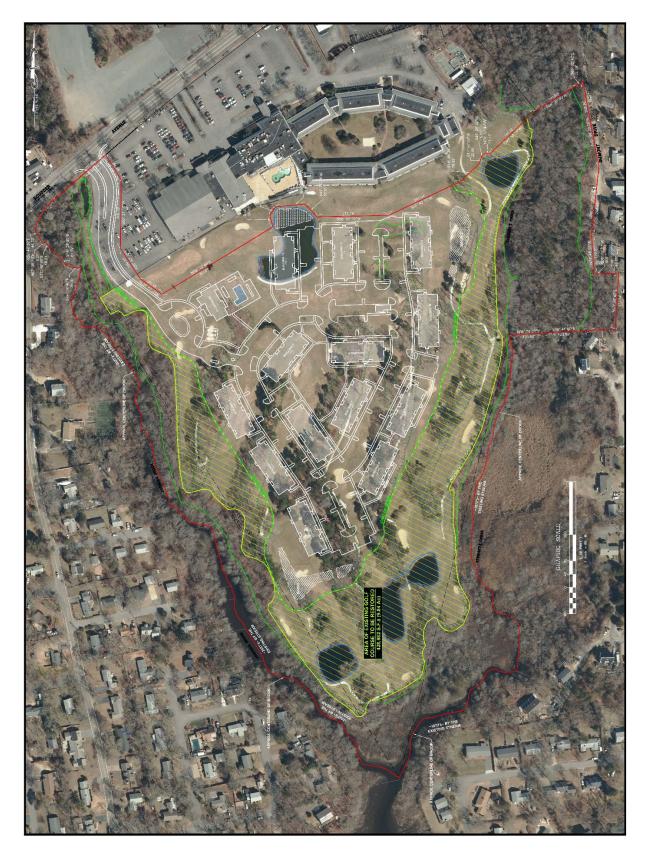
Figure 3: Revised Layout over Aerial Photo

The Emblem-Hyannis Restoration Plan provides an outline of work proposed for the restoration of approximately 9.8 acres of land that is presently an active golf course (see Figure 1) as mitigation for the redevelopment of the site. These 9.84 acres will be part of the 20.11 acre open space area that will be protected under a Conservation Restriction (see Figure 2). The restoration area is located between the main tree line which parallels both Joshua's Brook and Stewart's Creek and the limit of the proposed development. The remainder of the CR is vegetated with forested areas, wetlands, and waterways. The revised site plan which clusters development away from the wetlands is shown in Figure 3.

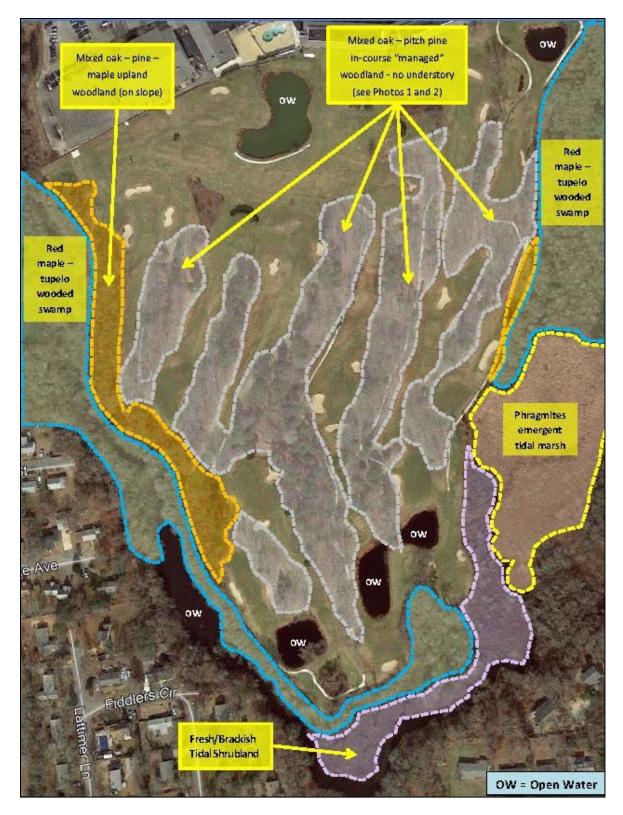
Figure 4: Vegetative Cover Types

The topography of the Site is relatively flat (from clearing activities to build the golf course), with some small hills, ranging in surface elevation from approximately 35 feet in elevation above mean sea level (MSL) at the high point near the center, to approximately to 5 feet in elevation along the southeastern side near Stewart's Creek. There are moderate to steep-sided slopes between the uplands and wetlands adjacent to the two perennial streams. The southern tip of the Site is approximately 2,100 feet north of the mean high water line at Hyannis Harbor. The wetlands at the Site are freshwater transitioning to a more estuarine (i.e., salt water) habitat to the south of the Site and are likely freshwater wetlands that are tidally influenced. This section describes the upland and transitional wetland habitats observed at the site which will be used to help guide the type of restoration to be designed. Photographs of existing conditions are provided in Appendix A. A general vegetation cover type map is provided as Figure 4.

The majority of the Site is a golf course that includes all of the highly managed play areas and landscape features, both vegetated and unvegetated, that typically occur at a golf course including tee boxes, fairways, greens, and roughs (all of which are frequently mowed and irrigated), also sand traps, paved and unpaved cart paths, water features (or "hazards"), and small service structures. In addition to the highly managed play areas, upland cover types include managed woodland "in course" and pitch pinemixed oak woodland as described below. The restoration involves areas that are presently managed turf, sand traps, and buffer areas between managed areas and natural areas.

- Managed Woodland "in-course": Open woodland areas are managed within the golf course that serve as boundaries between many of the numbered fairways. These woodland areas are of various widths and consist primarily of mature hardwood trees with lesser amounts of coniferous trees. Scarlet oak (*Quercus coccinea*) is the predominant hardwood species and pitch pine (*Pinus rigida*) is the predominant coniferous species. Other than mowed grass, a woody understory within these woodland areas is absent.

- Pitch Pine-Mixed Oak Woodland: The only unmanaged upland cover type at the golf course is the pitch pine-mixed oak woodland, which comprises only relatively small and narrow portions of the Site. This cover type of comprised of mature, second-growth oak with scattered pines. This cover type is located between the wetlands along Joshua's Brook and the west margin of the golf course and between the wetlands along Stewart's Creek and the east margin of the course. This cover type has a canopy of pitch pine and tree oaks such as black oak (*Quercus velutina*), scarlet oak, chestnut oak (*Q. prinus*), and white oak (*Q. alba*), with blueberries (*Vaccinium angustifolium* and *V. pallidum*), black huckleberry (*Gaylussacia baccata*), and other ericaceous shrubs forming an often continuous low shrub layer.

This vegetation cover types found in the wetlands at the Site including red maple-tupelo wooded swamp, phragmites emergent tidal marsh, and fresh/brackish tidal shrubland (scrub-shrub emergent tidal marsh). Wetland resources form the Site's eastern, western, and southern boundaries. Generally, the transition from golf course and other upland areas to wetland habitat in most areas of the Site is abrupt due to existing, moderate to steep-grade slopes and golf course management practices.

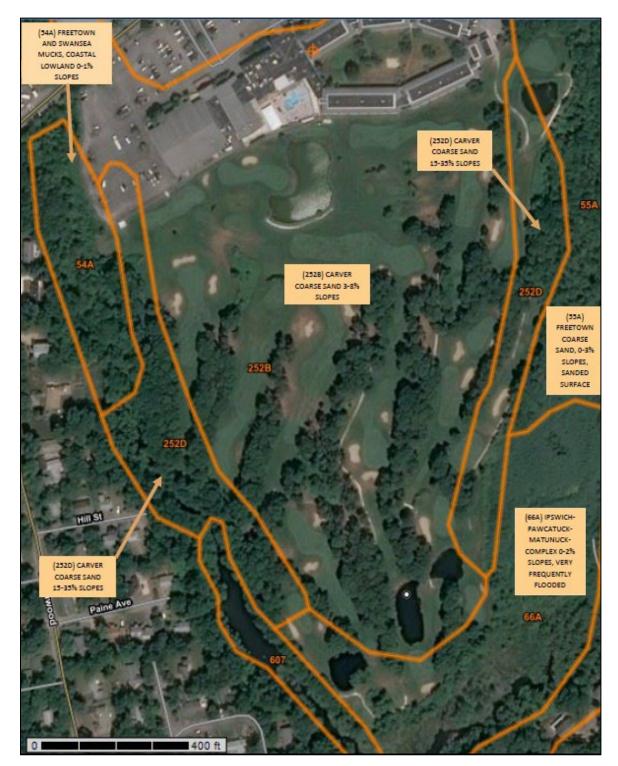
Figure 5: Soils

According to the USDA Natural Resource Conservation Service (NRCS), soils at the Site are comprised primarily as Carver coarse sand for upland areas and as either Freetown coarse sand or Freetown and Swansea mucks for wetland areas along both stream corridors (see Figure 5). For the wetland habitat at the most southern end of the Site, the soil type is mapped as Ipswich - Pawcatuck - Matunuck complex

(0-2% slopes, very frequently flooded). Soil profile observations made during wetland delineation efforts were generally consistent with the descriptions of these identified soil types. None of the soil classes identified for the Site are defined as Prime Farmland, Farmland of Unique Importance, or Farmland of Statewide Importance.

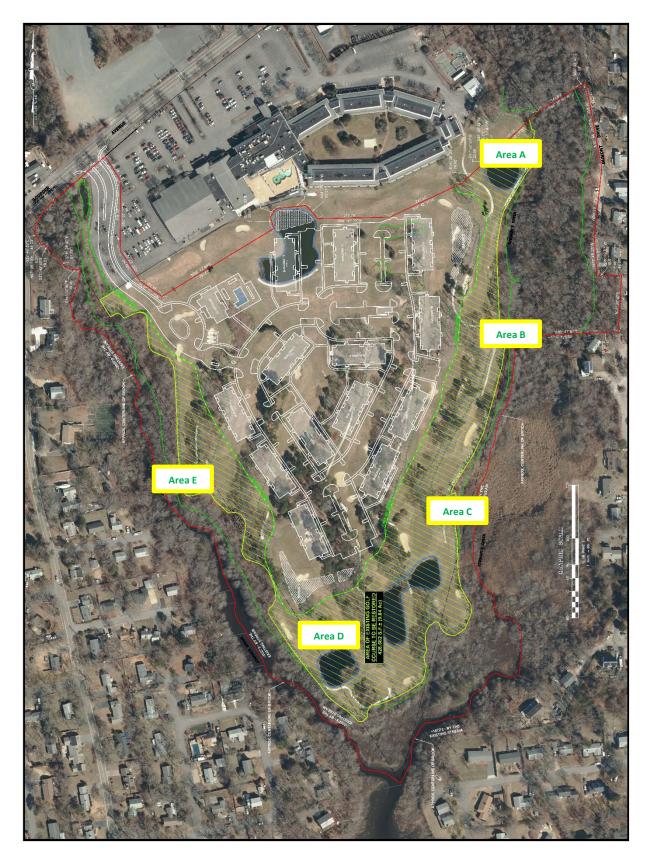
Figure 6: Management Areas

In order to determine what restoration treatment is to go in what location, we have identified five management areas as described below. Each management area typically includes all or some of the typical features found in a golf course (i.e., tees, fairways, roughs, bunkers, water hazards, cart paths, buildings, putting greens, etc.) Each feature may require specific treatment depending on conditions in the field such as soil compaction, soils chemistry, type of vegetation present including grass used for the different parts of a course, removal of subsurface irrigation, removal of buildings or other structures, etc. This section describes the management areas and the restoration of different habitats. The 9.84 acres has been divided up into five areas (Area A through Area E) as shown on Figure 5. Oblique aerial photos are included for each of the management areas to show more detail of what existing conditions are. These photos are provided in Appendix B. The following table provides an overview of the treatment proposed based on the existing golf course feature.

Golf Course Feature	Acreage	Treatment Proposed
Tees and Greens	1.88	 Removal of grass Aeration of surficial and subsoils Removal of gravel drainage material if appropriate Removal of piping if present Planting of trees and shrubs
Fairways	2.15	 Removal of grass if considered invasive Determine if surficial and subsoils need aeration Regrade if needed for more natural landscape Planting of trees and shrubs
Roughs	2.85	 Allow to revegetate naturally where native grasses are present If any of the roughs contain invasive grasses, treat like fairways
Bunkers/Sand Traps	0.27	 Determine if areas are compacted, aeration if needed Maintain some sand traps for diversity of habitat, possible turtle nesting areas if any individuals are nearby
Managed Woodlands	1.46	 Determine if areas are compacted, aeration if needed Plant some understory Allow remainder of understory to revegetate naturally Manage for invasive species

Water Hazards/Ponds	0.92	 Allow edges and buffer zones to revegetate naturally Supplemental plantings of shrubs and trees Allow for access to ponds edge in limited areas Manage for invasive species
Cart Paths	0.31	 Allow unpaved cart paths to remain as walking trails Remove pavement from paved cart paths and replace with gravel or other similar suitable material If necessary, remove compacted soils in areas where walking trails are not needed or need to be relocated Allow natural vegetation to grow along edges of cart paths for a more natural experience Maintain walking trails per recreational specifications (to be determined)
Structures	NA	Maintain existing structures which may be used in association with possible recreational trails
TOTAL	9.84 acres

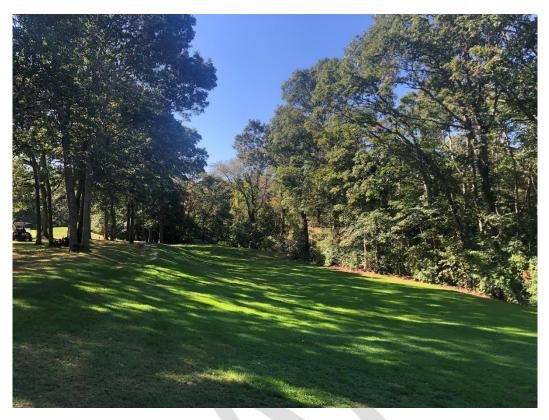
Looking south toward the tee at the 17th hole across the fairway.

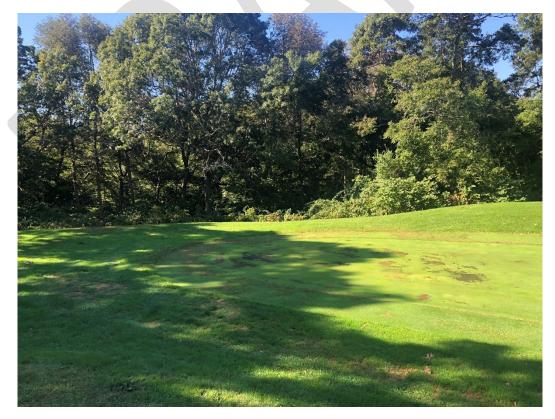
Looking at the 16th putting green with western tree line in the background.

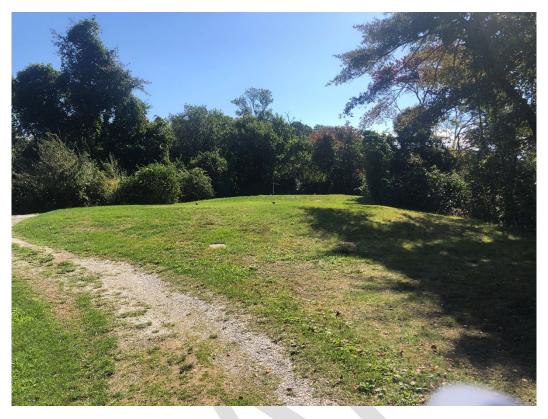
Looking to the southeast toward the 14th tee from cart path.

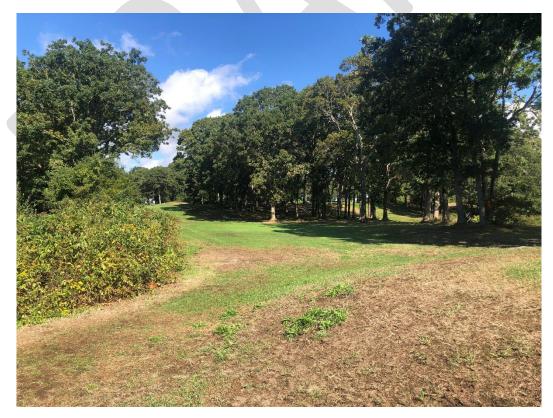
Looking north toward the $14^{\rm th}$ putting green across the fairway (between two ponds).

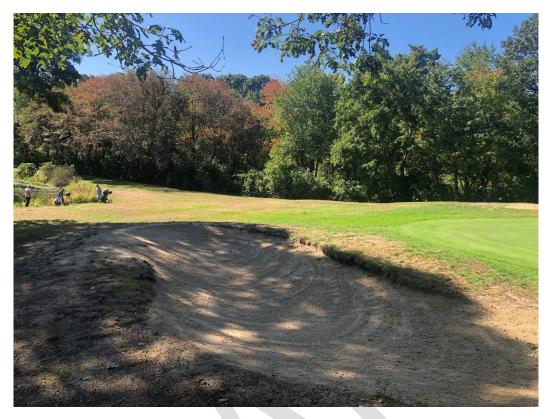
Looking south from the 13th putting green over sand trap.

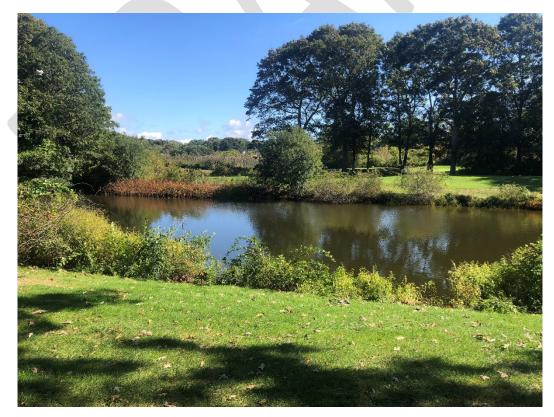
Looking to the east from 12^{th} fairway towards the 5^{th} and 6^{th} holes.

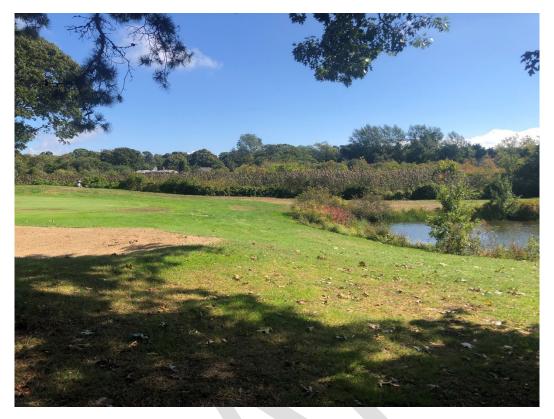
Looking east toward the 6th putting green.

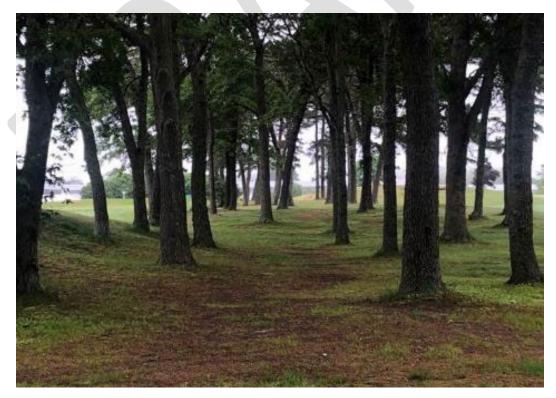
Looking north through managed woodlands.
