ROAD SAFETY AUDIT

Route 28 (Falmouth Road) at Strawberry Hill Road
Town of Barnstable

May 2015

Prepared By:
McMahon Associates, Inc.
300 Myles Standish Blvd. Suite 201
Taunton, MA 02780

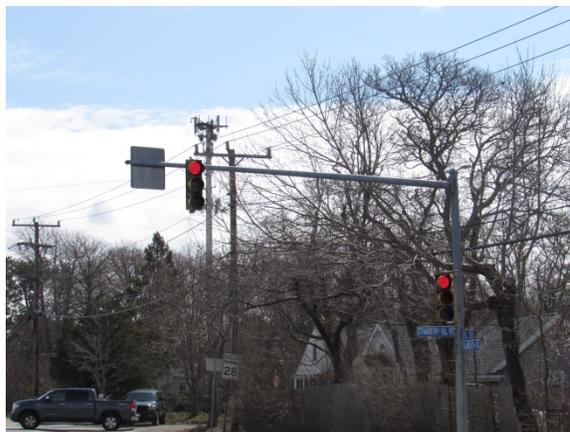
Lack of Backplates on Existing Signal Heads

In regards to the signal visibility, it was mentioned that the solar glare, specifically in the eastbound and westbound directions, presented a safety concern. During the site visit, the RSA team witnessed that the signal heads are lacking backplates, which improve the visibility issues pertaining to solar glare. Crash data supports solar glare potentially being an issue, as 38% of crashes occurring at this intersection are during the 4 pm to 6 pm time frame, when solar glare is at a maximum. In addition, review of the crash data presented a recurring issue of rear-end crashes, which accounted for six (38%) of the total crashes. The significant amount of rear-end crashes in the eastbound and westbound directions appear to coincide with the fact that the signal heads are lacking backplates.

- Install backplates with reflective borders for overhead signals to minimize the effects of solar glare.
- Install advance warning signage on all approaches.

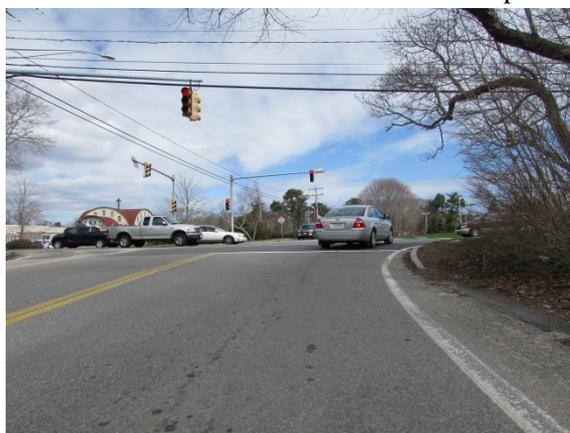
During the RSA discussion, some members of the team provided insight on the current alignment of the northbound and southbound approaches of Strawberry Hill Road at the intersection with Route 28. The concern focused on the offset of the roadway at the intersection and the perception of drivers that they may be directed toward the opposing lanes as they approach the intersection. Another discussion point related to the visibility of signal heads, specifically on the northbound and southbound approaches to the intersection, which is impacted by vegetation encroaching on the roadway.

Sight distance at the intersection was also raised as an issue by several RSA participants. From the northbound approach, the sight distance is impacted by vegetation on the southeast corner that is encroaching onto the roadway, as well as the uphill grade on the northbound approach. In regards to the southbound approach, there is a horizontal curve at the intersection of Strawberry Hill Road and Wequaquet Lane, which impacts the sight distance of drivers approaching the intersection.

Roadway Alignment and Grade from Strawberry Hill Road Northbound Approach

- Evaluate lane and/or roadway alignment for both Strawberry Hill Road approaches of the intersection to improve sight distance and reduce the risk of head-on collisions.
- Install an Intersection Ahead (or Signal Ahead) warning sign on the southbound approach, prior to the horizontal curve.
- Consider trimming the vegetation within the roadway right-of-way on the Strawberry Hill Road northbound approach to improve visibility.
- Evaluate the feasibility of obtaining easements for vegetation trimming on private property along the northbound approach of the intersection to improve visibility.
- Evaluate existing right-of-way restrictions and proposed widening improvements where feasible to create a consistent cross section along Strawberry Hill Road, specifically the northbound approach of the intersection.

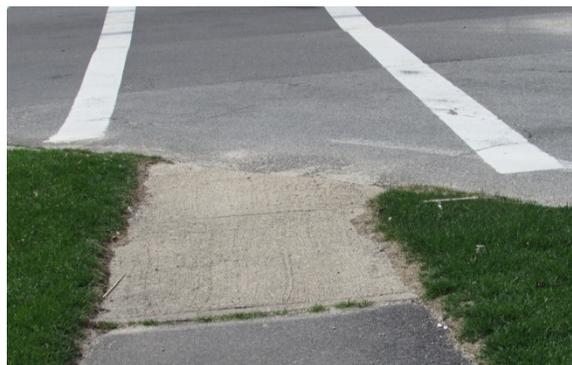
Observations made during the RSA indicate that the intersection is lacking pedestrian amenities, including pedestrian signals and sidewalks on the northern side of Route 28. Another observation was made regarding the lack of tactile pads on the existing handicapped ramps. It was also mentioned that the residential neighborhoods on the north side of Route 28 lack pedestrian connectivity due to the lack of pedestrian

Existing Crosswalk Markings and Ramp

- Evaluate ramps for compliance with ADA standards.
- Install pedestrian signals and push button actuation at the signalized intersection.
- Evaluate the installation of crosswalks on the southbound and eastbound legs of the intersection.
- Construct sidewalks adjacent to the intersection to help guide pedestrians around the traffic signal and provide improved access to the church located in the northwestern quadrant of the intersection.
- Consider improvements of the mixed use path at the southeast corner of the intersection on Route 28.
- Evaluate crosswalk signage and pavement markings to ensure that they are visible.
- Evaluate “STOP” sign height on southwest side of the mixed use path.
- Evaluate lighting along the mixed use path to provide additional safety for pedestrians and cyclists.

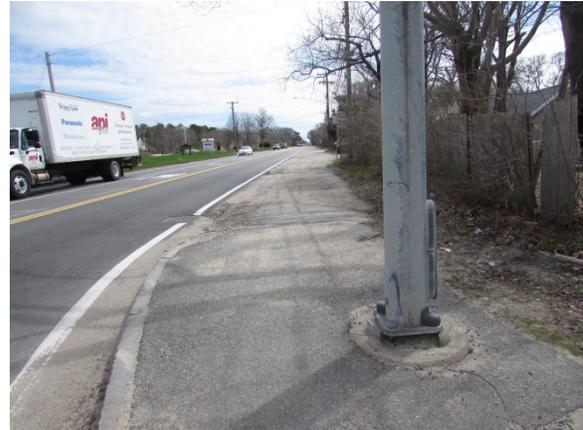
In regards to the mixed use path, the section that is located on the eastern side of the intersection exhibits poor conditions and the lack of curbing presents a safety concern. During the field visit, it was observed that the mixed use path stop sign height may present an issue for cyclists crossing the southern leg of the intersection. The group also recognized the lack of lighting along the mixed use path and raised that as a safety concern.

Mixed Use Path on Southeastern Corner of Route 28 and Strawberry Hill Road Intersection

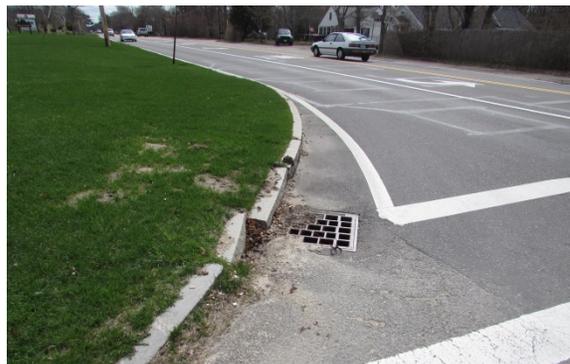
During the site visit portion of the RSA, the team observed the conditions of the existing roadway. In general, the pavement conditions at the intersection of Strawberry Hill Road at Route 28 did not appear to exhibit significant signs of distress. However, some of the observations were related to the conditions of the pavement markings on the approaches on Strawberry Hill Road. In addition, there was a portion of curbing that appeared to be damaged on the northeast corner of the intersection.

Curbing Damage on Northeastern Corner of Intersection

- Evaluate existing pavement markings and consider re-striping the approaches from Strawberry Hill Road to ensure visibility.
- Repair or replace the damaged curbing on the northwest corner of the intersection.
- Encourage coordination between Barnstable Department of Public Works and MassDOT for snow plowing activities at the intersection.

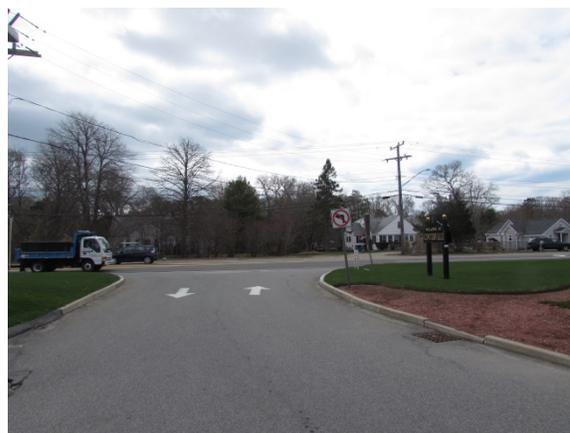
Throughout the Route 28 corridor, there are several driveways that provide access to commercial and residential land uses. According to members of the RSA team, efforts have been made to minimize the amount of access points along the corridor through the use of shared driveways. One particular driveway discussed during the audit was the “right-in, right-out” CVS driveway east of the intersection, which provides access from and to Route 28 in the westbound direction. The egress point of the driveway onto the corridor is currently restricted to right turns only by a sign and a scored median. However, the consensus amongst the RSA team was that left turns into and out of this driveway continue to occur, creating a potential safety risk. In general, the concerns in terms of access management related to the egress from the CVS driveway onto Route 28, as well as the frequency of driveways along the corridor.

Egress Point from CVS to Route 28

- Implement a structural barrier on Route 28 and/or a raised driveway island at the CVS driveway access onto Route 28 to prevent left turn movements.
- Encourage the use of shared driveways and/or internal driveways along the Route 28 corridor to reduce amount of access point that could cause potential crashes.

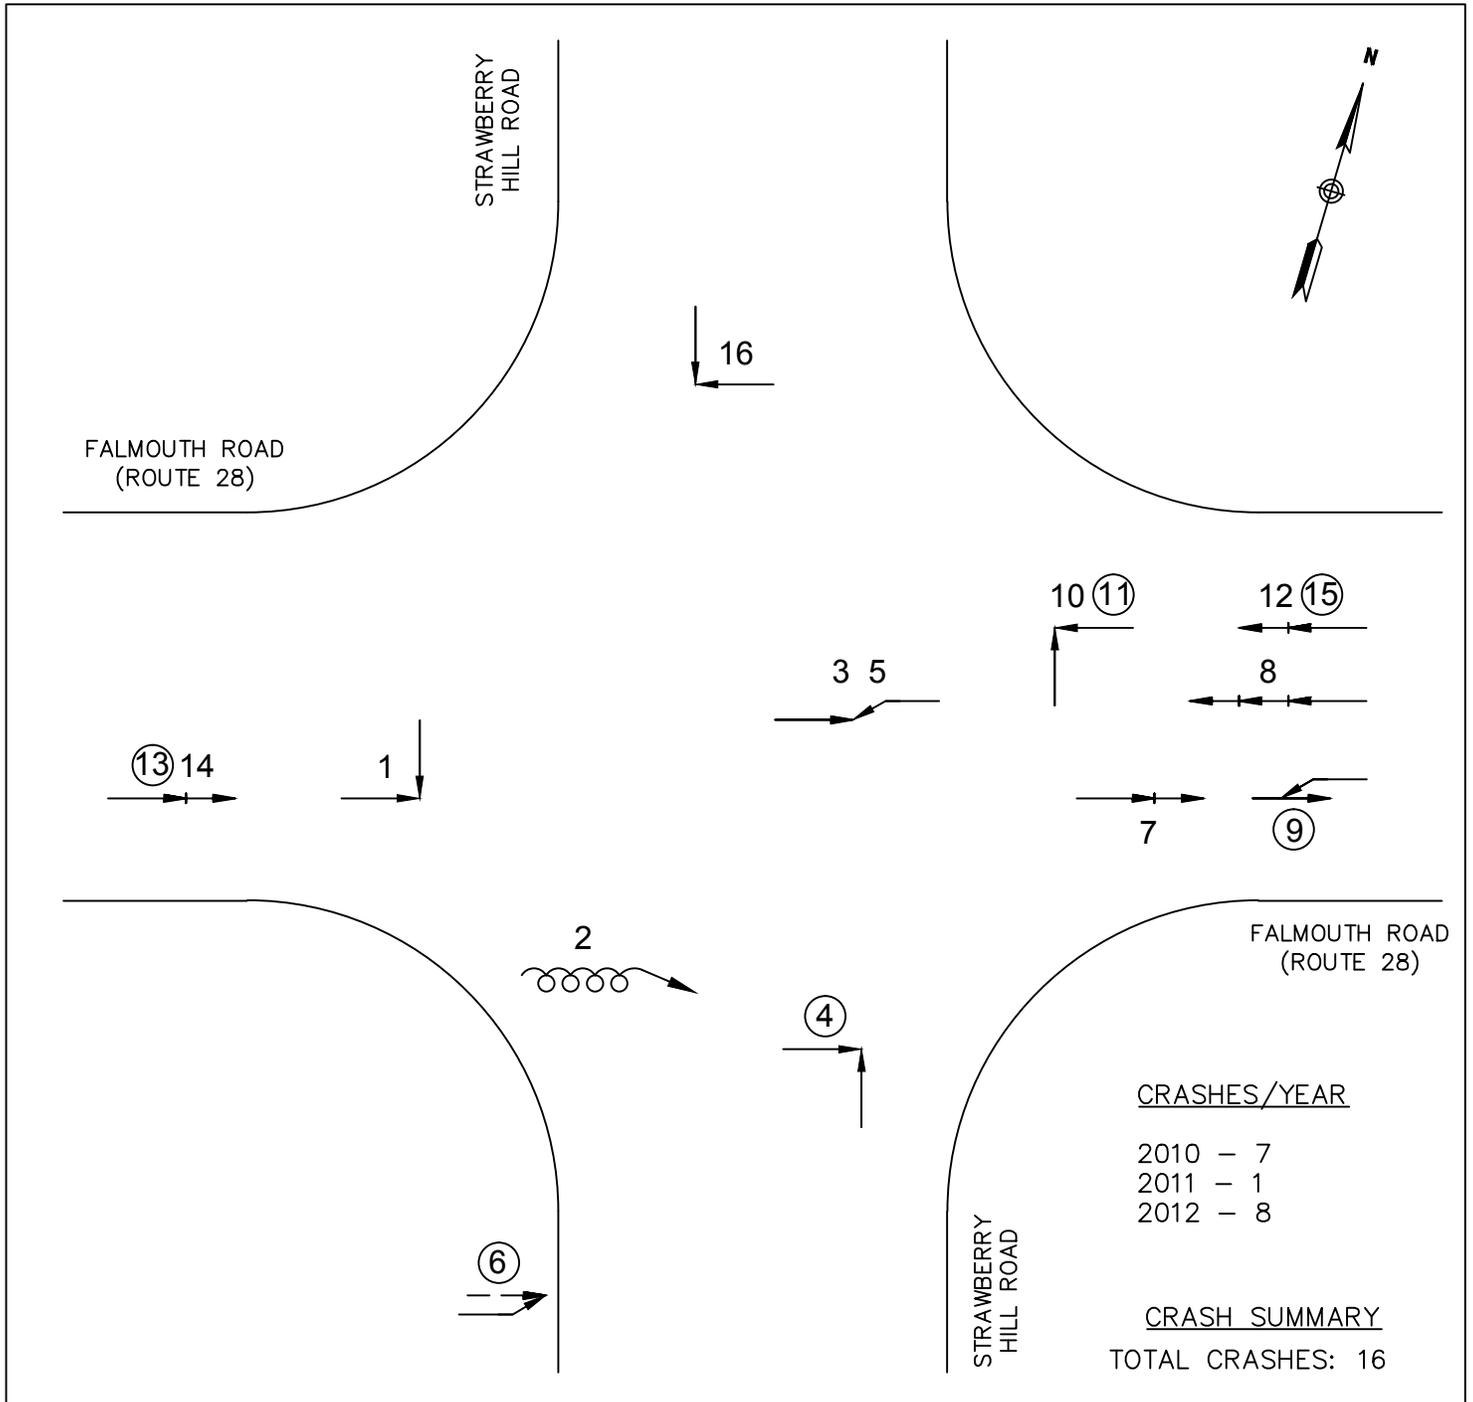
Appendix C. Detailed Crash Data

Falmouth Road (Route 28) at Strawberry Hill Road
