Mashpee Wampanoag Tribe of Massachusetts Road Safety Audit

Final Findings Report – May 2016

Prepared by:
Eastern Tribal Technical Assistance Program at
Michigan Technological University

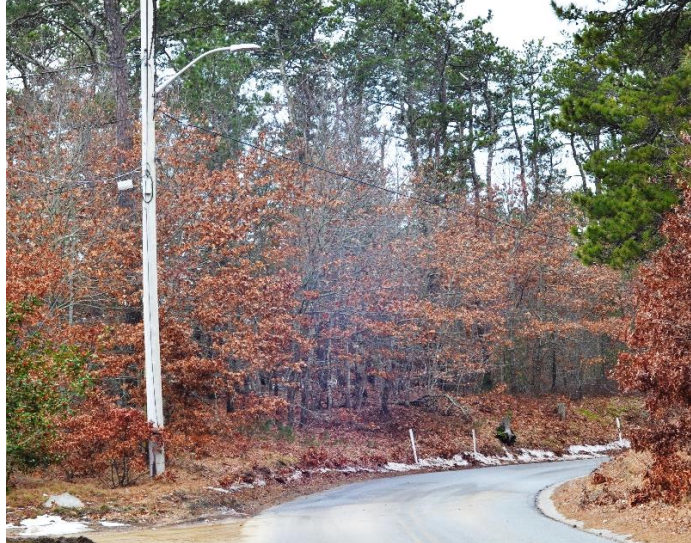
<p>Lighting</p> <p>Some overhead lighting is installed. Many of the observed lights were not functioning during the night reviews and are noted in the safety issues section.</p>

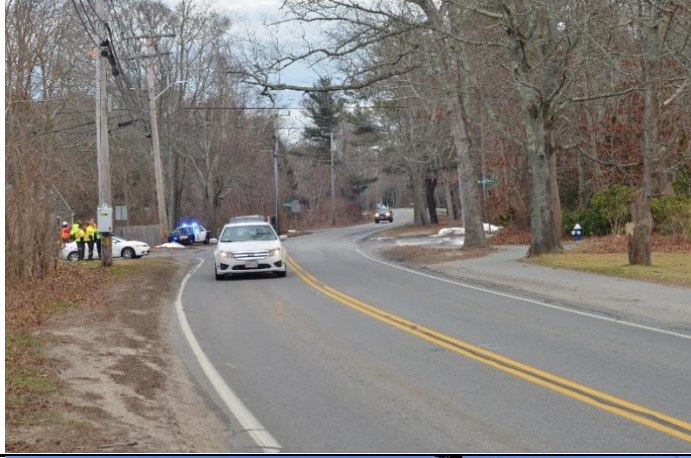
<p>Pavement Markings</p> <p>Center, edge, turn guidance, and pedestrian markings vary from excellent to poor. Most markings showed poor retroreflectivity at night. Some embedded reflectors were in place, but few were functional.</p>

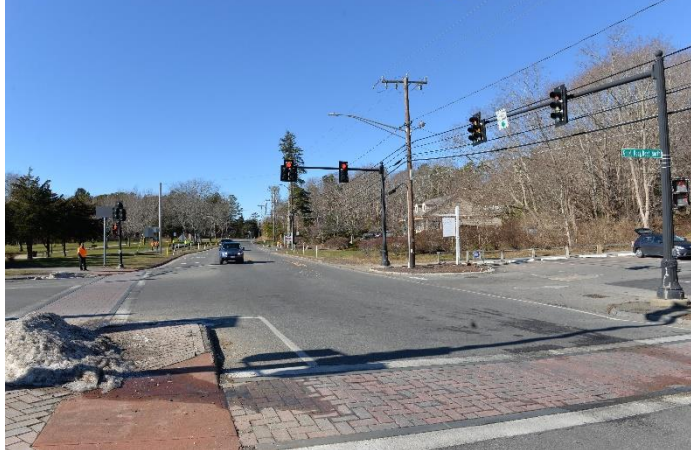
<p>Signals</p> <p>Few signals are installed near the reviewed locations, and none within the scope of this RSA, but nearby signals were generally in good working condition and installed according to modern standards. The observed pedestrian signals had countdown timers and on-demand switching. Most signals had backplates, but they were not retroreflective.</p>

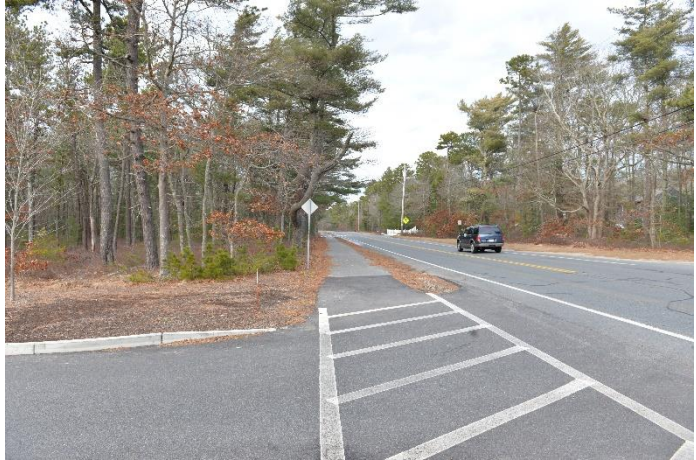
<p>Drainage</p> <p>Drainage at all locations was generally good. Some exceptions are identified in the safety issues section. Most exceptions were near guardrail installations.</p>

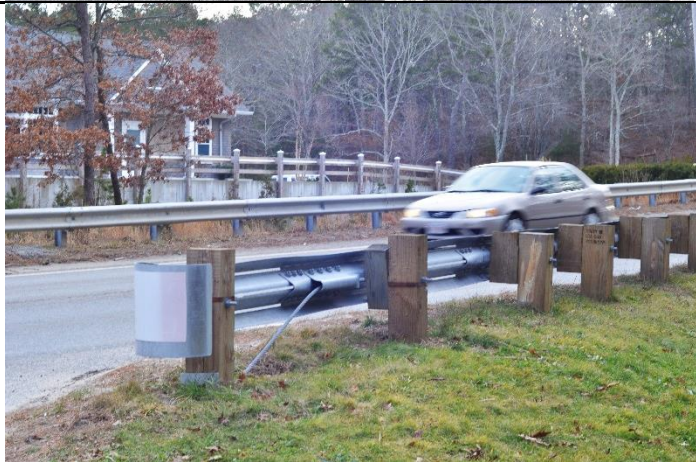
<p>Roadside Features</p> <p>Roadside features were occasionally good, but many of the safety issues listed in this report are related to obstructions in the clear zone and poor access control and sight lines. The RSA team noted generally fair to poor roadside safety measures throughout the region.</p>

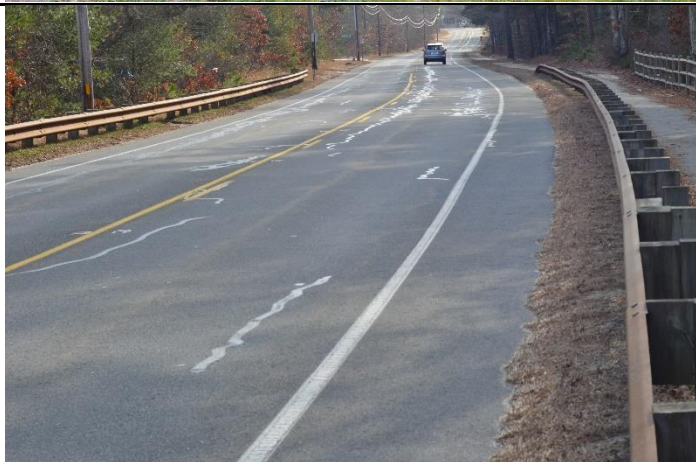
<p>Road Conditions</p> <p>The general condition of all observed roads was good to excellent. No significant safety issues related to surface condition were noted. Occasional minor surface and edge maintenance issues are noted in the safety issues sections.</p>

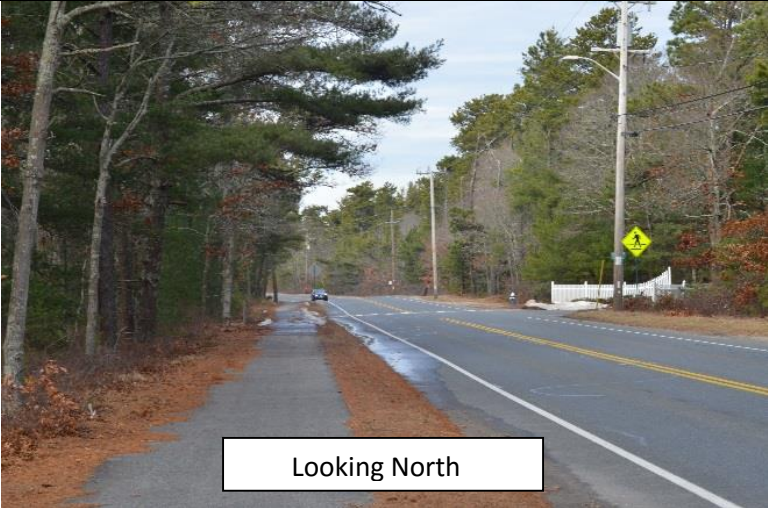
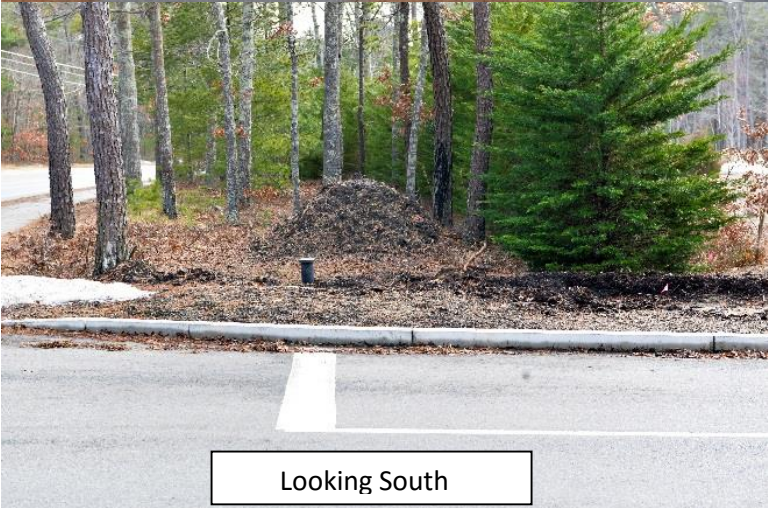
Tribal Government Center/North Entrance: Safety Issue 1		
EXPECTED FREQUENCY	EXPECTED SEVERITY	RISK RATING
Occasional	High	C to D
<p>OBSERVATION: Poor sight distance both directions when trying to pull out onto Great Neck Road South Sight lines much worse when looking south.</p>		
<div style="display: flex; flex-direction: column; align-items: center;">

<div style="border: 1px solid black; padding: 2px; margin: 5px;">Looking North</div>

<div style="border: 1px solid black; padding: 2px; margin: 5px;">Looking South</div> </div>		
<p>SUGGESTION:</p> <p>Med: Create sight lines according to design specifications by removing trees and brush.</p>		
<p>Comments: When looking north, there is a horizontal curve in Great Neck Road South. a few hundred yards away from the drive that limits sight distance of approaching traffic. The bigger issue is that when looking south, and attempting to pull out onto Great Neck Road South traveling north, it is nearly impossible to see approaching traffic due to the slight curve in the road and the ample trees and brush. Motorists are forced to creep out to see, in the process blocking the multi-use path, then have to very quickly accelerate if there is an opening.</p>

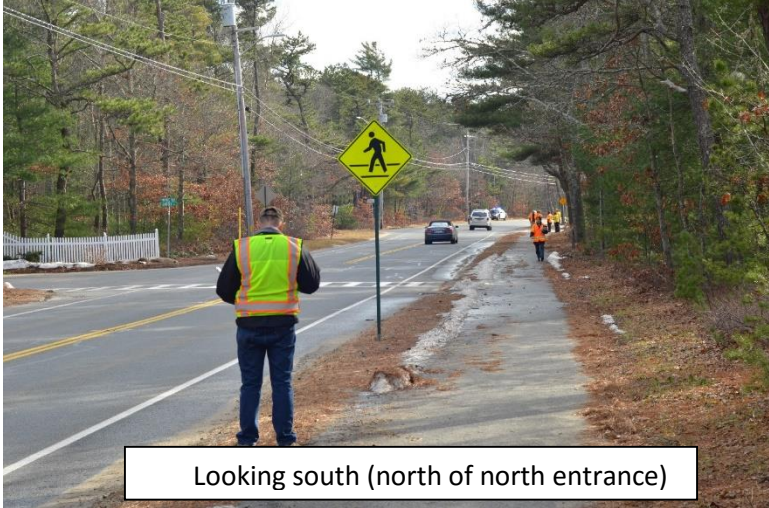
Tribal Government Center/North Entrance: Safety Issue 2		
EXPECTED FREQUENCY	EXPECTED SEVERITY	RISK RATING
Occasional	High	C to D
<p>OBSERVATION: For approaching motorists from the north, no warning or signage to indicate drive. This is compounded by the curve in the road, along with tree and brush hiding the entrance.</p>

<p>Looking south (north of north entrance)</p>		
<p>SUGGESTION:</p> <p>Low: Install warning signs of approaching driveway and guide signs announcing the entrance and Tribal facility.</p> <p>Low: Install retroreflective tape or paint on the curb to better define the driveway.</p> <p>Med: Install street light above entrance.</p> <p>Med: Create sight lines according to design specifications by removing trees and brush.</p>		
<p>COMMENTS: When approaching the drive from the North it is difficult to see the drive, causing motorists to slow down quickly and creating potential for a rear end collisions and lane departures. There is a street light on the pole for the street across from the entrance, but no light over the entrance or other visual indicators announcing the entrance. No guide signs announce the presence of a driveway or facility.</p>

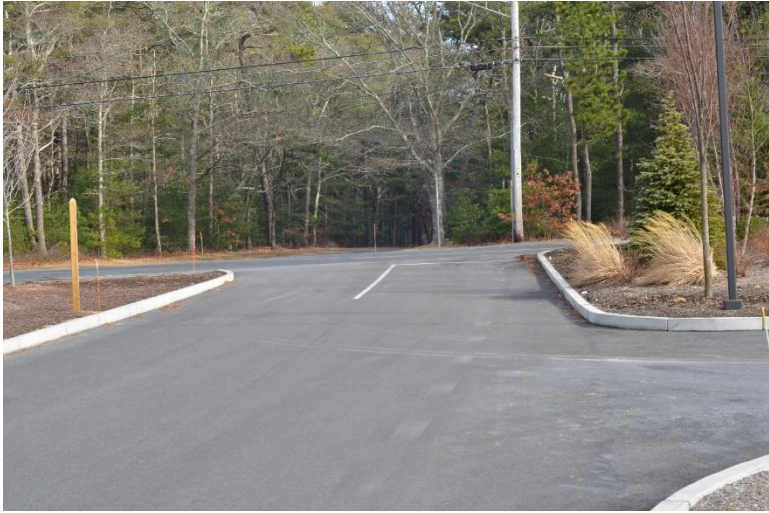
Tribal Government Center/North Entrance: Safety Issue 3		
EXPECTED FREQUENCY	EXPECTED SEVERITY	RISK RATING
Occasional	High	C to D
OBSERVATION: Lack of Signage, improper use of pavement markings

<p>SUGGESTION:</p> <p>Low: Relocate stop line to proper location, repaint center line with a double yellow line to indicate two-way traffic, install stop sign, install cross-walk sign, install retroreflective tape or paint on the curb to better define the driveway.</p> <p>Low: Consider changing the use of both driveways so the north drive is enter only, south drive is exit only.</p> <p>Low: Install warning signs and marking for motorists and trail users to indicate that the trail crosses the access drive.</p>		
<p>COMMENTS: The stop line is located too far back from the intersection. This is compounded by the fact that there is a multi-use path along the western side of Great Neck Road South and the sight lines are inadequate, but the stop line can be moved forward approximately four feet with no other changes.</p> <p>The center line is a simple single white line, which does not comply with MUTCD guidance.</p> <p>There is currently no stop sign at the roadway.</p> <p>There is no signage to indicate to motorists leaving the Tribal office that there is a crosswalk for the multi-use path crossing the driveway.</p>

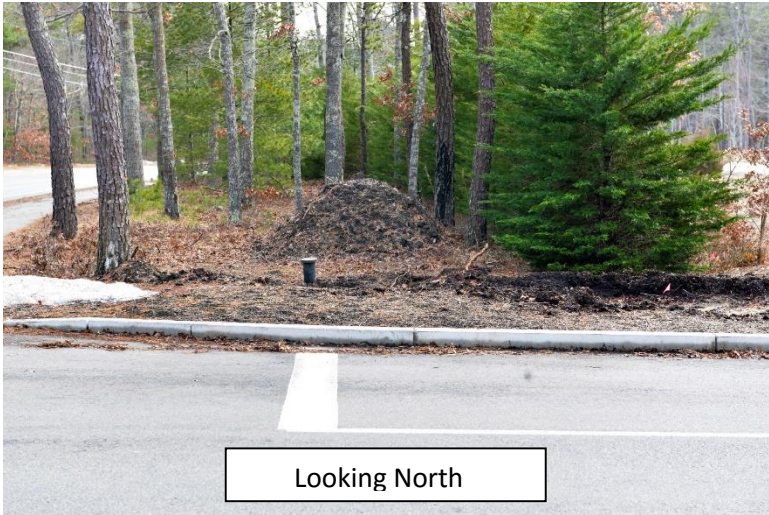
Tribal Government Center/North Entrance: Safety Issue 4		
EXPECTED FREQUENCY	EXPECTED SEVERITY	RISK RATING
Occasional	High	C to D
OBSERVATION: Future wall/sign location on the southern side of drive could be in line of sight

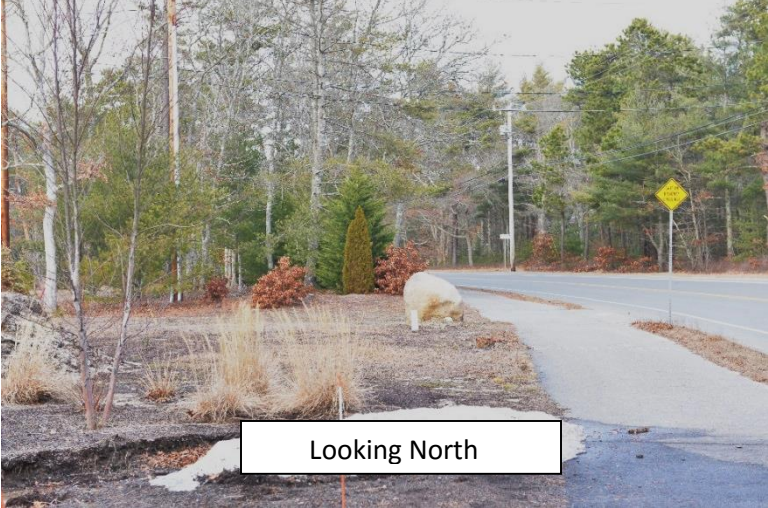
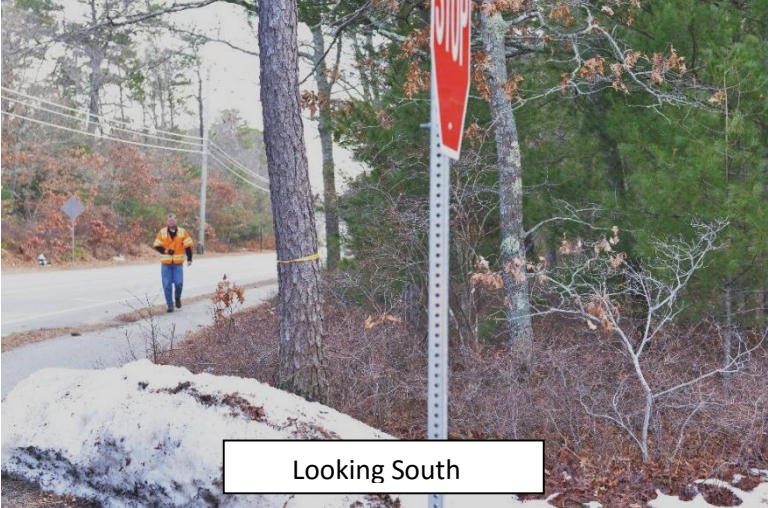
Tribal Government Center/South Entrance: Safety Issue 5		
EXPECTED FREQUENCY	EXPECTED SEVERITY	RISK RATING
Occasional	High	C to D
<p>OBSERVATION: Sight distance from southern drive is limited when looking south on Great Neck Road South, and it is very limited when looking north.</p>		
<div style="display: flex; flex-direction: column; align-items: center;">

<div style="border: 1px solid black; padding: 2px; margin: 5px;">Looking North</div>

<div style="border: 1px solid black; padding: 2px; margin: 5px;">Looking South</div> </div>		
<p>SUGGESTION:</p> <p>Low: Consider changing the use of both driveways so the north drive is enter only, south drive is exit only.</p> <p>Med: Create sight lines according to design specifications by removing trees and brush.</p>		
<p>Comments: When looking north, trees and a curve in the road severely restrict the sight distance. When looking south, trees and brush restrict the view, but a straighter road is an improvement over the north view. As with the north drive, motorists are forced to creep out further to try and see oncoming traffic, which in turn blocks the multi-use path.</p>

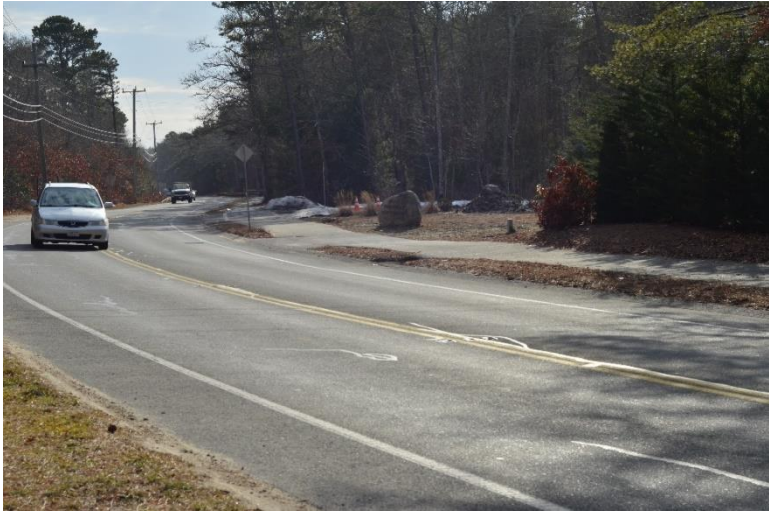
Tribal Government Center/South Entrance: Safety Issue 6		
EXPECTED FREQUENCY	EXPECTED SEVERITY	RISK RATING
Occasional	High	C to D
OBSERVATION: Poor visibility, lack of signage, old drive entrance causes driver confusion

<p>SUGGESTION:</p> <p>Low: Remove old driveway curb cut, replant the strip of grass between the multi-use path and the edge of the road to match the surrounding area.</p> <p>Low: Install warning signs of approaching driveway and guide signs announcing the entrance and Tribal facility.</p> <p>Low: install retroreflective tape or paint on the curb to better define the driveway</p> <p>Med: Install street light above entrance.</p> <p>Med: Create sight lines according to design specifications by removing trees and brush.</p>		
<p>COMMENT: When approaching the south drive from the north, the remaining old driveway curb cut and apron causes confusion with the potential of motorists pulling into the removed driveway. Also, there are no signs to indicate a drive. A warning sign is in place when approaching from the south.</p>

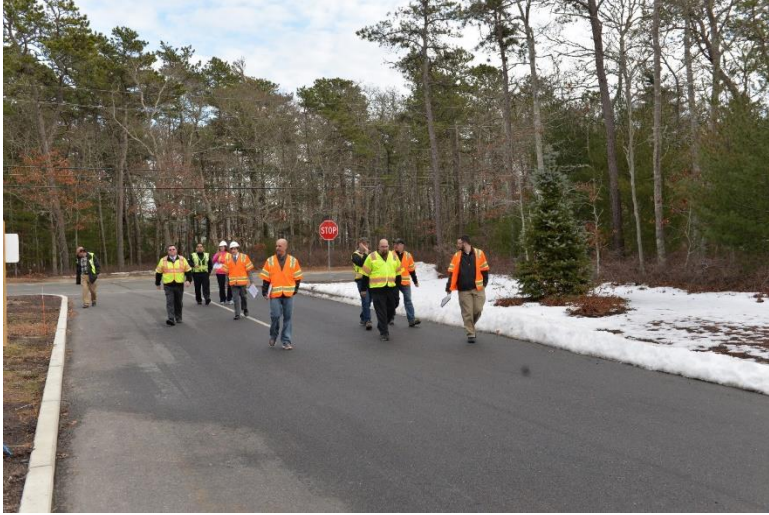
Tribal Government Center/South Entrance: Safety Issue 7		
EXPECTED FREQUENCY	EXPECTED SEVERITY	RISK RATING
Occasional	High	C to D
OBSERVATION: Lack of Signage, improper use of pavement markings

<p>SUGGESTION:</p> <p>Low: Relocate stop line to proper location, repaint center line with a double yellow line to indicate two-way traffic, install cross-walk sign, install retroreflective tape or paint on the curb to better define the driveway.</p> <p>Low: Consider changing the use of both driveways so the north drive is enter only, south drive is exit only (this change affects first suggestions).</p> <p>Low: Install warning signs and marking for motorists and trail users to indicate that the trail crosses the access drive.</p>		
<p>COMMENTS: The stop line is located too far back from the intersection. This is compounded by the fact that there is a multi-use path along the western side of Great Neck Road South and the sight lines are inadequate, but the stop line can be moved forward approximately four feet with no other changes.</p> <p>The center line is a simple single white line, which does not comply with MUTCD guidance.</p> <p>There is no signage to indicate to motorists leaving the Tribal office that there is a crosswalk for the multi-use path that crosses the driveway.</p>

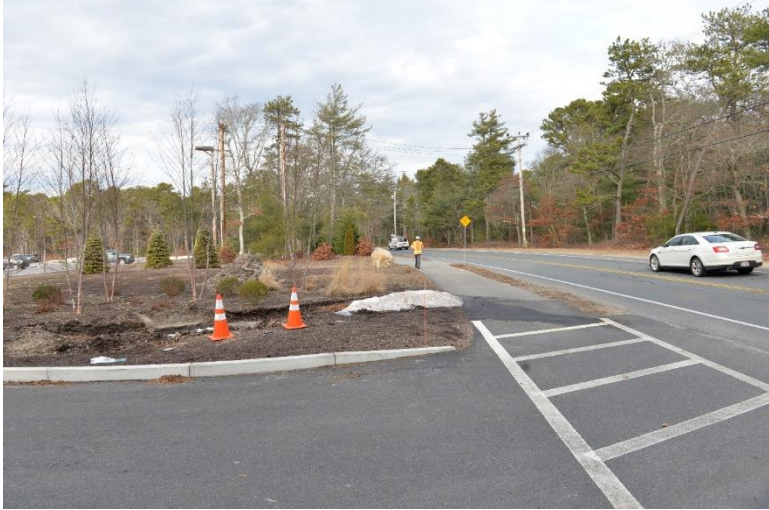
Tribal Government Center/South Entrance: Safety Issue 8		
EXPECTED FREQUENCY	EXPECTED SEVERITY	RISK RATING
Occasional	High	C to D
OBSERVATION: Future wall/sign location could be in line of sight

SUGGESTION:		
Low: Locate the wall/sign according to design specifications for sight distance.		
COMMENTS: A trench dug for a proposed future wall/sign is located on the northern side of the driveway. The wall/sign, as proposed, will block the line of sight for motorists trying to pull out of the southern driveway, further exacerbating the existing poor sight lines, but helping announce the existence of the access drive and Government Center.

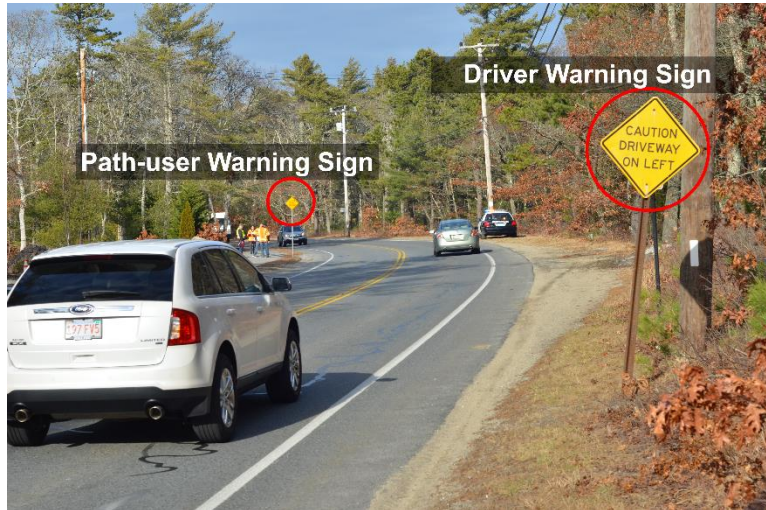
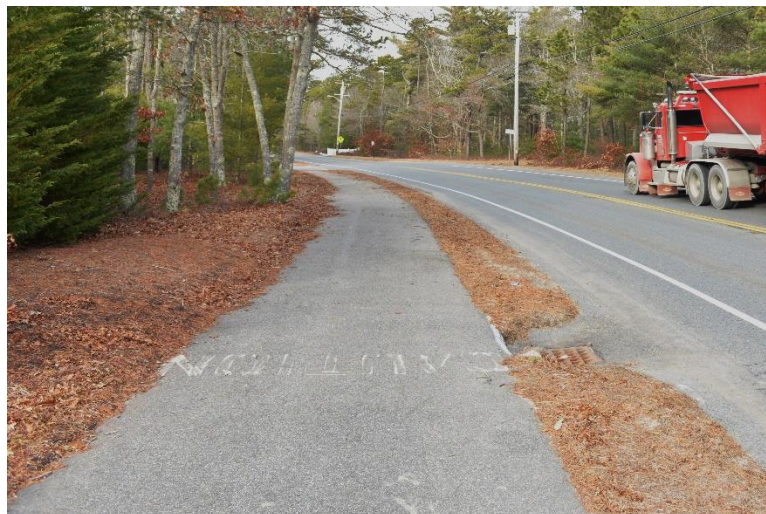
OBSERVATION: Non-motorized path markings require maintenance, path signing may confuse motorists, potential hazards near/on path

Utility poles in the recovery and clear zone.

COMMENTS: The RSA team noticed warning signs installed for path users that are installed at a height and location that is similar to roadway signs, making them confusing for both motorists and path users. Although the signs are smaller than standard roadway sign specifications, they are highly retroreflective, even more so than most of the nearby installed road signs. Trail/path sign installation is covered in the MUTCD Section 9B.01 Application and Placement of Signs, but local or state standards may dictate the locally-observed installation practices, and if that is the case, then those practices should be reviewed to better serve the intended users and to avoid confusing roadway users.

The path has been marked in the past, but the condition of crosswalk and path markings vary in quality. Some potential hazards, such as a drainage grate adjacent to the path, were observed on the path near the Government Center.

Although roadside features of Great Neck Road South beyond the Government Center were not in the scope of this RSA, the team observed many utility poles very close to the road edge and the path edge. Some poles had retroreflective demarcation in generally poor condition, or no demarcation was visible.

Install/replace retroreflective markers on utility poles that encroach on the road or path edges.

High: Relocate utility poles further from the road edge according to recommended design standards.

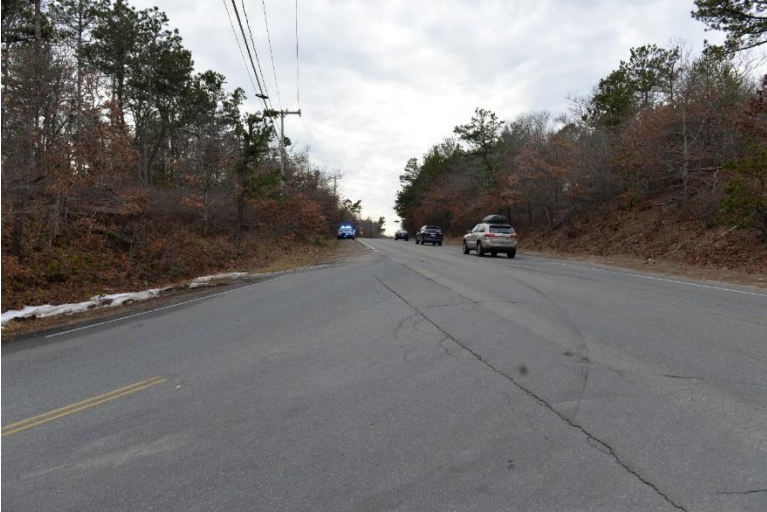
Sampsons Mill Road at Route 28: Safety Issue 1		
EXPECTED FREQUENCY	EXPECTED SEVERITY	RISK RATING
Frequent	High to extreme	E to F
<p>OBSERVATION: Poor sight distance/difficult intersection angle, incline on Old Sampsons Mill Road adds to poor visibility and difficulty pulling onto Route 28.</p>

<p>COMMENTS: This intersection poses a number of difficult challenges. A hill crests on Route 28 just to the southwest of the intersection that creates a compound horizontal/vertical curve, making it difficult to see northbound (NB) Route 28 traffic. In addition, trees and brush, along with the banked shoulder, reduce visibility of the intersection for Route 28 drivers.</p> <p>Sampsons Mill Road meets up with Route 28 at a severe obtuse angle for NB 28 traffic. This, coupled with the incline of Sampsons Mill, makes it extremely difficult to see southbound Route 28 traffic. Numerous skid marks were observed at the Sampsons Mill/Route 28 intersection, indicating that drivers may have difficulty accelerating to enter gaps, and the group witnessed a vehicle pulling out with spinning tires while trying to overcome the hill and merge into traffic.</p> <p>NB Route 28 vehicles tend to enter Sampson Mill Road at a high rate of speed given the alignment of the intersection. SB Route 28 vehicles have an extended slow turning movement.</p>

<p>SUGGESTION:</p> <p>Low: Additional warning and guide signs for motorists on Route 28, including trucks entering highway signs from both directions, cut back brush/trees on southwest side of intersection to improve sight distance.</p> <p>Med: Install overhead intersection warning beacon. Install overhead intersection lighting.</p> <p>High: Realign intersection to make it closer to 90°, vertically realign Sampsons Mill Road to reduce the incline pulling onto Route 28, vertically realign Route 28 to reduce the slope that is immediately southwest of the intersection to drastically improve sight distance, and cut back slope on the southwest side of the intersection to increase sight distance.</p>

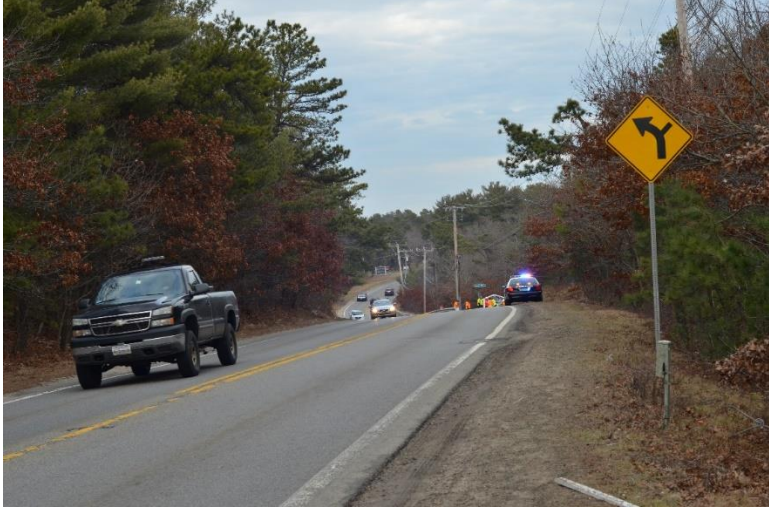
Sampsons Mill Road at Route 28: Safety Issue 2		
EXPECTED FREQUENCY	EXPECTED SEVERITY	RISK RATING
Frequent	High to extreme	E to F
<p>OBSERVATION: Poor intersection visibility when approaching on Route 28 from the Southwest, compounded by posted and observed speeds</p>

<p>SUGGESTION:</p> <p>Low: Trim landscape to improve sight distance, add/improve warning signs for intersection, add speed advisory signs, add advance street name sign and street name sign at SE intersection corner.</p> <p>Med: Install overhead intersection warning beacon.</p> <p>High: Redesign intersection and approaching segments according to expected approach speeds and to reduce vertical curve and significantly increase the visibility of and from the intersection.</p>		
<p>COMMENTS: As you approach the intersection on Route 28 from the southwest, there is a sign warning of the intersection, but the compound vertical and horizontal curve of the roadway prevents motorists from seeing the actual intersection, and the posted and observed speeds may exceed current design. The suggestions include changes that may negate each other: The safety issues might be addressed with marking, signing, and clear zone maintenance, or geometric changes may negate the need for additional signing or speed control.</p>

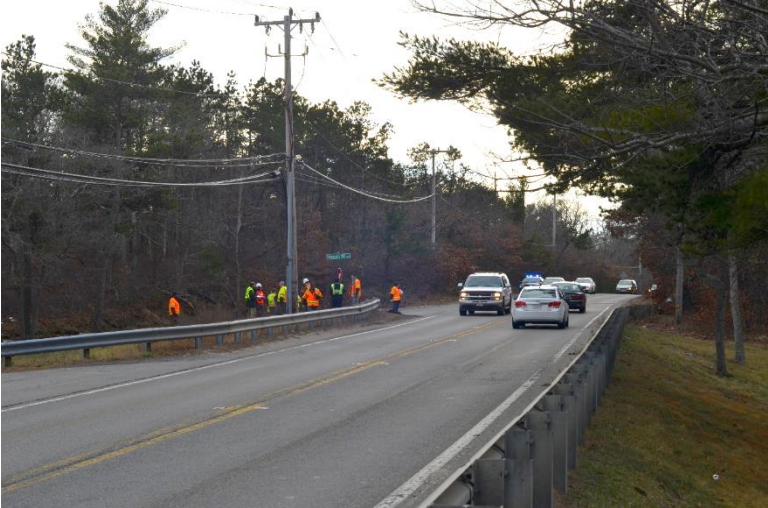
Sampsons Mill Road at Route 28: Safety Issue 3		
EXPECTED FREQUENCY	EXPECTED SEVERITY	RISK RATING
Frequent	High to extreme	E to F
<p>OBSERVATION: Lack of warning and guide signs, missing and bent guardrail reflectors in the corridor from the Sampsons Road intersection heading northeast towards the Mashpee Center on the north side of Route 28, guardrail maintenance needed.</p>

<p>SUGGESTION:</p> <p>Low: Install warning and guide signs to indicate the presence of access drives and intersection, install/replace guardrail reflectors, and maintain guardrails by clearing buildup of sand/debris.</p> <p>Med: Install Street lights over the drives.</p>		
<p>COMMENTS: Discussion within the group determined that there are concerns not only with the Sampsons Mill Road intersection itself, but also with the corridor heading northeast along Route 28 between the intersection and the Mashpee Center, which is located on the north side of Route 28 a few hundred yards from the intersection. This corridor is flanked by guardrail on both sides, with no signage warning motorists of the drives for either the Mashpee Center, or the Cape Cod Surgery Center on the south side. Furthermore, the drive for the adjacent outpatient clinic is located in close proximity to the Sampsons Mill intersection, potentially causing conflict.</p> <p>There are no street lights to indicate the presence of the drives. The group also witnessed a vehicle approach the drive for the Mashpee Center at a high rate of speed, then have to quickly slow down to navigate the entrance. In the process, the trailing vehicle had to brake severely, nearly causing a rear-end collision and a chain reaction event with the other trailing vehicles.</p> <p>The guardrail appears to be installed at the correct height; however, there is a buildup of sand/dirt/other road debris that should be cleared out from under the guardrail. This maintenance would ensure that vehicles contact the guardrail at the proper height. During evening observations, the group noted that the guardrail is not well delineated, as the reflectors were either nonfunctional, damaged, or missing.</p>

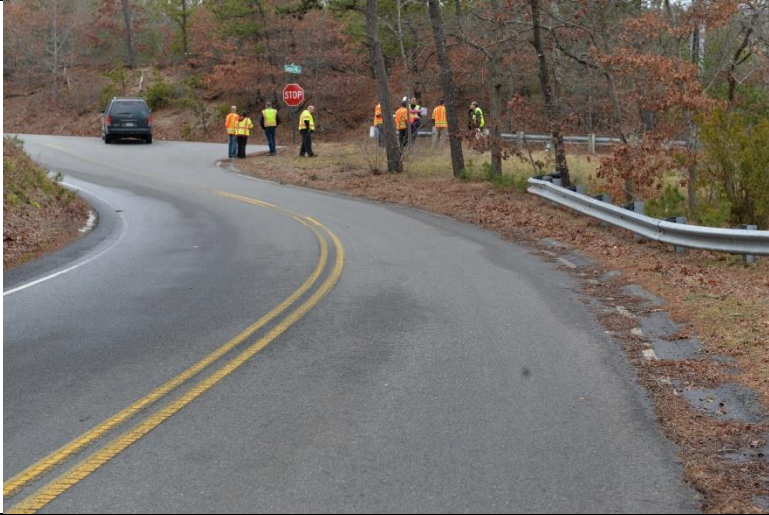
Sampsons Mill Road at Route 28: Safety Issue 4		
EXPECTED FREQUENCY	EXPECTED SEVERITY	RISK RATING
Frequent	High to extreme	E to F
<p>OBSERVATION: Improper/missing signs on Sampsons Mill Road Stop sign is installed too low, has poor retroreflectivity, and is bent showing signs of being struck most likely by a taller vehicle such as a truck.</p> <p>The approach is missing chevrons for curve, a curve warning sign, and missing Stop Ahead sign on approach.</p> <p>Improper guardrail installation - guardrail is too low, could possibly be extended, should have reflectors.</p> <p>Available crash data indicated possible winter maintenance needs.</p>

COMMENTS: As you approach the intersection heading northeast on Sampsons Mill Rd, there is a fairly long straight away just before the sharp curve and intersection, with no warning to motorists of the approaching curve, stop, or intersection. The geometry of the road prevents motorists from seeing the stop sign until they start to navigate the curve.

The guardrail on Sampsons Mill Road as you approach the intersection appears to be in place to protect a generator and associated gas line/meter that is located on the outside of the curve. The guardrail is installed too low and is missing any sort of delineation. Given the high rate of speed that motorists tend to enter Sampsons Mill Road from Route 28, and the fact that there is a depression closer to Route 28, it is worth considering extending the guardrail towards the intersection.

<p>SUGGESTION:</p> <p>Low: Replace stop sign and install at proper height. Install chevrons, proper curve warning sign, and stop ahead sign. Install reflectors to delineate guardrail. Improve winter maintenance and maintenance of existing signing, marking, and countermeasures.</p> <p>Correct rail mounting so that posts do not create a snag hazard.</p> <p>Med: Reinstall guardrail to proper height and evaluate length to ensure proper for vehicles entering the intersection at a high rate of speed (dependency on Geometric Issue 1 for this location – a realignment negates this suggestion).</p>

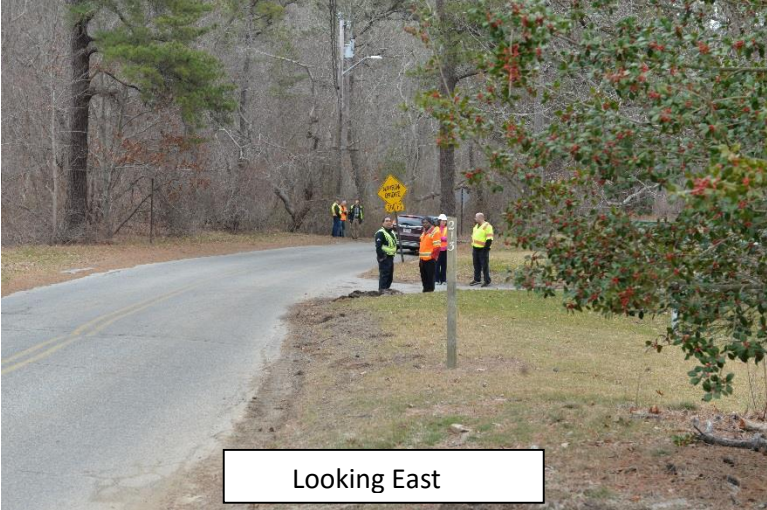
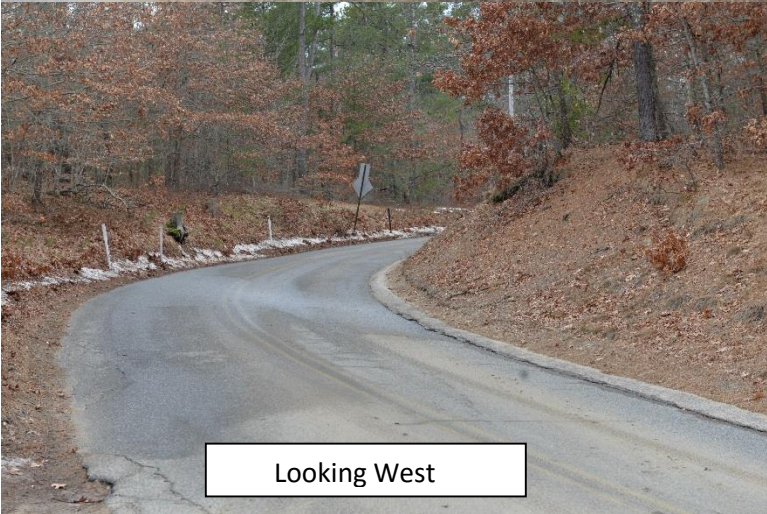
Sampsons Mill Road/Farm: Safety Issue 1		
EXPECTED FREQUENCY	EXPECTED SEVERITY	RISK RATING
Rare	Low to moderate	A to B
<p>OBSERVATION: Extremely poor sight lines looking northwest from both driveways, poor sightlines when looking southeast.</p>		
<div style="display: flex; justify-content: space-around;"> <div style="text-align: center;">

<p>Looking East</p> </div> <div style="text-align: center;">

<p>Looking West</p> </div> </div>		
<p>SUGGESTION:</p> <p>Low: Trim trees and brush along the southwest side of the road.</p> <p>Low: Use the western drive as entrance only, and the eastern drive as exit only, as looking to the west from the eastern drive provides a slightly longer reaction time.</p> <p>Med: Cut back the bank along the south side of the road at the east entrance to see around the curve and down the hill.</p> <p>Med: Cut back bank on the inside of the curve on the north side of the road to the west of the western drive to drastically increase sight distance to see around the curve and up the hill.</p>

Med: Widen eastern drive to account for the truck and potential bus traffic.

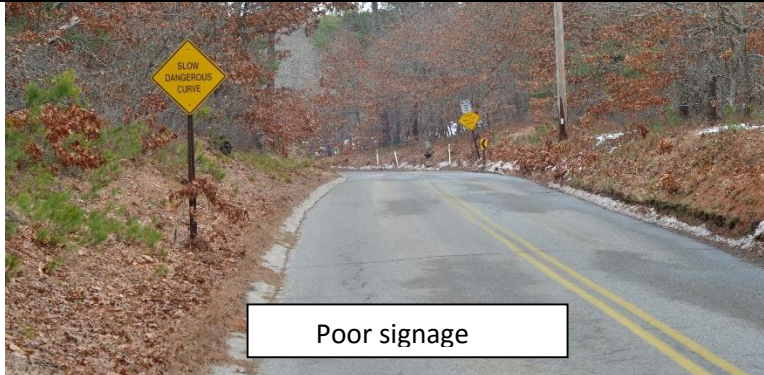
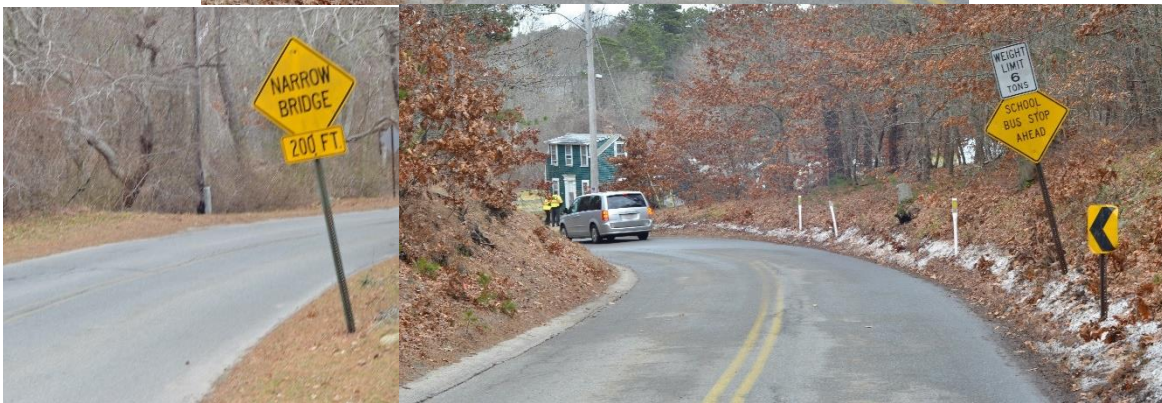
OBSERVATION: Improper signage, missing signs, signs located in very close proximity to travel lane, poor to no retroreflectivity.

COMMENTS: There are currently school bus stop signs on either side of the driveways, but interviews with local staff indicated that buses no longer stop at this location. There are signs leaning very close to the travel lane. There is only one bent chevron sign indicating the curve, though there are reflector posts on the curve. While driving through during the evening, the team noted that none of the signs, nor the reflector poles, are retroreflective. There is a street light located over the western drive, but the light is not functional. None of the remaining pavement markings are retroreflective, and there are no pavement edge markings.

Low: Remove School Bus Stop Ahead sign, or reinstall so it's not leaning into the travel lane, replace all signs with updated versions with proper retroreflective sheeting, install additional chevrons for curve, install curve warning sign, install hidden drive ahead sign, install bridge weight limit sign in the proper location.

Repair street light.

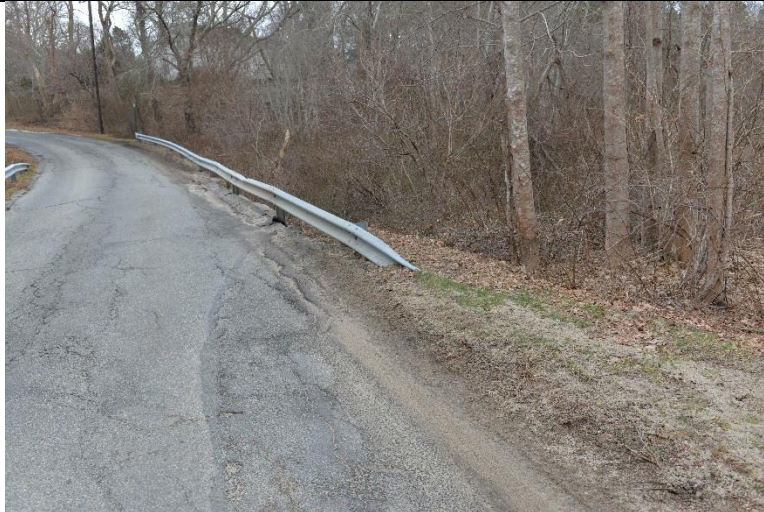
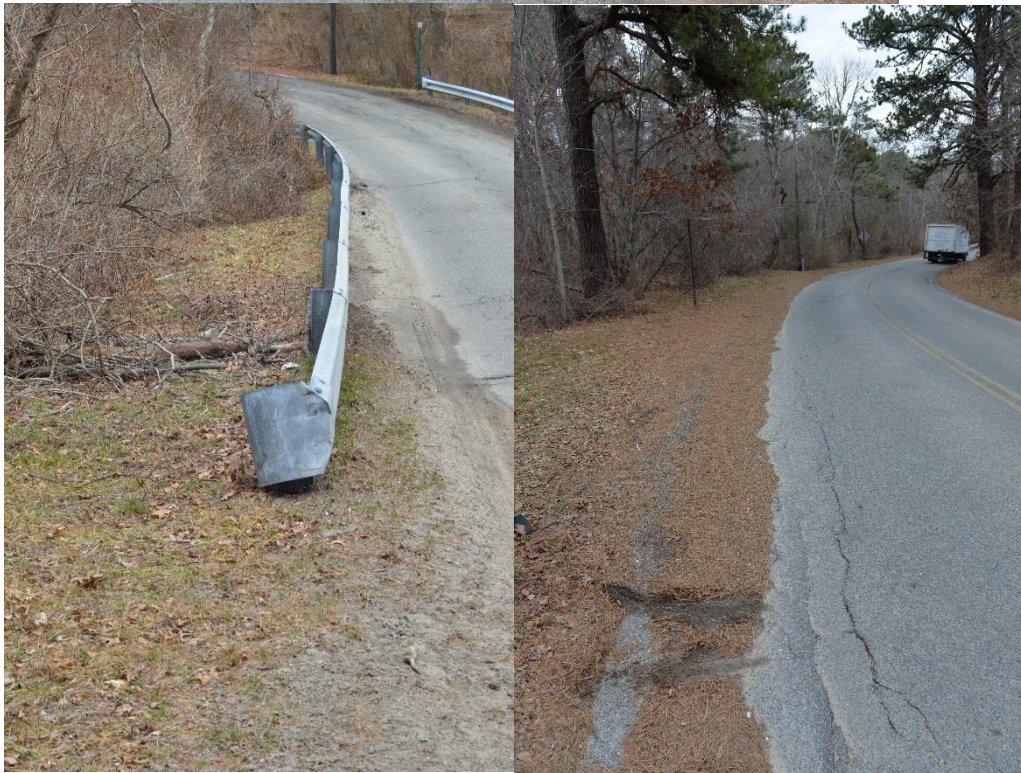
OBSERVATION: Improper guardrail installation, improper guardrail end treatments, pine straw/debris along edge of pavement, general lack of clear zone including banks, trees, utility poles, signage, etc. Non-functional street light over western drive.

Low: Sweep pine straw and debris off roadway. Repair the street light over the west drive. Remove trees and other obstructions within the clear zone.

Med: Replace guardrail at proper height and use appropriate end treatments. Cut back banks.

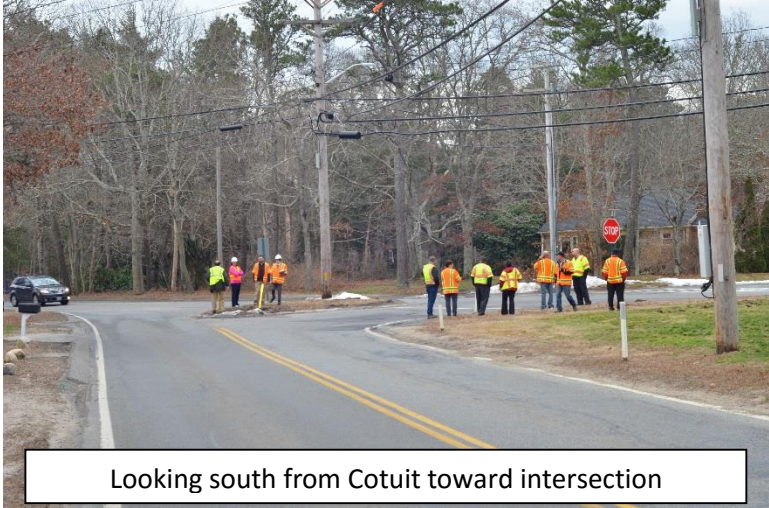
Route 130 at Cotuit Road: Safety Issue 1		
EXPECTED FREQUENCY	EXPECTED SEVERITY	RISK RATING
Occasional	Low to moderate	B or C
<p>OBSERVATION: Island in intersection has numerous issues: evidence of being repeatedly struck, lack of signage, lack of delineation/demarcation, missing/improper traffic control, driver confusion, inoperable street light, and fixed objects in clear zone.</p> <p>When approaching the intersection southbound on Cotuit, issues include inadequate warning signs, stop sign at intersection is not visible until very close to intersection, and a visual trap for southbound drivers who may see the northbound lane as the normal travel lane.</p>

<p>Looking south from Cotuit toward intersection</p>

When visited at night, the team observed that the street light on the pole in the island isn't operating and the visual trap of the northbound Cotuit lane appearing as the normal travel lane to southbound drivers significantly increases. There is no retroreflectivity in any of the remaining pavement markings, and there is minimal retroreflectivity on the flexible poles on the island, on the remnants of reflectors attached to the utility pole, and the stop sign. The island and pole are also poorly delineated for drivers approaching from northbound on Route 130.

Add an additional stop sign on northwest side of island and replace stop ahead signs before the curve immediately preceding the intersection (nighttime observation showed very poor retroreflectivity). Use a stop ahead sign with curving arrow pictograph.

Improve sign and marking maintenance to quickly repair them after being damaged in the frequent crashes.

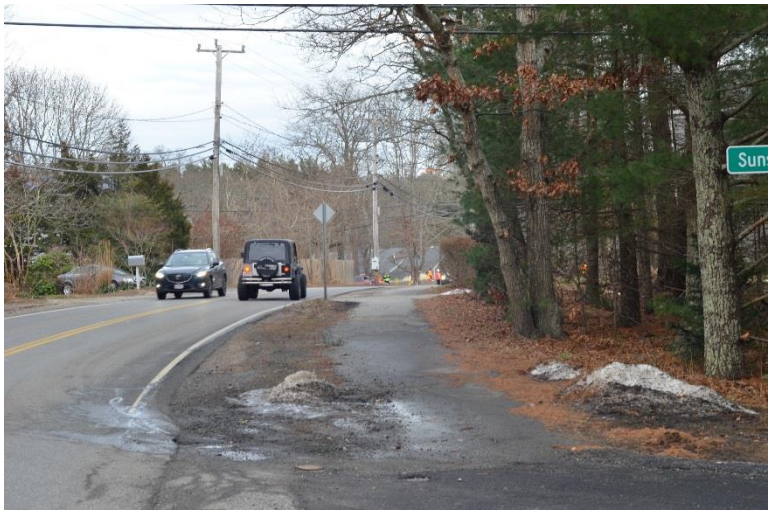
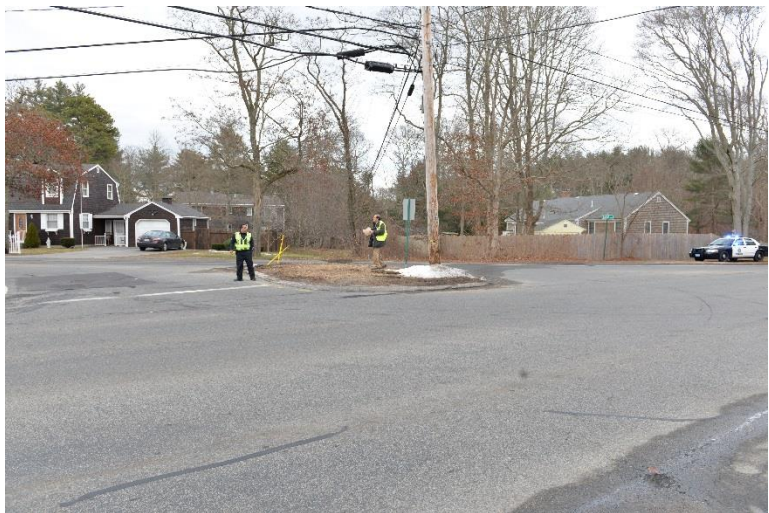
OBSERVATION: When approaching the intersection from the north on Route 130, inadequate warning or signage, driver confusion on where to turn onto Cotuit.

When approaching the intersection from the south on Route 130, inadequate warning or signage, driver confusion on where to turn onto Cotuit vs. Shields Rd, which is located almost adjacent to the southeast of Cotuit Road

COMMENTS: When approaching the intersection from the north on Route 130, there is inadequate warning or signage to alert motorists of the approaching intersection, or of the odd nature of the intersection. There is driver confusion on where to turn onto Cotuit, as we witnessed drivers attempting to turn into the southbound lane. There is a slight curve on Route 130 that partially blocks the view of the intersection for drivers as they approach it, causing them to brake quickly to either turn or avoid traffic pulling onto Route 130 from Cotuit.

When approaching the intersection from the south on Route 130, there is inadequate warning or signage to alert motorists of the approaching intersections, or of the fact that there are two roads within 100 ft.

Low: Install intersection warning sign and add Do Not Enter signs to prevent Route 130 traffic from turning onto Cotuit in southbound lane.

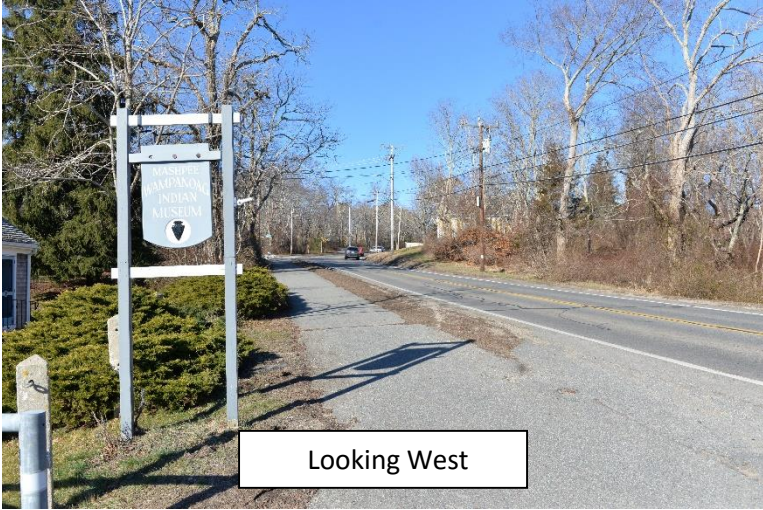
Route 130 Near Museum: Safety Issue 1		
EXPECTED FREQUENCY	EXPECTED SEVERITY	RISK RATING
Occasional	High to Extreme	D to E
<p>OBSERVATION: Difficult to pull out of the Mashpee Indian Museum due to drive incline and limited sight distance in both directions. The location attracts very high pedestrian densities during holidays and culturally significant events.</p>		
<div style="display: flex; flex-direction: column; align-items: center;">

<div style="border: 1px solid black; padding: 2px; margin: 5px;">Looking West</div>

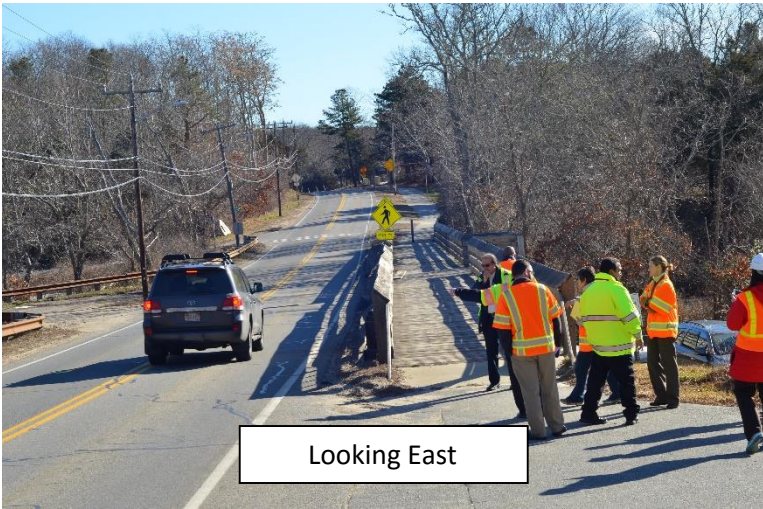
<div style="border: 1px solid black; padding: 2px; margin: 5px;">Looking East</div> </div>		
<p>SUGGESTION:</p> <p>Low: Install driveway warning signs in both directions, use temporary interactive flashing speed signs during peak visitation seasons, provide on-location law enforcement traffic and pedestrian direction during peak visitation days/times, and install additional speed limit sign for the eastern lane on Route 130 prior to the Museum.</p>

Install a barrier under the boardwalk to prevent children and animals from entering Route 130 from under the boardwalk.

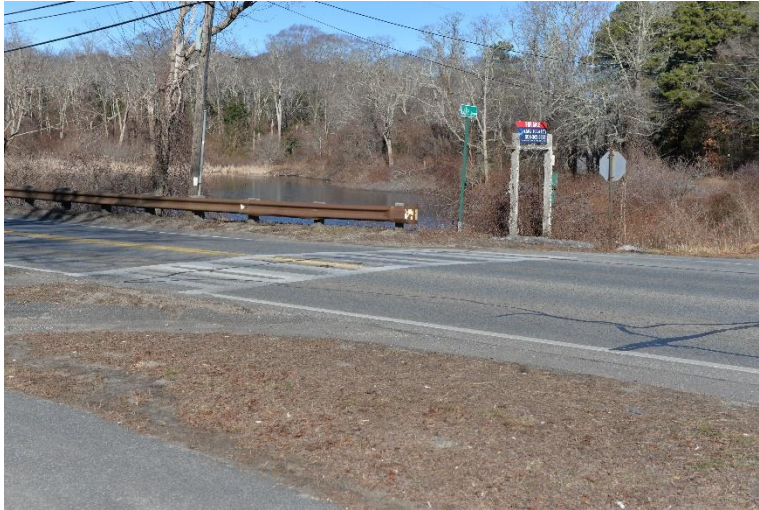
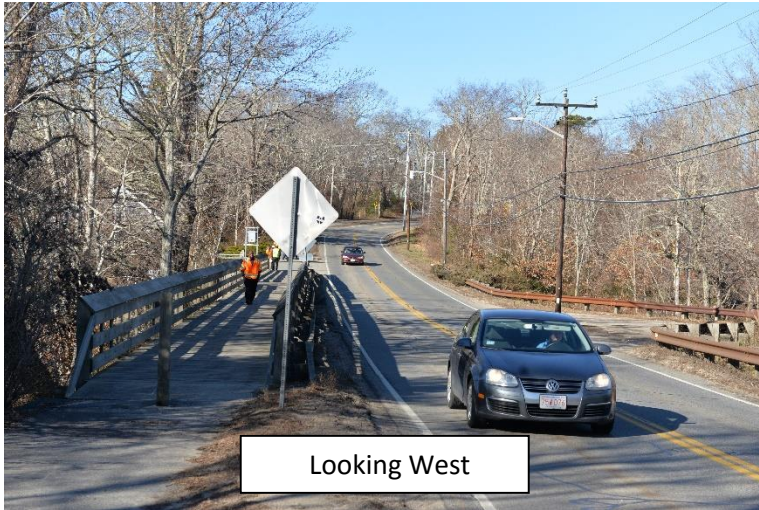
OBSERVATION: A crosswalk with seasonally high use is poorly delineated and partially obscured to drivers heading westbound.

Low: Repaint crosswalk with retroreflective paint.

COMMENTS: It was noted that there is a considerable amount of pedestrian traffic that uses the crosswalk during the herring run, but it is well used all summer long by Tribal members walking to and from the beach at Mashpee Pond, located to the north. Efforts have already been made to improve this crosswalk, including the installation of crosswalk warning signs. The visibility is good to the west, but to the east it is somewhat limited by the vertical and horizontal curve of Route 130.

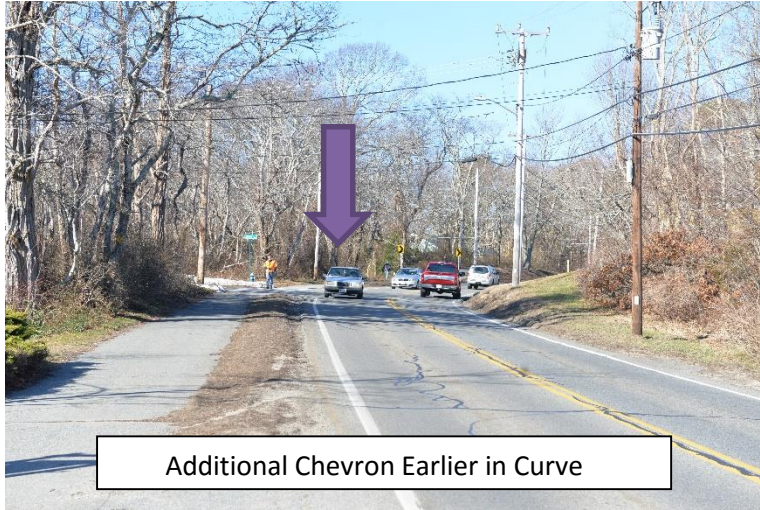
OBSERVATION: Install and Improve signage, ensure signs with wooden posts are breakaway, clear under guardrail on north side of Route 130, reduce signage near Great Neck Road North to reduce clutter, remove unnecessary guard rail near Great Neck Road North intersection.

Additional Chevron Earlier in Curve

Low: Replace or repair signs not meeting federal retroreflective guidelines or that have graffiti, install missing curve ahead warning sign before curve west of the Mashpee Museum, install additional chevron at beginning of curve, replace missing chevron in middle of curve, remove

redundant No Parking and Right Lane Must Turn Right signs to reduce sign clutter at Great Neck Road North intersection, modify or replace sign posts to meet breakaway standards, clean under guardrail on north side of Route 130, remove unnecessary guardrail on south side of Route 130 near the Great Neck Road North intersection.
