Mashpee Wampanoag Tribe of Massachusetts Road Safety Audit

Final Findings Report – May 2016

Prepared by:
Eastern Tribal Technical Assistance Program at
Michigan Technological University

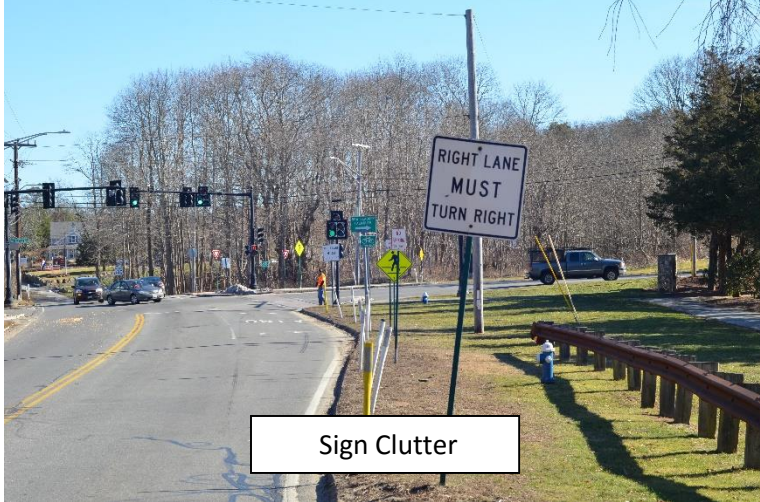
Sign Clutter

COMMENTS: Even though this road segment was part of a previous road safety audit, and safety measures were taken as a result, there are still a number of safety concerns that can be easily addressed. In general, as this segment was travelled at night, it was noted that the vast majority of signs have little to no retroreflectivity. Any sign not meeting the federal guidelines should be replaced. For the west bound lane, there is a guardrail installed along the northern edge of the roadway. Although it is rusted, it appears to be functional. There is, however, a berm of sand and dirt built up below it, reducing the effective height. This debris should be removed to ensure vehicles strike the guardrail at the proper height. Continuing west, it was noted that there isn't an advance Curve Ahead warning sign to warn of the upcoming curve to the west of the Mashpee Museum. Also, although there are chevrons installed on the curve, there should be an additional chevron installed at the beginning of the curve. Additionally, it was noted that there is a missing chevron about mid-way around the curve, apparently having been struck by a vehicle but not repaired. When traveling east, as you near the Great Neck Road North intersection, there is a Stop Ahead sign that has some paint on it. This sign should be replaced as painting typically damages the surface of the sheeting enough to permanently affect the retroreflectivity. There is an older Mashpee welcome sign that has stout 6x6 wooden supports. The sign isn't designed as a breakaway sign. The base of each post should be modified or the posts replaced per MUTCD specs to convert it to breakaway. There is an old guardrail with outdated end treatment situated a considerable distance away from the edge of the roadway. Perhaps this is a remnant of a prior roadway design or alignment, but at this point it isn't needed and should be removed. Near the intersection of Great Neck Road North, there are a number of signs, which could potentially create sign clutter. It was noted that there are duplicate No Parking and Right Turn Must Turn right signs that can be removed to help eliminate the clutter.

redundant No Parking and Right Lane Must Turn Right signs to reduce sign clutter at Great Neck Road North intersection, modify or replace sign posts to meet breakaway standards, clean under guardrail on north side of Route 130, remove unnecessary guardrail on south side of Route 130 near the Great Neck Road North intersection.

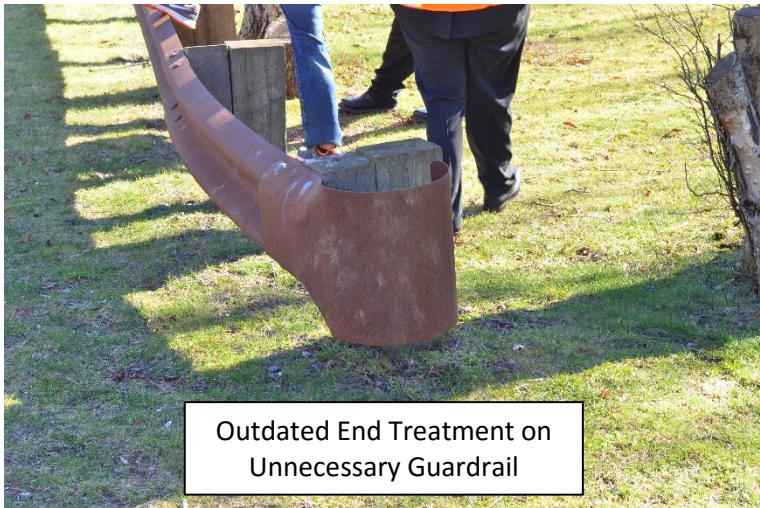
OBSERVATION: Install and Improve signage, ensure signs with wooden posts are breakaway, clear under guardrail on north side of Route 130, reduce signage near Great Neck Road North to reduce clutter, remove unnecessary guard rail near Great Neck Road North intersection.

Outdated End Treatment on Unnecessary Guardrail

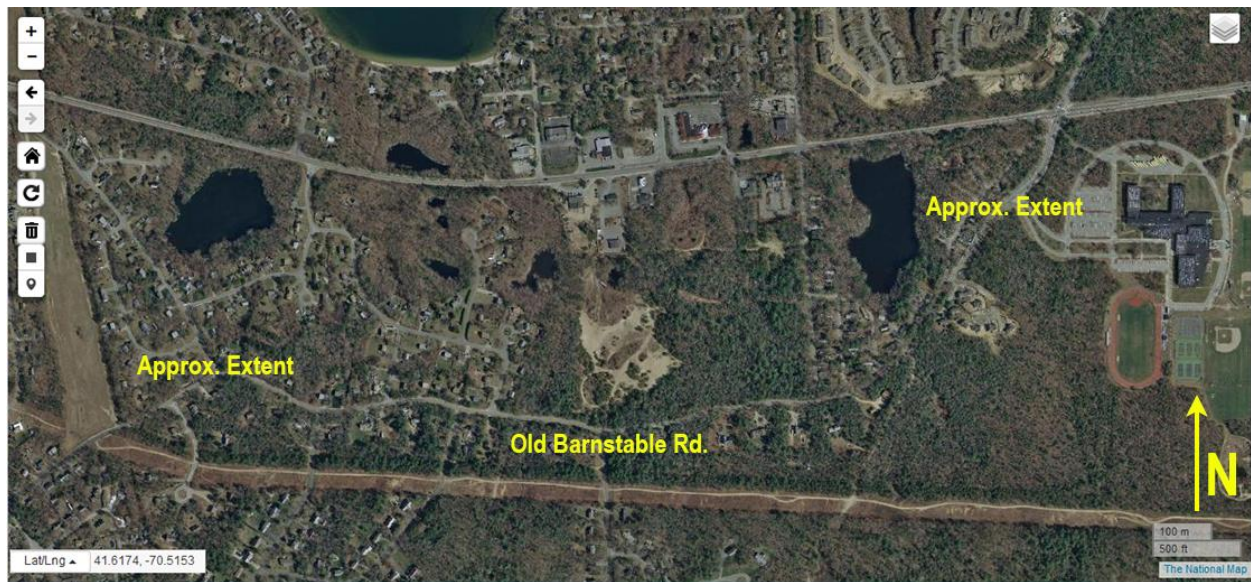
Figure 9: Old Barnstable Location

Old Barnstable Road is a two-lane urban collector (MassDOT designated) exhibiting rural road characteristics with medium to high traffic volumes. The reviewed section connects MA Route 151 with County Road at the Mashpee/Falmouth town line. The Mashpee High School is located near the signalized 151/Old Barnstable intersection. The 151/Old Barnstable intersection and Old Barnstable road near the high school access drives have been recently reconstructed with turn lanes and modern geometry to accommodate school traffic. The road is a designated MA bike route and frequently used by bicyclists and pedestrians, including school-aged children walking or biking to and from school and social functions. Mashpee High School offers 100% busing for regular school hours, but many residences are within walking and biking distance, and students may be choosing to walk or bike to school in order to attend sports and social functions outside the academic schedule, or for other reasons.

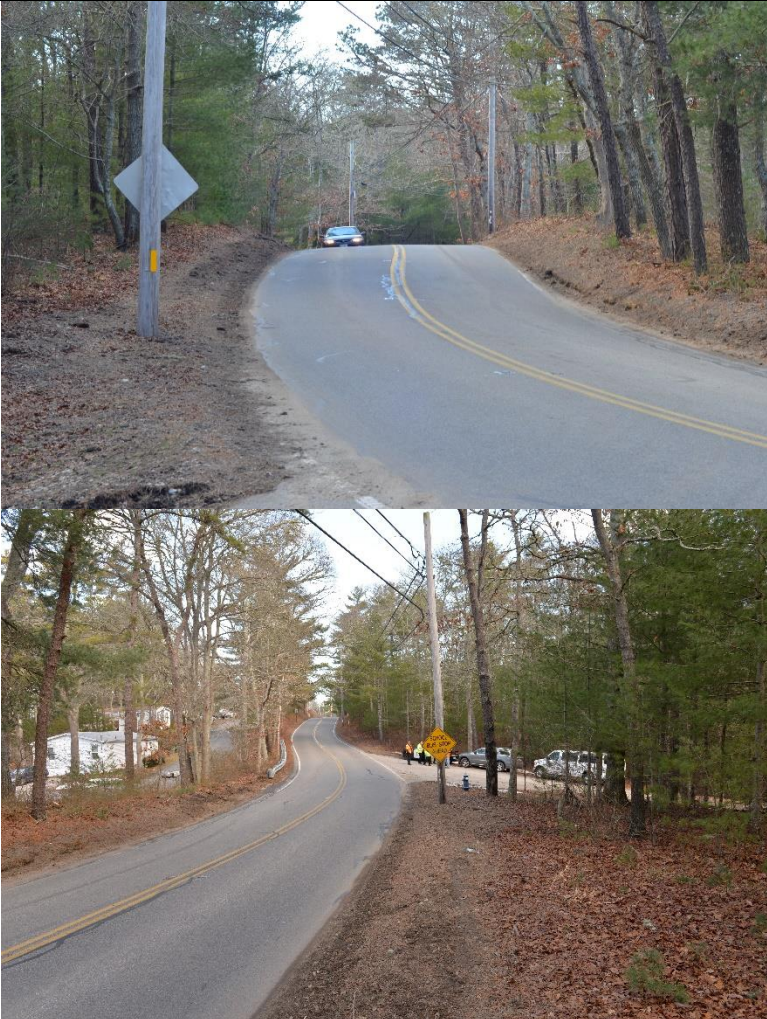
Old Barnstable Road: Safety Issues		
EXPECTED FREQUENCY	EXPECTED SEVERITY	RISK RATING
Frequent	High - Extreme	E - F
<p>OBSERVATION: Old Barnstable road is a very narrow, winding road with steep, close banks at many locations, steep and frequent rises and drops, trees and utility poles within inches of the road edge, very narrow or no shoulders, low guardrails, outdated guardrail end treatments, little or no recovery zones, poor sight distances, high traffic volumes, presence of pedestrians and bicyclists in the travel lane with few escape opportunities, little or no signing, poorly maintained marking, significant edge drop-offs, and little or no lighting. A memorial for a recent pedestrian fatality was observed.</p>

COMMENTS: The team felt that Old Barnstable Road was such a high risk that most team members remained in the observation vehicles safely parked on side roads. Although this road does limit speed due to psychological and physical constraints of the narrow road, the risk of failing to navigate the many curves is generally very severe due to large trees, utility poles, and steep banks along the entire route and very close to the road's edge.

Low: Conduct a systemic analysis of entire section to identify known traffic safety risks, and/or conduct a comprehensive evaluation of entire section to provide consistent safety features, including the Low, Medium, and High recommendations listed here.

Repair, replace and/or install guardrails according to standard practices.
