# Town of Wellfleet Road Safety Audit Route 6 at Main Street

**December 2016**

**Prepared by the Cape Cod Commission in cooperation with the Town of Wellfleet, and  
MassDOT Highway Division Traffic Safety and District 5 Offices.**

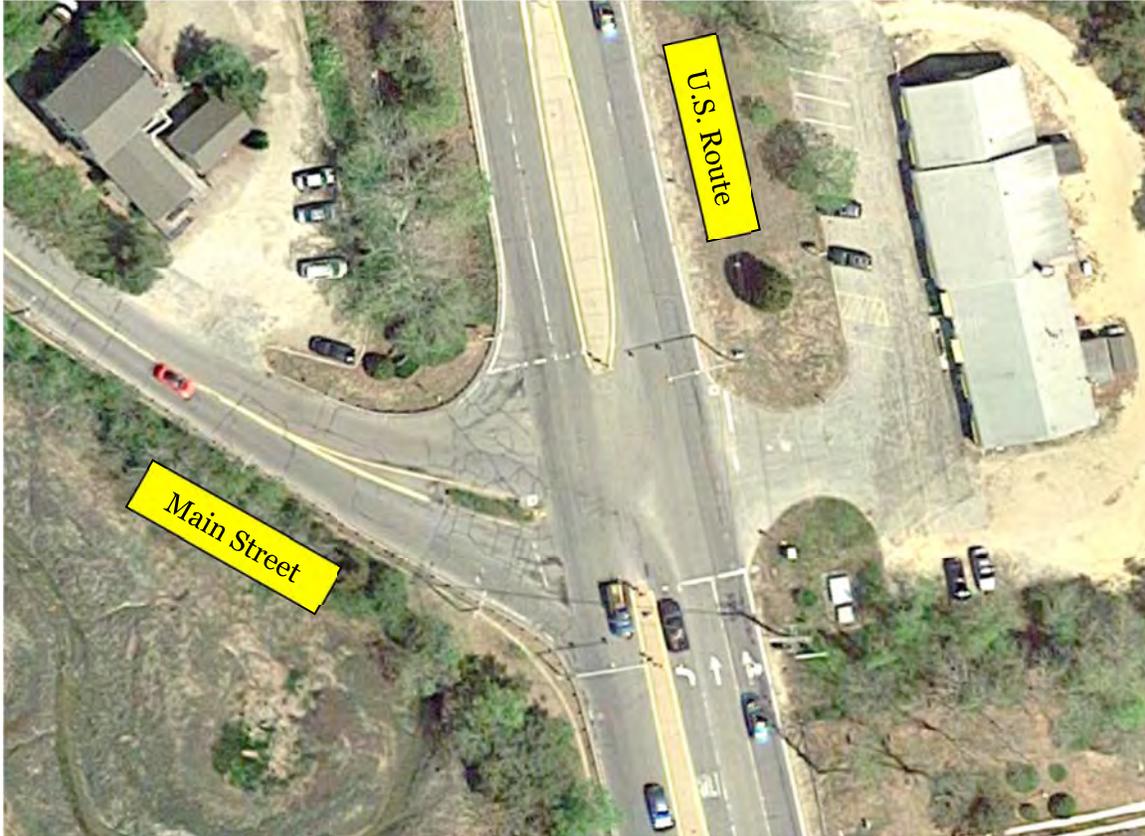
**Figure 2 – Close Aerial View of Route 6/Main Street Intersection**

Figure 2 shows a close-up view of the intersection. Northbound Route 6 consists of a left-turn-only lane, a through-lane, and a through/right-turn lane. Southbound Route 6

consists of a through/right-turn lane and a through/left-turn lane. Main Street is a two-lane road, in the vicinity of the intersection widening occurs to allow for separate turning movements. While not shown in the aerial photo, there is a right-turn pavement marking on the Main Street approach. The commercial driveway is served by a single multi-purpose lane approaching the intersection. There are no pedestrian push buttons at the traffic signal, nor any crosswalks.

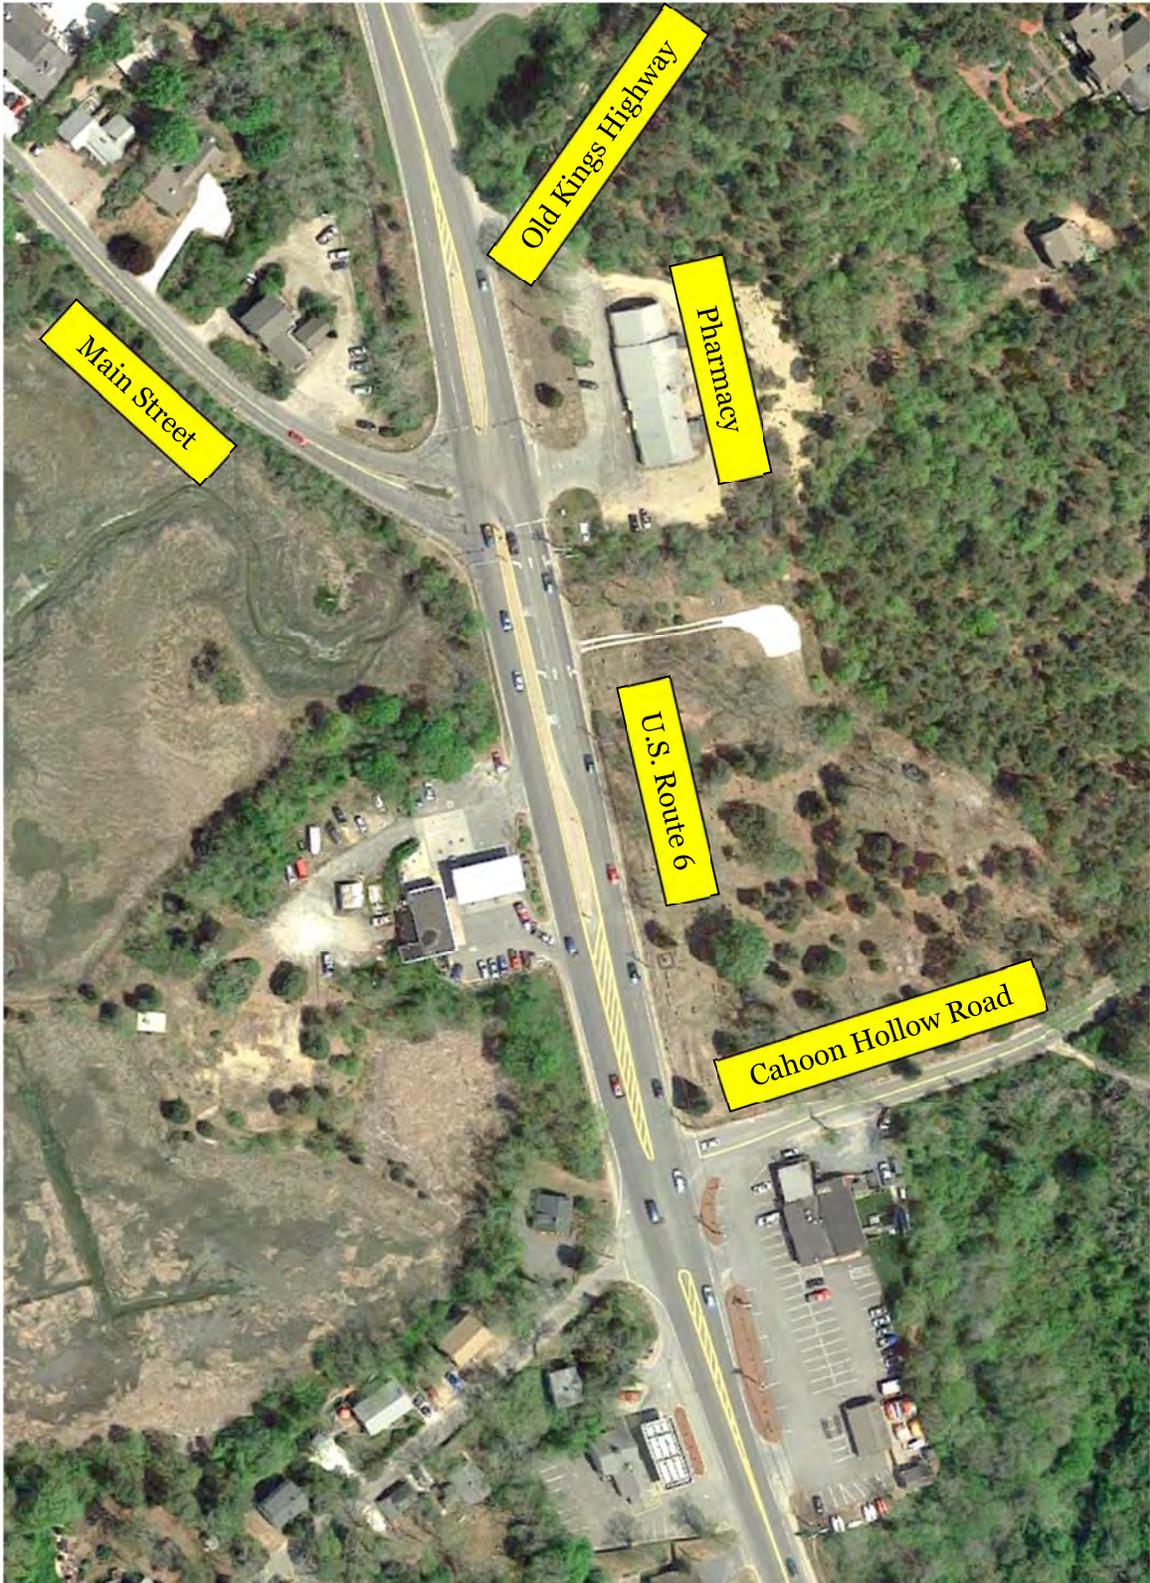
**Figure 3 – Large-scale aerial view of Route 6 at Main Street intersection**

Figure 3 on the following page shows a larger-scale aerial of the study location. As shown in this view, Route 6 to the north of the study area is a two-lane roadway; southbound Route 6 transitions to a four-lane roadway in the vicinity of Old Kings Highway. Likewise, Route 6 to the south of the study area is a two lane roadway and begins its transition to a five-lane cross section from the south of Cahoon Hollow Road.

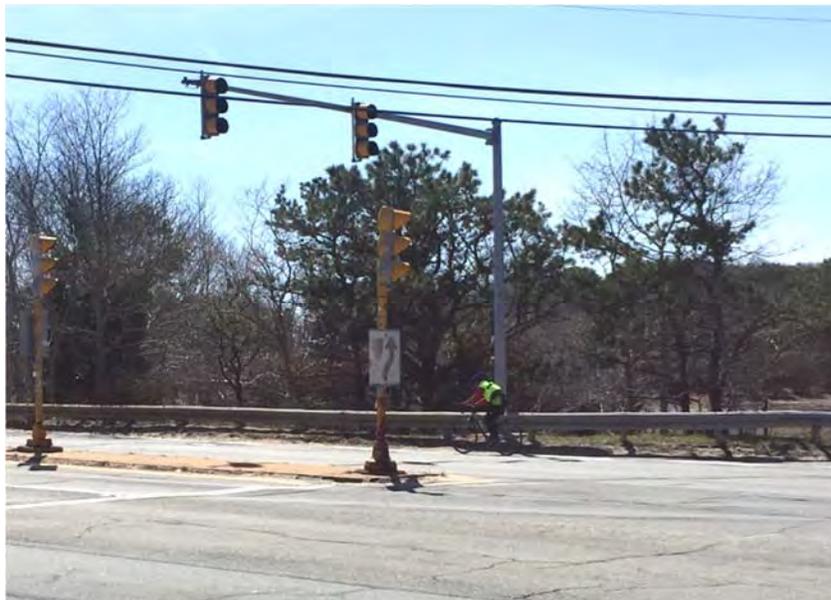
**Figure 5 - Cyclist traveling from Main Street to southbound Route 6**

Bicyclist and pedestrian accommodations are essentially non-existent within the study area. There are no sidewalks along any of the study area roadways. The study team noted throughout the intersection the existence of “goat paths” (evidence of pedestrians traveling along the roadways on unimproved surfaces). Team members with local knowledge noted that many bicyclists and pedestrians travel along the south side of Main Street and turn right at the intersection, staying along the west side of Route 6 destined for residential areas, commercial establishments, and to eastern areas via Cahoon Hollow Road. Pedestrians traveling between Main Street and the pharmacy do have the benefit of the median island that can be used as a pedestrian refuge while crossing Route 6. Many pedestrians and bicyclists have been observed crossing Route 6 to access Cahoon Hollow Road and various other destinations - some at their peril as evidenced by a 2013 fatality of a bicyclist crossing about 100 feet south of the gas station (about a quarter-mile south of the Main Street/Route 6 intersection).

The potential for danger to bicyclists and pedestrians is demonstrated by the damaged guardrail observed on the northwest quadrant of the intersection; additionally, the height of this guardrail appears too low. Team members noted that travel speeds on Route 6 can be excessive especially in such close proximity to pedestrians and bicyclists.

Install crosswalks; signal upgrade to include pedestrian phase.

Provide pedestrian & bicycle accommodations along Route 6 between Main Street and Cahoon Hollow Road. This may include sidewalk and bicycle accommodating shoulders and/or separated share-use path.

Provide bicycle accommodating shoulders along Route 6 north of Main Street and south of Cahoon Hollow Road.

Repair damaged guardrail and reset the existing guardrail to the standard height.

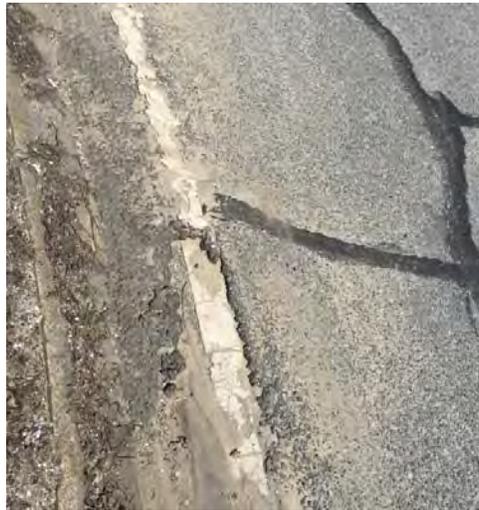
**Figure 6 - Edge line markings obscured by sand**

Pavement markings seem to be in reasonable condition, however, sand and debris are obscuring a fair amount of the markings along the east side of Route 6. Participants also noted that there were no guide signs on the approach to Route 6 from Main Street and felt that a guide sign may help to convey to motorists that they will be entering a major arterial roadway, and also for general wayfinding.

Update pavement markings with retro-reflective materials.

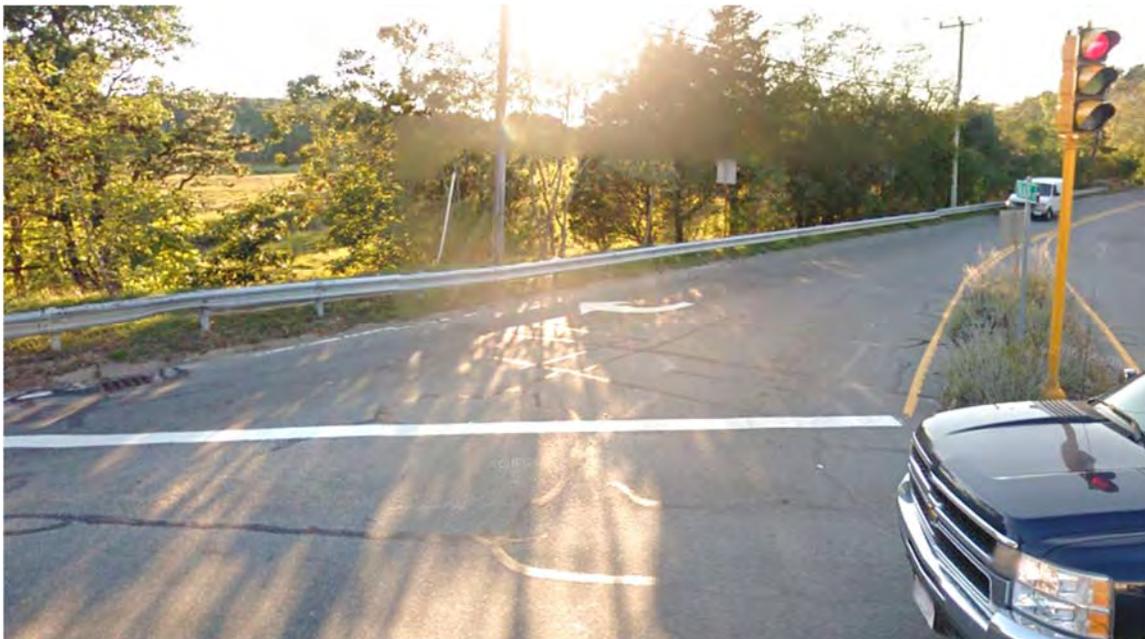
**Figure 7 - Looking west toward Main Street approach**

Team members noted the unusual guidance provided by the “right-turn-only” symbol installed on the right-hand side of the Main Street approach; however no lane markings are provided at this approach (see Figure 7).

Include “through/left-turn” pavement marking on Main Street approach separated by single white line from existing “right-turn only” marking.

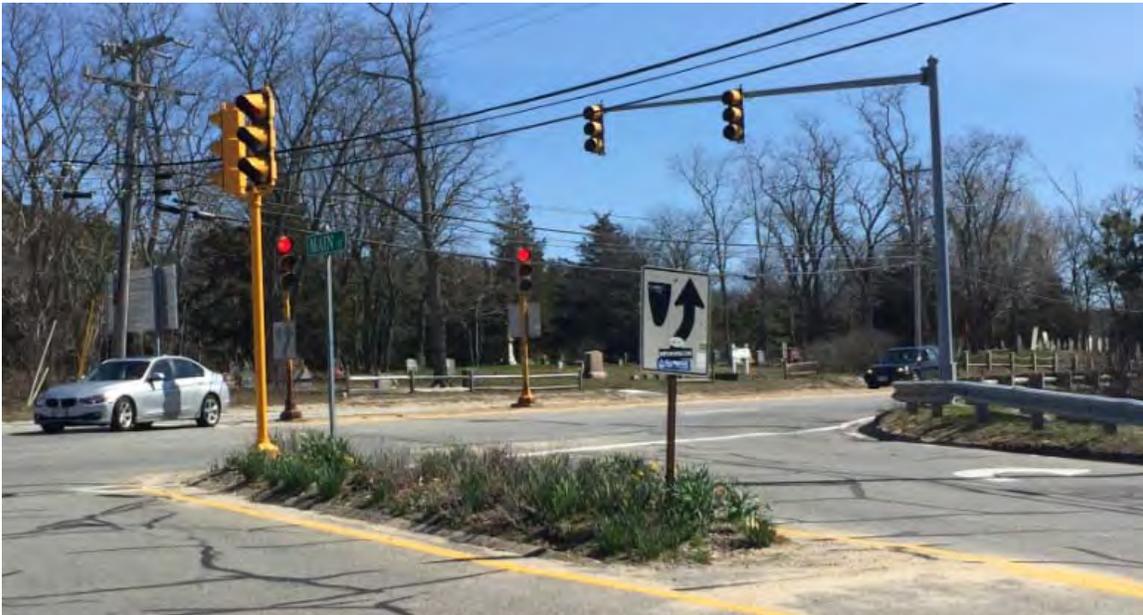
**Figure 8 - Looking east from Main Street - note low height of "Keep Right" signs**

Retroreflectivity of signs was considered to be very poor especially on some of the signs installed in the median of Route 6. The height of some of the signs seemed to be too low and had the potential to block sight lines (see Figure 8).

Assess correct sign height and positioning, replace as needed with retroreflective signage.

Install “keep-right” signage on entrance to Main Street.

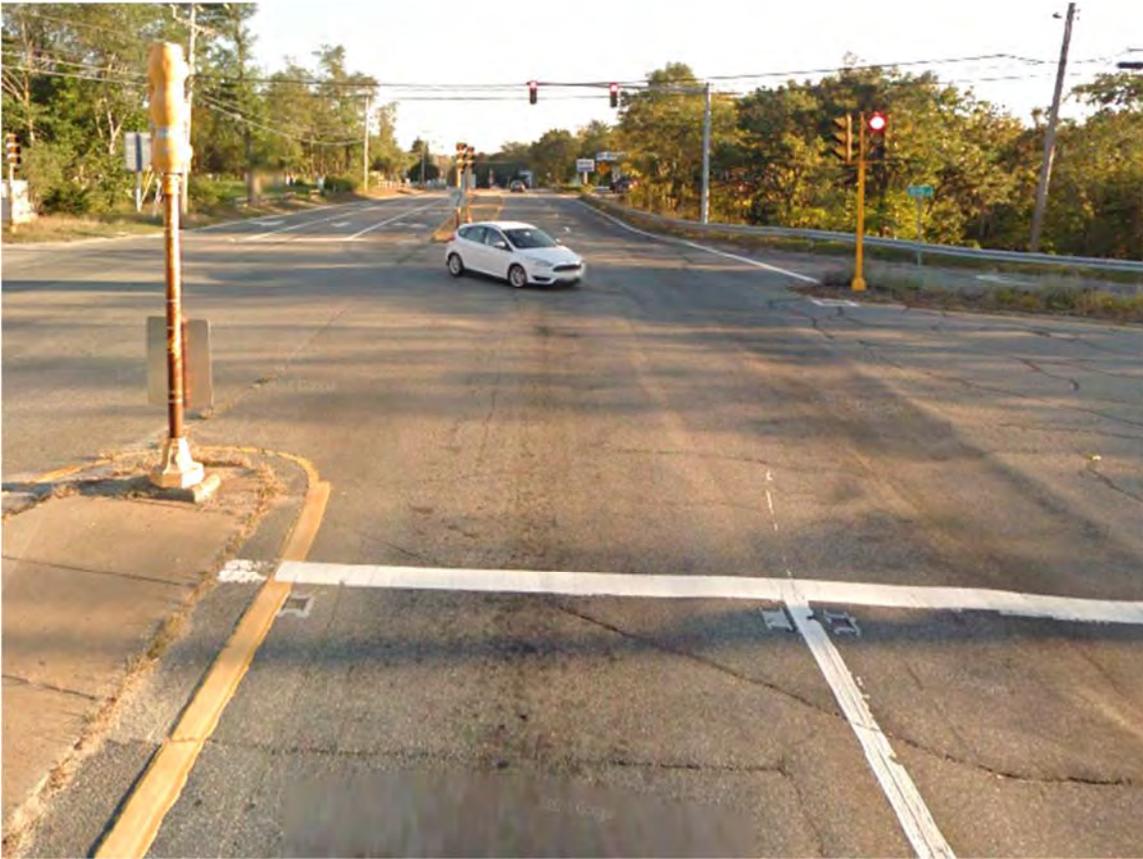
**Figure 9 - Looking south -note oncoming left turn lane (when occupied) obscures view of southbound left-turning motorists**

As noted in above safety issues, there are a number of intersection control elements (signs, signal housing poles) that interfere with sight lines. The most serious obstruction to sight lines occurs when the northbound Route 6 left-turn lane is occupied. Southbound motorists waiting to turn left into the pharmacy cannot identify safe gaps in the northbound traffic stream to complete their maneuver. This is evidenced by the five left-turn angle crashes (two involving injuries) at this location (as shown in the collision diagram in the appendix). Additionally, southbound motorists’ view of the signals is briefly blocked by a large tree at the edge of the roadway.

During intersection upgrade, remove post-mounted signal housings and replace with overhead housings; add left-turn phase for southbound Route 6; add left-turn lane/signal phase for southbound Route 6 (to eliminate the hazard caused by northbound left-turning vehicles obscuring the view of southbound left-turning motorists).

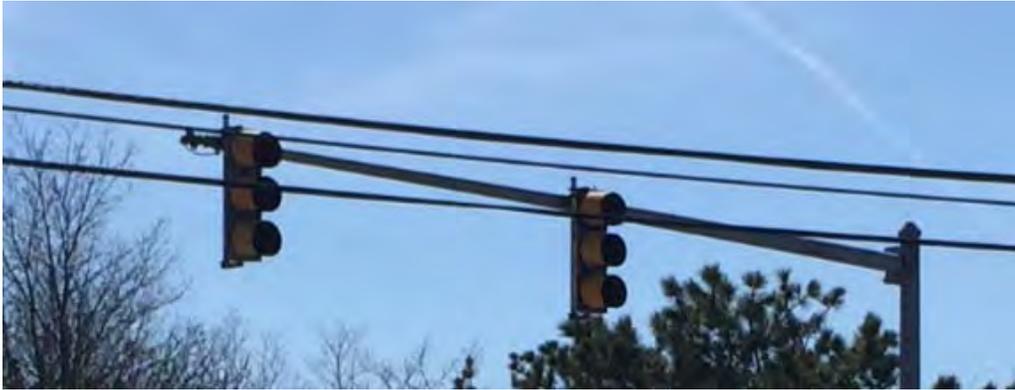
**Figure 10 - Potential obstructed view of signal housings due to utility cables**

Another visual defect is the elevation of the overhead utility cables, some of which may interfere with a motorist's view of the signal housings (see Figure 10). The location of the signal control box in combination with vegetation and a guide sign obscures the view from motorists entering the intersection from the pharmacy.

Investigate increasing elevation of utility cables.

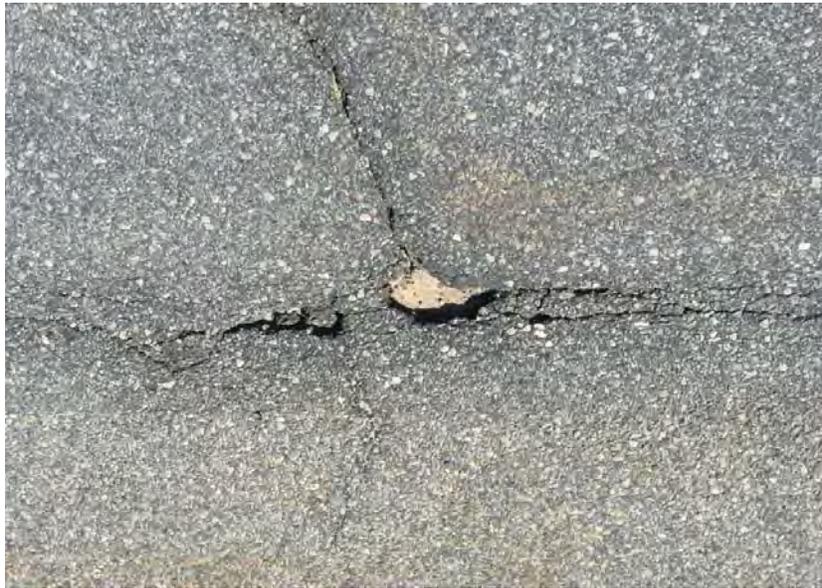
**Figure 11 - Example of pavement distress**

A number of pavement distresses were observed throughout the study area including weathering, spalling, transverse and longitudinal cracking. Paving material loss is so great that portions of the signal loop detectors are exposed.

Areas of the intersection showed evidence of ponding and rutting which could contribute to hydroplaning such as in the northwest quadrant. Uneven settling of pavement was noted by the varying curb reveal in the area.

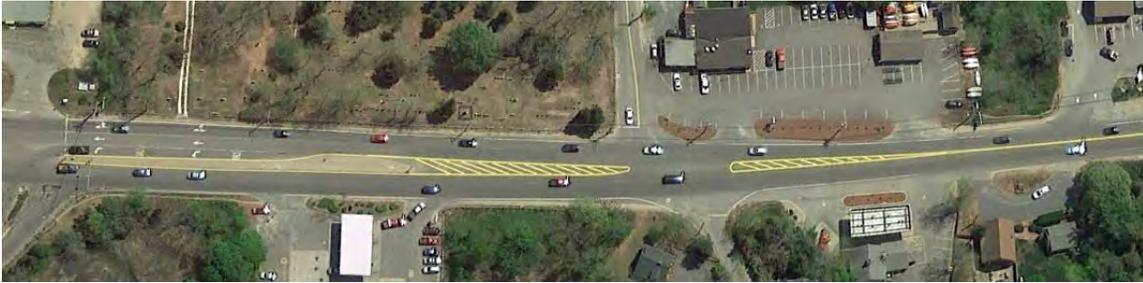
**Figure 12 - Aerial view of Route 6 south of Main Street (north to left)**

The team noted that Route 6 drivers often take advantage of the additional lanes in the intersection to pass slower drivers since Route 6 north and south of the intersection is a two-lane road with limited passing opportunities. For northbound drivers (see aerial view in Figure 12) the total pavement width begins to increase south of Cahoon Hollow Road, eventually accommodating two through lanes and a dedicated left-turn lane. Through travelers designated for points north occasionally will “race” the vehicle in the adjacent lane.

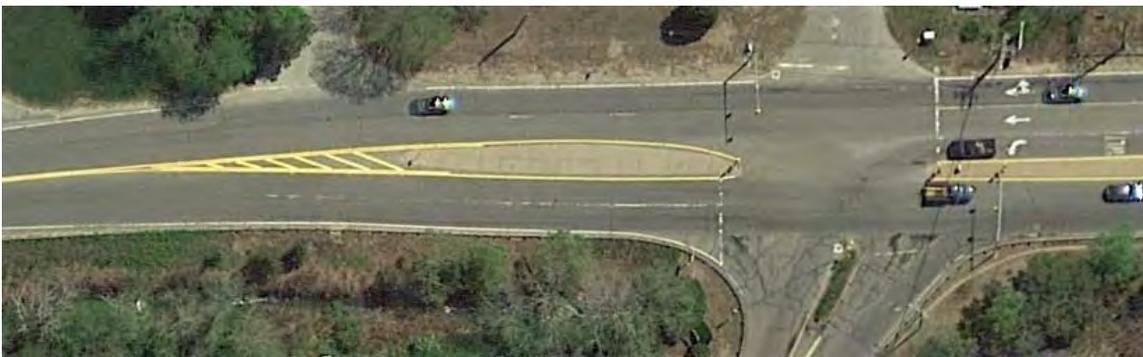
**Figure 13 - Aerial view of Route 6 north of Main Street (north to left)**

This same phenomenon occurs for southbound vehicles (see aerial view in Figure 13). The “racing” phenomenon is occasionally complicated by vehicles waiting to turn left into the pharmacy.
