CAPE COD
COMMISSION

Town of Barnstable Road Safety Audit - Route 6A (Main Street) at Mary Dunn Road/Indian Trail

April 3, 2019

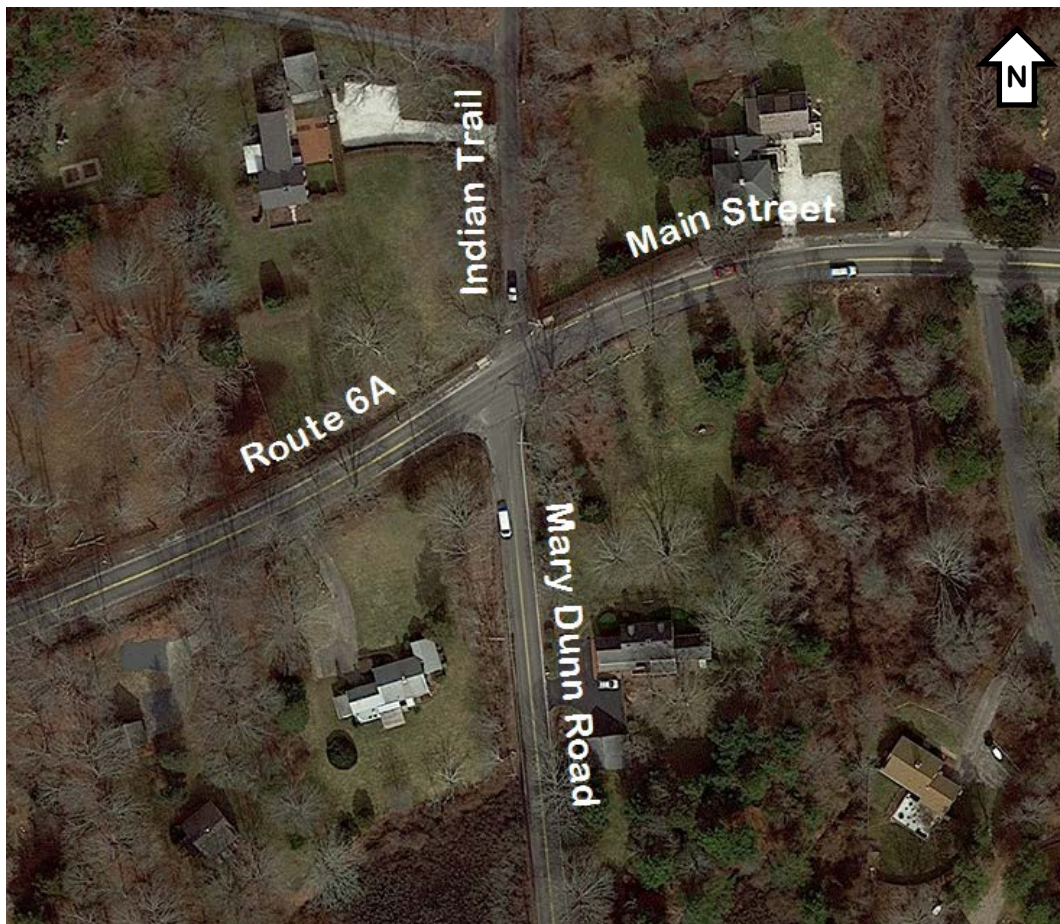
Figure 1 – Aerial view of Route 6A and Mary Dunn Road/Indian Trail intersection

Route 6A (Main Street) at Mary Dunn Road/Indian Trail in Barnstable is a four-way, unsignalized intersection. Route 6A is a major east-west connection north of Route 6 on Cape Cod, connecting Bourne with Orleans before joining with Route 6 at the Orleans/Eastham Rotary.

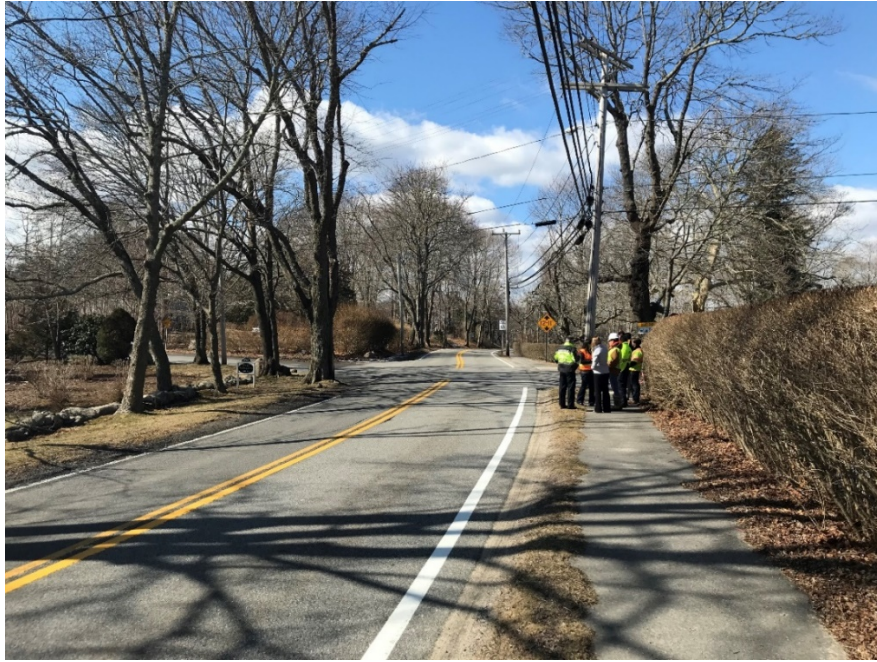
- Route 6A includes a sidewalk along the northern side of the roadway, however, there is no sidewalk along the southern side.
- The existing sidewalk is fairly close to the road with little to no separation from the travel lanes and there is a lack of marked crosswalks throughout the Route 6A corridor; hedges were noted as infringing on the sidewalk, making it feel narrower.

Figure 4 – Route 6A westbound sidewalk with minimal separation approaching intersection

- Add designated bike lanes or bicycle tolerant shoulders along Route 6A and Mary Dunn Road.
- Install a sidewalk (or a portion of sidewalk) along Mary Dunn Road.
- Install a crosswalk on the westbound approach of the intersection. A sight distance evaluation should be performed prior to installation.
- Paint “sharrows” on Route 6A and Mary Dunn Road indicating to motorists to share the road with bicyclists.
- Trim back hedges that are encroaching on the sidewalk and confirm sidewalk is ADA compliant.

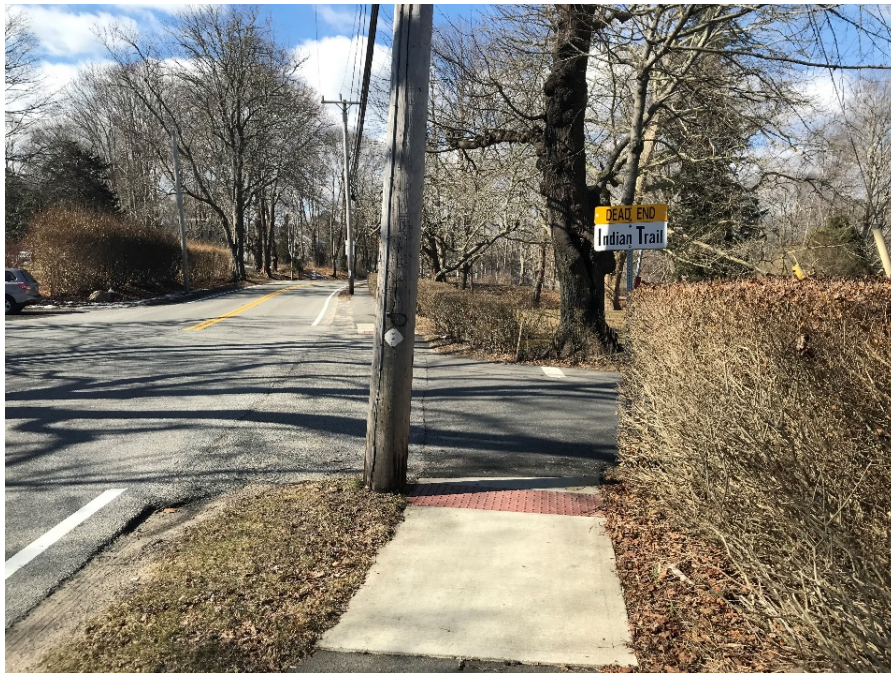
Figure 5 – Route 6A westbound approach sidewalk at Indian Trail

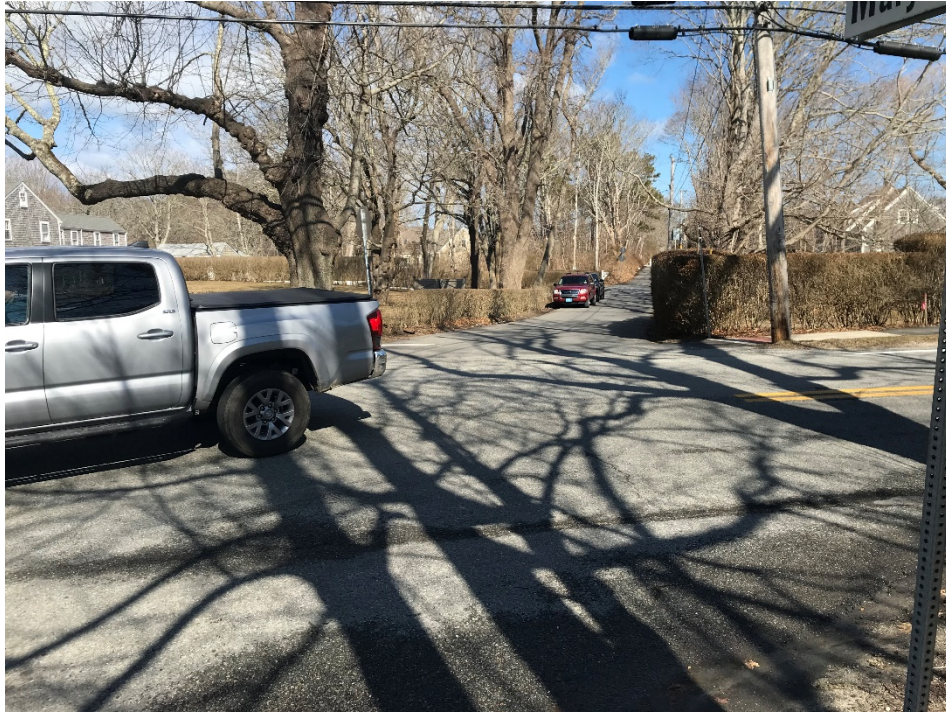
- Indian Trail is a narrow roadway making it difficult for two cars to enter and exit the roadway at the same time.
- Safety issues exist with left turn queues on Route 6A as the intersection is located on a curve making it difficult for motorists to anticipate a stopped vehicle, as noted by the Route 6A westbound rear end collision (#4).

Figure 6 – Narrow road width on Indian Trail

When developing potential solutions to improve safety at intersections, the Commission considers conversion to roundabout as well as traditional signal-controlled options.

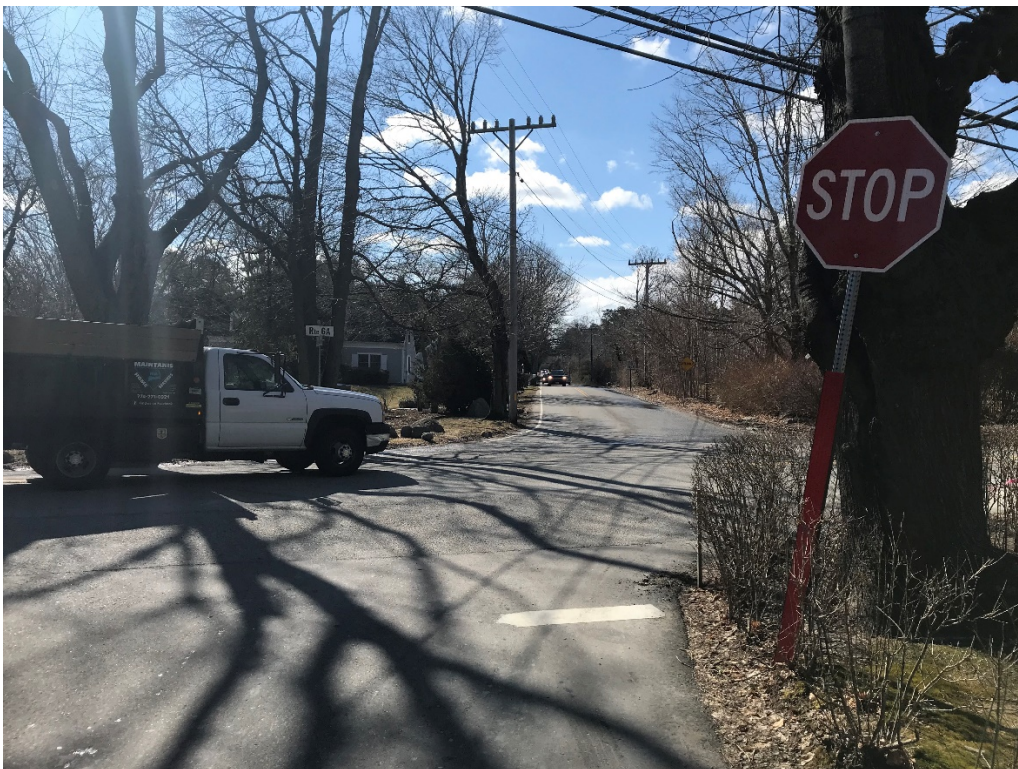
- Mary Dunn Road and Indian Trail are offset slightly; vehicles must jog slightly to the right when trying to continue straight through the intersection from either Mary Dunn Road or Indian Trail. The offset alignment may be a contributing factor to the angle collisions (#3, 5) at this intersection.

Figure 7 – Indian Trail approach showing offset intersection alignment

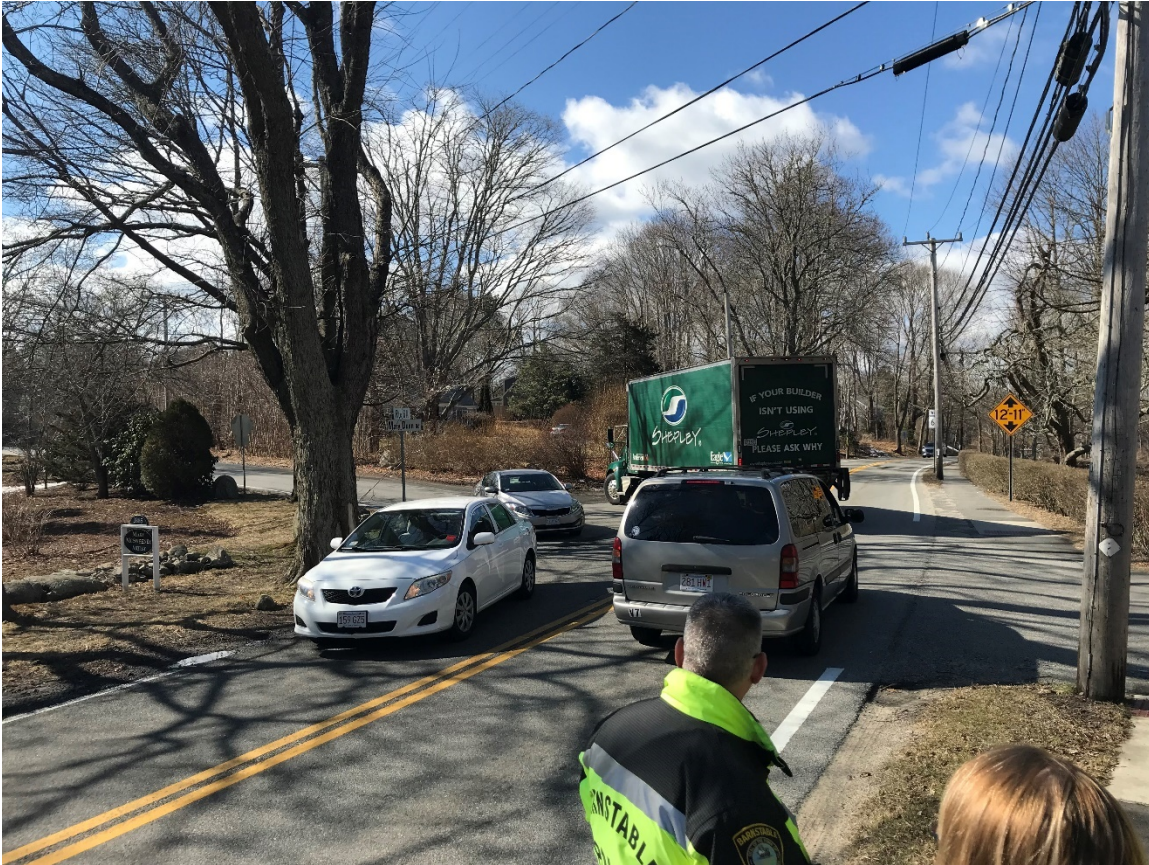
- Many larger trucks were taking such wide turns and encroaching on the lawn of the property on the southeast corner when taking a right from Route 6A eastbound. Conversely, trucks encroach on the southeast corner when making a left turn onto Mary Dunn Road when there is a vehicle at the stop bar on Mary Dunn Road.

Figure 8 – Truck turn difficulty

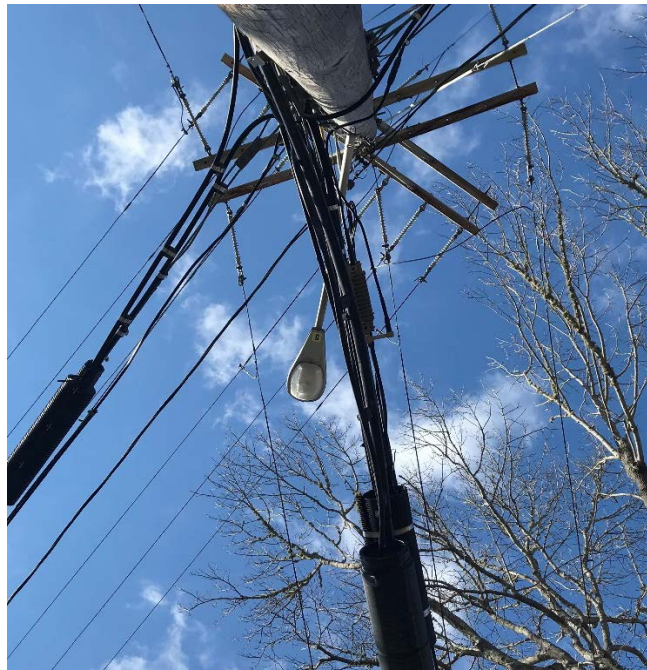
- There is one, older style, street light on the northeast corner of the intersection; LED lighting may be too bright for the nearby homes at the intersection, however, 3 out of 8 crashes occurred outside of normal daylight hours.
- Route 6A is posted for 40-mph at the intersection; speeding is a concern for all users, speed limits vary greatly throughout the corridor, which causes confusion and makes it difficult for the police department to enforce.
 - Speeding was a noted concern on Mary Dunn Road (posted at 30-mph) and is noted as a contributing factor for a rear-end crash on Mary Dunn Road (#8). It was also noted that the existing radar sign in the northbound direction is broken.

Figure 9 – Existing Street Light

- Replace street light with newer model and consider additional lighting fixtures to help address nighttime crashes.
- Add traffic calming pavement markings or consider reducing travel lane widths with a painted median to slow traffic through the intersection to help reduce the severity of crashes at the intersection.
- Conduct a follow-up speed study after short-term improvements implemented.
- Fix the broken radar speed sign on Mary Dunn Road.

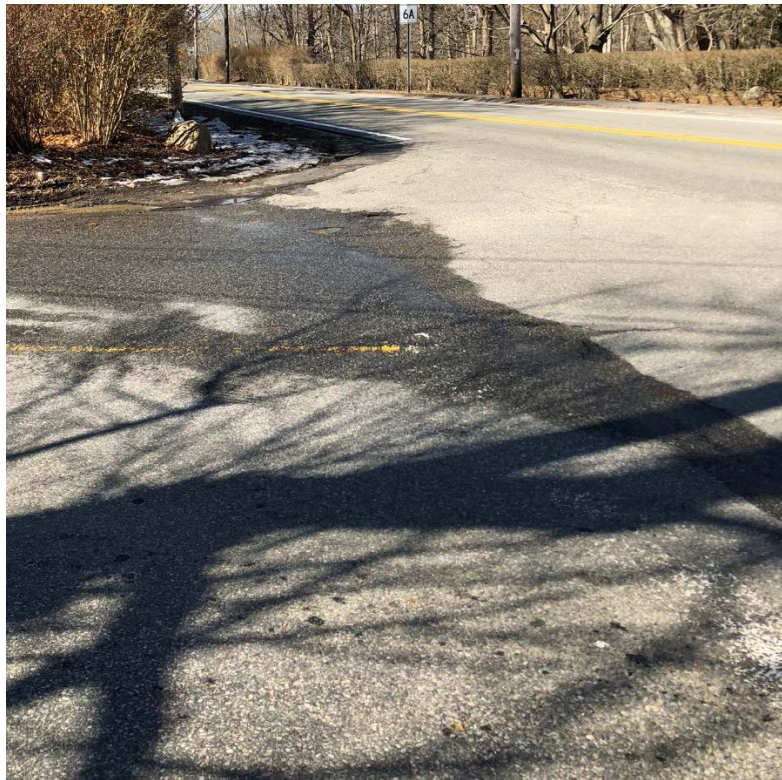
- The stop line pavement markings on Mary Dunn Road and Indian Trail are worn and missing in sections.
- The stop sign on Mary Dunn Road has a warning sign under it reading “cross traffic does not stop” and is not located at the stop line.
- There are several existing recessed pavement markers on Route 6A that are broken or missing, which may have been a contributing factor for the sideswipe crash during nighttime hours on Route 6A (#7).
- There are horizontal alignment signs approaching the intersection on both Route 6A approaches that were recently installed by MassDOT.

Figure 10 – Worn stop bar on Mary Dunn Road

- Add intersection name plaques to intersection warning signs on Route 6A to alert motorists of the intersection that they are approaching.
- Replace worn pavement markings, including stop lines on Mary Dunn Road and Indian Trail and recessed pavement markers on Route 6A.
- Include destination information & arrows for bike route signs (e.g., “To Cape Cod Rail Trail”) to provide better wayfinding for cyclists, pedestrians, and motorists.
- Improve stop sign placement on Mary Dunn Road approach.

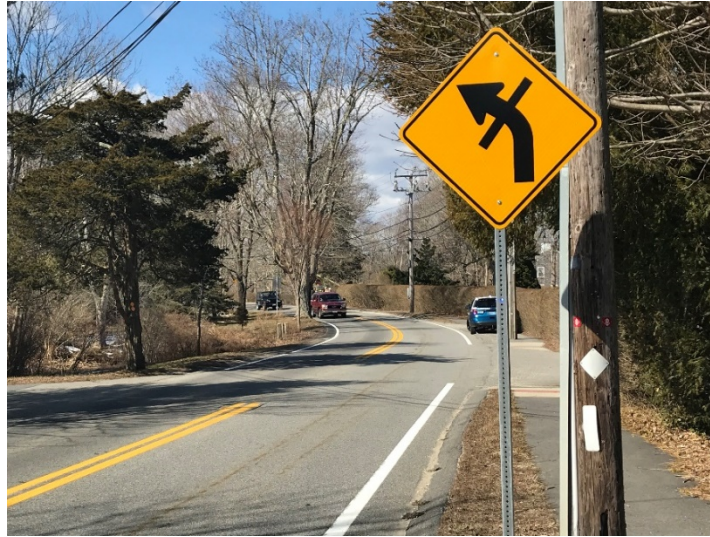
Figure 11 – Horizontal curve sign on Route 6A approaching intersection

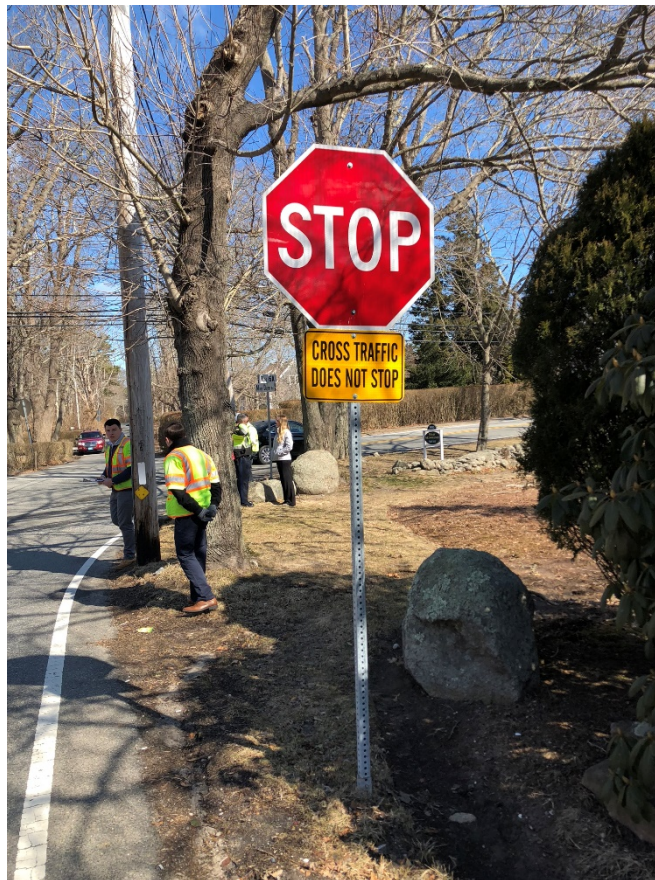
Figure 12 – Mary Dunn Road stop sign with warning plaque

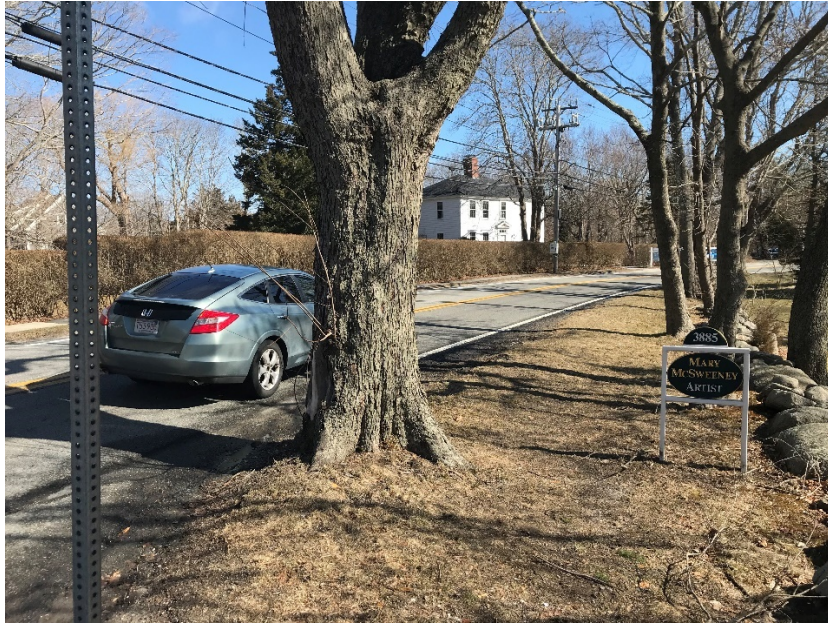
- For vehicles exiting Indian Trail, sight distance is limited by overgrown vegetation/hedges in both the northwest and northeast quadrants as well as a utility pole in the northeast quadrant; additional vegetation obscures the view of the stop sign. These sight obstructions likely contributed to the angle collision originating from Indian Trail (#5).
- For vehicles exiting Mary Dunn Road, sight distance is limited by overgrown vegetation/hedges and in the southwest quadrant along Route 6A, as well as trees in the southeast corner. These sight obstructions likely contributed to the angle collision originating from Mary Dunn Road (#3).
 - The trees in the southeast corner also obstruct vehicles travelling westbound on Route 6A from seeing vehicles stopped on Mary Dunn Road.

Figure 13 – Trees causing sight obstructions in southeast quadrant of intersection

- Conduct a tree assessment for the existing large trees at the intersection.
- Potentially remove trees on the southeast quadrant of the intersection that are currently obstructing sight lines along Mary Dunn Road and Route 6A to reduce single vehicle crashes at the intersection
- Relocate the utility pole on the northeast corner of the intersection. Consider removal of the empty utility pole to the west of the intersection on the south side of the roadway.
- Trim or consider removal of the overgrown hedges on all corners of the intersection to improve sight lines. Coordinate with abutters on potential remedies if obstructions are on private property.

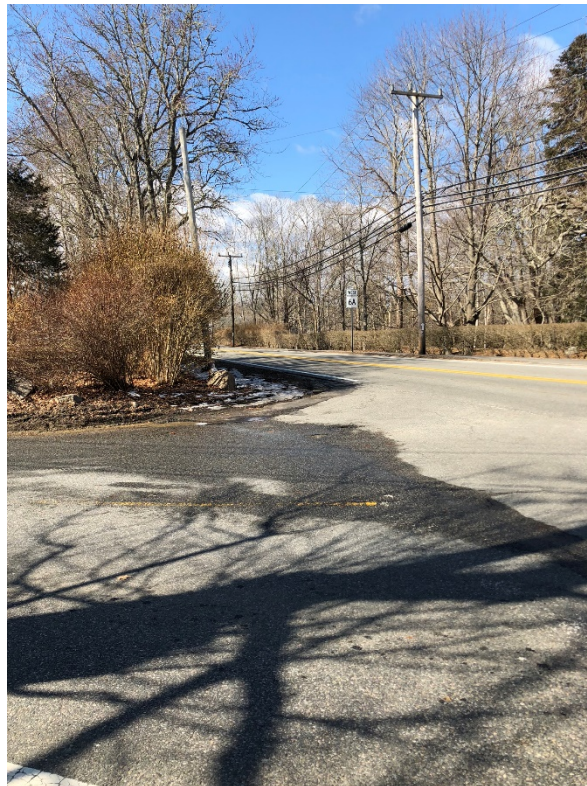
Figure 14 – Sight line obstructions in the southwest quadrant of the intersection

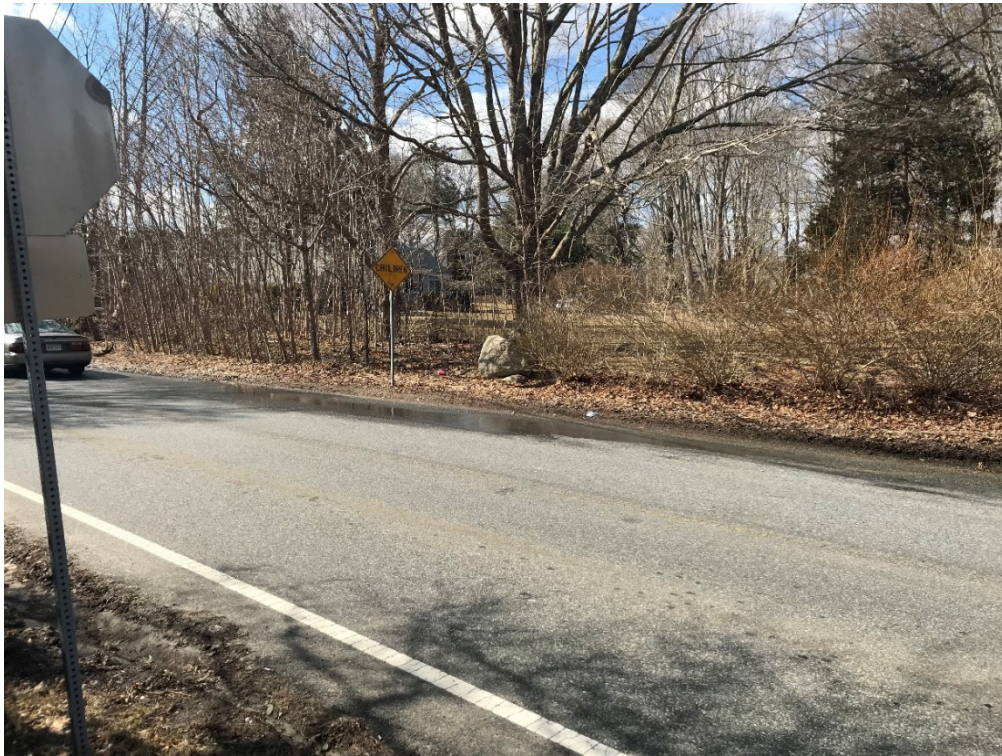
- Pavement on Route 6A is showing signs of wear including weathering and pot holes along the edge of the pavement on the south side of the roadway.
- There was some runoff/ponding along Mary Dunn Road. Wet pavement conditions were noted as a possible contributing factor for a rear-end collision on Mary Dunn Road (#8).

Figure 15 – Runoff flowing toward intersection on Mary Dunn Rd

- Further investigate drainage runoff issue on Route 6A.
- Maintain catch basins, re-install covers as needed to improve roadway drainage.
- Consider filling in potholes along the shoulder of the roadway.
