Town of Mashpee  
Road Safety Audit  
Route 151 (Nathan Ellis Highway) at  
Ninigret Ave, Algonquin Ave, and Job's  
Fishing Road/Frank E Hicks Drive

**May 9, 2018**

Prepared by the Cape Cod Commission in cooperation with the Town of Mashpee and MassDOT Highway Division, Traffic Safety, and District 5 Offices.

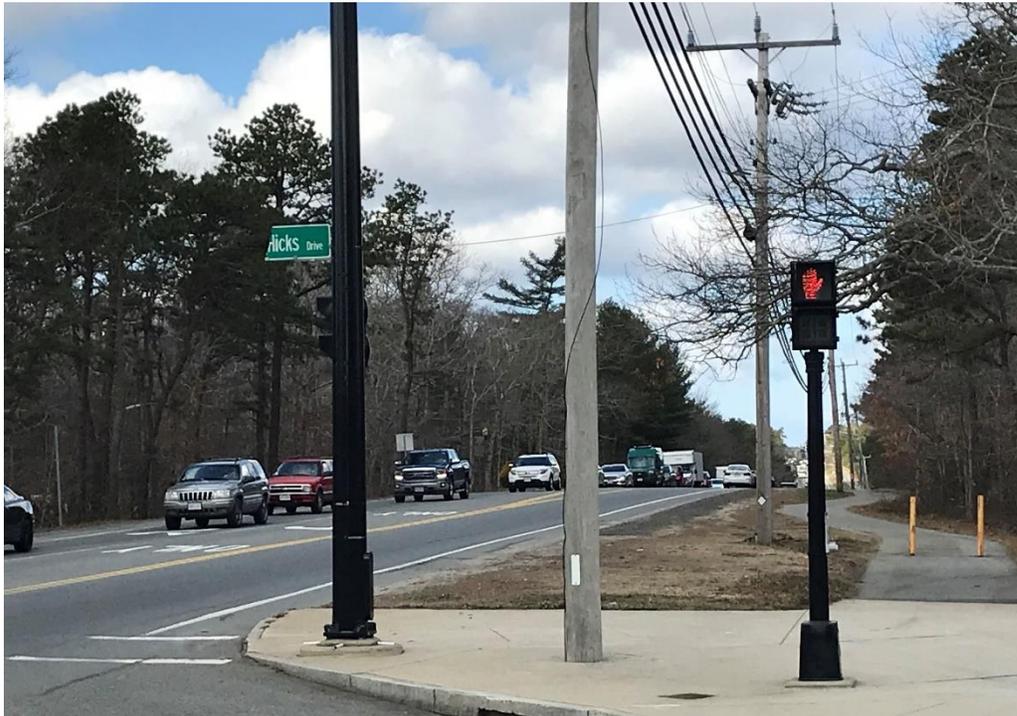
- The Frank E Hicks Drive street name sign is broken in half probably due to the turning radii.

**Figure 3 – Frank E Hicks Drive sign broken on signal pole**

- Replace broken Frank E Hicks Drive street sign, and consider relocating the new one to overhead signal bar.
- Replace the existing black on white Route 151 street signs along the top of the signal bar with MUTCD-compliant white on green signs on the signal post, or the MA-M1-5 state route signs.

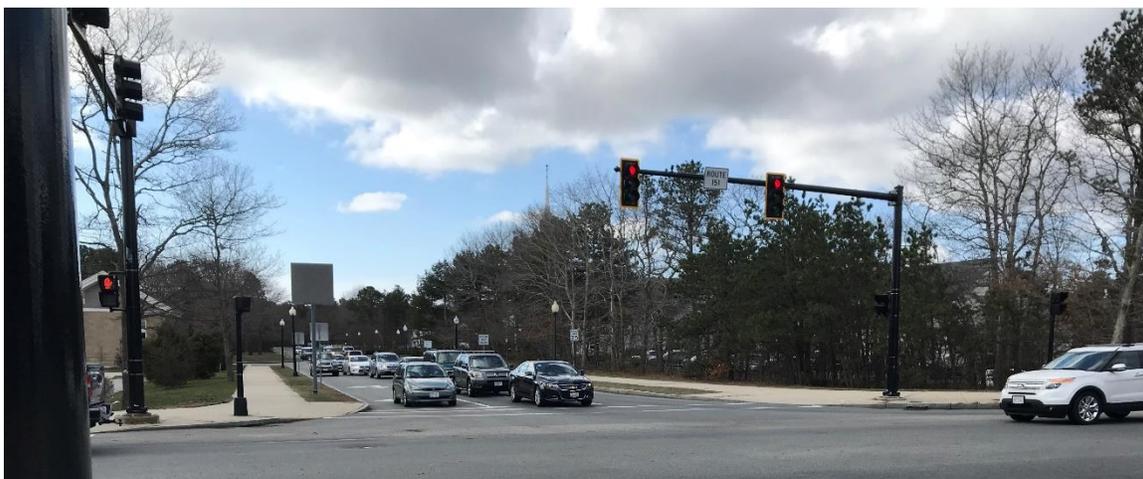
**Figure 4– Motorists queuing on Job's Fishing Road in left turn lane**

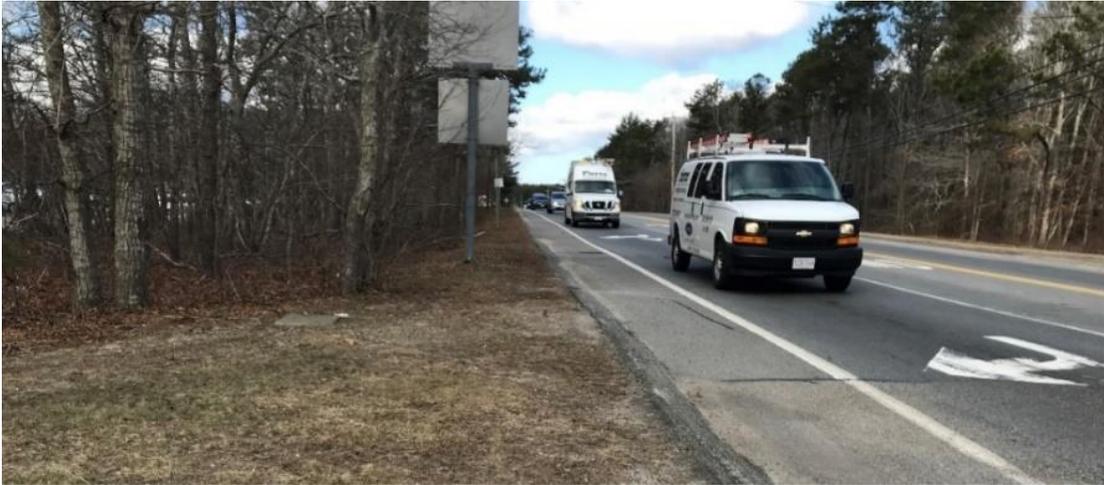
- The speed limit approaching the intersection eastbound along Route 151 is posted at 50 MPH, and due to some of the poor sight lines many vehicles are needing to slow down rapidly to avoiding running a red light; this intersection is prone to many rear-end crashes, presumably due to the differential in speeds when approaching the light. The vertical curve of the roadway could also be a factor in speeding.
- Audit team members noted that many vehicles run red lights to avoid having to wait for the next green light, causing more congestion for the lanes that were now green.

**Figure 5– Vehicles approaching intersection along Route 151 eastbound**

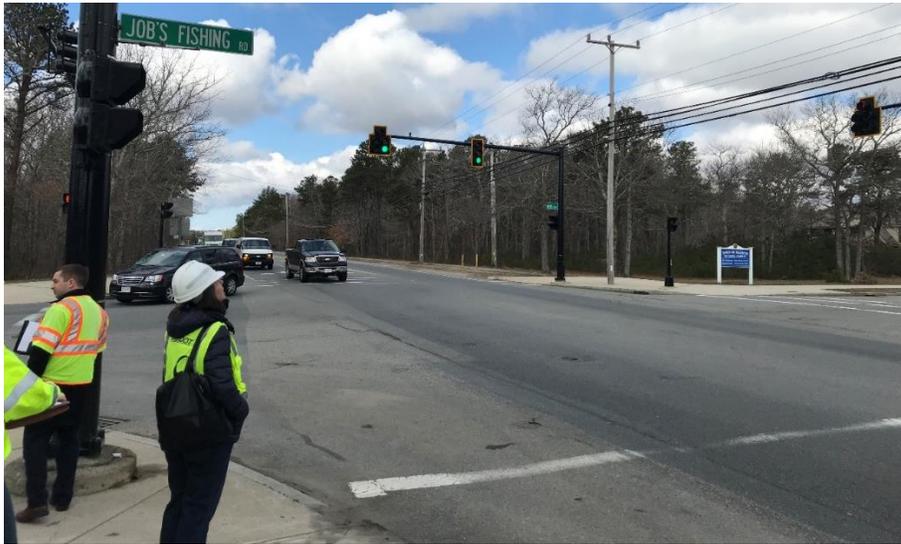
- The crosswalks and stop bars at the intersection are worn.
- There is rutting near the stop lines in the eastbound and westbound directions along Route 151.

**Figure 6– Faded crosswalk markings across Route 151**

- Repaint the stop bars, crosswalks, and lane marking at the intersection to enhance their visibility to motorists.
- Repair ruts and cracks in pavement

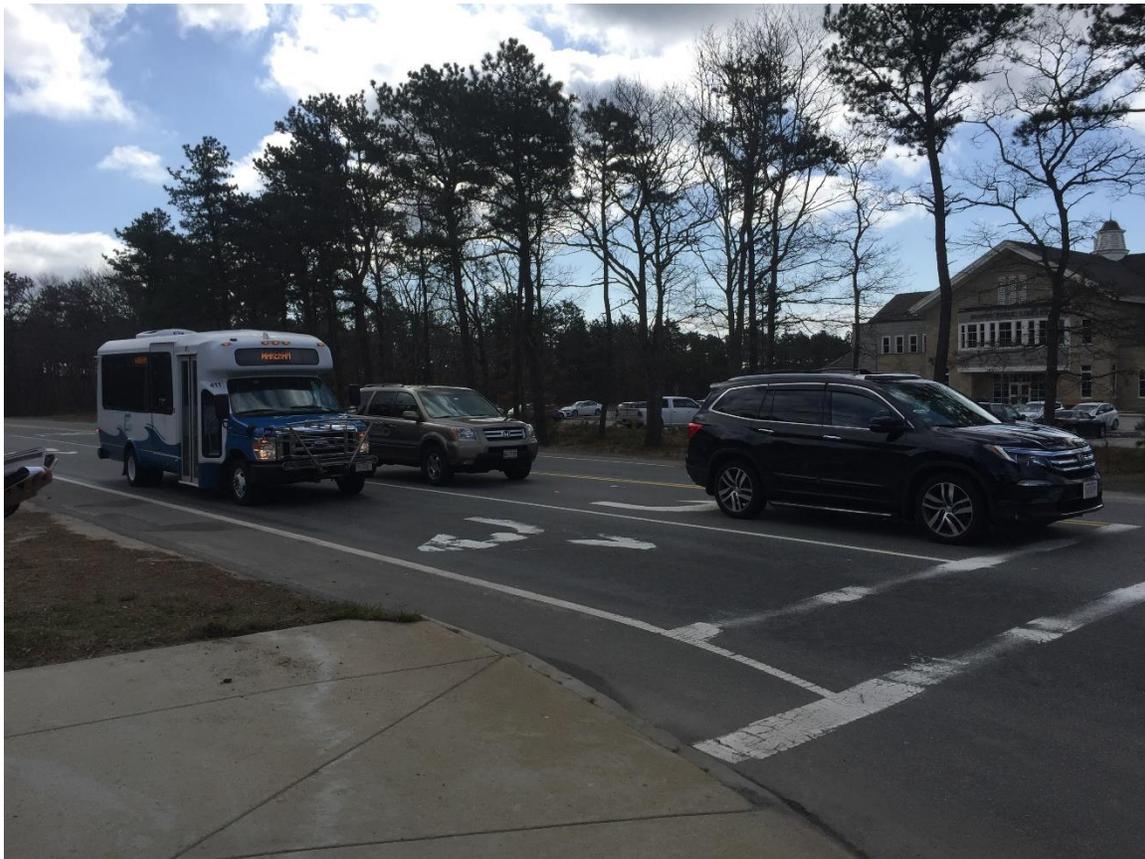
**Figure 7 - Stop bar, crosswalk, and lane marking worn on Route 151 westbound**

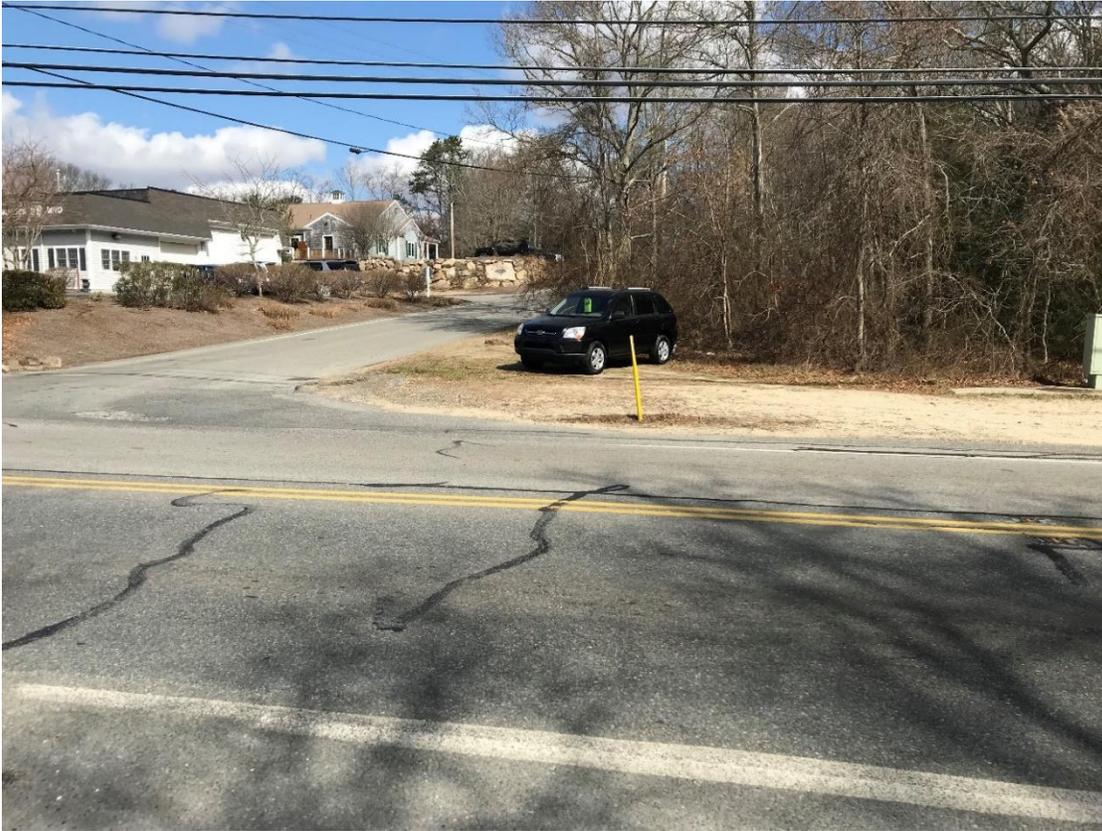
- The speed limit approaching the intersection eastbound along Route 151 is posted at 45 MPH, while the westbound approach is at 50 MPH; speeding has been noted as a problem along the corridor.
- There was a car parked in the northeast corner of the intersection blocking the view for travelling motorists. Also noted but unobserved during the RSA is significant visibility issues on that same corner from snow and foliage during the summer, fall, and winter months.
- There are several signs for businesses located on multiple corners of the intersection, often posing problems for vehicles seeing oncoming traffic.

**Figure 8– Car blocking sight distance on northeast corner of intersection**

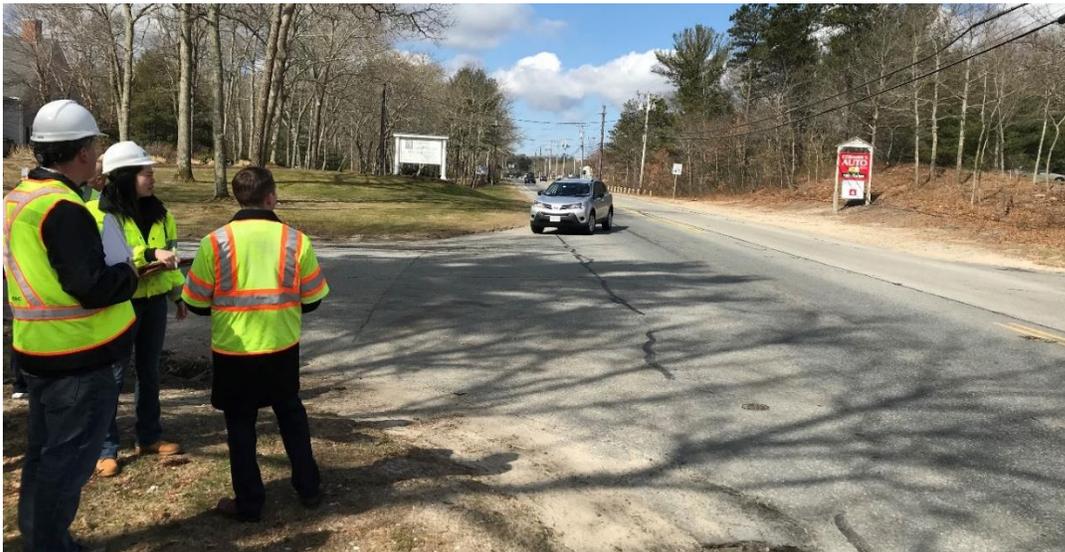
**Figure 9– Car turning left onto Algonquin Ave, large signs along Route 151 affecting sight distance**

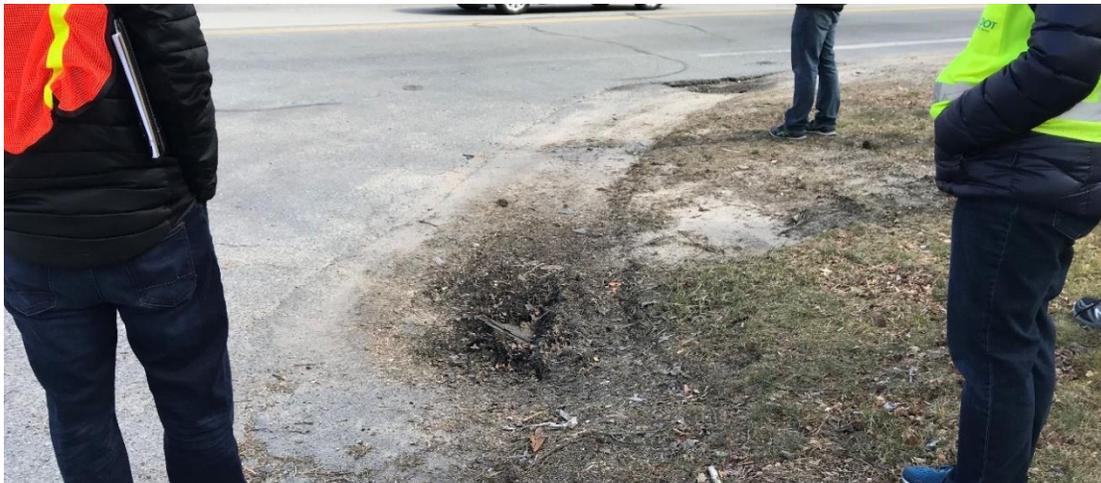
- The drainage on the south side of the intersection is non-functioning, and there are large holes in the roadway at the two southern corners.
- The north side of Algonquin Ave is at a downgraded slope towards Route 151, this was noted as being problematic, especially during snow, ice, and rain events.
- Taking left turns out of Algonquin Ave southbound can be very difficult due to sight distance, speed issues, and a tight turn radius.
- There is no shoulder along Route 151.

**Figure 10– Large hole along corner of intersection**

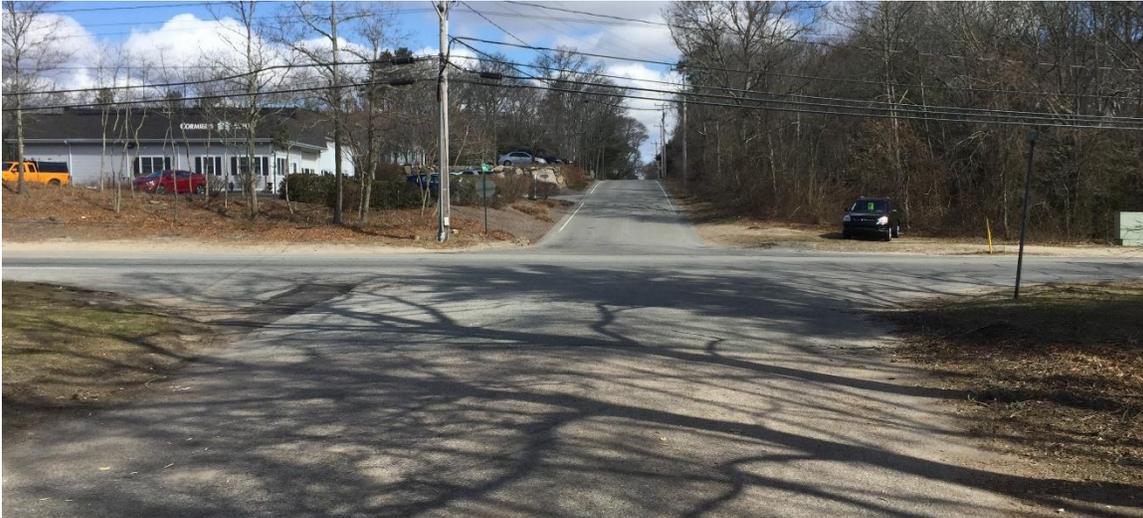
**Figure 11– Downgraded slope approaching intersection from north on Algonquin Ave**

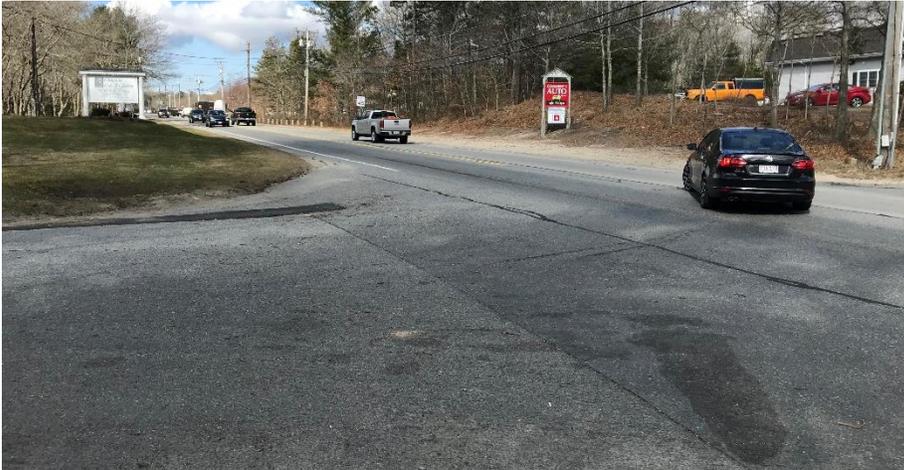
- The southeast corner of the intersection experiences flooding around the large hole along the corner of the intersection; the flooding stays on Algonquin Ave, avoiding intrusion to Route 151.
- There is a large pothole on the northern side of the intersection.
- There is significant sand build up along the four corners of the intersection as well as the shoulders approaching the intersection.
- There is rutting along the shoulders of the intersection.
- 50% of crashes at the intersection occurred during wet/snow/ice road conditions.
- The stop bar on the north leg is faded,

**Figure 12 – Car turning left on Route 151, poor pavement conditions along southeast corner**

- Repair the pothole on the northern side of the intersection, or consider repaving the entire intersection.
- Schedule more regular street maintenance including street sweeping to avoid large amounts of sand from collecting on the roadway.

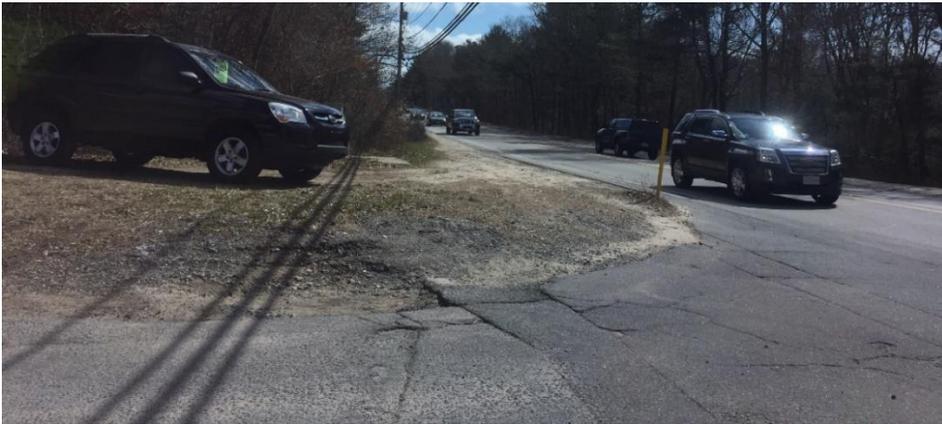
**Figure 13 – Northeast corner of intersection with poor pavement conditions and parked car blocking sight distance**

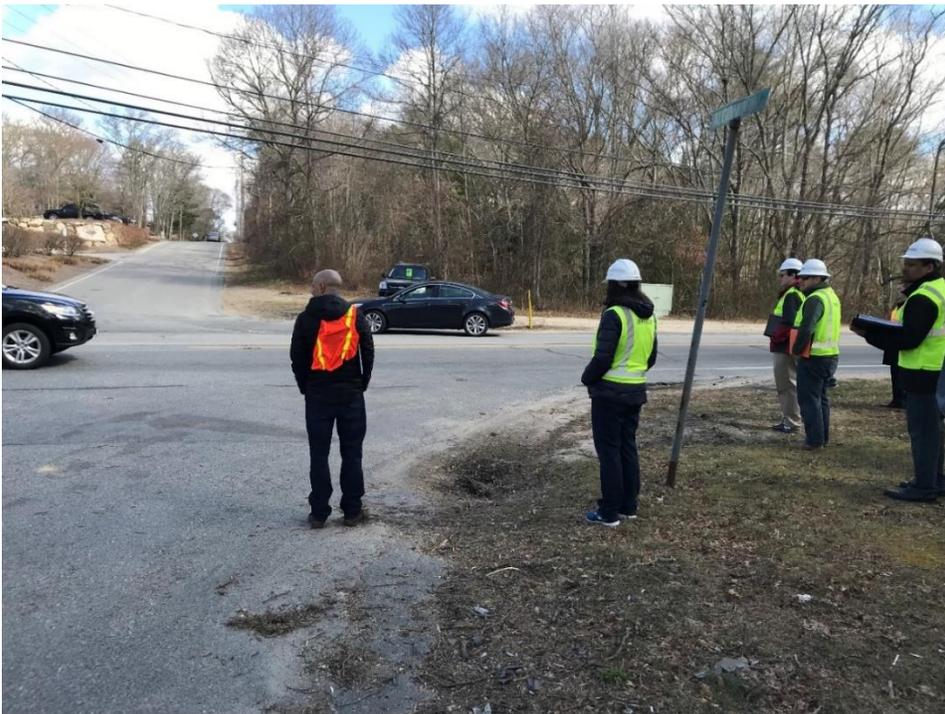
- There is no stop sign at the northbound approach (the privately-owned section of Algonquin Ave).
- There is no sign along Route 151, eastbound or westbound, indicating that the motorist is approaching an intersection.
- Business sign in the northwest corner blocks visibility of Algonquin Ave sign travelling eastbound.

Figure 14– No stop sign at Algonquin Ave northbound approach, bent street sign

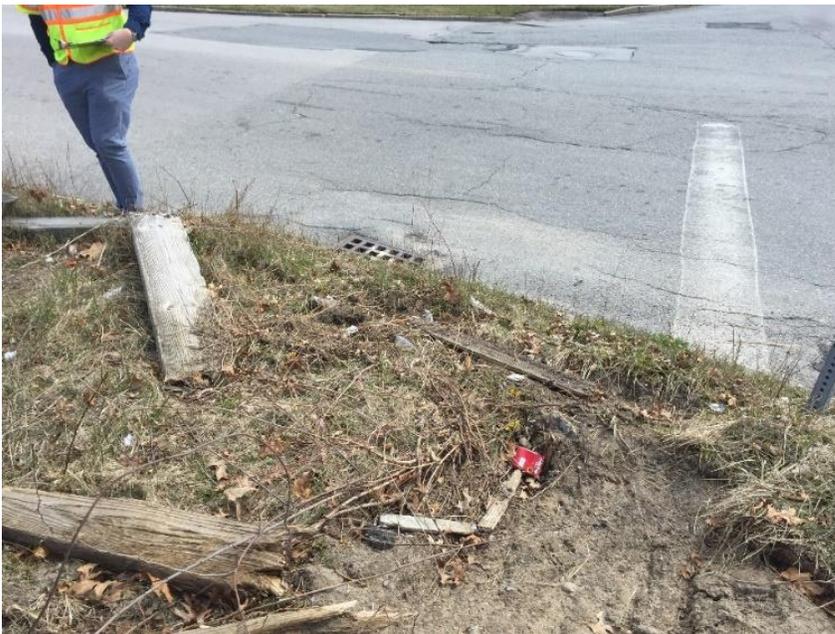
- There are a significant number of weeds and other obstructions blocking sight distance down Route 151 in the vacant lot in the northwest corner of the intersection.

**Figure 15– Debris on northwest corner of intersection causing sight distance issues**

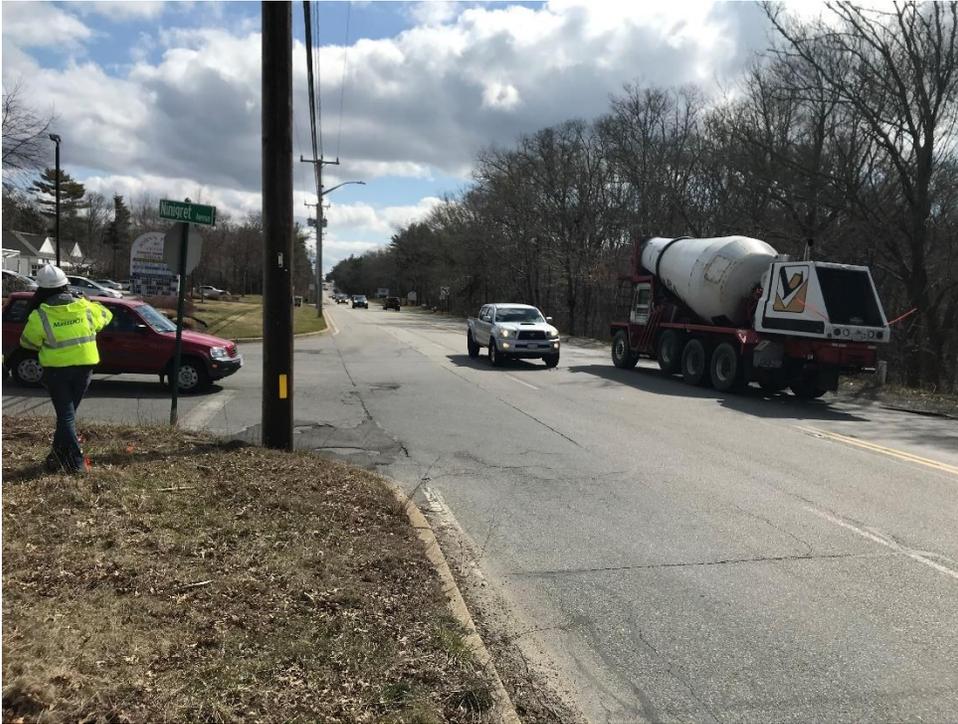
- There is driver confusion regarding blinker usage; vehicles changing lanes on Route 151 westbound give the illusion they are taking a right turn onto Ninigret Ave by using their blinker. This could be responsible for the numerous angle crashes at this intersection.

**Figure 16– Two-lane travel along Route 151 westbound**

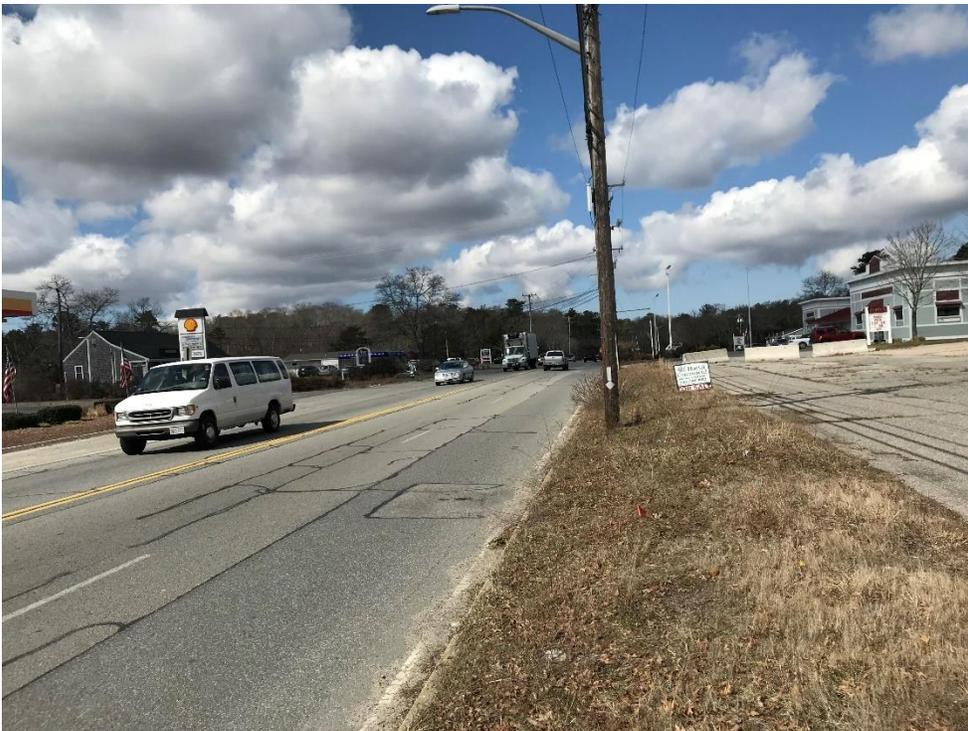
- Due to the wide pavement many vehicles were observed passing other vehicles waiting to take lefts onto Ninigret Ave along the gravel shoulder on the eastbound direction on Route 151. This could partly be responsible for the numerous rear end crashes at this location.

**Figure 17– Vehicles travelling eastbound along Route 151**

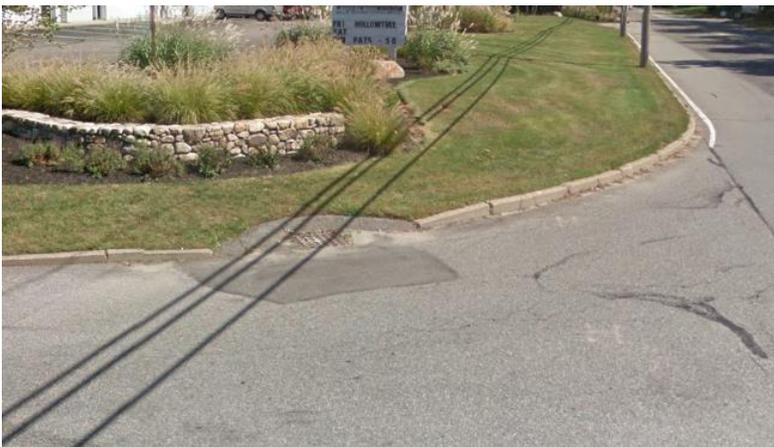
- There is significant puddling on the northeast corner of the intersection near the drainage system.
- The Shell gas station entrance/exit is negatively offset to Ninigret Ave, posing issues for vehicles trying to get onto the mainline of Route 151 as well as vehicles taking lefts into Shell and onto Ninigret Ave.
- Ninigret Ave is one wide lane; however, left-turns and right-turns wait side by side in the lane, blocking the view of each other pulling onto Route 151.
- Provide a left-turn pocket into Ninigret Ave to reduce the number of rear end crashes.

**Figure 18– Drainage on northeast corner leads to puddling during large storm events**

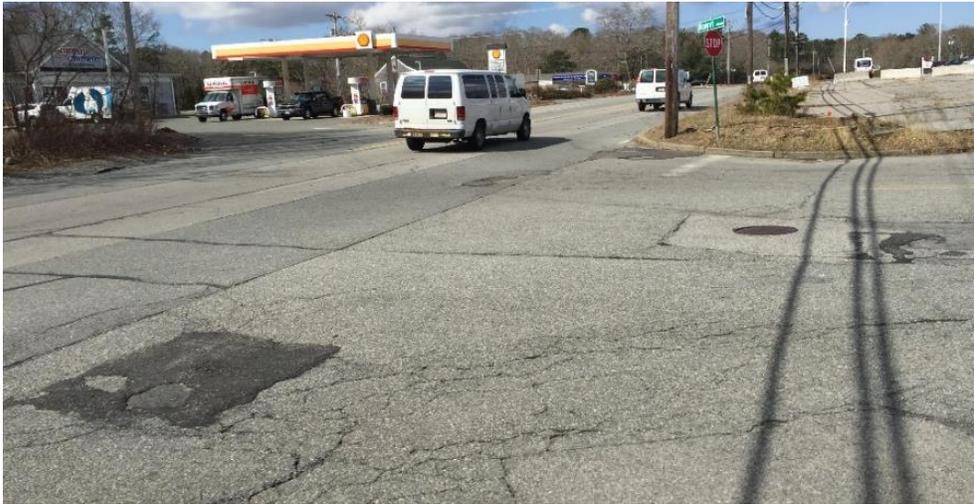
- The pavement along the Shell driveway is in poor condition. There are several patches, cracks, and small potholes along the Ninigret Ave approach to the intersection as well.
- The pavement along the eastbound shoulder is significantly compromised due to vehicles passing along the shoulder.
- The stop bar along Ninigret Ave is worn.
- The broken white lines delineating the travel lanes on Route 151 westbound are worn and very difficult for drivers to see, particularly at night.
- The fog lines along the shoulder of Route 151 are significantly worn.

**Figure 19– Patched pavement and worn pavement marking on Ninigret Ave**

- Repave the entrance/exit to the Shell gas station.
- Repave Ninigret Ave/repair potholes and cracks in the pavement.
- Repaint all pavement markings including stop bar on Ninigret Ave, white dashed line along Route 151 westbound, and fog lines on both sides of Route 151.
- Review placement of stop bar on Ninigret Ave.

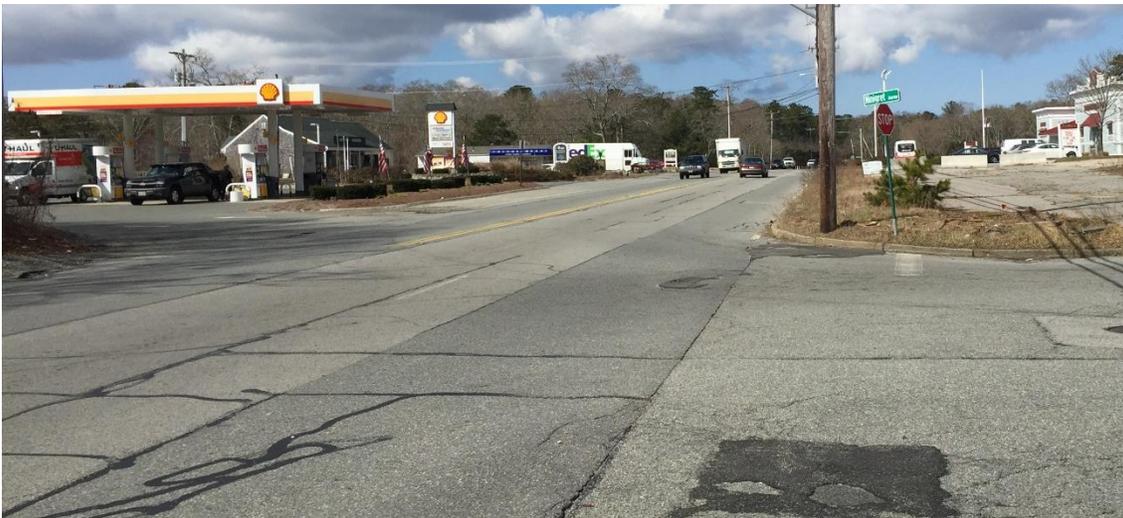
**Figure 20– Worn white dashed line along Route 151**

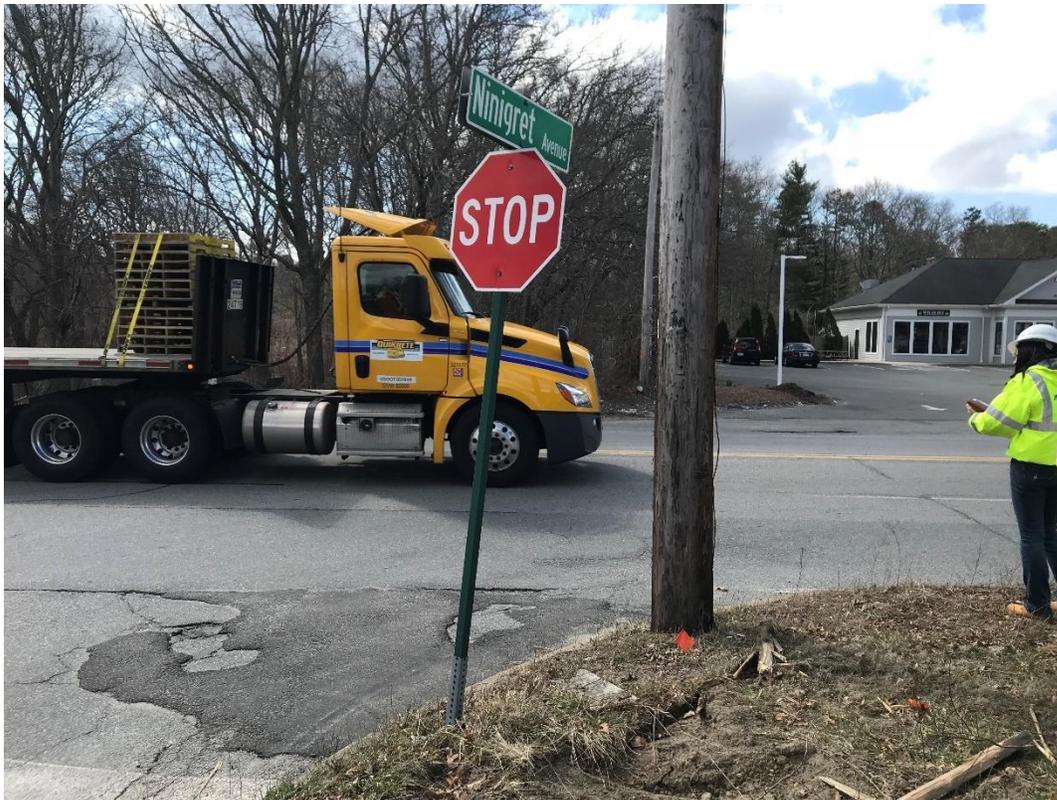
- The stop sign at Ninigret Ave is undersized and bent backwards slightly.
- There is a faded “Do Not Enter” sign at the Dunkin Donuts exit.
- There is a “No Left Turn” sign approaching the Dunkin Donuts entrance eastbound on Route 151, but there is a Dunkin Donuts sign indicating a left turn to enter the drive thru.
- There are no intersection ahead warning signs on Route 151 approaches.
- There are overhead lights east and west of the intersection, but no street lights above the intersection.

Figure 21– Undersized and bent stop sign at Ninigret Ave

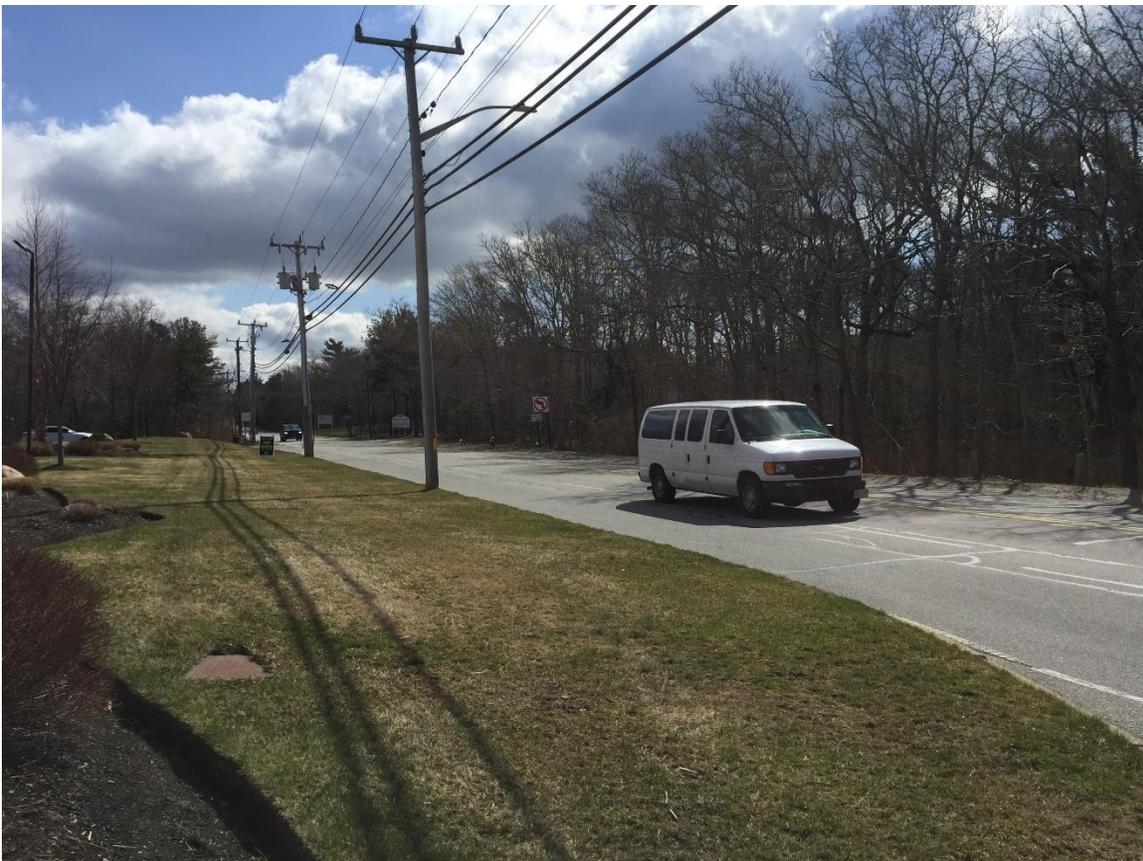
- Wooden posts used as a crash barrier along the south side of Route 151 are not up to standard.
- There is no curb or sufficient shoulder along south side of Route 151, encouraging vehicles to pass on gravel shoulder.
- Utility poles are very close to roadway on north side of Route 151 and could disrupt sight lines.

**Figure 22– Utility poles very close to roadway on north side of Route 151**

- Replace wooden posts along south side of intersection with guardrail to prevent vehicles from running off the road and into the wetland area south of Route 151.
- Consider constructing a vertical curb along south side of Route 151.
- Consider relocating utility poles along north side of Route 151 for better visibility and overall safety.
- Consider providing a shoulder along Route 151 as well as adding pedestrian and bicycle accommodations.

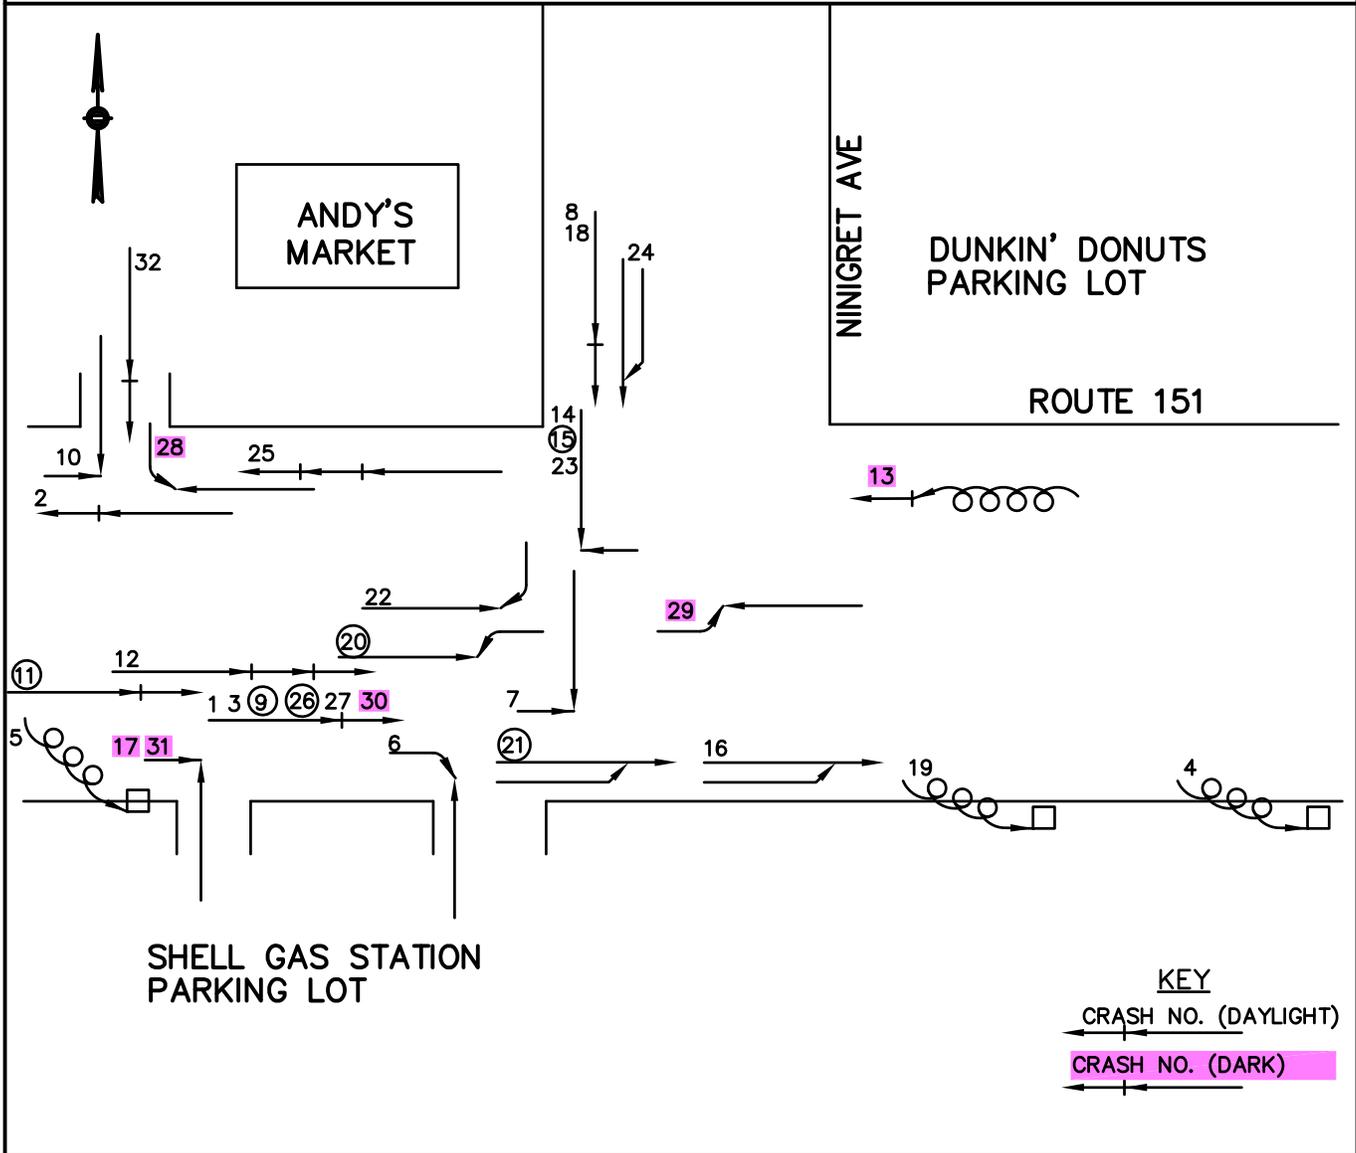
FIGURE 1  
COLLISION DIAGRAM

INTERSECTION: NATHAN ELLIS HWY (RTE 151) AND: NINIGRET AVE  
 PERIOD: 2013-2015 FROM: JANUARY TO: DECEMBER  
 CITY/TOWN: MASHPEE PREPARED BY: STANTEC

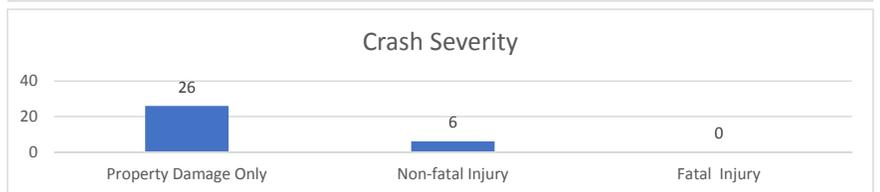
## Nathan Ellis Highway (Route 151) at Ninigret Avenue (2013-2015)

Crash Severity	Count
Property Damage Only	26
Non-fatal Injury	6
Fatal Injury	0
<b>Grand Total</b>	<b>32</b>

Manner of Collision	Count
Angle	11
Head-on	0
Rear-end	13
Rear-to-rear	0
Sideswipe, same direction	4
Sideswipe, opposite direction	1
Single Vehicle Crash	3
<b>Grand Total</b>	<b>32</b>

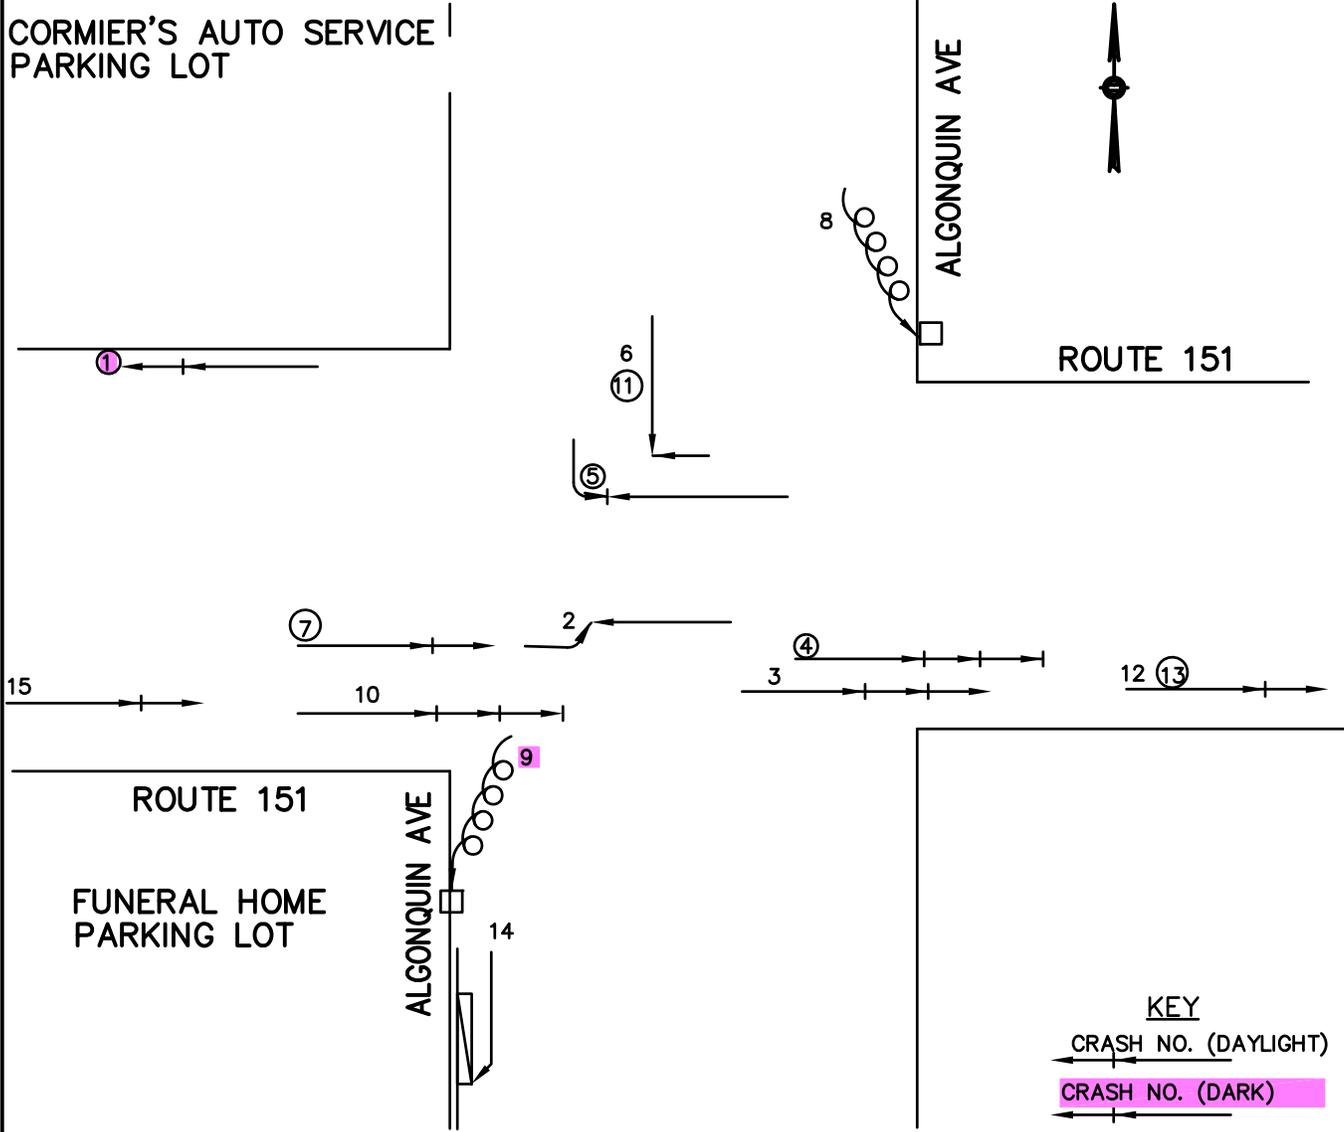
FIGURE 2  
COLLISION DIAGRAM

INTERSECTION: NATHAN ELLIS HWY (RTE 151) AND: ALGONQUIN AVE  
 PERIOD: 2013-2015 FROM: JANUARY TO: DECEMBER  
 CITY/TOWN: MASHPEE PREPARED BY: STANTEC

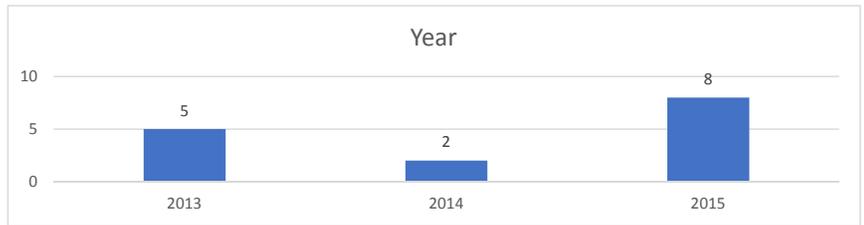
## Nathan Ellis Highway (Route 151) at Algonquin Ave (2013-2015)

Year	Count
2013	5
2014	2
2015	8
<b>Grand Total</b>	<b>15</b>

Month	Count
January	0
February	1
March	2
April	1
May	2
June	2
July	2
August	0
September	2
October	1
November	2
December	0
<b>Grand Total</b>	<b>15</b>

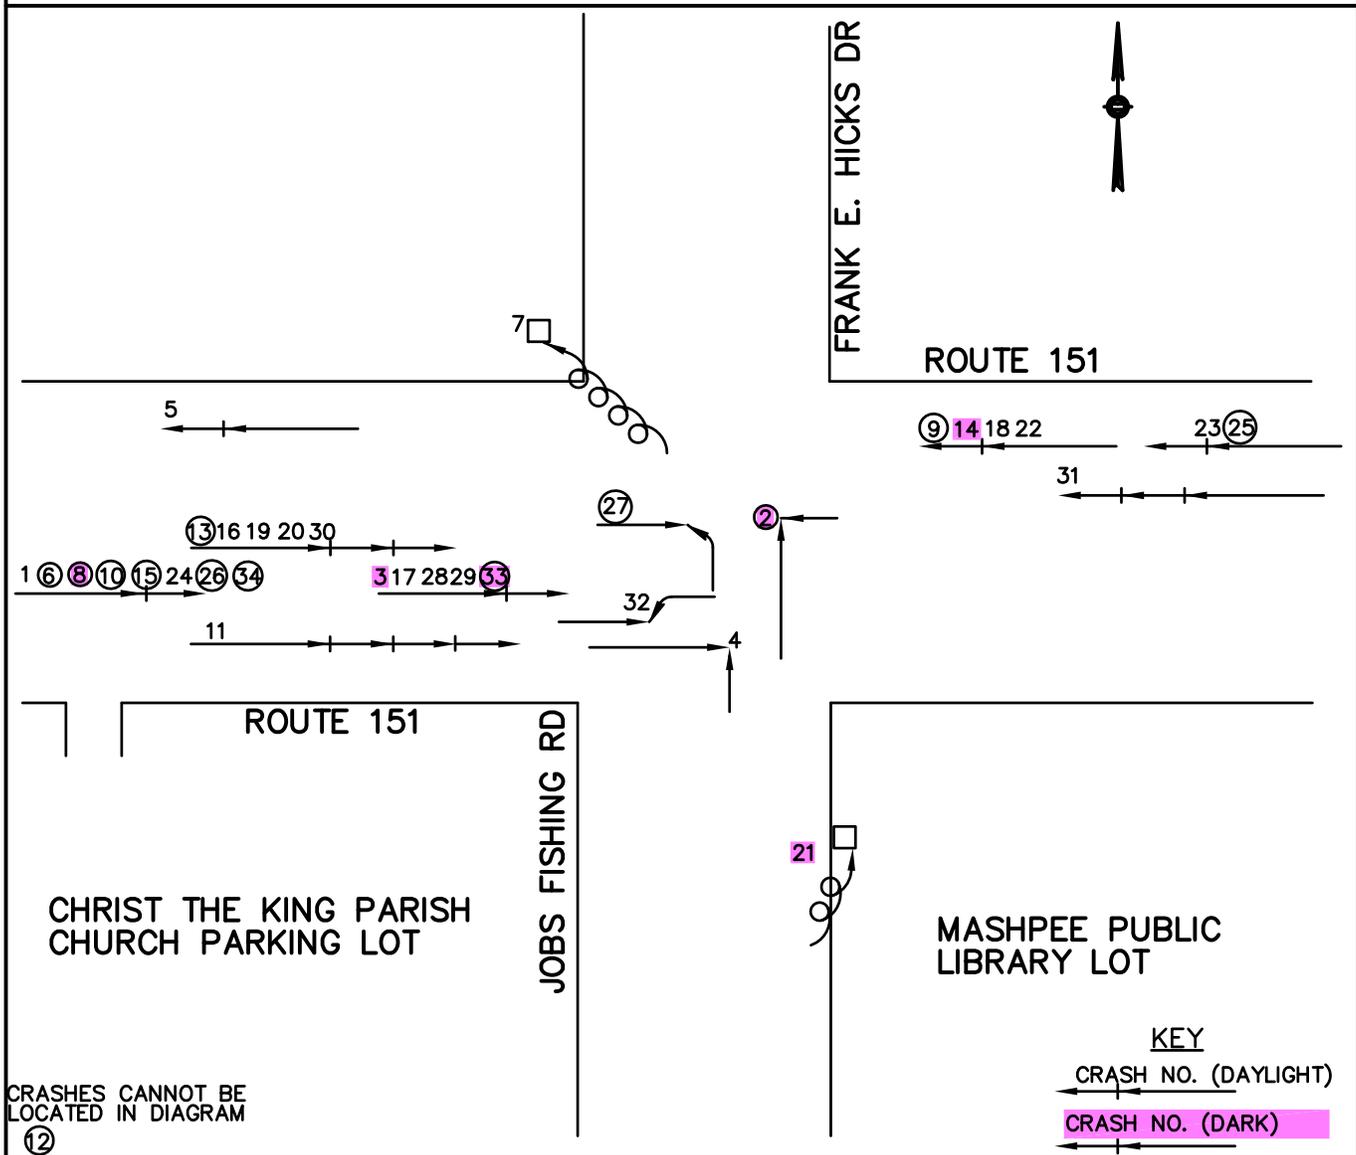
FIGURE 3  
COLLISION DIAGRAM

INTERSECTION: NATHAN ELLIS HWY (RTE 151) AND: FRANK E. HICKS DR/JOBS FISHING RD  
 PERIOD: 2013–2015 FROM: JANUARY TO: DECEMBER  
 CITY/TOWN: MASHPEE PREPARED BY: STANTEC
