# ROAD SAFETY AUDIT

Route 134 High Crash Locations

Town of Dennis

Prepared By:  
Cape Cod Commission  
3225 Main St, Barnstable, MA 02630

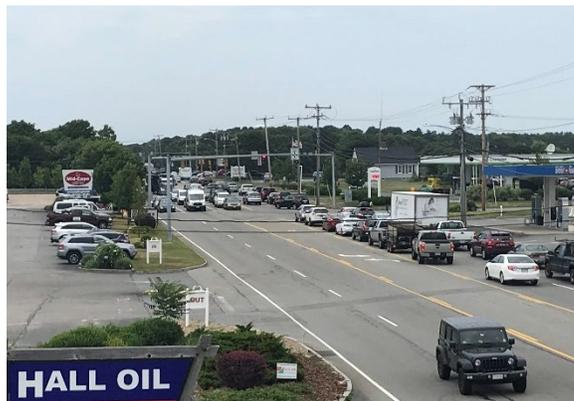
Based on the large percentage of red light-running angle crashes and the high presence of rear-end collisions, there appears to be inadequate timing during the clearance intervals at several of the signalized

**Image 1: Route 134 Congestion**

intersections, which was also confirmed by CCC Staff during a site visit. It is also unclear if the pedestrian signal intervals meet the latest standards.

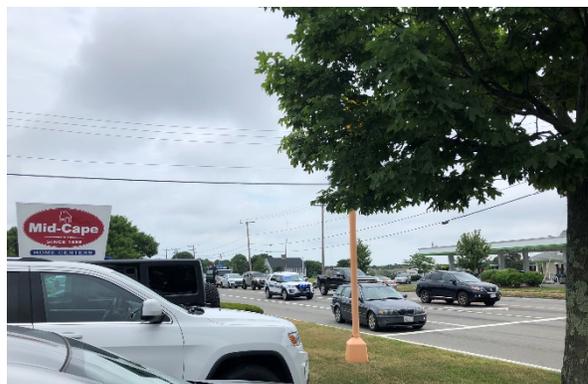
The Town of Dennis Police and Fire Departments are currently equipped with emergency pre-emption transponders within their vehicles; however, emergency pre-emption is not currently provided at any of the three RSA signalized intersections. The Route 134 and Upper County Road traffic signal, located south of Theophilus F. Smith Road, currently has emergency pre-emption installed. Due to the congestion experienced along the corridor and at the signalized intersections, emergency pre-emption at the three RSA signalized intersections would aid by reducing emergency response times. The same technology could also be used to give signal-priority to CCRTA vehicles in order to ease congestion for transit riders. A structural analysis of the existing traffic signal mast arms may be required to assess if the additional equipment can be added.

**Image 2: Police Vehicle Maneuvering Through Intersection**

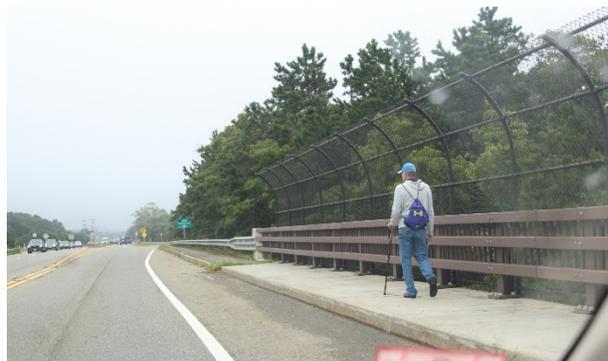
Overall, there were five bicycle related crashes and one pedestrian related crash reported at the Route 134 intersections of Patriots Square/Market Place and Theophilus F. Smith Road. The majority of non-motorist crashes appear to involve the pedestrian or bicyclist disregarding the pedestrian signal indications. There are push button activated pedestrian phases at both of these intersections which are currently in working condition. Additionally, there is confusion as most of the bicycle crashes involve a bicycle traveling southbound along the sidewalk adjacent to the northbound lanes due to the lack of bicycle accommodations, which confused motorists at the intersections. There is a large portion of seasonal workers on Cape Cod during the summer peak season who do not have access to a vehicle and often travel by bicycle, walking and using transit. These seasonal workers may be foreign and not be familiar with roadway conditions and laws in Massachusetts.

**Image 3: Pedestrian walking along Route 134 on Route 6 overpass sidewalk**

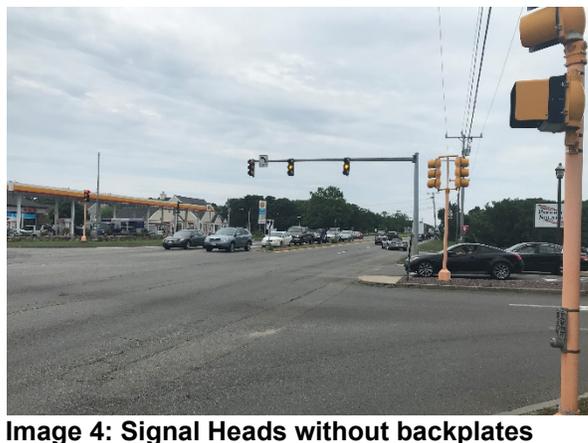
There were several issues discussed regarding the existing traffic signal system at the Route 134 and Patriots Square/Market Place intersection. During collection of the drone footage for the RSA, the signal loop for the northbound left turn lane was not working for three cycles even though there was a vehicle waiting on the vehicle detector. A large vehicle queue was created as vehicles were not being processed at the

**Image 4: Signal Heads without backplates**

signal. Eventually as cars left the queue in frustration, the re-shuffling of vehicles within the queue eventually re-actuated the signal phase and vehicles were then processed. The Town of Dennis has noted an issue with this signal detector loop recently, which may have been a contributing factor to crashes #13, 63.

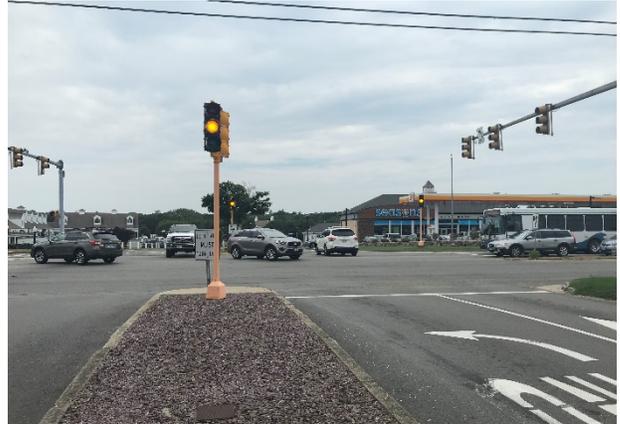
As previously mentioned, the study area is a congested corridor that carries many heavy vehicles, including tractor trailers, delivery vehicles, public works and transit buses. Currently, the traffic signals along Route 134 are mounted overhead on mast arms, however, the side street approaches from Patriots Square and Market Place are pole-mounted. Due to the uphill gradient, presence of trucks and multiple lanes on both approaches, visibility can be limited for motorists from the two side streets. Limited visibility can contribute to red light running and rear end crashes.

**Image 5: Pedestal Pole Mounted Signal Heads**

There are no backplates on any of the signal heads, which may help alleviate crashes that were caused by glare (#28) and crashes where vehicles ran the red light (eight reported crashes). A structural analysis may be required to evaluate if backplates can be added to the existing traffic signal mast arms.

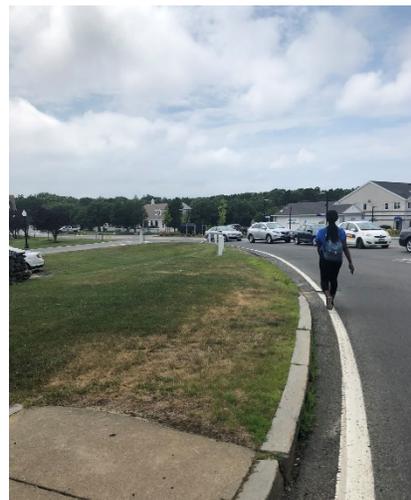
Pedestrian activity was observed during a previous site visit at this intersection where pedestrians and bicyclists were forced to walk within the roadway as there are gaps within the sidewalk network. The existing sidewalk on the eastern side of Route 134 terminates at this intersection with the signalized crosswalk. However, there is no connecting sidewalk into Patriots Square or Market Place. Additionally, there were three crashes at this intersection involving a non-motorist. Two of the crashes involved the non-motorist walking within the existing crosswalk but disregarding the pedestrian signal phase and indications. Excessive delay may cause pedestrian non-compliance at the signalized crosswalk. CCC Staff confirmed the pedestrian signal equipment was in working condition during a site visit. The crosswalk across Route 134 is very long – across five lanes of traffic. Currently, the pedestrian signal equipment and associated crosswalk and ramps do not meet current standards for Americans with Disabilities Act (ADA).

**Image 6: Pedestrian walking in roadway on Market Place**

- Reconstruct existing sidewalk and curb ramps.
- Install new connecting sidewalks into Patriots Square and Market Place.
- Consider relocating the crosswalk to the north side of the intersection and provide a refuge area, which would allow for a concurrent pedestrian phase with potentially a two-stage crossing.
- Upgrade pedestrian signal equipment to the latest standards, including countdown timers.
- Consider constructing a bus-pull off on Route 134 to improve service times for the CCRTA buses.
- If sidewalks are constructed along Route 134, install high visibility crosswalks on missing approaches along with pedestrian signal equipment.

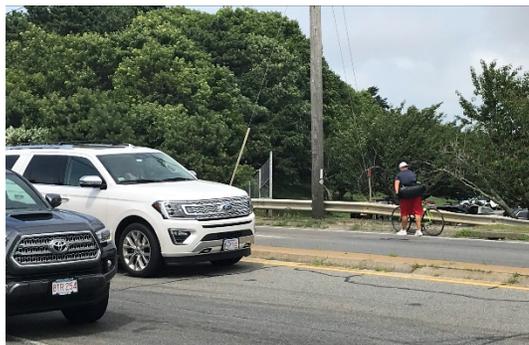
turn lane makes it difficult for drivers to see approaching vehicles. Participants noted that there are a lot of near misses on both the eastbound and westbound channelized right turn lanes. The majority of those crashes involved a rear-end collision where the second vehicle thought the first vehicle had merged onto Route 134 but did not. One of the collisions within the westbound right turn lane resulted in a collision with a bicyclist who was traveling southbound within the Route 134 northbound lanes.

**Image 7: Bicyclist traveling on Route 134 northbound**

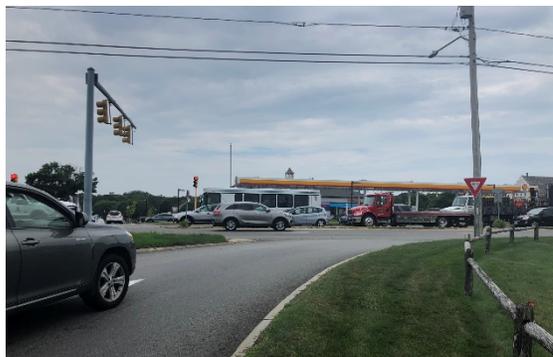
Continued discussions on the safety issues with the existing channelized right turn lanes also focused on the existing yield signage. Currently, there is one yield sign located on the right-hand side of each right turn lane in the eastbound and westbound directions. There are no pavement markings for left-turns from minor streets through intersection which can cause conflict given the phasing. However, participants noted that vehicles sometimes do not yield properly onto Route 134 and drive aggressively, potentially contributing to the rear-end crashes.

**Image 8: Westbound Channelized Right Turn Lane**

- Consider upgrading the existing yield signs for the channelized right turn lanes with flashers. A second yield sign could be installed on the left-hand side.
- Consider replacing the yield signs with stop signs.
- Restripe the channelized right turn lanes to narrow the lane width and install yield pavement markings.
- Consider providing skip lines to delineate travel path for east/west left turns.

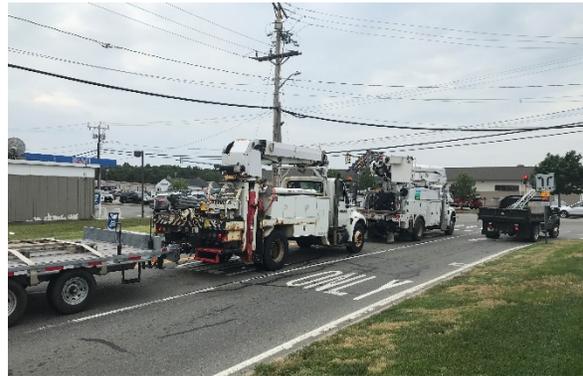
There were several issues discussed regarding the existing traffic signal system at the Route 134 and Theophilus F. Smith Road intersection. The signal heads for the intersection are mounted overhead on mast arms on both of the Route 134 approaches but mounted on pedestal poles for the Theophilus F. Smith Road approach. The pole mounted signal heads may be frequently blocked due to large trucks that travel often on this roadway and may have been a contributing factor to crashes #3 and #36 where the westbound left turn ran a red light. Additionally, there are no backplates on any of the signal heads, which may help alleviate the high occurrence of rear end crashes and red light running.

**Image 9: Large Trucks Traveling on Theophilus F. Smith Road**

- Replace pole mounted signal heads for Theophilus F. Smith Road with mast arm signals.
- Install retroreflective backplates on all signal heads.

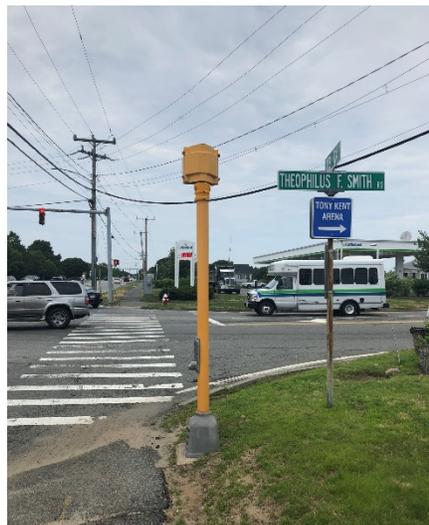
Pedestrians are accommodated at the signal with an exclusive pedestrian signal phase with an actuated push button. The existing sidewalk on the eastern side of Route 134 is in poor condition. Additionally, the pedestrian signal equipment and associated crosswalk and ramps do not meet current standards for ADA/AAB.

**Image 10: Poor condition of existing sidewalk and curb ramp**

- Reconstruct existing sidewalk and curb ramps.
- Upgrade pedestrian signal equipment to the latest standards, including countdown timers.
- If sidewalks are constructed along Route 134, install high visibility crosswalks on missing approaches along with pedestrian signal equipment.

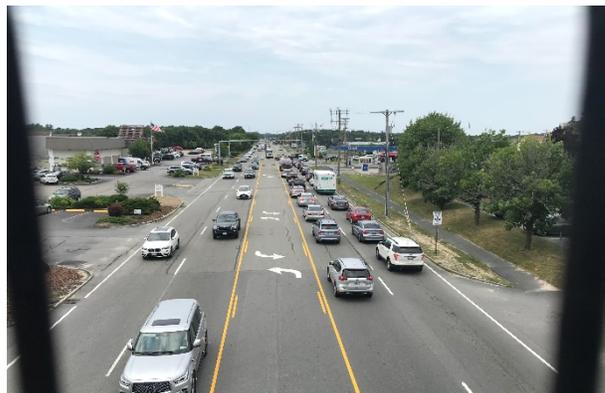
Even though no crashes directly relate to this issue, participants noted motorists are often confused with the existing TWLTL pavement markings and layout on Route 134 which terminates in close proximity to the Theophilus F. Smith Road intersection. It was noted that some westbound vehicles travel over the scored concrete median TWLTL terminus when turning left. However, no reported crashes appear to be related to the TWLTL.

**Image 11: Two Way Left Turn Lane on Route 134**

- Install a left turn skip lane line for westbound left turns to guide them to Route 134 southbound.
- Review and update TWLTL striping and layout to the most current standards.
- Investigate potential striping improvements for the Route 134 southbound left turn lane to delineate left turns destined to Cumberland Farms versus left turns destined to Theophilus F. Smith Road.

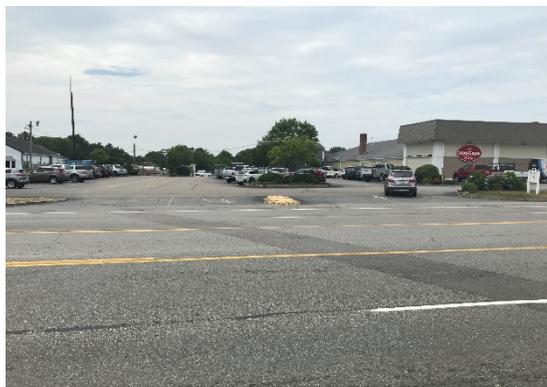
Access management was a key discussion item for the Theophilus F. Smith Road intersection. The commercial parcels of Cumberland Farms, Mobil Gas, Mid Cape Home Centers and Enterprise Road are all commercial parcels in close proximity to the intersection that cause additional friction and conflict points along the roadway. The Cumberland Farms parcel was redeveloped sometime between 2013 and 2014 and the driveways were consolidated, and some crashes may no longer be directly applicable (#2, #4). Previously there were two Cumberland Farms driveways along Route 134 north of the intersection which was reduced to one driveway with exiting left turns restricted by the installation of a concrete mountable island. However, the condition of the island is currently in poor condition. The Cumberland Farms driveway on Theophilus F. Smith Road appears to remain in the same location but is intended to be restricted to only right turns with the presence of a channelized island. Participants also noted there used to be a sign restricting turns for this driveway, but it has been frequently knocked over. Four crashes were related to turning movements at the Cumberland Farms driveway on Theophilus F. Smith Road (#19, 24, 37, 40). Additionally, two rear-end crashes (#13, 22) seem to be related to the vehicle queuing resulting from the commercial driveways on Theophilus F. Smith Road.

**Image 12: Mid-Cape Home Center Driveway**

- Consider installing a median on Theophilus F. Smith Road to minimize conflicts from adjacent commercial driveways.
- Consider minor signage and striping improvements to the adjacent commercial driveways.
- Consider narrowing and removing the center island from the existing Mid-Cape Home Center driveway.
- Consider long-term improvements for a new Mid-Cape Home Center driveway (i.e., new enter only driveway upstream of signal or incorporating a new driveway into the signalized intersection). This enhancement may be infeasible since it likely requires major modification to the building.
- Consider installing a median on Route 134 between Market Place and Theophilus F. Smith Road to minimize conflicts from commercial driveways.
- Encourage the use of shared driveways and/or internal driveways between commercial properties along Route 134.

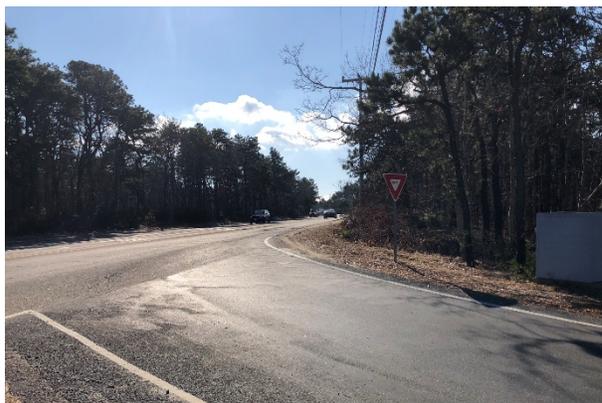
The most prevalent type of crash at the Route 134 and Bob Crowell Road intersection was the ten rear end collisions which occurred in the eastbound channelized right turn lane. The majority of those crashes involved a rear-end collision where the second vehicle thought the first vehicle had merged onto Route 134 but did not. One rear-end crash noted that their visibility was limited due to the curvature of the roadway. RSA participants noted that there is a heavy tree cover in the southwest quadrant of the intersection that likely causes shadowing on Bob Crowell Road and may be restricting sight lines. It should be noted that the parcel of land in the southwest quadrant of the intersection is

**Image 13: Bob Crowell Road Channelized Right Turn Lane**

owned by the Town of Dennis Water Department. It was also noted that vehicles on Bob Crowell Road may be traveling too fast as they are approaching the intersection and may not be aware of vehicles queued in the right turn lane, which does not currently accommodate the existing queues. Due to the uphill grade at this lane, drivers may have foot on accelerator to avoid rolling back possibly contributing to rear end crashes. The uphill gradient also results in stopped vehicles not having their braking lights on which may cause vehicles to think the vehicle in front of them are merging/moving).

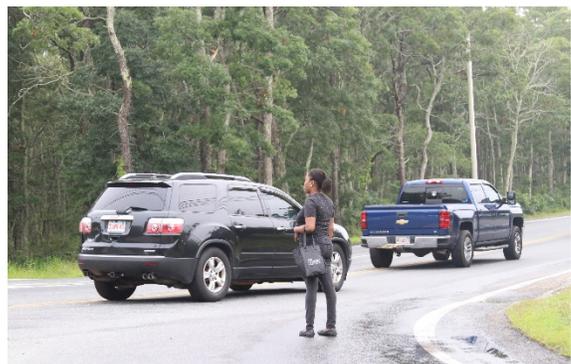
Multi-modal accommodations do not currently exist within the Route 134 and Bob Crowell Road intersection. There is currently a shared use path on the western side of Route 134 (north of Bob Crowell Road) and a sidewalk on the northern side of Bob Crowell Road. However, there are no crosswalks, ramps or pedestrian signal accommodations provided at the intersection. RSA participants noted that there is currently pedestrian activity at the intersection as there is a desire line to continue south on Route 134 to the Patriots Square commercial area. South of Bob Crowell Road, there is only a small section of sidewalk on the Route 6 overpass, so pedestrians are forced to walk in the road or within the small grass shoulder. There are pedestrian desire lines between the large residential neighborhood from

**Image 14: Existing Pedestrian Activity at Bob Crowell Road intersection**

Hemlock Lane to recreation facilities on Bob Crowell Road and to the Patriots Square commercial area, but there currently no crosswalks are provided at the intersection to connect to the existing sidewalk network.
