ROAD SAFETY AUDIT

Route 28 at Pitcher's Way, Lincoln Rd, & Barnstable
Intermediate School

Town of Barnstable

January 17, 2023

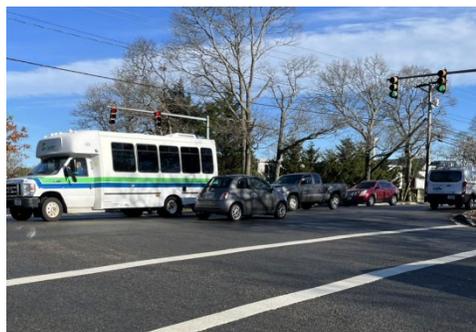
Image 1: Traffic congestion on Route 28 at Pitcher’s Way, due to a left turning movement.

Left turn lanes in the study area are provided only at Route 28 at Pitcher's Way, however, there is no left turn protected phasing present. Vehicles wishing to turn left from Route 28 to the other streets and driveways may lack adequate gaps. Corridor wide there were 15 crashes that result from vehicles attempting to turn left from Route 28 onto a minor street/driveway. Vehicles attempting to take left turns from Route 28 onto Pitcher's Way resulted in two angle crashes (#35, 42), two rear-end (#17, 43), a single vehicle crash (#8), and a sideswipe, in the opposite direction (#39). Vehicles attempting to take left turns from Route 28 onto Lincoln Road resulted in one angle crash (#2), one single vehicle crash (#15) and two rear-end crashes (#3, 5). Vehicles attempting to take left turns from Route 28 in the BIS Area resulted in two rear-end crashes (#4, 6), an angle crash (#11), a single vehicle crash (#12), and a sideswipe in the same direction (#23). Additionally, RSA participants observed drivers accepting inadequate gaps while turning onto

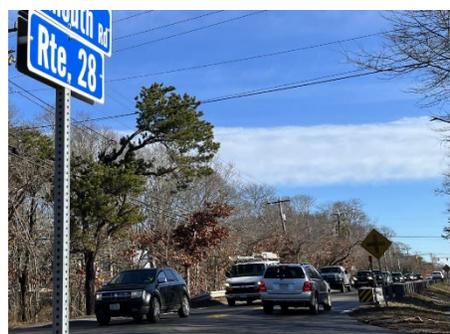
Image 2: A left turning vehicle creates congestion on Route 28 at Lincoln Road, backing up to Route 28 at Pitcher’s Way.

the Route 28 corridor from the minor roadways. The unpaved shoulders show signs of vehicle treads indicating vehicles are using these shoulders for passing turning vehicles.

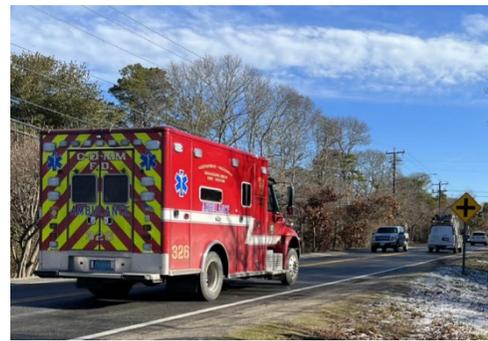
This section of corridor is narrow with unpaved shoulders and metal guardrails which limits the ability for drivers to safely pull over for emergency responders. During the RSA, Barnstable Police noted that this area is difficult to enforce due to the lack of safe pull-off areas.

Image 3: Ambulance traveling eastbound on Route 28, observed during RSA.

- Review the possibility of widening the corridor to allow for paved shoulders or bus pull-off locations to improve vehicular safety and emergency response.

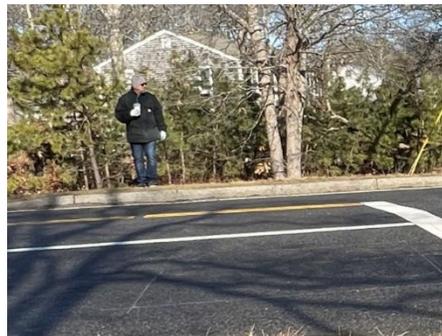
RSA participants noted that multi-modal accommodations throughout the corridor are either inconsistent or missing entirely. This section of Route 28 has schools present but lacks basic pedestrian and bicycle accommodations to connect to nearby residential neighborhoods. Site visits have noted that pedestrian and bicycle activity is present in this area. With the presence of a shared use path, there is an opportunity to further enhance the multi-modal accommodations to connect to the off-road facilities and other roadways. The current shared use path has poor pavement conditions, with areas of puddling or sand present. The current shared use path does not meet the minimum recommended width of 10 ft for two-way travel. Signage and pavement markings are older or missing along the shared use path which may affect compliance for pedestrians/bicyclists to stop when approaching roadway crossings. Additionally, there is a lack of signage and pavement markings for vehicles to warn of bicyclist/pedestrian activity when approaching or turning across the shared use path.

Image 4: Pedestrian attempting to cross Route 28 without an available crosswalk or pedestrian signal equipment.

- Re-paint/re-stripe existing pedestrian and bicycle facilities including crosswalks and stop bars.
- Review and install missing signage for the shared use path where appropriate.

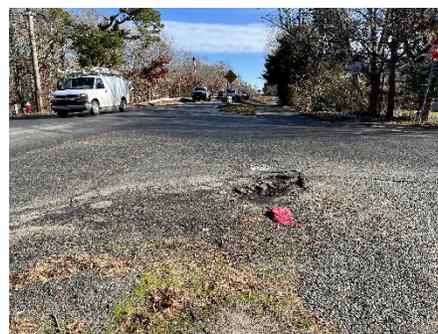
Currently, there are two portions of existing sidewalk approaching Route 28 that are not connected to the corridor. These sections are on Lincoln Road and the Barnstable High School Access Road. The lack of connectivity may result in pedestrians having to walk without the benefit of sidewalks to access Route 28. There is a lack of safe walking space on the northside of the corridor, particularly at night. There is also a noticeable absence of lighting across the entire corridor. There is a distinct lack of sidewalk and crosswalk connectivity across Route 28 which affects the multi-modal connectivity and safety in this area. Furthermore, there is a noticeable lack of ADA accommodations at the RSA intersections and the shared use path crossings, including detectable warning pads and concrete curb ramps.

Image 5: Lincoln Road shared use side path crosswalk, with faded pavement markings and lacking ADA compliant features

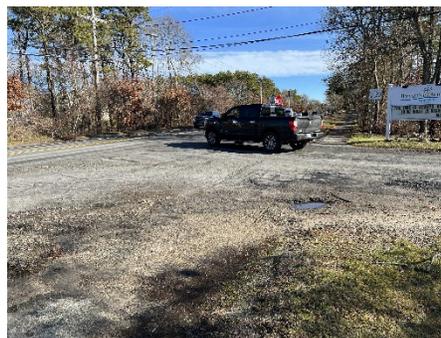
With the high traffic on Route 28, the pavement markings along the entire corridor are well worn and faded. During the RSA, participants noted various locations along the entire corridor where pavement markings were faded or missing. RSA participants noted during the site visit that several roadway signs and shared use path signs were either missing, damaged or in need of replacement.

Image 6: Faded and missing pavement markings observed at the Barnstable High School access road.

- Evaluate the existing pavement markings on the corridor and determine which markings need to be added or re-stripped.
- Conduct a sign inventory to determine what signs along the corridor need to be added or replaced.

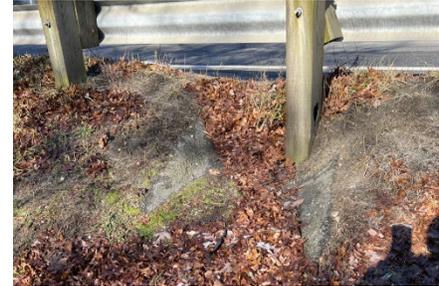
Areas of the corridor were observed to have signs of drainage issues. There was pooling in front of the Barnstable Intermediate School and in several other locations along the RSA limits from a rain event from the previous day. The side path had areas where rainwater had washed dirt onto the path creating a muddy surface. During the RSA, icy sections of the shared use path were observed as water had pooled on low points in the side path and froze. RSA participants noticed that this section of Route 28 does not have a lot of visible drainage systems. Pavement cross slope on the roadway and side path could also contribute to the drainage problems and puddling seen in the area. There were several crashes that happened during wet roadway conditions along the corridor, most notably a single vehicle crash at Route 28 and Lincoln Road (#17) where the vehicle fishtailed and crashed into a guardrail.

Image 7: Asphalt swale leading rainwater runoff from Route 28 onto the shared use side path.

- Evaluate the need for drainage systems and runoff collection corridor wide, review existing systems on the side streets to see if they are properly installed and maintained.
- Evaluate the need for drainage systems along the shared use path.

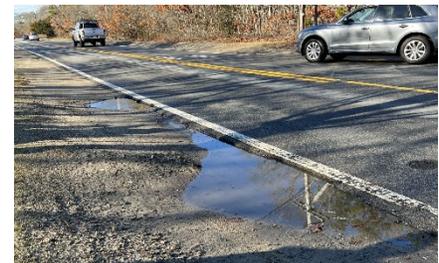
Image 8: Rainwater puddling along Route 28 at BIS Area across from Old Strawberry Hill Road.

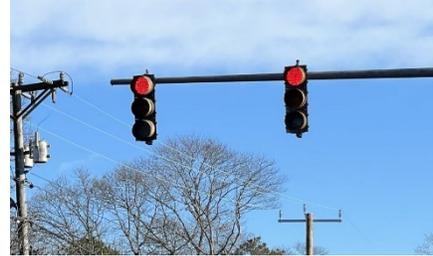
There were several issues discussed regarding the existing traffic signal at the Route 28 and Pitcher’s Way intersection. During the site visit, RSA participants noted that equipment was outdated when compared to modern standards. There is no pedestrian equipment at this signalized intersection. The signal equipment that is currently in place are basic three section heads which do not have the capability of allowing for an exclusive left turn phase or left turns on a flashing yellow arrow. All signal heads were missing retroreflective backplates, which are important for visibility of the signal heads at night. At this intersection, three of the reported crashes were due to glare or lack of visibility. The addition of retroreflective backplates may help alleviate crashes that happened at night and during the day due to glare or lack of visibility.

Image 9: Pitcher’s Way signal heads, faded visors and no backplates.

- Install retroreflective backplates on all signal heads. (Note: a structural analysis may be required)
- Install additional street lighting at the intersection for better night visibility.
- Consider the re-grading the Pitcher’s Way approaches to improve visibility.
- Consider upgrading signal equipment to meet current standards, including installing ADA compliant pedestrian signal equipment.
- Consider installing auxiliary heads for improved signal visibility.

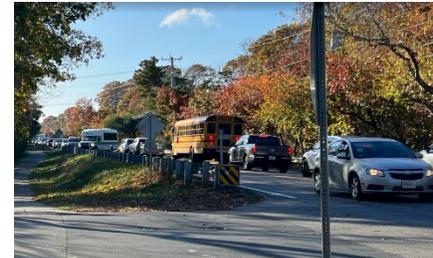
Image 10: Vehicle congestion.

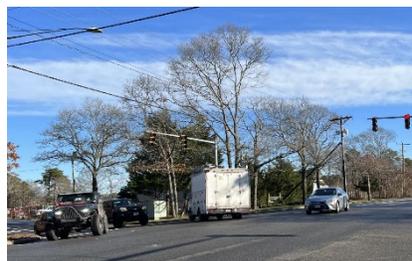
Currently at Route 28 at Pitcher’s Way, left turns operate under permissive signal control and are accommodated in an exclusive left turn lane on both approaches of Route 28 and in a shared left turn/through lane on Pitcher’s Way. There were several angle collisions that involved vehicles between the minor approach of Pitcher’s Way and the major approach of Route 28 (11 of the 51 crashes). These eleven crashes (#18, 22, 23, 28, 30, 33, 38, 40, 46, 48, 52) noted that a vehicle ran a red light. The yellow and all red clearance intervals may be inadequate and may contribute red light running crashes. Field observations indicated that the Route 28 eastbound and westbound permissive left turns often resulted in vehicles being stuck in the middle of the intersection due to congestion and lack of gaps, which may contribute to the high occurrence of angle collisions.

Image 11: Vehicle on Route 28 attempting to make a left turn during red clearance.

- Evaluate protected/permissive phasing for left turns on all approaches and the use of flashing yellow arrows, if not warranted, consider installing permissive flashing yellow arrow to improve left turn safety.
- Evaluate the yellow and all red clearance times and update signal clearance times based on the latest standards.
- Install emergency pre-emption for emergency response vehicles at current signalized intersections as well as any future signals along the corridor (Note: a structural analysis may be required to add to existing equipment).
- Consider the addition of traffic dividers on Route 28 to calm traffic for left turns.

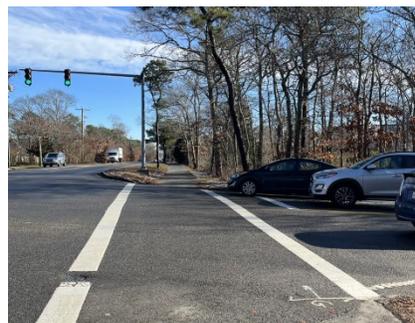
Image 12: Car attempting to take a right turn on red from Pitcher’s Way onto Route 28, inching into crosswalk.

The northbound approach of Pitcher’s Way at Route 28 has a crossing for a shared use side path. The side path is offset from Route 28 by approximately 14 feet, this allows path users separation from the road. At the intersection, the stop bar on this approach is before the crossing, which causes to motorists to obstruct the crossing while attempting to take a right-on-red. Westbound traveling bicyclists who do not stop at the intersection are impacted by drivers obstructing the path and attempting right turns. This geometry has resulted in 7 crashes (#1, 3, 4, 5, 6, 7, 29).

- Reconstruct existing curb ramps to comply with ADA regulations.
- Install new sidewalks along Pitcher’s Way to connect to the existing shared use path.
- Install sidewalks along the northern side of Route 28
- Install No Right Turn on Red restriction at the intersection on the northbound and eastbound approaches to reduce conflicts with vulnerable road users.

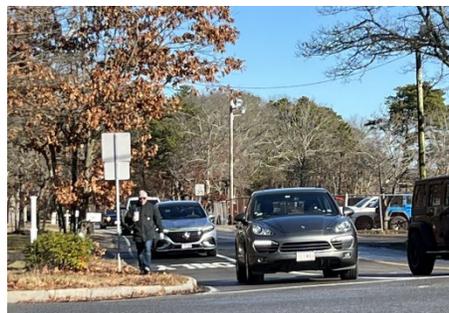
Pedestrian activity was observed during the RSA site visit at the intersection where a pedestrian was forced to walk within the roadway as there are gaps within the sidewalk network. There is currently only a shared use path on the southern side of Route 28 which extends the length of the RSA corridor. There are no connecting crosswalks or sidewalks from the northern side of Route 28 or Pitcher’s Way. There were 11 non-motorist crashes at this intersection, with 10 crashes occurring within the existing crosswalk. There is no pedestrian phase or signal equipment and there is little opportunity for a non-motorist to cross the intersection since the signal operates with only two phases. Additionally, there has been a high number of crashes (7 crashes) involving a motorist attempting to take a right turn on red and a non-motorist crossing in the crosswalk. RSA participants observed that there are currently no detectable warning pads or ramps at this crosswalk, to meet current standards for Americans with Disabilities Act (ADA).

Image 13: Pedestrian observed walking on Pitcher’s Way southbound where there are no present pedestrian facilities.

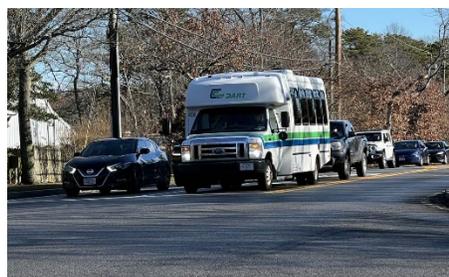
Image 14: CCRTA transit vehicle seen at the intersection of Route 28 at Pitcher’s Way.

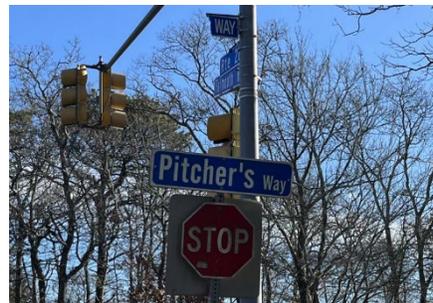
A street sign on one of the mast arms for Pitcher’s Way was broken and only displays the word “Way”. Observers on the RSA noticed that on the shared use path heading in the westbound direction there was no stop sign for bicyclists as well as no advanced warning signs on either approach. It appears that there are no Signal Ahead signs located approaching the intersection on Route 28 or on Pitcher’s Way southbound.

Image 15: A broken street sign on the mast arm and dirty stop sign on shared use path.

- Add a stop sign and no motor vehicles sign to the westbound shared use path approach.
- Add approaching intersection warning signs to both side path approaches.
- Install Signal Ahead signage on both approaches of Route 28 and Pitcher’s Way southbound.
- Re-stripe cracked and faded pavement markings and supplement with additional lane markings as needed.
- Review and relocate the existing stop bar locations on Pitcher’s Way.

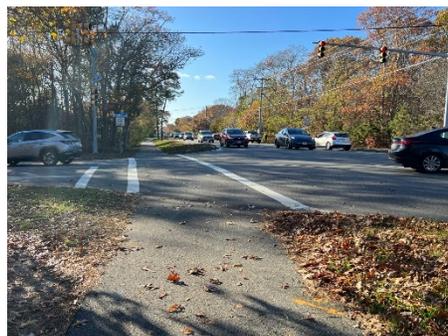
Image 16: The westbound shared use side path approach, missing the stop sign at the crosswalk and the no motor vehicles sign.

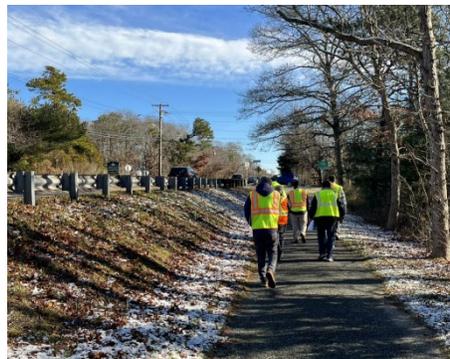
Image 17: Grade difference between shared use path and roadway separated by guardrail.

- Consider improving the gradation of the southern side of Route 28.
- Evaluate if existing guardrail meets current standards and replace damaged sections.
- Evaluate if reflective delineators are present throughout existing guardrail and install if necessary.

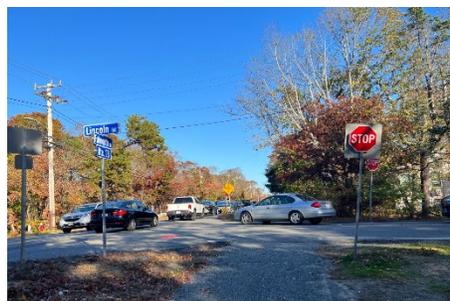
Since the intersection is close to the Pitcher’s Way signalized intersection, vehicle congestion and queuing often extends to the Lincoln Road intersection which can compound safety issues. Of the crashes observed at this intersection, many collisions (47%) were angle crashes. These angle crashes are likely because of motorists misunderstanding the courtesy of drivers in the opposite direction. Drivers failing to yield the right of way contrary to the rules of the road, resulted in 6 of the 18 crashes observed at this intersection during the study period (# 1,2, 4, 8, 13, and 18).

Image 18: Congestion backing into the Lincoln Road intersection from the Pitcher’s Way signal, vehicle is attempting to take a right turn onto Route 28.

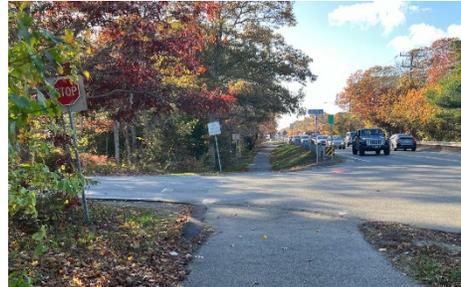
During the RSA, the lack of pedestrian and bicycle accommodations were noted along this entire section of Route 28. Nevertheless, at this intersection, there were several issues different from other areas along the corridor. There are faded bike route signs facing the roadways as well as faded stop signs on the shared use path. Four leg intersection warning signs on Route 28 are in poor condition as well and may need to be placed in better positions. There is no crosswalk to aid pedestrians in crossing Route 28 at this intersection. There are currently no detectable warning pads or ramps at this crosswalk, this does not meet current standards for ADA compliance.

Image 19: Lack of visibility of the shared use path crossing and guardrail obstructed view.

- Connect the existing sidewalk on Lincoln Road to the shared use path.
- Evaluate the need to install a crosswalk across Route 28 at the intersection. Crosswalk treatments such as RRFBs and signage would need to be considered should a crossing be installed.
- Replace older and faded signage on the shared use path and at the intersection.
- Install Intersection Ahead advanced warning signs on Route 28 and the shared use side path.
- Reconstruct existing curb ramps to comply with ADA regulations.

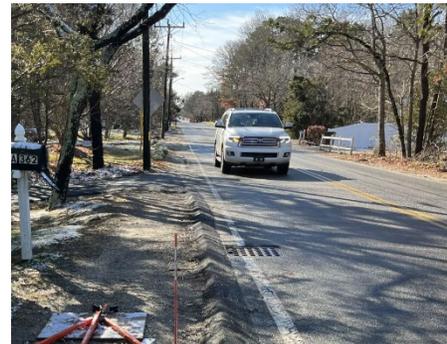
Unlike a lot of the minor streets on this section of corridor, Lincoln Road has a sidewalk. This sidewalk is situated on the western side of Lincoln Road; however, this sidewalk ends about 180 feet before the intersection. The existing sidewalk is a five-foot wide asphalt sidewalk with varying different types of curbing. The existing sidewalk lacks detectable warning pads and ADA compliant ramps. It should also be noted that the sidewalk on Lincoln Road only exists south of Route 28, running south toward West Main Street. Lincoln Road Extension does not have a sidewalk. RSA participants noted that connecting the sidewalk on Lincoln Road to the existing shared use side path would increase the level of pedestrian connectivity in this area and take pedestrians out of the roadway at the intersection.

Image 20: Missing sidewalks on Lincoln Road.

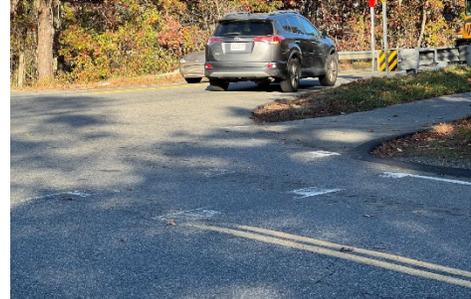
The pavement markings at the intersection of Route 28 and Lincoln Road are in poor condition. On the roadway, the stop bar on Lincoln Road has slowly faded away and the crosswalk markings on Lincoln Road are completely missing. The lack of any high visibility paint makes this already visibility obstructed crossing even less observable. A pedestrian was observed crossing at this location during the RSA and it appeared as if there was no crosswalk due to how faded the markings were. The fog lines in this area also show signs of extreme weathering, as they are faded and have many cracks. On the north side of Route 28, Lincoln Road Extension does not have any pavement markings besides a well faded stop bar.

Image 21: Faded crosswalk markings and stop bar on Lincoln Road, fog lines and centerlines are also cracked at this intersection.

- Re-stripe a high visibility crosswalk on Lincoln Road to connect the shared use path.
- Re-stripe the stop bars at the intersection, fog lines and centerlines as well, with high visibility paint for all approaches.

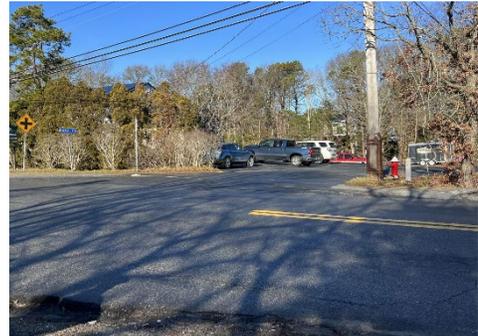
Image 22: Missing or faded fog line on Route 28, faded stop bar on Lincoln Road Extension and no visible lane markings.

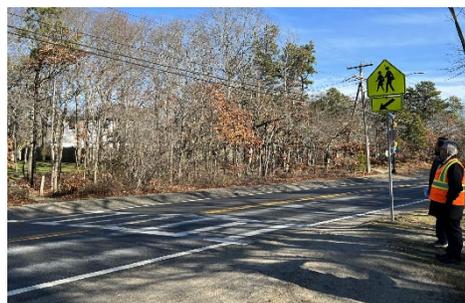
RSA participants from the Town of Barnstable remarked that many students often cross Route 28 in various places to get to school in this area from the various side streets. There is only one unsignalized mid-block crossing along this section of Route 28 near Old Strawberry Hill Road. A worn dirt path was observed in the northwest quadrant of the Route 28 at Old Strawberry Hill Road intersection showing a desire line for pedestrians from Old Strawberry Hill Road to the mid-block crosswalk. This crosswalk is halfway between the entrance to Barnstable Intermediate and the intersection of Route 28 at Old Strawberry Hill Road. The crosswalk has no corresponding sidewalk connections leading to the school and there are no ADA curb ramps either. A school crossing sign with a corresponding arrow is currently located on both sides of the marked crosswalk. Participants also noted there is a school crossing guard at this location but sometimes students cross the roadway too quickly before the crossing guard can stop traffic.

Image 23: Route 28 mid-block crosswalk between Barnstable Intermediate and Old Strawberry Hill Road.

- Install advance warning signs on Route 28 for the mid-block crosswalk.
- Install missing stop signs and stop bars on the shared use path.
- Consider the installation of Rectangular Rapid Flashing Beacon (RRFB) or a Pedestrian Hybrid Beacon at the existing mid-block crosswalk on Route 28 near Barnstable Intermediate School.

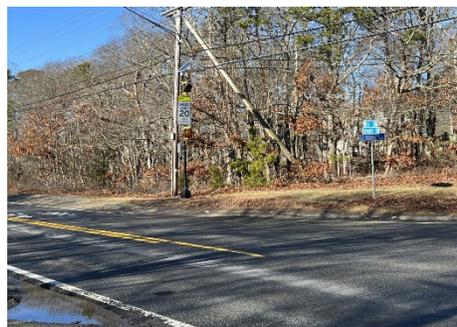
Image 24: Worn dirt path from Old Strawberry Hill Road to Route 28 connecting to mid-block crosswalk.

- Evaluate locations for optimal pedestrian crossings on Route 28
- Connect the shared use path with the existing sidewalks facilities on Barnstable High School Access Road.

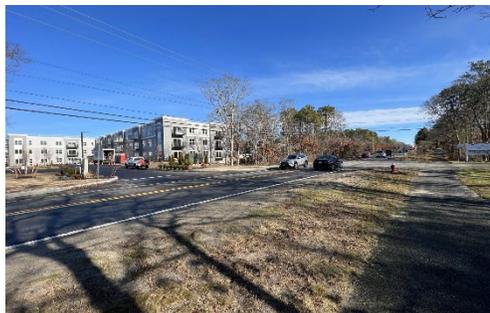
With the area having all these different destinations for motorists there are many clusters of curb cuts. Curb cut clusters create too many redundant access points to destinations and reduce efficiency of the main roadway. Reducing these clusters would in turn help to reduce congestion from turning vehicles and the high percentage of rear-ends in this area. Thirteen of the crashes observed in this area were rear-ends. There is an opportunity to widen the road in this section to allow for vehicles to have left turn lanes with decent storage lengths. A few of the intersections in this area

Image 25: New apartment complex entrance is offset from the Barnstable High Access Road.

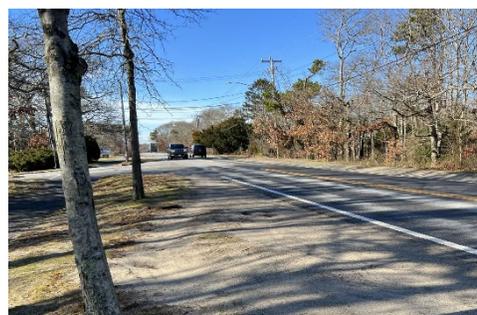
Image 26: Worn dirt shoulders in BIS Area used by motorists.

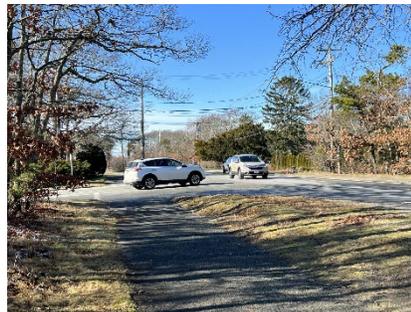
The speed limit along Route 28 in this area is 45 miles per hour (mph) and there is a 20 mile per hour (mph) school zone designation in the area in front of BIS during school hours. It was noted that the existing school pavement markings are faded, and the locations of the school zone assemblies may not reflect new guidance in the Massachusetts Amendments to the MUTCD (2022) which incorporates high schools. The stop line for the BIS driveway is located approximately 25 feet back from Route 28 before the shared use path. This leads to cars inching up toward Route 28 and stopping in the way of the path due to a lack of visibility.

Image 27: Vehicle attempting to turn onto Route 28 after the stop bar at the BIS driveway.
