ROAD SAFETY AUDIT

Pleasant Lake Avenue (Route 124) at Queen Anne Road

Town of Harwich

September 2025

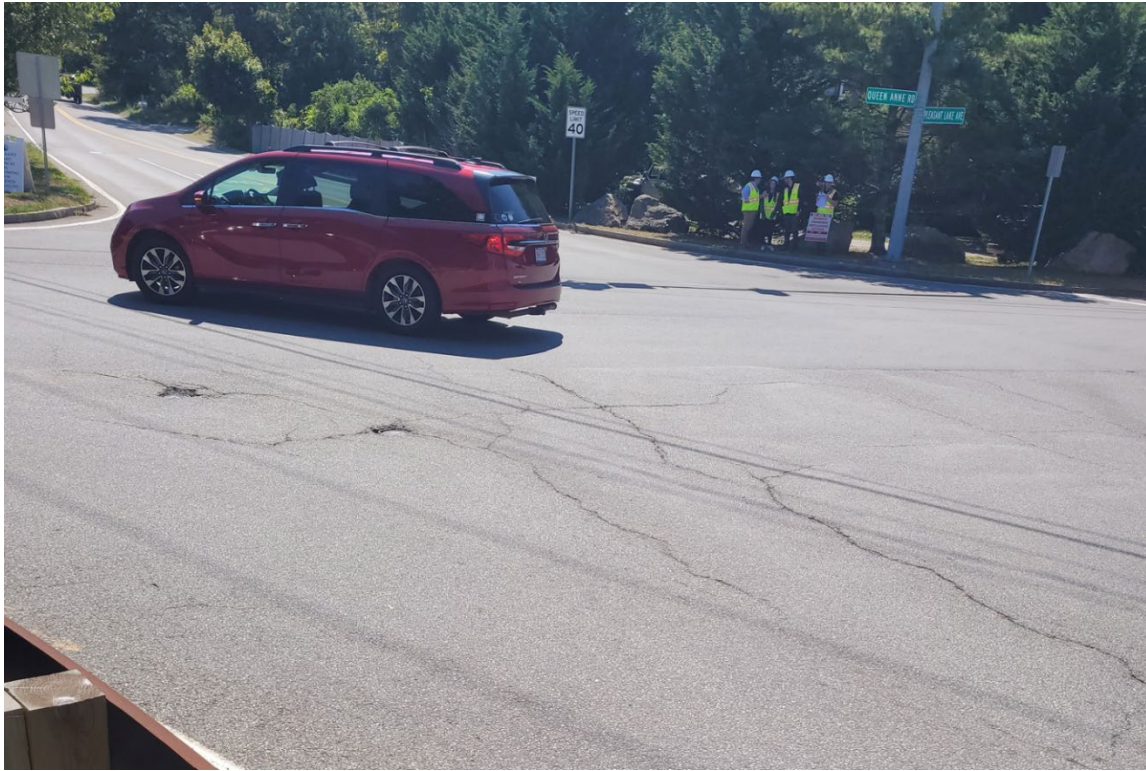
Figure 2: Speed Limit Sign on Pleasant Lake Avenue (Route 124) just south of Queen Anne Road

Lastly, during the site visit, audit team members noted that the regulatory speed limit sign on Pleasant Lake Avenue (Route 124) southbound was located just south of Queen Anne Road and visible at the intersection. Regulatory speed limit signs are not typically placed in an intersection like this and may not be effectively informing drivers of the roadway speed limit. This could contribute to sign clutter at the intersection and be overlooked by drivers as they navigate the intersection. Additionally, the placement may encourage higher speeds to continue through the intersection. Figure 2 depicts the location of the speed limit sign.

In addition, audit team members noted that the speed regulation for Pleasant Lake Avenue (Route 124) indicates the speed limit is 45 mph north of Queen Anne Road, but there are no signs posted. Similarly, Queen Anne Road's speed regulation indicates a 25 mph speed limit within the vicinity of the intersection with Pleasant Lake Avenue (Route 124), but there are no signs posted. Also, as shown in Figure 2, the street name signs are mounted on the side of the mast arms on the northeast and southwest corners of the intersection. These may not be placed in a location that is easily visible to drivers. The lack of speed limit signage or the improper placement may contribute to a range of speeds that vehicles are traveling. Keeping a uniform speed on a roadway allows for drivers to react better situations as all drivers are moving slowly relative to each other.

1. Consider installing advanced signal warning signs on all approaches to the intersection to provide notice of the upcoming traffic signal.
2. Remove the non-compliant unsignalized intersection warning (W2-1) sign on Pleasant Lake Avenue (Route 124).
3. Investigate and consider installing bus signage for the bus stop on Pleasant Lake Avenue (Route 124) south of Queen Anne Road to provide notice of the upcoming bus stop.
4. Evaluate the regulatory speed limit sign placement on Pleasant Lake Avenue (Route 124) for optimal locations.
5. Confirm existing speed limit signage matches the speed regulations for Pleasant Lake Avenue

(Route 124) and Queen Anne Road, and add/replace signs as needed.

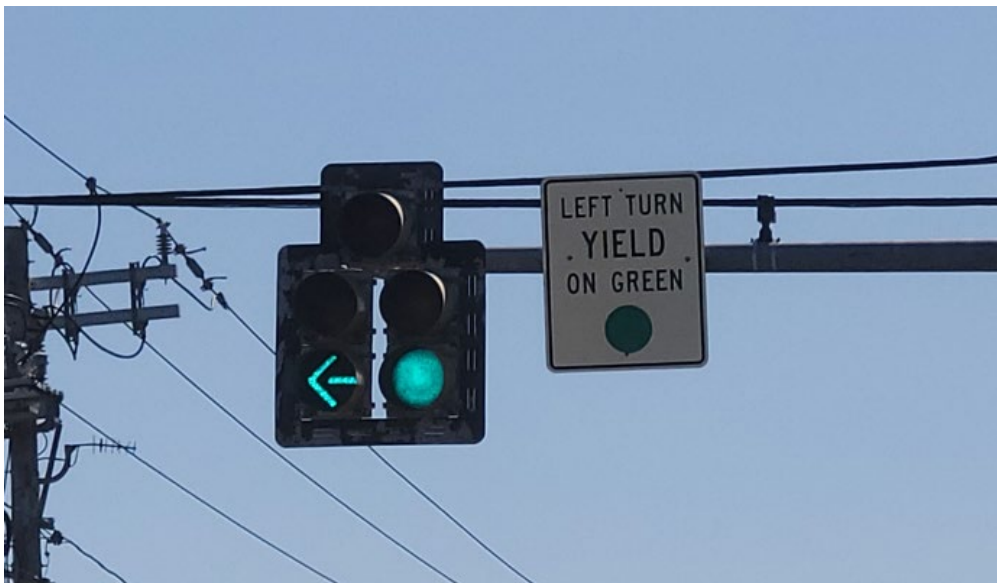
Figure 3: Traffic Signal Heads – No Retroreflective Strips on Backplates

The crash data indicated that 1 crash occurred under dark conditions and another occurred during dawn. Lighting in the area is provided by a streetlight mounted on a utility pole at the southeast corner of the intersection. Since the only streetlight is on the southeast corner, it may not directly illuminate the center of the intersection, which may be contributing to the nighttime crashes, specifically crashes 4 and 22. During the field visit, audit team members noted that the traffic signal heads did not have retroreflective strips on the back plates. Figure 3 depicts the traffic signal heads without retroreflective strips on the back plates.

This may be a contributing factor in the 10 rear-end collisions that occurred during the study period, as drivers may not be seeing the signal in time. Audit team members also noted that a tree on the property on the north corner of the intersection blocks visibility of one of the signal heads, so drivers on Queen Anne Road westbound can only see one of the two signal heads approaching the intersection. The lack of signal visibility may have contributed to the high number of rear-end crashes, specifically crashes 3, 19, 20, and 22. Figure 4 shows a view of the traffic signal from the Queen Anne Road westbound perspective.

1. Evaluate the adequacy of the existing lighting at the intersection and install additional lighting as needed.
2. Consider installing retroreflective strips on the backplates of all traffic signal heads at the intersection to improve signal visibility.
3. Consider trimming the tree on the north corner of the intersection such that both signal heads are visible to drivers approaching the intersection on Queen Anne Road westbound.

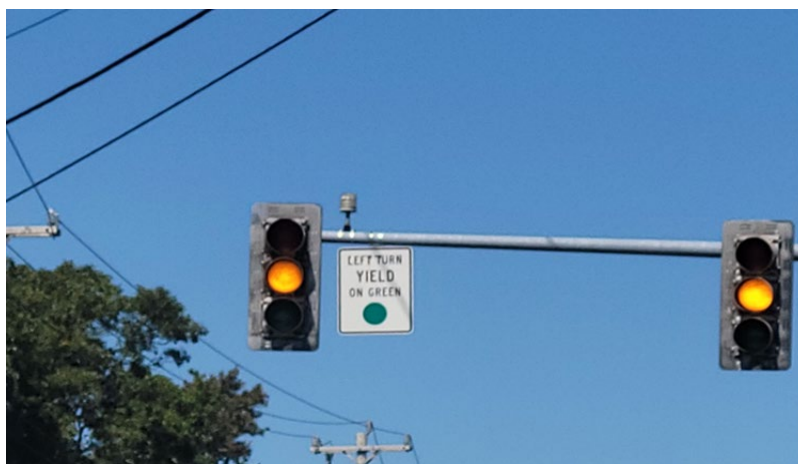
Figure 5: Pleasant Lake Avenue (Route 124) Southbound Approach Left-Turn Signal Head - Circle Green Indication

Audit team members noted that the Pleasant Lake Avenue (Route 124) southbound approach has protective/permissive left-turn phasing, while the northbound approach only has permissive phasing for left turns. Figure 5 shows the Pleasant Lake Avenue (Route 124) southbound left-turn signal head.

Similarly, Queen Anne Road only has permissive left-turn phasing. The phasing may be a contributing factor in the angle crashes involving left-turning vehicles (crashes 7, 15, and 17) as the vehicle with permissive phasing failed to yield the right-of-way to the through vehicle in all three instances. It was also noted that the permissive left-turn movement on Pleasant Lake Avenue (Route 124) southbound uses a solid green signal indication and not a flashing yellow arrow signal indication. This may also be a contributing factor in crashes 7 and 17, as this may lead to drivers thinking they have the right-of-way.

1. Evaluate traffic signal timings and adjust as needed for optimal performance.
2. Evaluate the clearance intervals for the intersection and update as needed.
3. Evaluate the left-turn signal phasing at the intersection:
 - a. Consider implementing protected-only left-turn phasing on Pleasant Lake Avenue (Route 124) at the intersection to reduce conflicts.
 - b. Should phasing remain unchanged, consider upgrading the signal to a flashing yellow arrow in order to further clarify the permissive left-turn phase to drivers.
4. Evaluate the adequacy of the left-turn lane storage on Pleasant Lake Avenue (Route 124) southbound and modify the storage length as needed.
