*Lighthouse Inn Groin Improvements
West Dennis, Massachusetts
MEPA Environmental
Impact Report*

*Prepared For:
Lighthouse Inn Inc.
April 2017*

MEPA Environmental Impact Report

*Project Municipality: Dennis, MA
Project Watershed: Cape Cod
EEA Number: 15623*

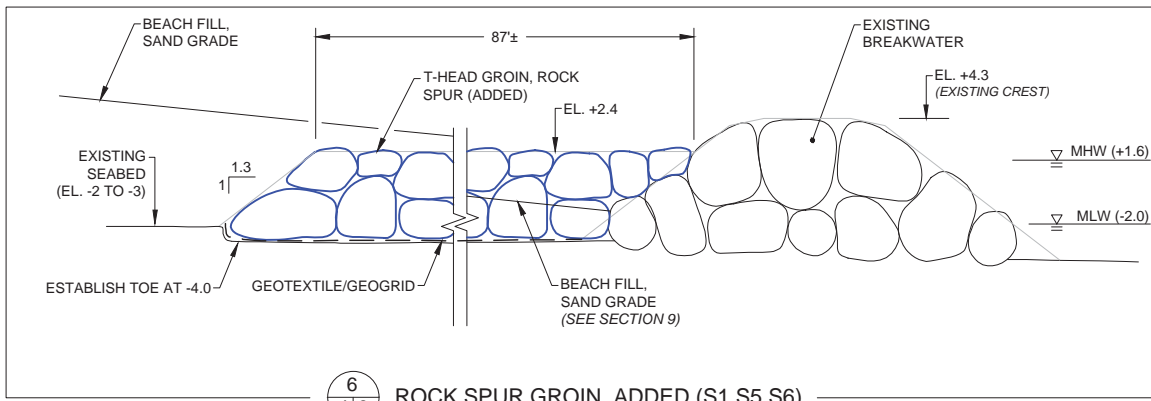
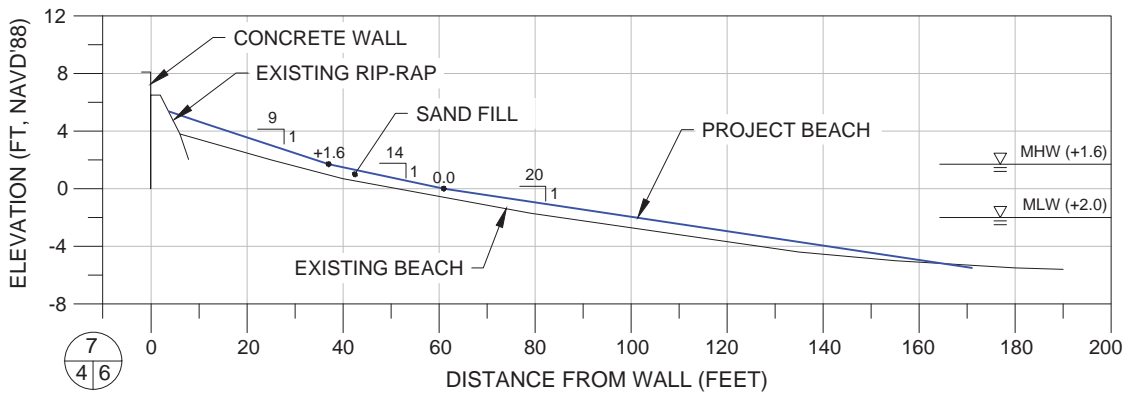
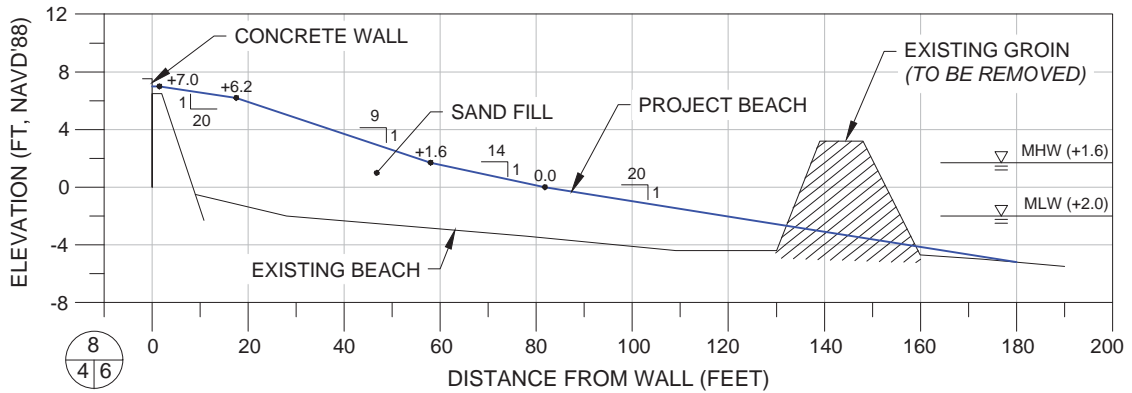
NOTE: SECTIONS 7-11 DEPICT 3:1 VERTICAL EXAGGERATION

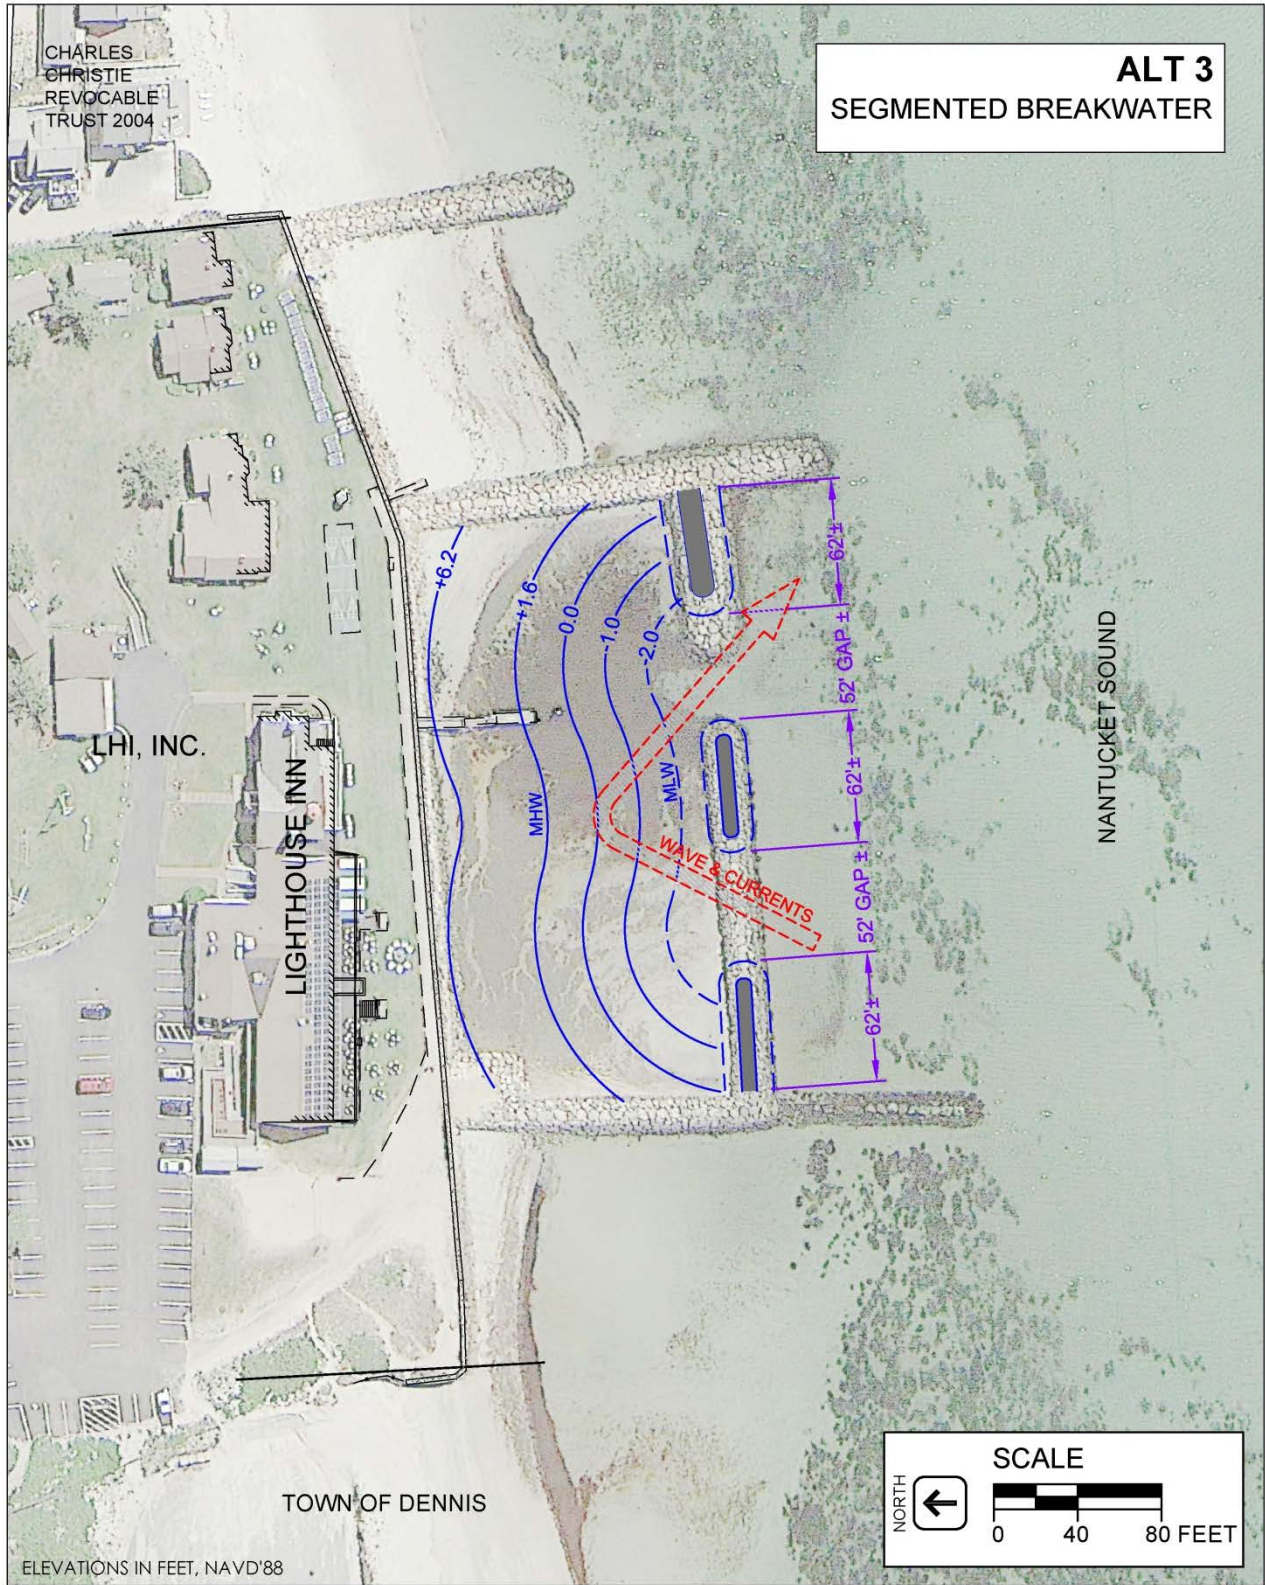
Figure 3: Alternative 3 – Partial breakwater removal resulting in a central segmented breakwater. Waves and currents between the two gaps ultimately act to erode the beach in the lee, compromising the beach and shore protection. There is no improvement along the east or west ends of the shorefront.

This alternative is not recommended because prototype experience indicates that it is not capable of reliably maintaining a beach in the lee of the two gaps, given the absence of a “stem” that segregates the flow between the gaps and which better defines two embayments. Additionally, this alternative does not provide improved beach stability and shore protection along the east or west thirds of the property shoreline.

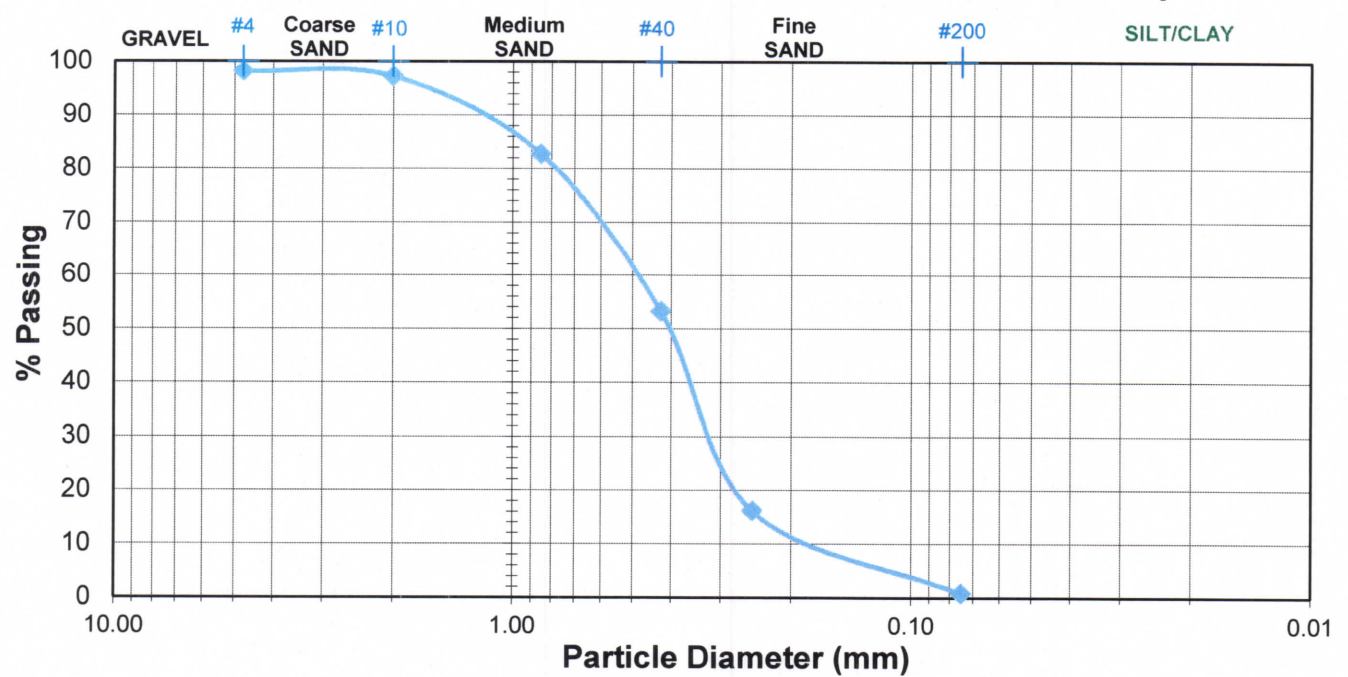
Grain Size Distribution Curve Results:

% Gravel: 0 **D₁₀:** 0.2 **C_u:** 2.5
% Sand: 99 **D₃₀:** _____ **C_c:** _____
% Fines: 1 **D₆₀:** 0.5

Three offshore sediment samples were collected in the vicinity of the Lighthouse Inn beach for grain size analysis. In summary, all three samples had a measure of shell fragments but otherwise clean uniformly graded medium sand. Sand observed on the higher beach area is finer due to it being primarily windblown. A sample location plan with the results of this sediment sampling are included in Appendix D.

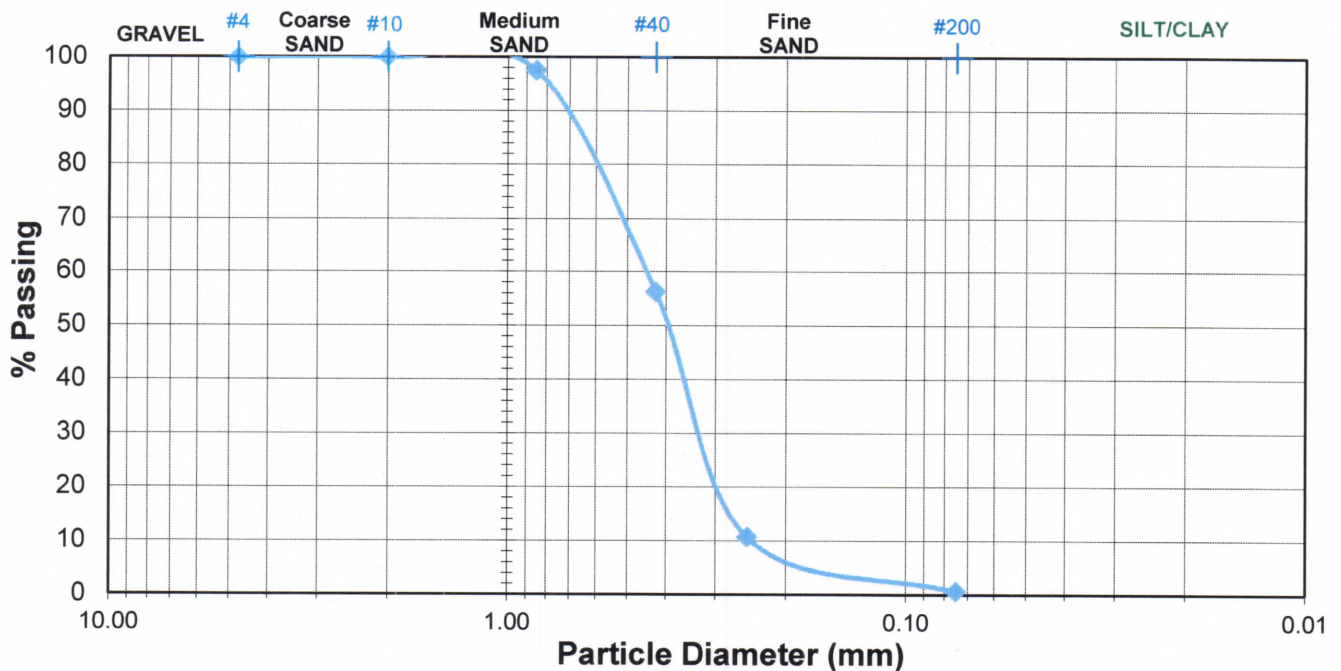
Grain Size Distribution Curve Results:

% Gravel: 0 **D₁₀:** 0.25 **C_u:** 1.8
% Sand: 99 **D₃₀:** _____ **C_c:** _____
% Fines: 1 **D₆₀:** 0.44

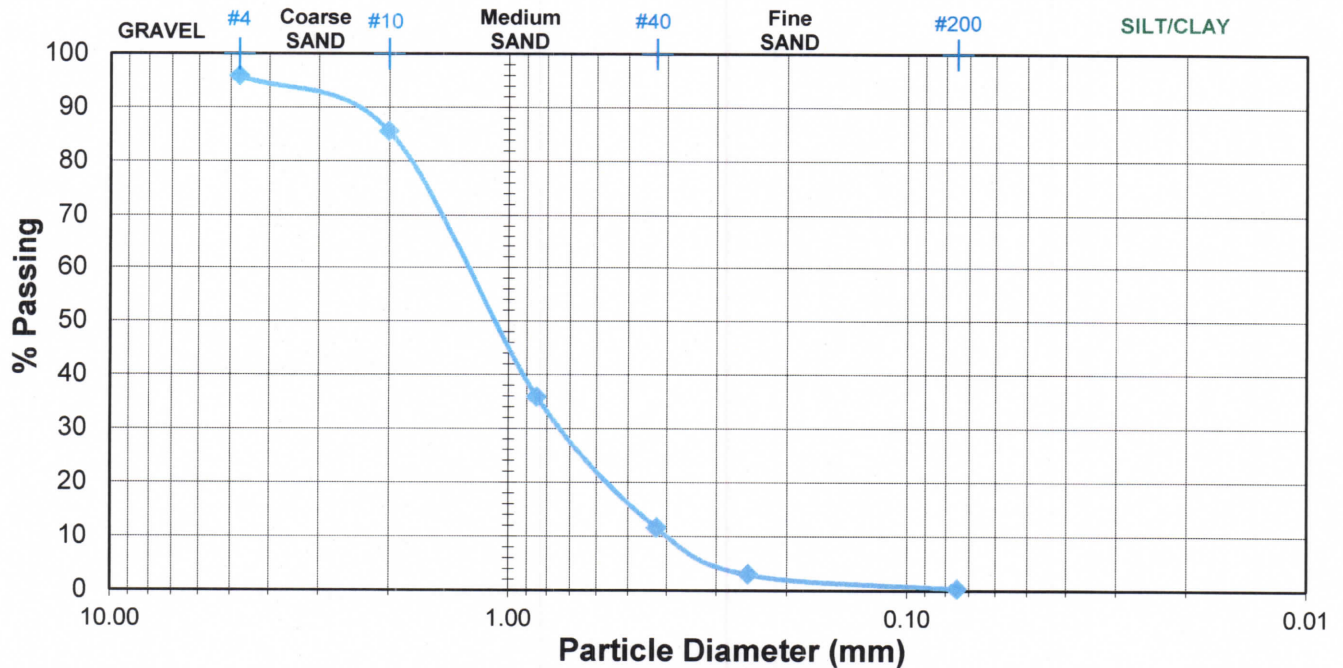
Grain Size Distribution Curve Results:

% Gravel: 0 **D₁₀:** 0.42 **C_u:** 2.9
% Sand: 98 **D₃₀:** _____ **C_c:** _____
% Fines: 1 **D₆₀:** 1.2

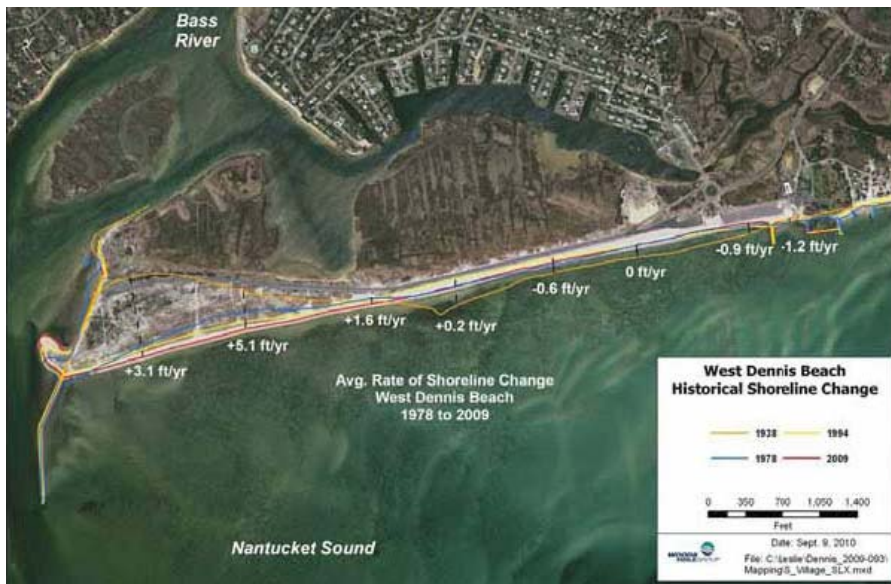
Figure 6: Shoreline change rates along West Dennis Beach (WHG 2010).

sand spits across the entrance; but there is also shoaling on the east (downdrift) side of the inlet jetties. WHG (2010) indicates a shoreline accretion rate of +0.4 to +1.8 ft/yr along the west, updrift side of the Swan Pond River jetty, with shoreline erosion rates of -0.4 ft/yr further to the west (**Figure 7**). These observations suggest robust, gross littoral transport in both the westerly- and easterly-directions, trapped (impounded) by the inlets and jetties at each end of the shoreline. This indicates significant sand transport along the shoreline in both east- and west-directions, and that the inlets on each end act as littoral sinks that reduce the volume of sand otherwise available to drift along, and maintain, the shoreline between the inlets. The net result is long-term historical accretion at the ends of the coastline, and erosion in the middle. This is not to say that the beach conditions at the project site are wholly due to inlet influences; but instead, that the adjacent inlets have impounded littoral material (thus adding to the erosion distress) and that there is evidence of both substantial westerly- and easterly-directed littoral drift along this shoreline beyond the overly simplified view of net easterly-directed drift.

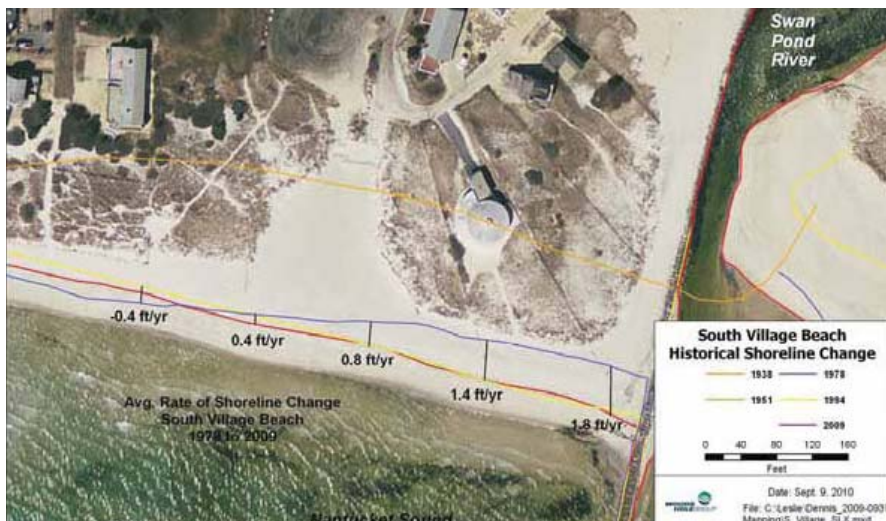
Figure 7: Shoreline change rates east of Lighthouse Inn, at South Village Beach, west of Swan Pond River entrance (WHG 2010).

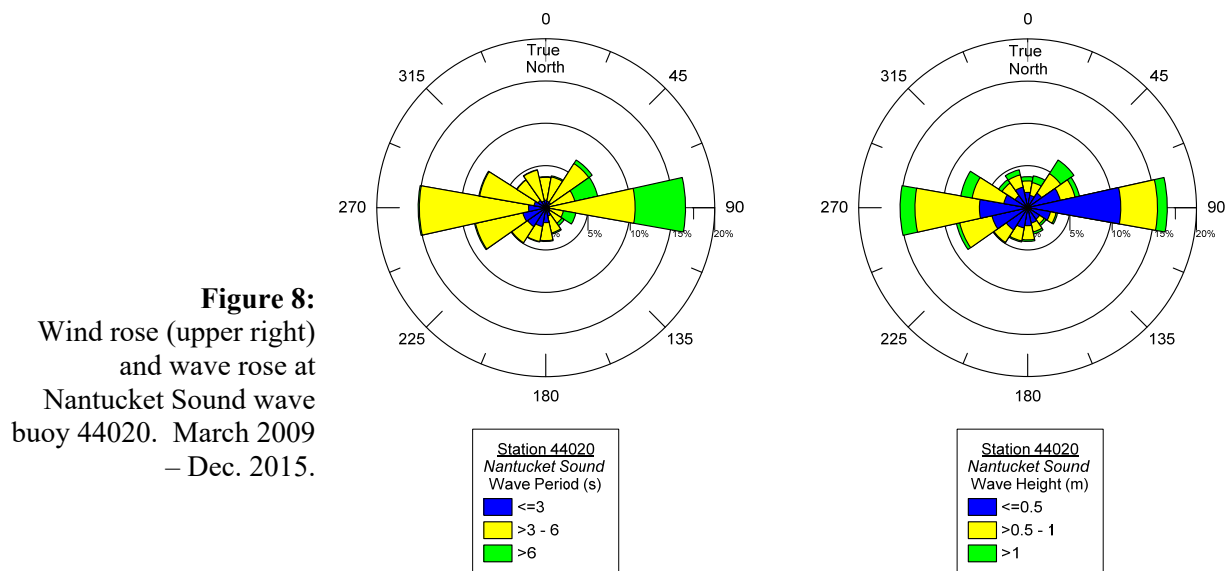
Figure 8: Wind rose (upper right) and wave rose at Nantucket Sound wave buoy 44020. March 2009 – Dec. 2015.

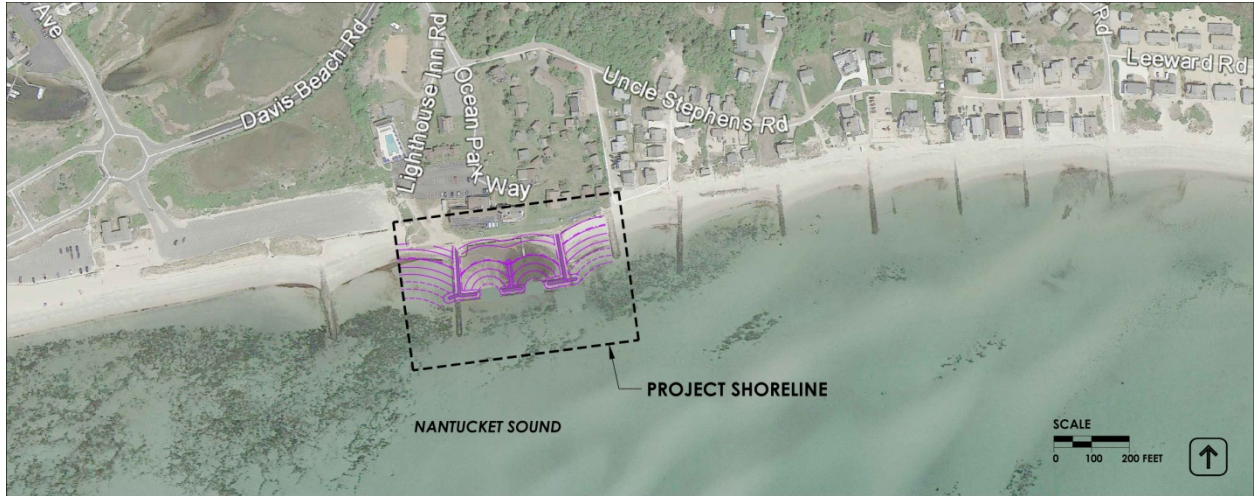
Figure 9: Proposed project plan of improvement.

The proposed plan of improvements is illustrated in **Figure 9**, including depiction of the project relative to the overall shoreline setting. The Alternatives Analysis describes the formulation and selection of the proposed (selected) plan. The following section describes the coastal engineering methodology and coastal processes associated with the project.

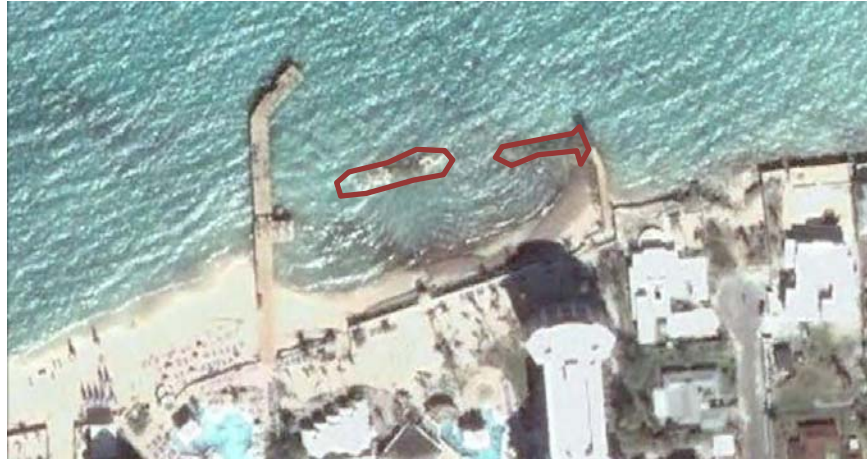
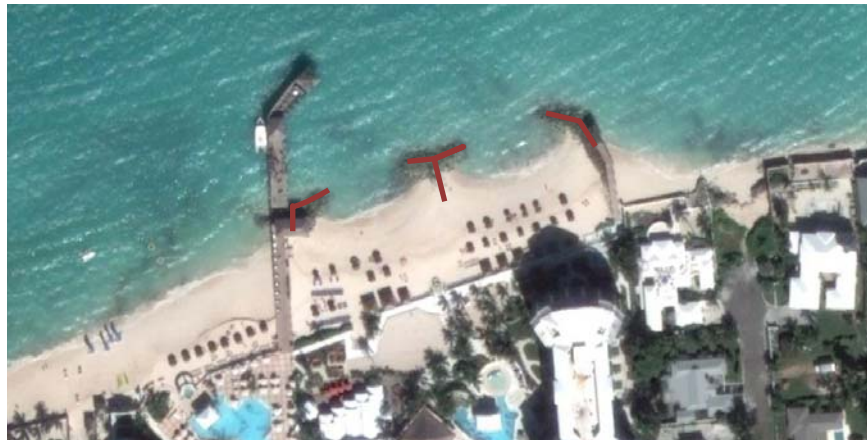
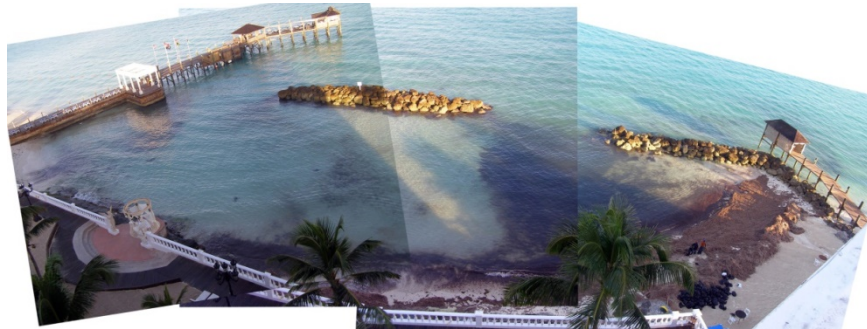
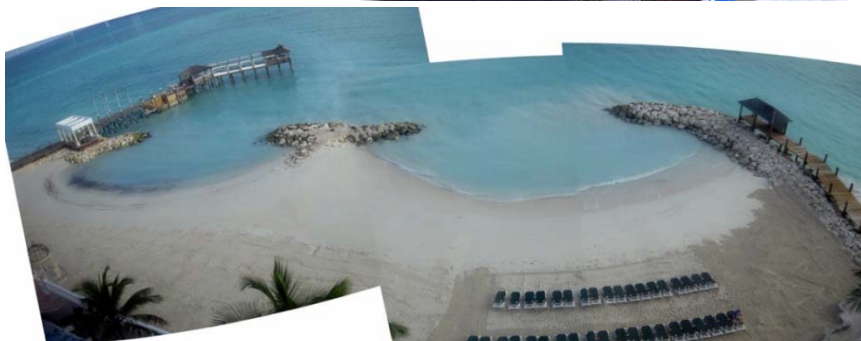
Figure 10: Sandals Royal Bahamian (Nassau, Bahamas). An existing breakwater and groin were partly removed and reconfigured to build two pocket-beach embayments with central T-head groin and sand fill in 2009, and eliminating the daily accumulation of detrital seagrass. (Top and third photograph – pre-project (2004 & 2008). Second and bottom photograph – post-project (2015 & 2010).

A very similar example is the eastern beach of the Sandals Royal Bahamian Resort (Nassau, Bahamas). It was modified in 2009 to deconstruct an existing offshore breakwater and reconfigure the east-end groin to create a central T-head groin, two adjoining spur groins, and two pocket beaches, with initial sand fill of about 5,000 cy (*Figure 10*.) The project length of 360-ft is similar to the central beach length of Lighthouse Inn behind the existing breakwater (280-ft). The pre-project shoreline featured little or no usable sand beach that was covered daily by detrital seagrass. Since project construction, the restored beach has remained stable and there is little or no accumulation of seagrass -- owing to the restoration of wave & tidal circulation, and the replacement of the unnatural embayment (behind the old structures) by a proper, stable beach. No adverse impacts to adjacent shorelines have been observed.

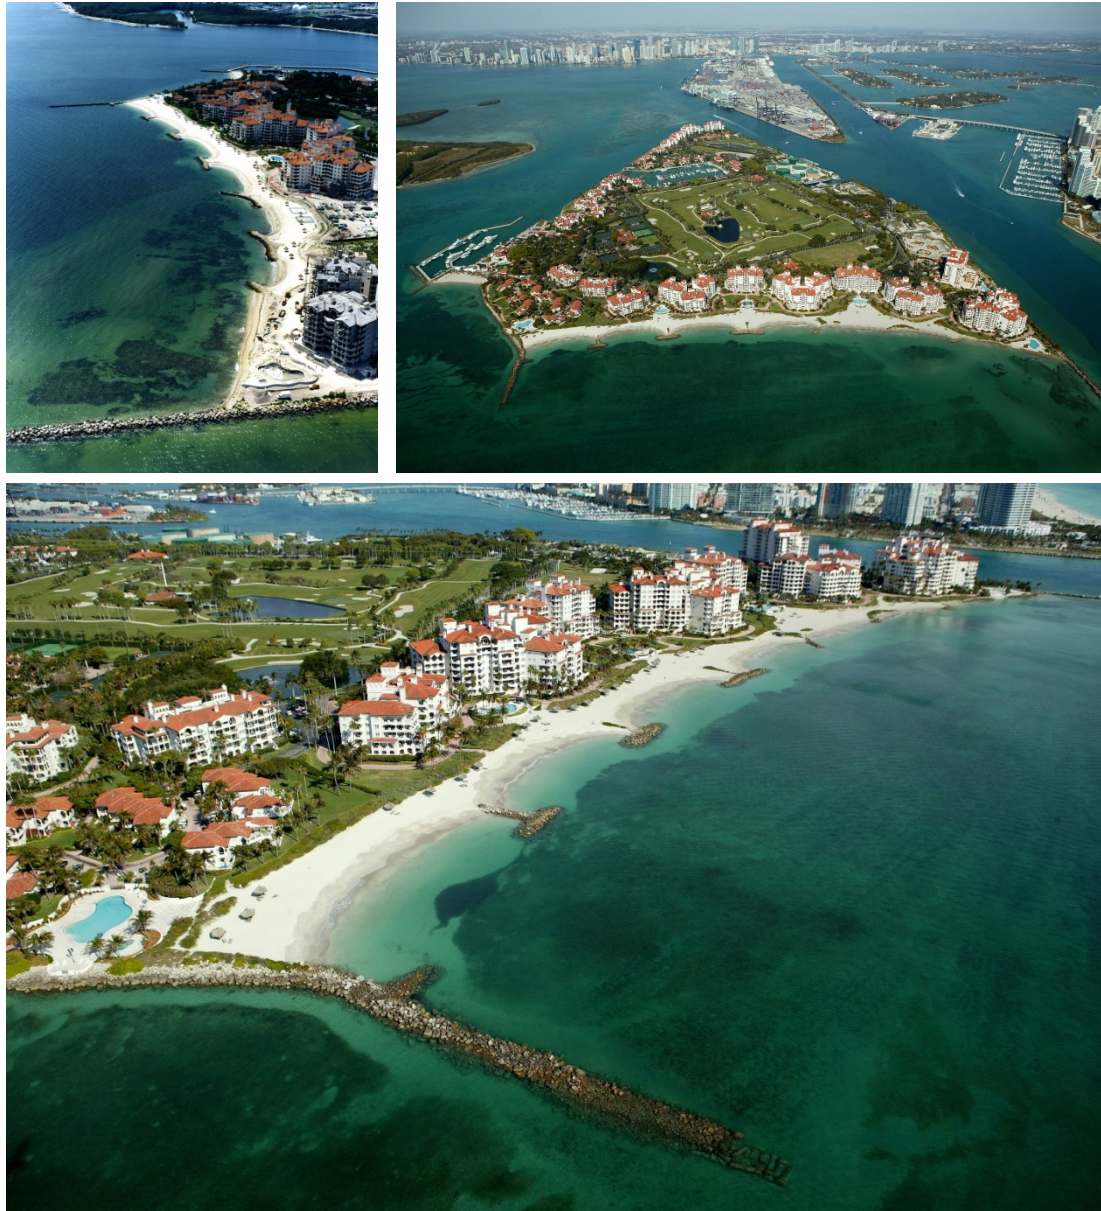
Figure 11: Fisher Island, Florida. Seven T-head and spur groin structures, with sand fill, constructed in 1991 to restore a beach eroded after the construction of Government Cut at Miami Beach in 1904.

The Fisher Island, Florida project, at Miami Beach, was constructed in 1991. The project employed seven T-head and spur-groins, with initial sand fill from the Bahamas, to restore the sand beach that had been completely eroded after the 1904 opening of the adjacent Government Cut inlet (*Figure 11*). The project has not required renourishment since its initial construction, despite numerous hurricane impacts.

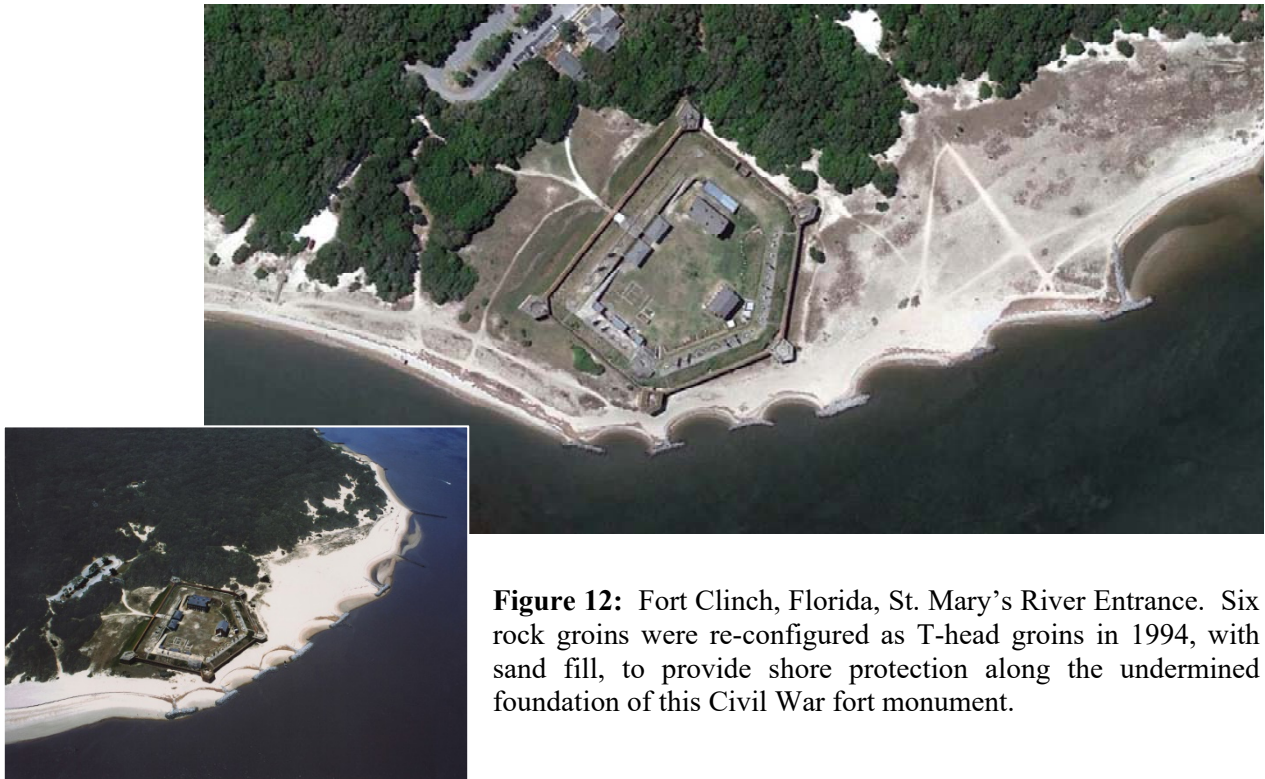
Figure 12: Fort Clinch, Florida, St. Mary's River Entrance. Six rock groins were re-configured as T-head groins in 1994, with sand fill, to provide shore protection along the undermined foundation of this Civil War fort monument.

At Fort Clinch, St. Mary's River Entrance (Florida), a half-dozen existing straight rock groins were reconfigured in 1994 as T-head groins with beach fill, to protect the foundation of this U.S. Civil War era fort from being undermined by chronic beach erosion along the St. Mary's River inlet (**Figure 12**). The site is a popular museum, historical re-enactment site and recreational beach & campground operated by the Florida Park Service near the Florida-Georgia state line. The project site is periodically renourished with sand dredged from the inlet.

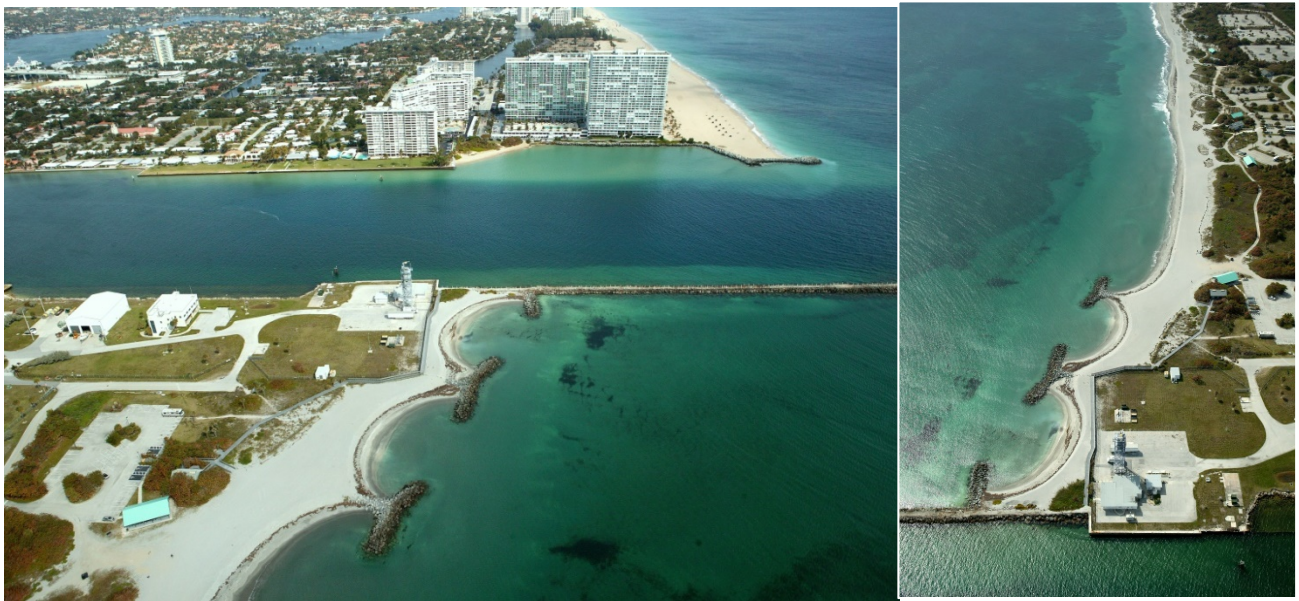
Figure 13: John U. Lloyd State Park, Port Everglades Entrance, Florida.

The two T-head structures and jetty spur, with beach fill, were constructed in 2007 to restore and stabilize the chronically eroded shoreline immediately south (downdrift) of the Port Everglades inlet. The project provides public beach recreation along the Park and shore protection to the US Navy facility adjacent to the jetty.

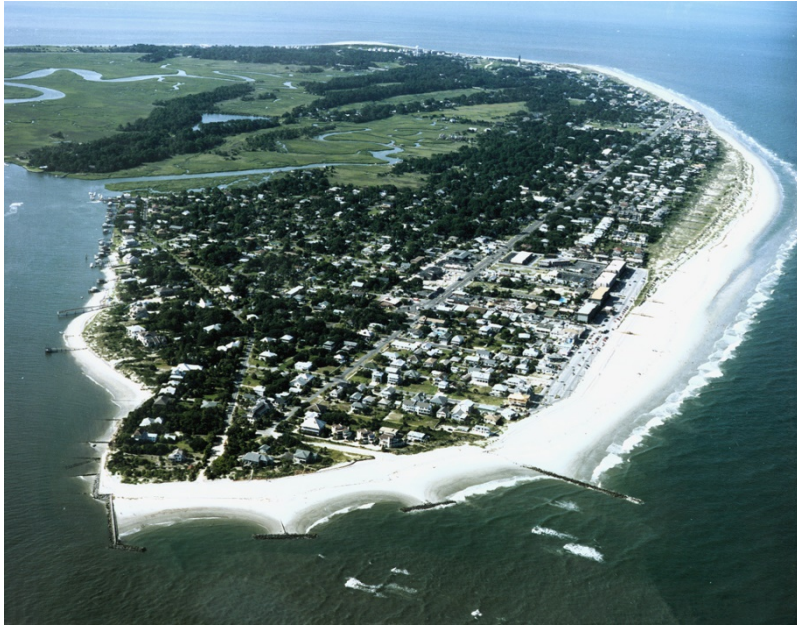
Figure 14: Tybee Island, Georgia

Two T-head groins and a terminal groin & spur were constructed in 1995 at the south end of Tybee Island, Georgia to create and stabilize a sand beach along this chronically eroded shoreline. The pre-existing jetties were modified as part of the plan. The shoreline has maintained the condition shown in the photograph since its construction.

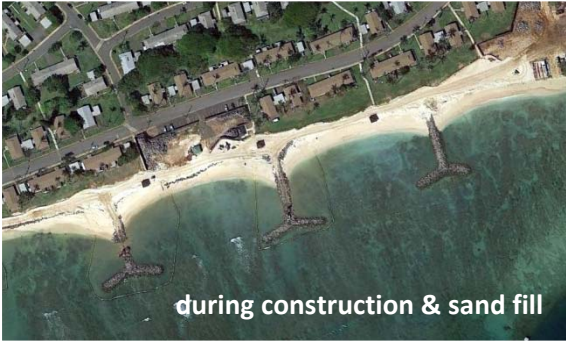
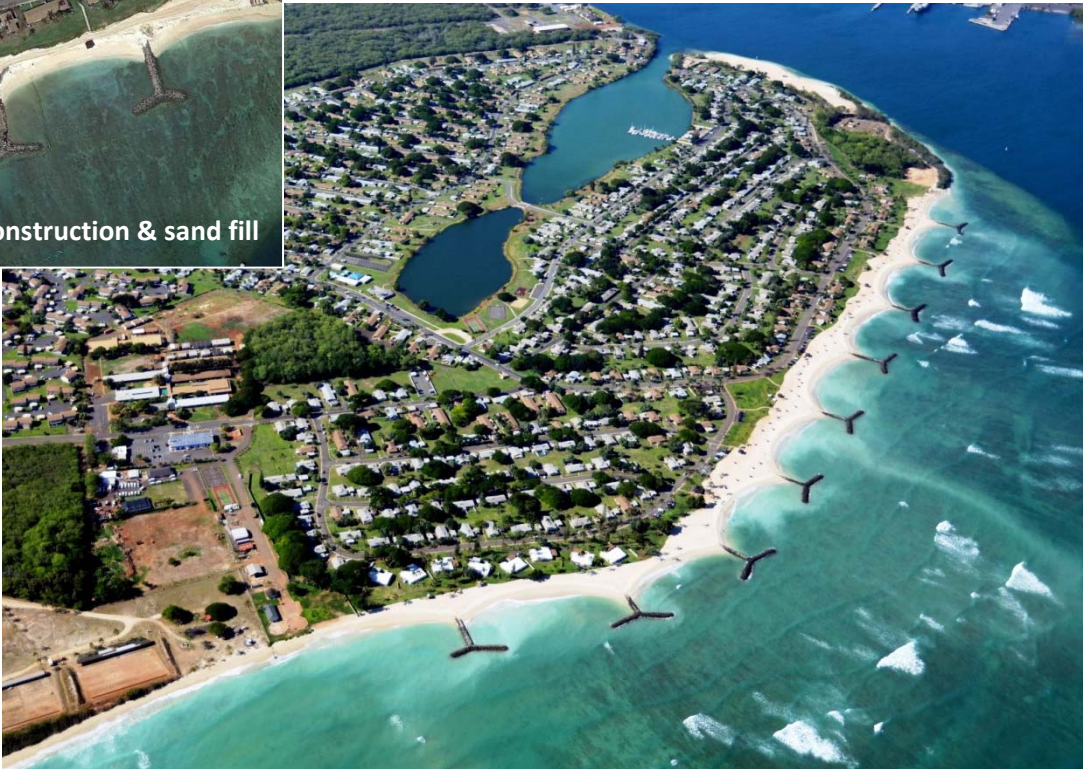
**Figure 15:
Iroquois Pt.
Oahu, Hawaii.**

Nine T-head groins and sand fill, constructed in 2013, restored this U. S. Navy shoreline adjacent to the Pearl Harbor ocean inlet. The sand fill came from maintenance-dredging along the west bank of the inlet channel (background), by excavator and dump-truck. This is the first large-scale beach nourishment project constructed in Hawaii during the last 30+ years.

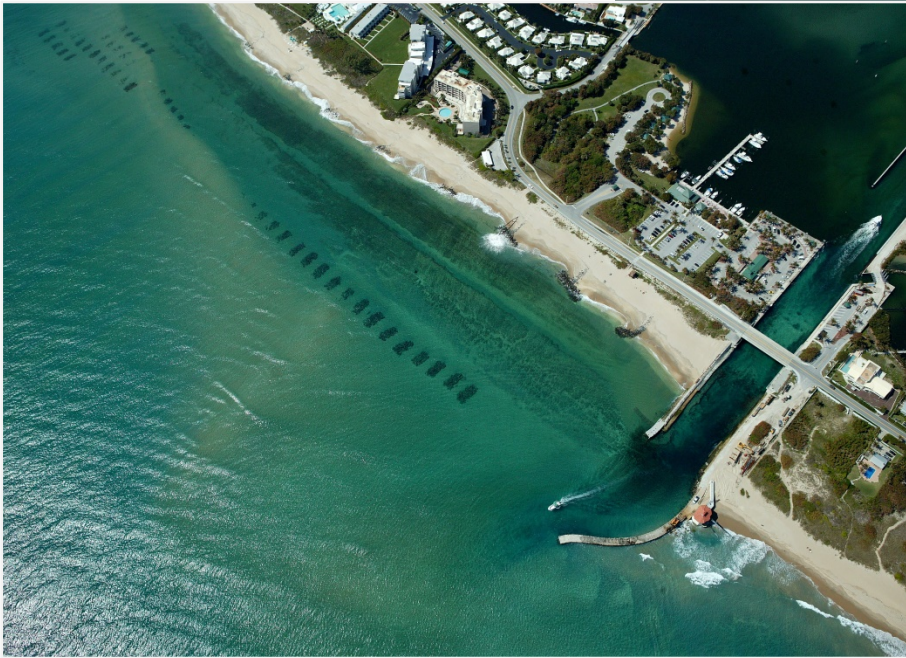
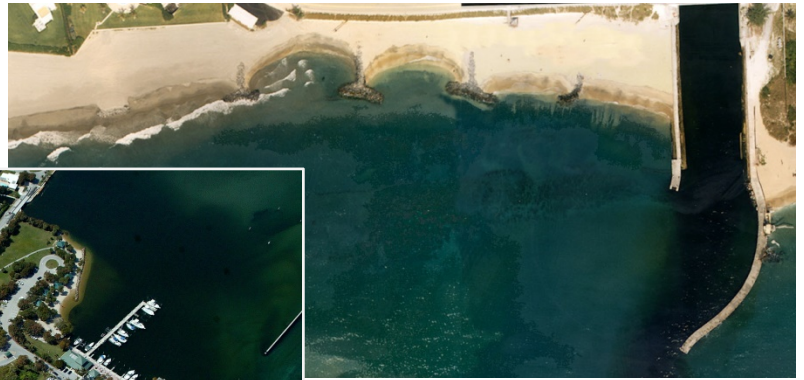
Figure 16: Ocean Ridge, Palm Beach County, Florida

Eight rock T-head structures (mostly buried in sand in these photographs) were constructed in 1998 to stabilize the beach immediately downdrift of South Lake Worth Inlet, FL, and to limit the beach encroachment upon nearshore reefs. Sand is pumped from a bypassing plant, across the inlet, and placed within the groin field.

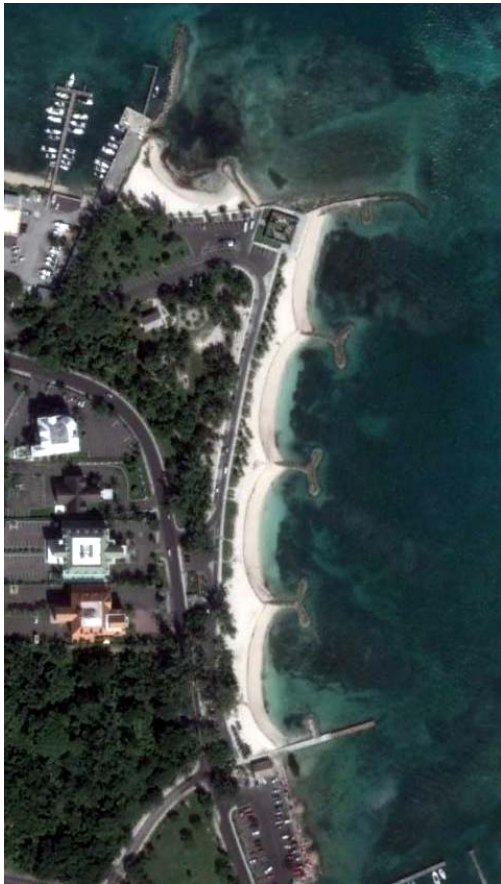
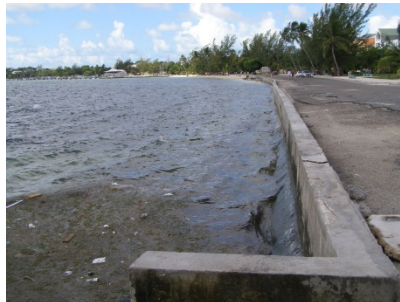
**Figure 17:
Montagu Foreshore,
Nassau Bahamas**

Left: Pre-Project Condition

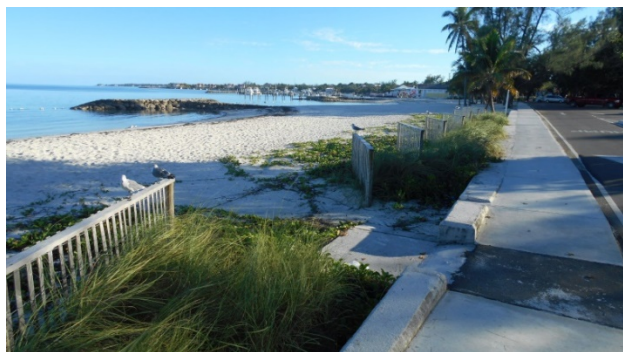
The sand beach along this popular public beach park in Nassau was restored with seven T-head and spur-groin structures and sand fill in 2011, eliminating the seagrass and debris deposits along the shoreline.

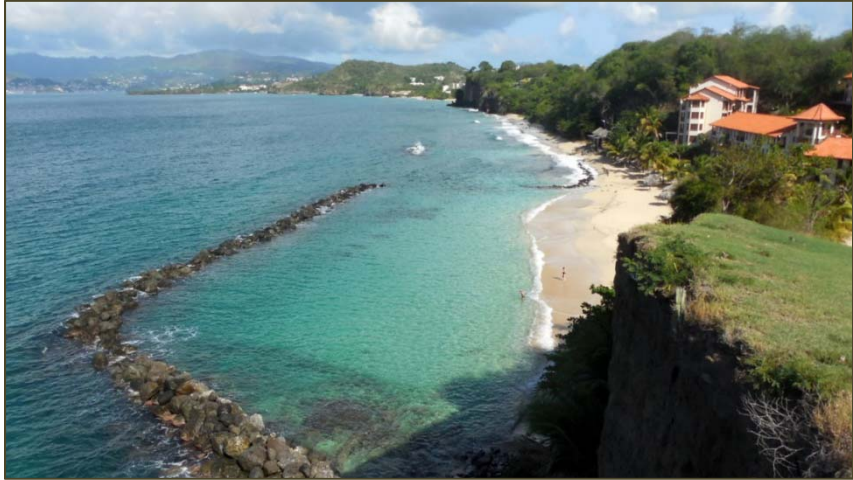
**Figure 18:
Sandals - La Source, Grenada**

Existing breakwaters and rock revetments were re-configured & removed to improve the sand beach and restore tidal circulation. Constructed in 2012-13 (bottom left); completed in Dec 2013 (below).

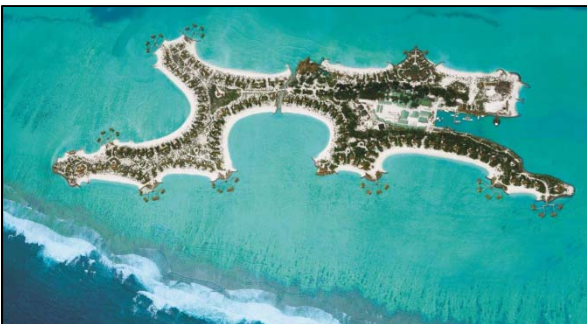
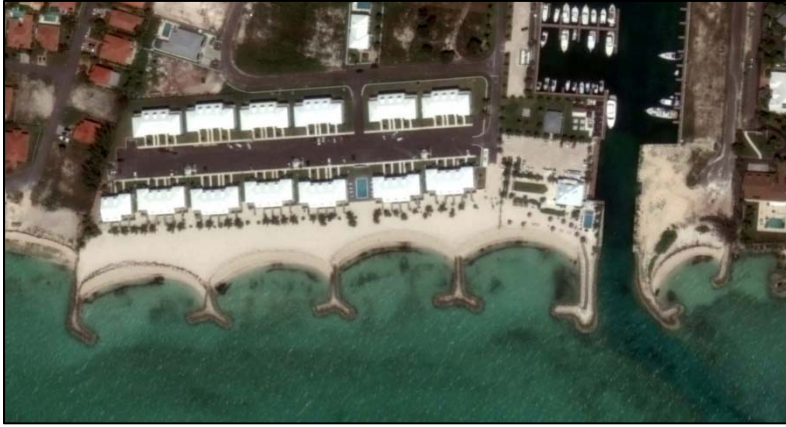
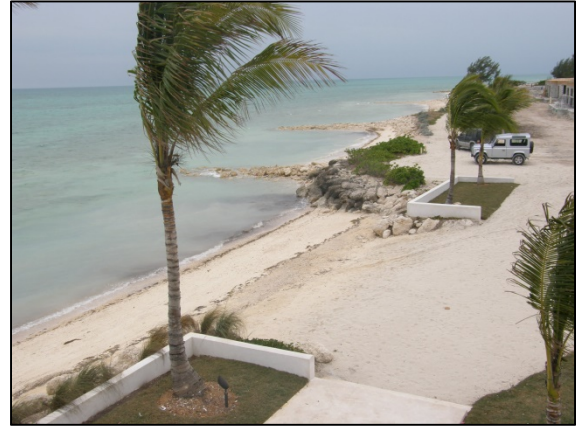
Figure 19: One&Only Reethi Rah Resort, Maldives

Over 50 rock structures, including numerous T-head and pocket-beach designs, were used to stabilize the architectural shoreline at this island resort, constructed in 2004. Through 2016, the beaches have performed per design without need for renourishment.

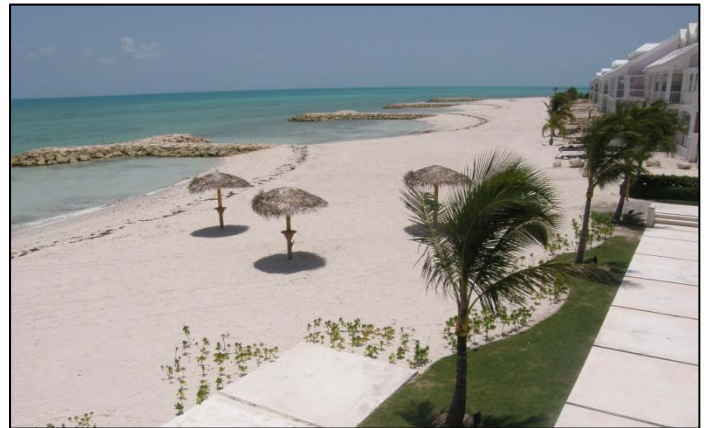
Figure 20: Palm Cay, New Providence, Bahamas

T-head, terminal and spur groins were constructed in 2012 – along with sand fill placement -- to replace derelict groins and breakwaters along a 1400-ft long residential shoreline near Nassau, Bahamas. The project created five 275-ft long pocket-beach embayments.

Above Right: Pre-Project
Right: Post-Project
