*Lighthouse Inn Groin Improvements
West Dennis, Massachusetts
MEPA Environmental
Impact Report*

*Prepared For:
Lighthouse Inn Inc.
April 2017*

MEPA Environmental Impact Report

*Project Municipality: Dennis, MA
Project Watershed: Cape Cod
EEA Number: 15623*

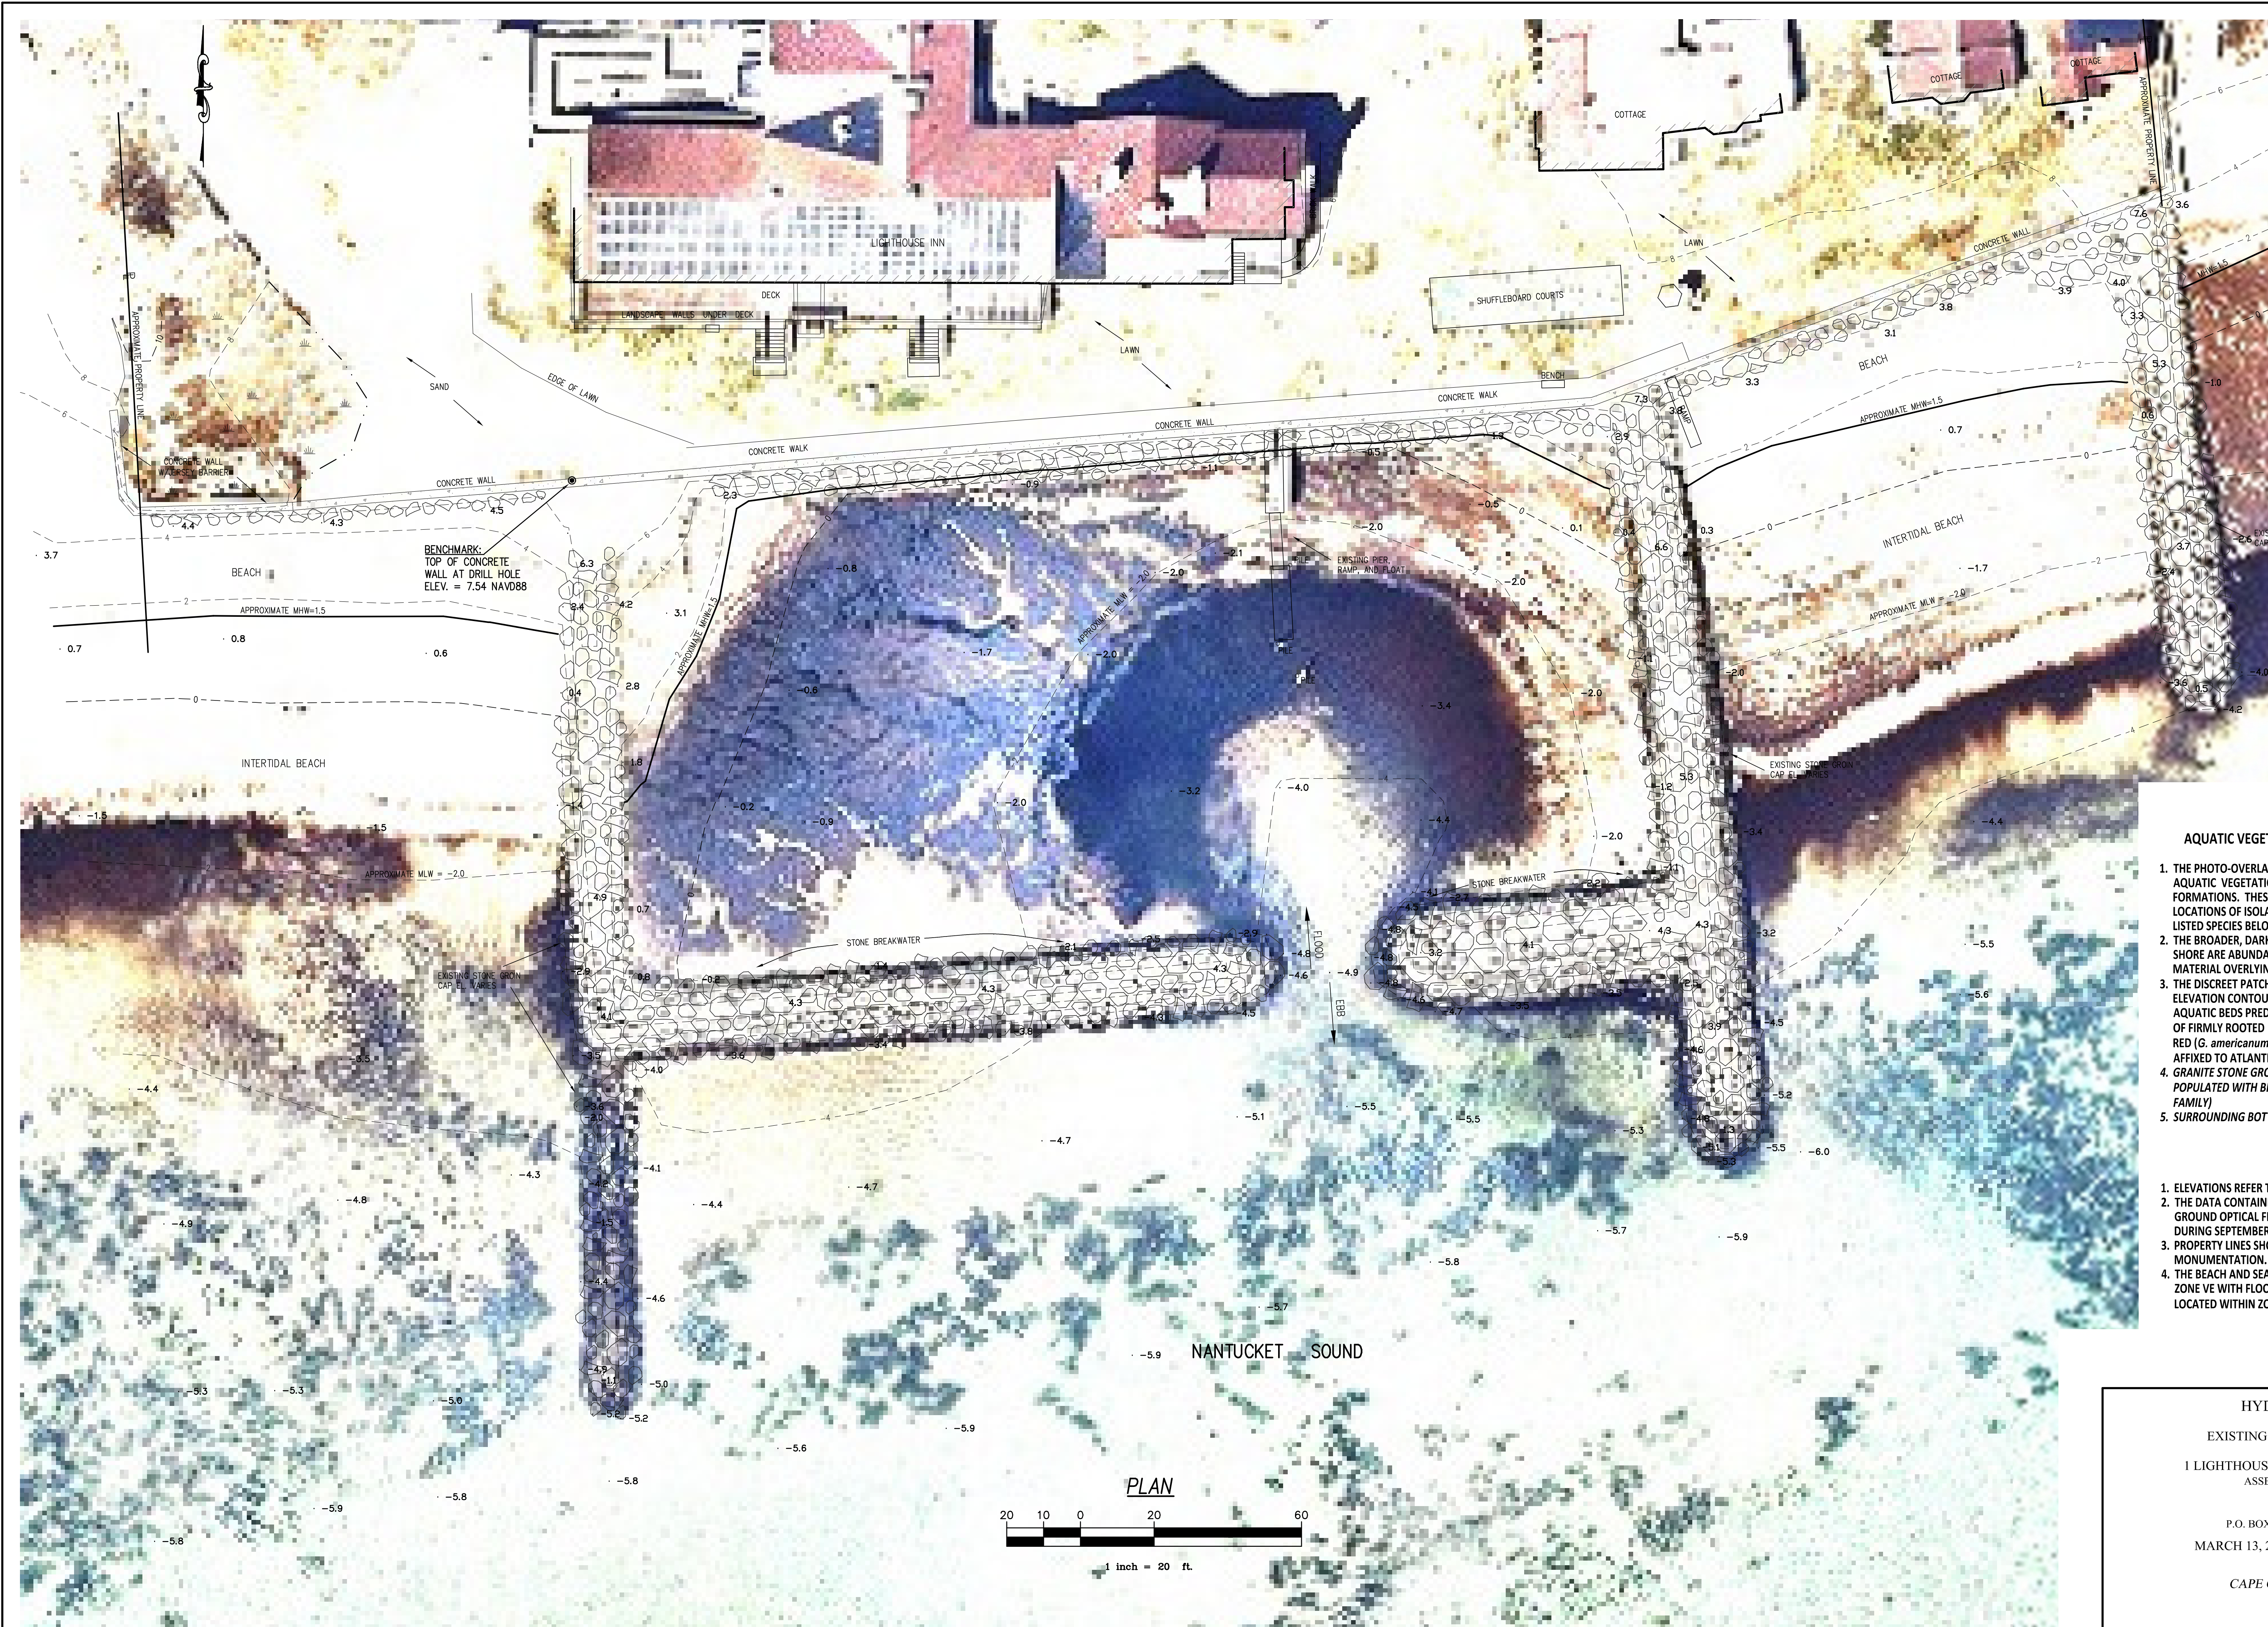
- AQUATIC VEGETATION OBSERVATION NOTES**
1. THE PHOTO-OVERLAY SHOWS THE DARKER DISCREET PATCHES OF AQUATIC VEGETATION IN THE VICINITY OF THE STONE GROIN FORMATIONS. THESE AREAS ARE THE OBSERVED AND SAMPLED LOCATIONS OF ISOLATED AQUATIC BEDS CONTAINING THE LISTED SPECIES BELOW.

HYDROGRAPHIC PLAN
 OF
 EXISTING SHOREFRONT CONDITIONS
 AT
 1 LIGHTHOUSE INN ROAD, WEST DENNIS, MA
 ASSESSORS' MAP 12, PARCEL 7
 PREPARED FOR
 LHI, INC.
 P.O. BOX 128, WEST DENNIS, MA 02670
 MARCH 13, 2017 SCALE - AS NOTED

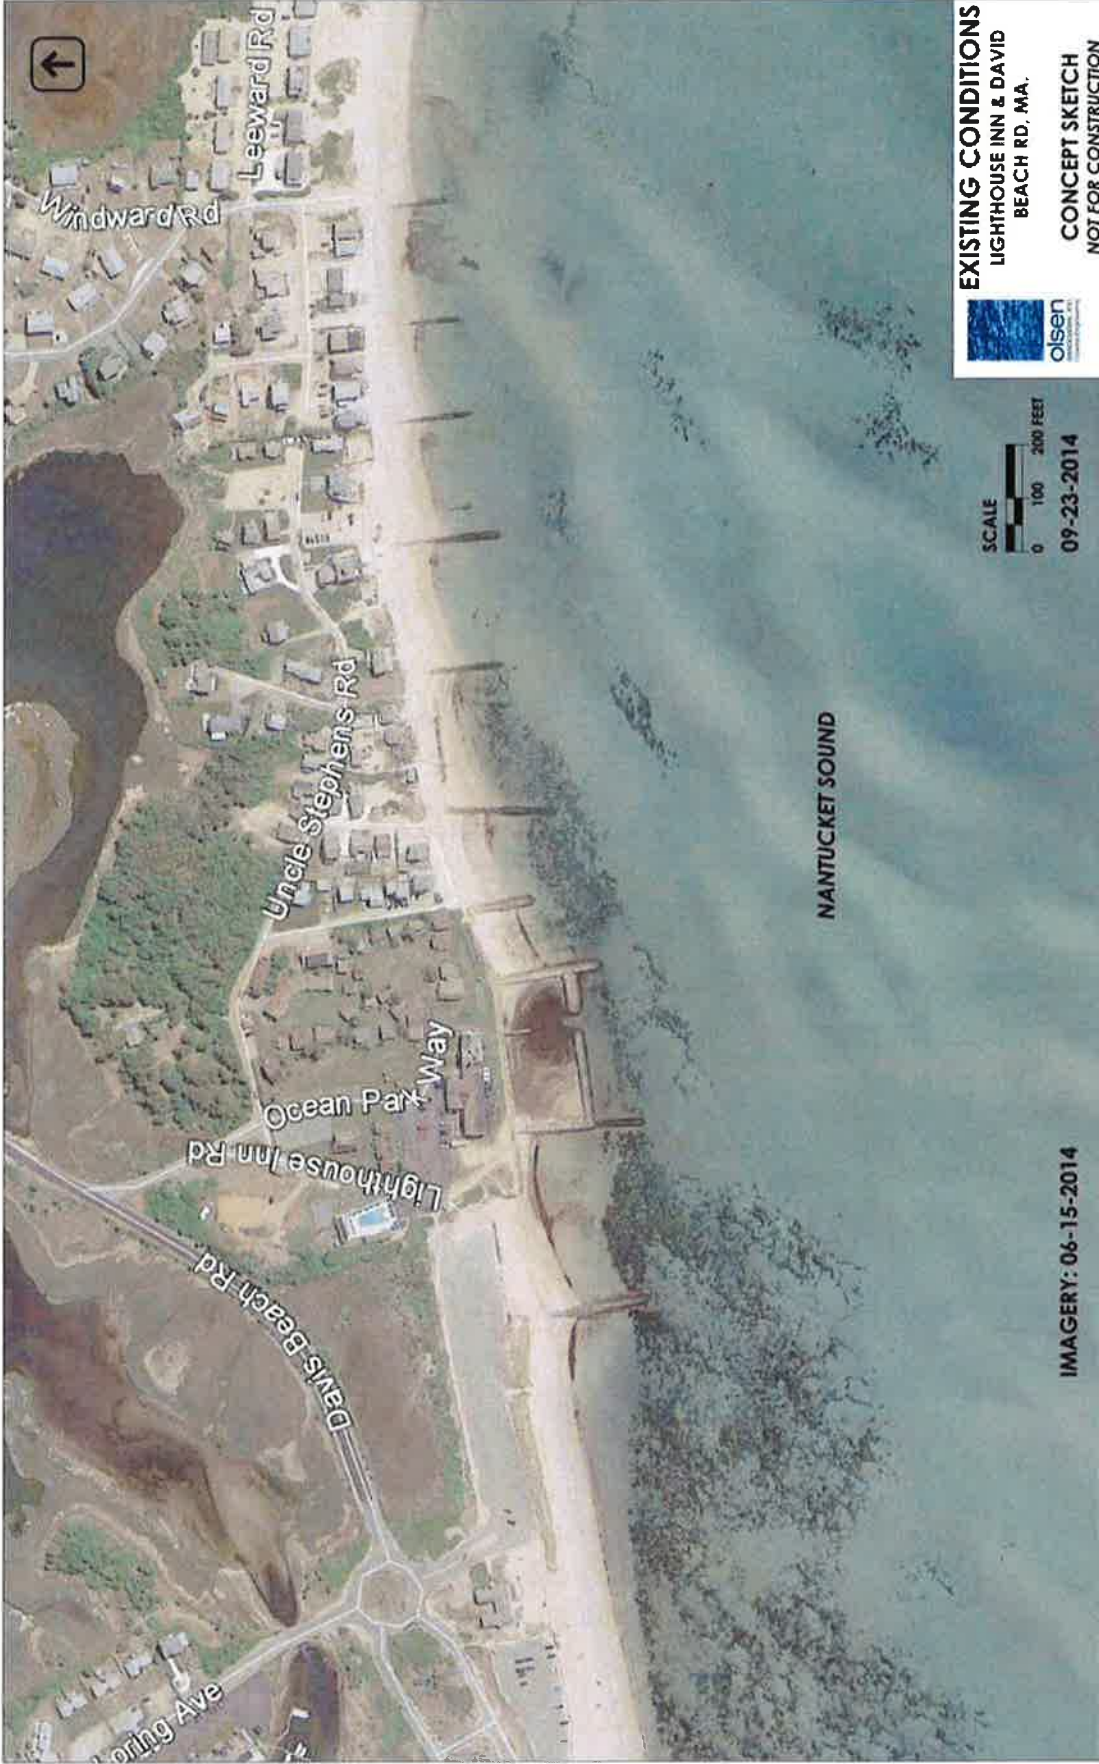
EXISTING CONDITIONS
LIGHTHOUSE INN & DAVID
BEACH RD, MA.
CONCEPT SKETCH
NOT FOR CONSTRUCTION

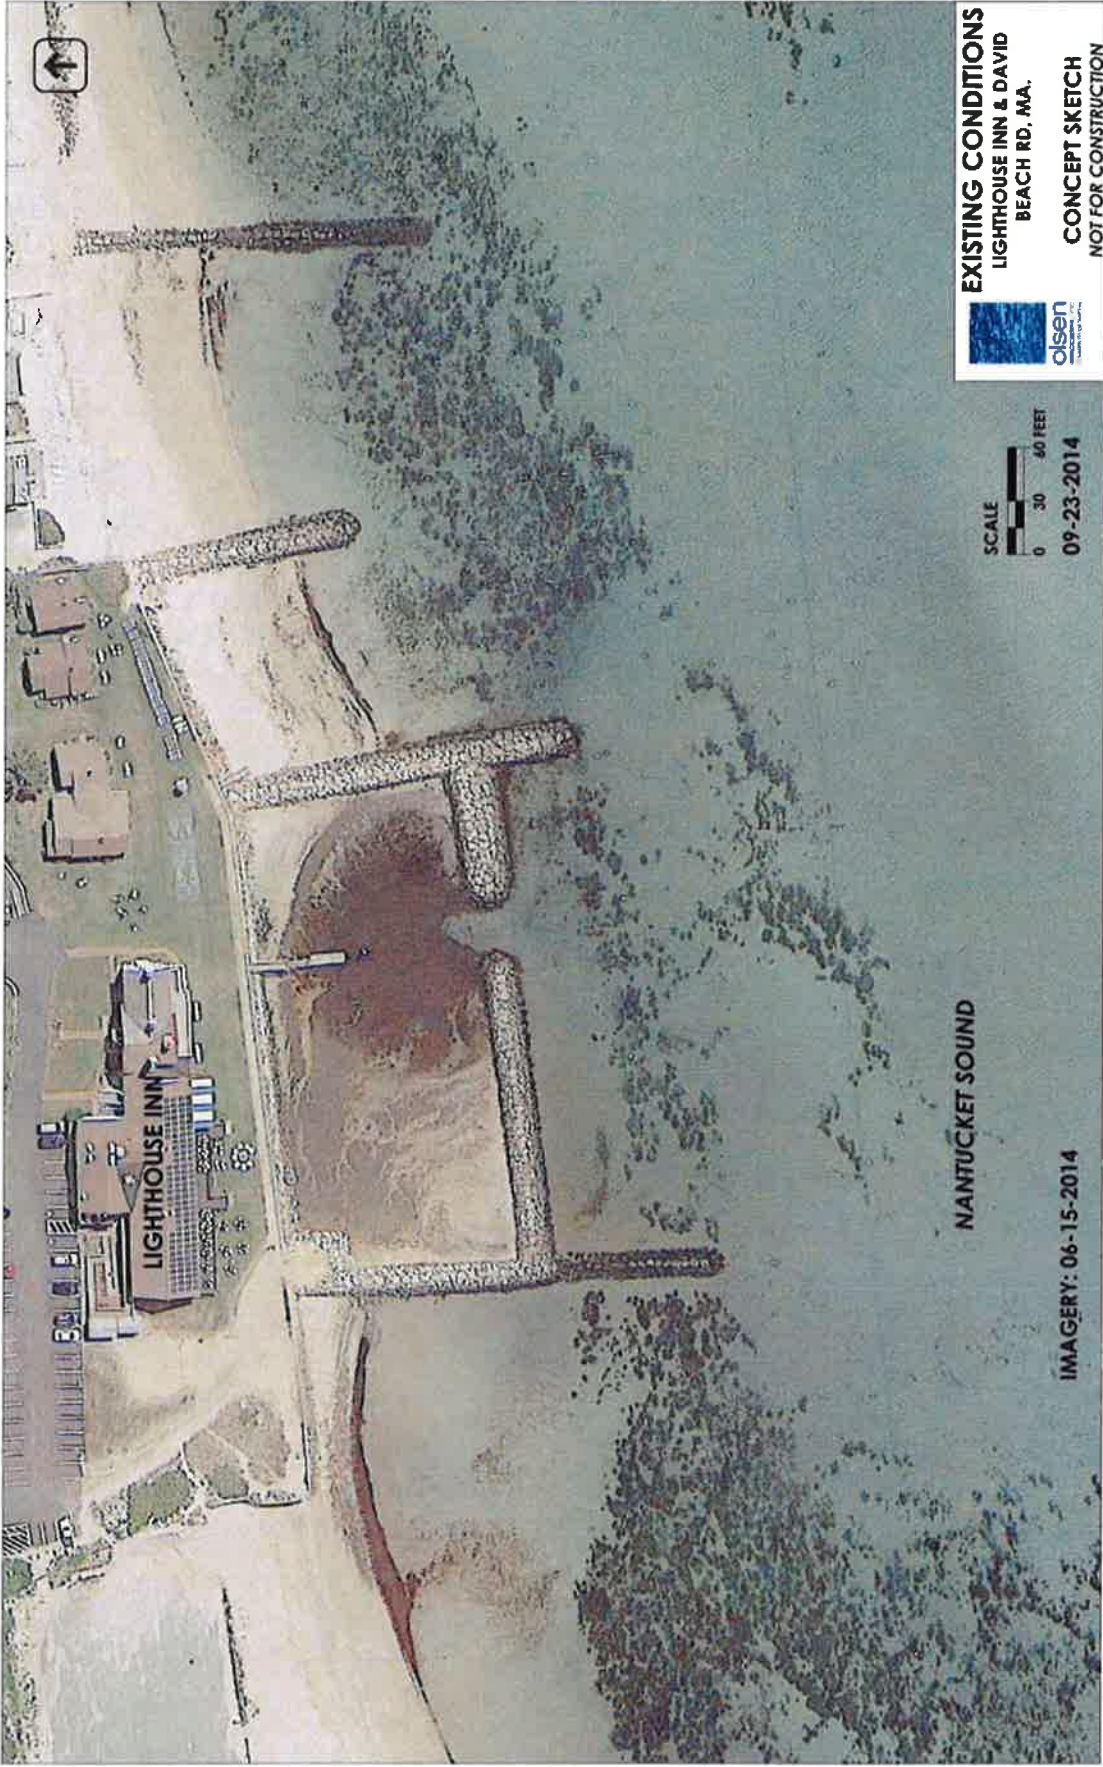
EXISTING CONDITIONS
LIGHTHOUSE INN & DAVID
BEACH RD., MA.
CONCEPT SKETCH
NOT FOR CONSTRUCTION
