Barnstable Ponds Report: Long Pond, Mystic Lake & Middle Pond

2022 Hydrilla Monitoring and Management Program

SOLITUDE
LAKE MANAGEMENT

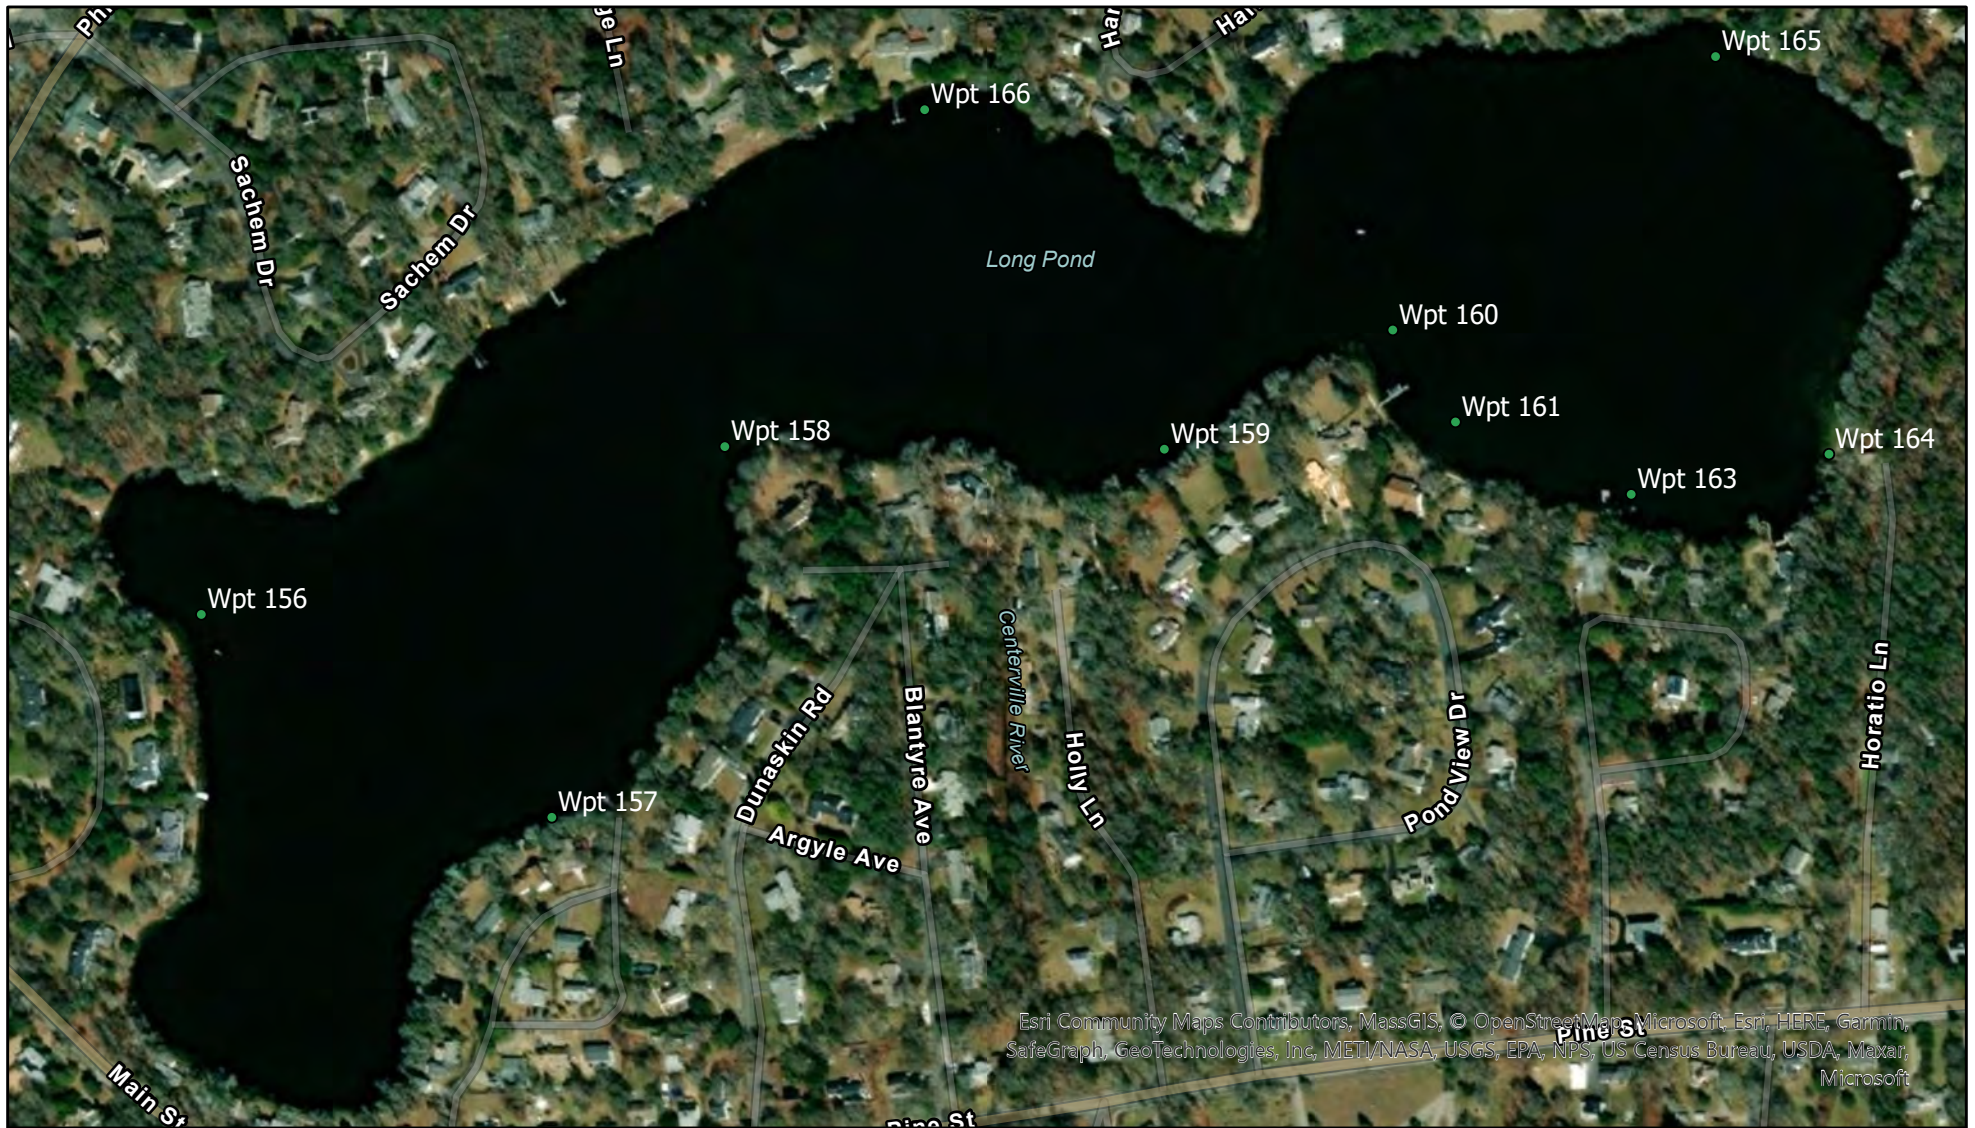
FIGURE 1: Tuber sampling locations
Long Pond

Late season tuber sampling was performed on the same day as the post-management survey. Table 2 lists the number of tubers collected at each tuber sampling site. Figure 1 shows the tuber sampling sites within Long Pond.

Point ID	2017 Total	2018 Total	2019 Total	2020 Total	2021 Total	2022 Total
156	Not present	Not present	Not present	Not present	Not present	Not present
157	Not present	Not present	Not present	Not present	Not present	Not present
158	Not present	Not present	Not present	10	Not present	Not present
159	Not present	Not present	Not present	1	Not present	Not present
160	Not present	Not present	Not present	15	8	92
161	Not present	Not present	Not present	4	Not present	6
163	Not present	Not present	Not present	18	5	Not present
164	Not present	Not present	Not present	Not present	3	Not present
165	Present	Present	Not present	Not present	1	14
166	Present	Present	Not present	Not present	Not present	53

These tuber quantities indicate an increase from prior years and suggestive of effective hydrilla propagation. The current dosing limitations coupled with recent program interruptions associated with cyanobacteria growth, have impaired the efficacy of the treatment program and its ability to prevent hydrilla reproduction. Fortunately the distribution of the tubers seems to be limited to just a few locations that have historically harbored some of the highest hydrilla abundance. Modifications to the treatment approach will be required in 2023 to ensure effective reproductive prevention.

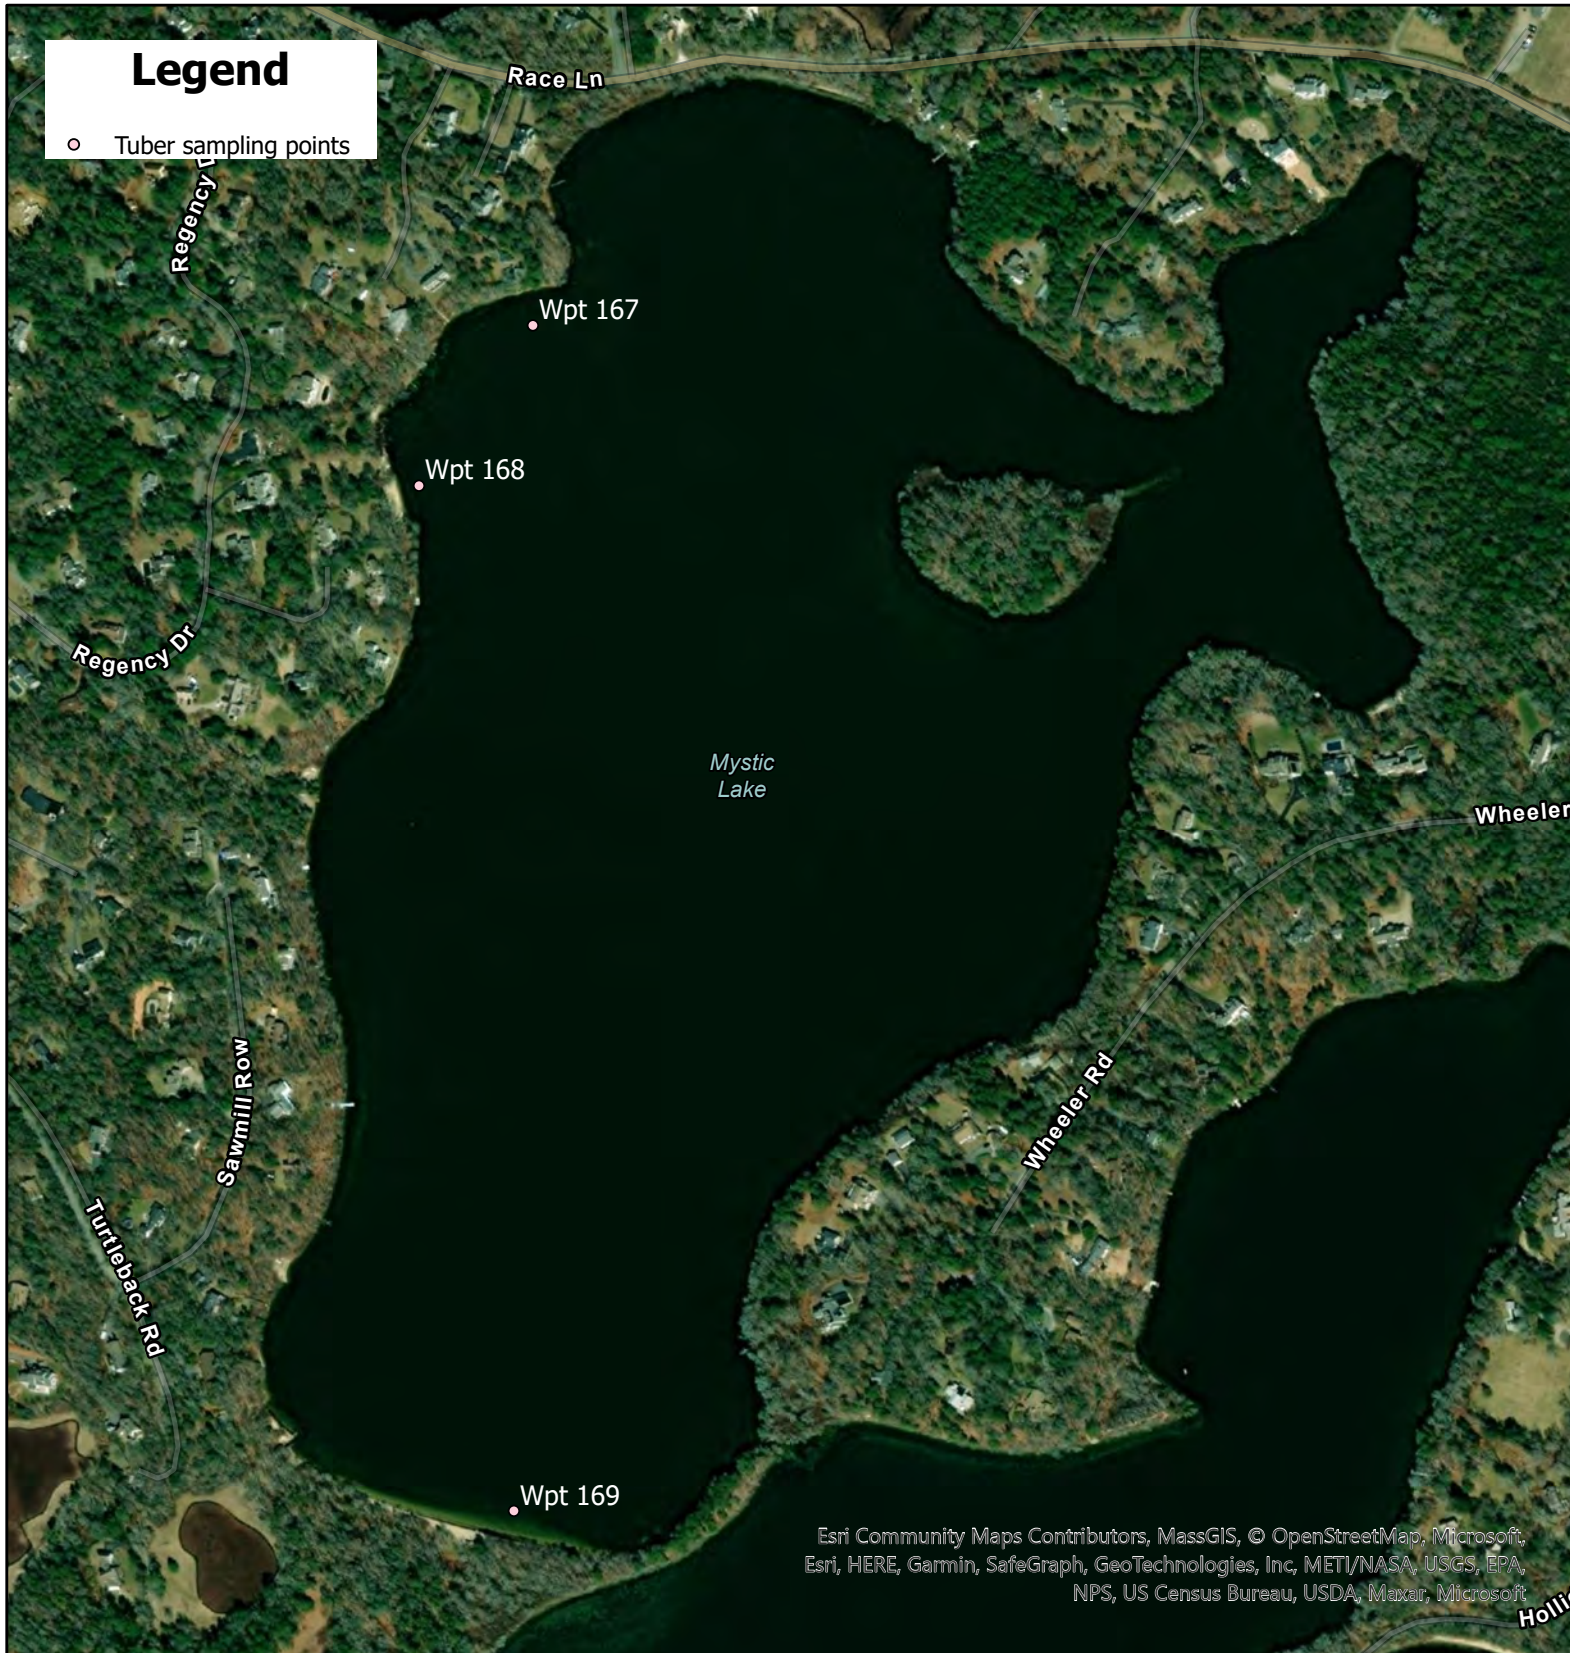
FIGURE 2: Tuber sampling locations
Mystic Lake/Middle Pond

During the survey, sparse tubers were collected. Native vegetation was similar to that found during the early-season survey, but growth was more abundant and higher in the water column than the July survey. See Figure 2 for tuber sampling sites within Mystic Lake and Middle Pond, and Figure 6 for late-season vegetation survey results.

Point ID	2017 Total	2018 Total	2019 Total	2020 Total	2021 Total	2022 Total
167	Not present	Not present	Not present	Not present	Not present	Not present
168	Not present	Not present	Not present	Not present	Not present	32
169	Not present	Not present	Not present	Not present	Not present	36

- Sparse hydrilla tubers were collected during the post-management survey.
- Benthic filamentous algae was prominent across both basins at the time of the late-season survey.
- Mystic Lake and Middle Pond native vegetation assemblages appear relatively unchanged.

While only sparse hydrilla tubers were documented in Mystic Lake, monitoring and treatment is still recommended. Hydrilla tubers are reproductive bodies that can remain dormant for 5+ years before sprouting. Given the limitations of the tuber sampling methodology, a lack of tubers does not necessarily indicate that these hydrilla reproductive bodies are not present in the pond system. There is a margin of error with sampling sites, as it cannot be expected to sample the exact same area of each point year after year. Based on our experiences over the years at Long Pond, Mystic Lake, and Middle Pond, it is likely that both tubers and active hydrilla growth can go undetected due to the size and scattered nature of this infestation. In order to maintain long-term control and prevent spread of hydrilla growth, we recommend continued monitoring and treatments.

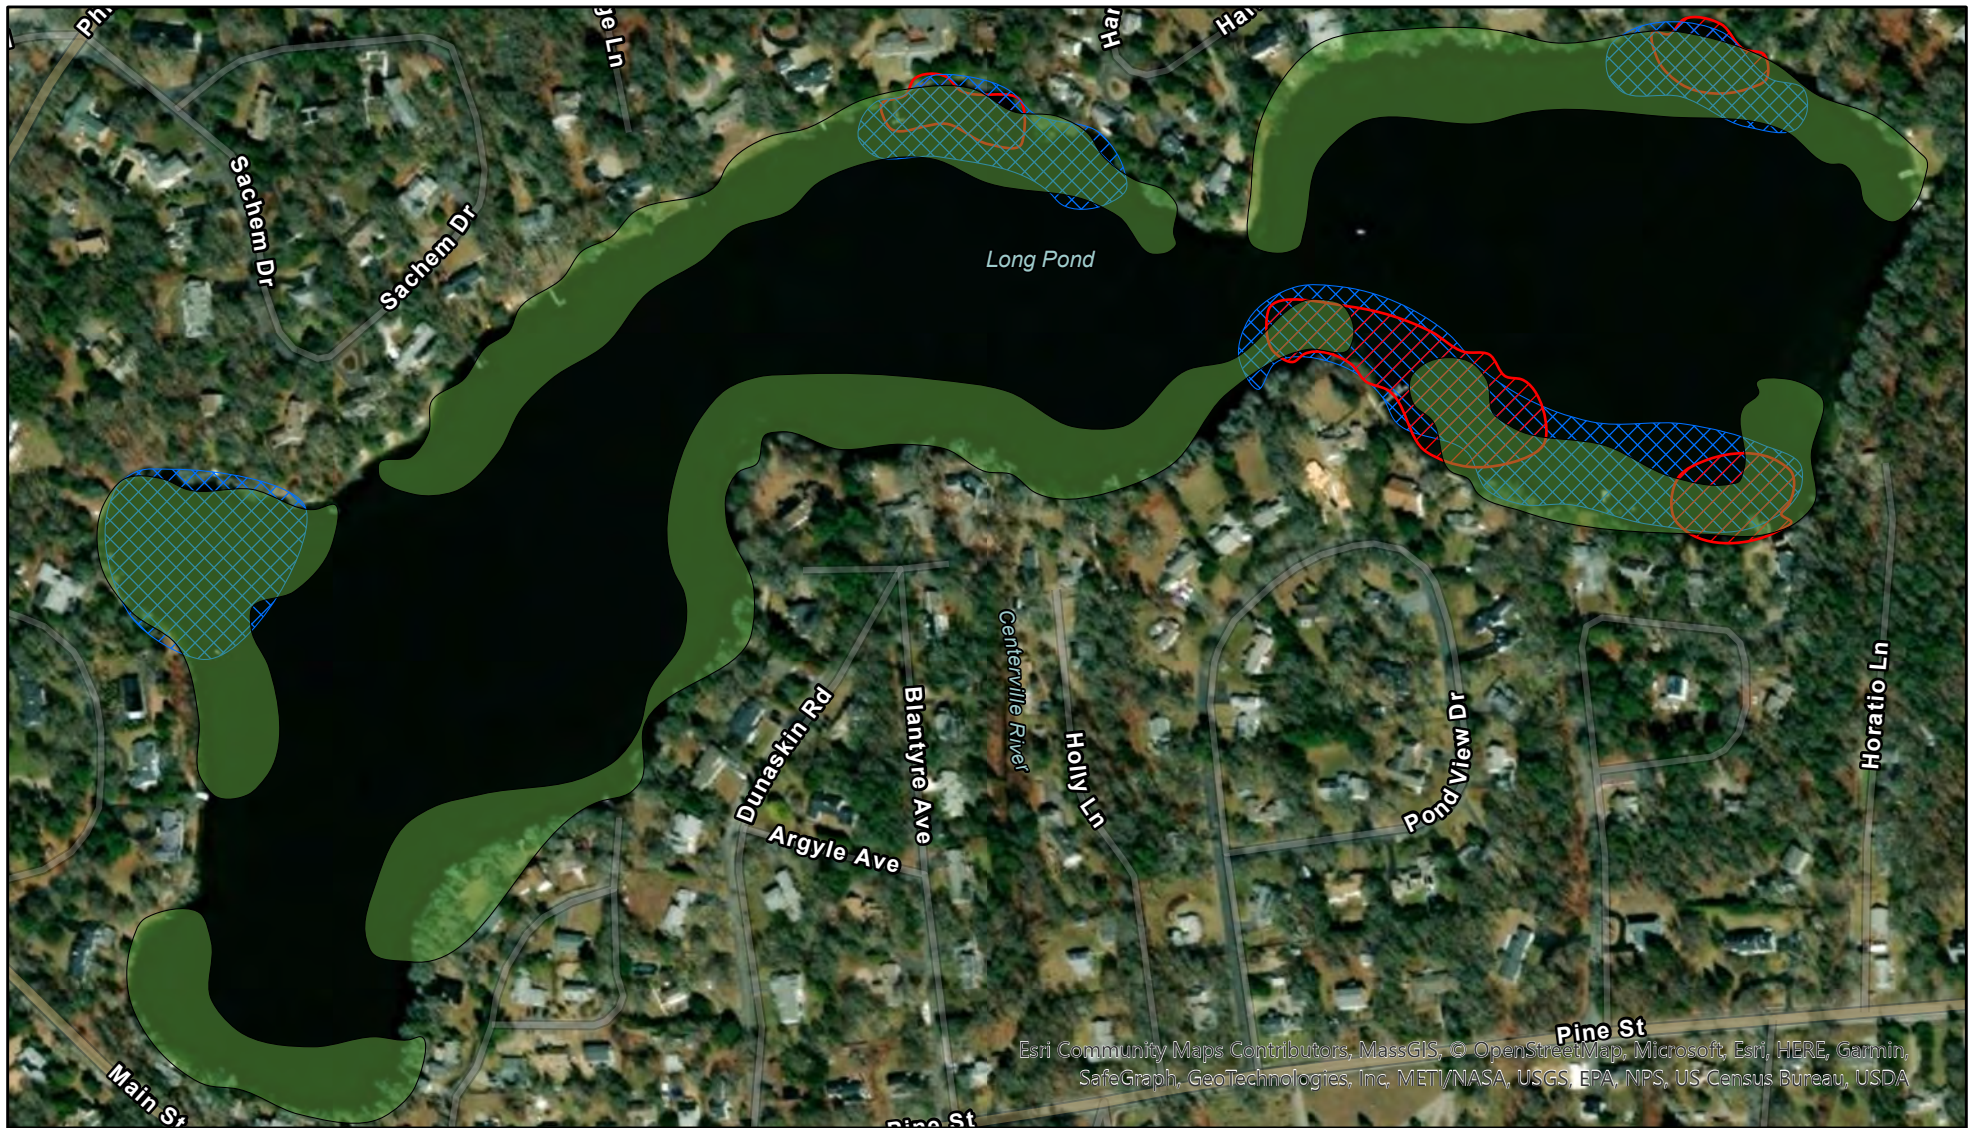
FIGURE 3: Early season vegetation survey
Long Pond

During the survey on July 7th, growth of hydrilla was not observed and tuber sampling was not performed. Clasping-leaf pondweed was the most prominent species throughout Long Pond, followed by several other pondweeds, bladderworts, and emergent, shallow water plants. The other species were only seen at sparse densities and were observed growing alongside the pondweed sections on the map (Figure 3). Filamentous algae was observed in several patches around the pond in clouds throughout the water column.

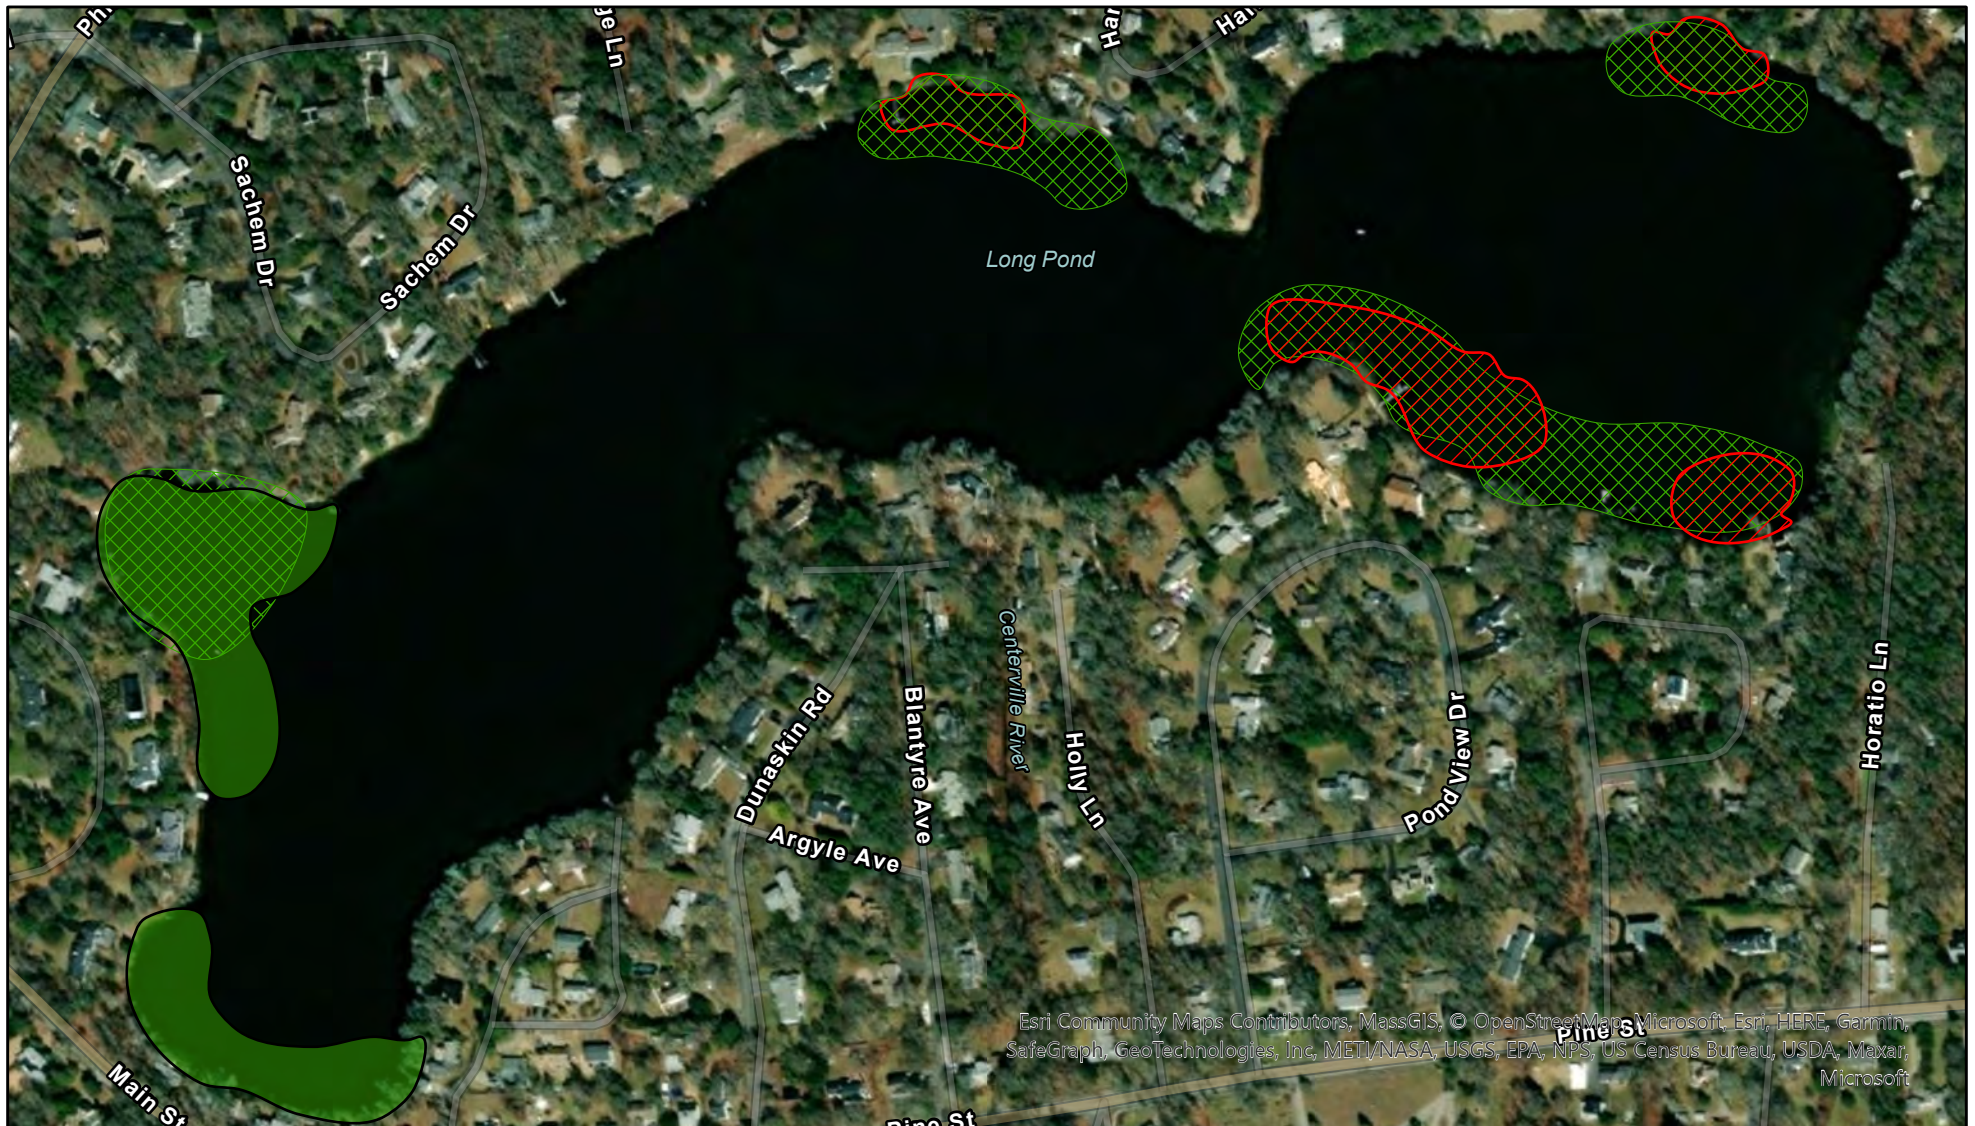
FIGURE 4: Late-season vegetation survey
Long Pond

Growth in the littoral zone was dominated by three native species: clasping-leaf, Robbins', and ribbon-leaf pondweeds. Clasping-leaf pondweed was the dominant plant during the October survey, while Robbins' and ribbon-leaf pondweed were only slightly less abundant. Much of the bottom of the pond was covered in patches of quill-leaved arrowhead. Filamentous algae mats were visible around the shoreline of the pond and throughout the water column. See Figure 4 for late-season native species distribution.
