ROAD SAFETY AUDIT

Route 28 between Bourne Rotary and Otis Rotary

Town of Bourne

April 2013

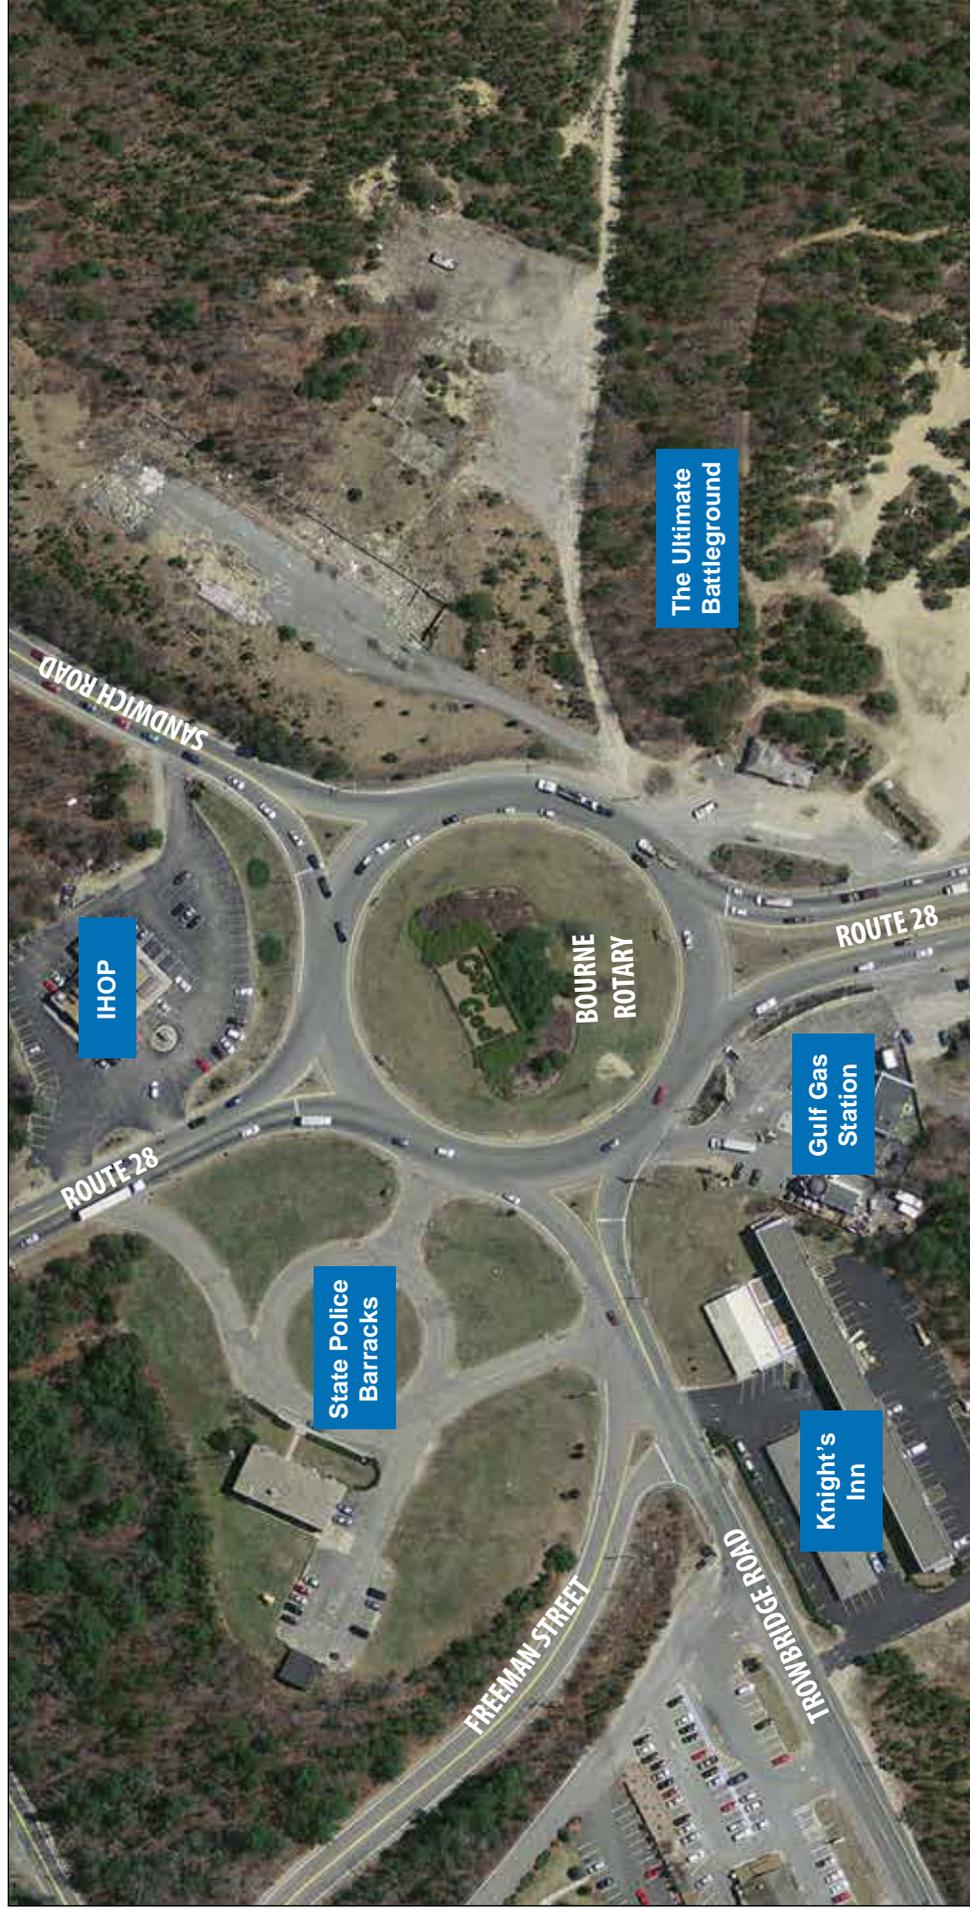
Figure 2. Bourne Rotary

The ***Bourne Rotary*** is a two-lane rotary with four approaches. The Trowbridge Road eastbound approach consists of one lane in each direction. The Route 28 northbound and southbound approaches each consist of two lanes in each direction; this allows vehicles to travel to and from the rotary onto Route 28 from the inside and outside lanes. The Sandwich Road westbound approach consists of one travel lane in each direction. In addition to the roadway approaches, three driveways also have direct access to the rotary. A Massachusetts State Police barracks driveway is located on the northwest corner of the rotary, between the Trowbridge Road eastbound and Route 28 southbound approaches; a dirt driveway accessing The Ultimate Battleground is located on the southeast corner of the rotary, just east of the Route 28 northbound approach; and two driveways for a Gulf gas station are located on the southwest corner of the rotary, just west of the Route 28 northbound approach. The speed limit is 25 mph within the Bourne Rotary. The rotary has an inner radius of approximately 150 feet. An aerial image of the Bourne Rotary is shown in **Figure 2**.

The RSA team noted that there is very little advance guide signage indicating the street names route numbers, and/or destinations of the available exits from the rotary. The only guide signage for exits to the rotary are within the rotary itself. This can create confusion, especially among drivers that are unfamiliar with the rotary, since motorists may not know when their exit is approaching until they read a sign located at the exit itself. There is no existing signage that indicates which lane a vehicle should be in if it is exiting the rotary or continuing to circulate. This lack of direction can cause angle crashes between vehicles exiting the rotary from the inside lane and vehicles remaining in the rotary in the outside lane. Twenty-nine crashes occurred between vehicles exiting the rotary onto Route 28 southbound from the inside lane and vehicles continuing around the rotary in the outside lane. Three similar crashes involved vehicles exiting to Sandwich Road, and one similar crash occurred involving a vehicle attempting to exit to Route 28 northbound occurred.

Team members also noted that some of the existing guide signage is too small to read, and that some motorists slow down unexpectedly to read guide signage.

RSA team members also noted that there are no pavement markings along the Trowbridge Road eastbound and Sandwich Road westbound approaches that indicate the intended number of travel lanes entering the rotary. Each is wide enough for two vehicles to stack at the entrance to the rotary; however, allowing multiple entrance lanes may cause confusion.

RSA team members noted that the decorative vegetation facing Route 28 southbound traffic entering the rotary, spelling out “Cape Cod”, may be distracting for motorists. It was also noted that the height of the vegetation behind the Cape Cod topiary in the center of the rotary may make it difficult for motorists to judge the speed of circulating traffic. However, team members said anecdotally that the number and severity of crashes through the rotary has dropped dramatically since the mound was built.

There are four driveways that allow direct access to the Bourne Rotary. The driveway to The Ultimate Battleground is not paved and does not have a defined edge. A team member stated that the driveway often floods, and water flows into the rotary. There are also two driveways that serve the Gulf gas station and the American Lobster Mart. Team members noted that the easternmost of the two driveways is located extremely close to the Route 28 southbound exit, causing confusion when vehicles exit the Gulf driveway. Eight crashes involved vehicles exiting the Gulf gas station into the rotary; six occurred at the easternmost of the two driveways.

RSA team members noted that vehicles often enter the Bourne Rotary from Route 28 at high speeds, which may contribute to motorist frustration within the rotary and interfere with vehicles being able to exit the rotary safely. It was noted that, since Route 28 traffic enters and exits as two lanes, vehicles entering from Sandwich Road or Trowbridge Road must compete with fast-moving Route 28 through traffic in order to navigate the rotary. A team member noted that Route 28 northbound traffic is not adequately deflected, and high travel speeds are able to be maintained through the rotary.

2. Remove the guide signage from the center island of the rotary.
3. Remove guide signage that is too small for circulating traffic to read. Replace with MUTCD-compliant signage if the signage is deemed necessary. Ensure that all guide signage visible from the rotary or the approaches to the rotary is useful and necessary.

4. Provide larger “Reduced Speed Ahead” signage (W3-5) along the Route 28 northbound approach to the rotary. Consider whether more gradually reducing the speed limit along the approach would reduce the number of rear-end crashes.

5. Continue enforcing speeding violations within the rotary and along approaches to the rotary.
6. As part of long-term planning efforts, consider the safety benefits of providing overhead signage to improve motorist visibility.

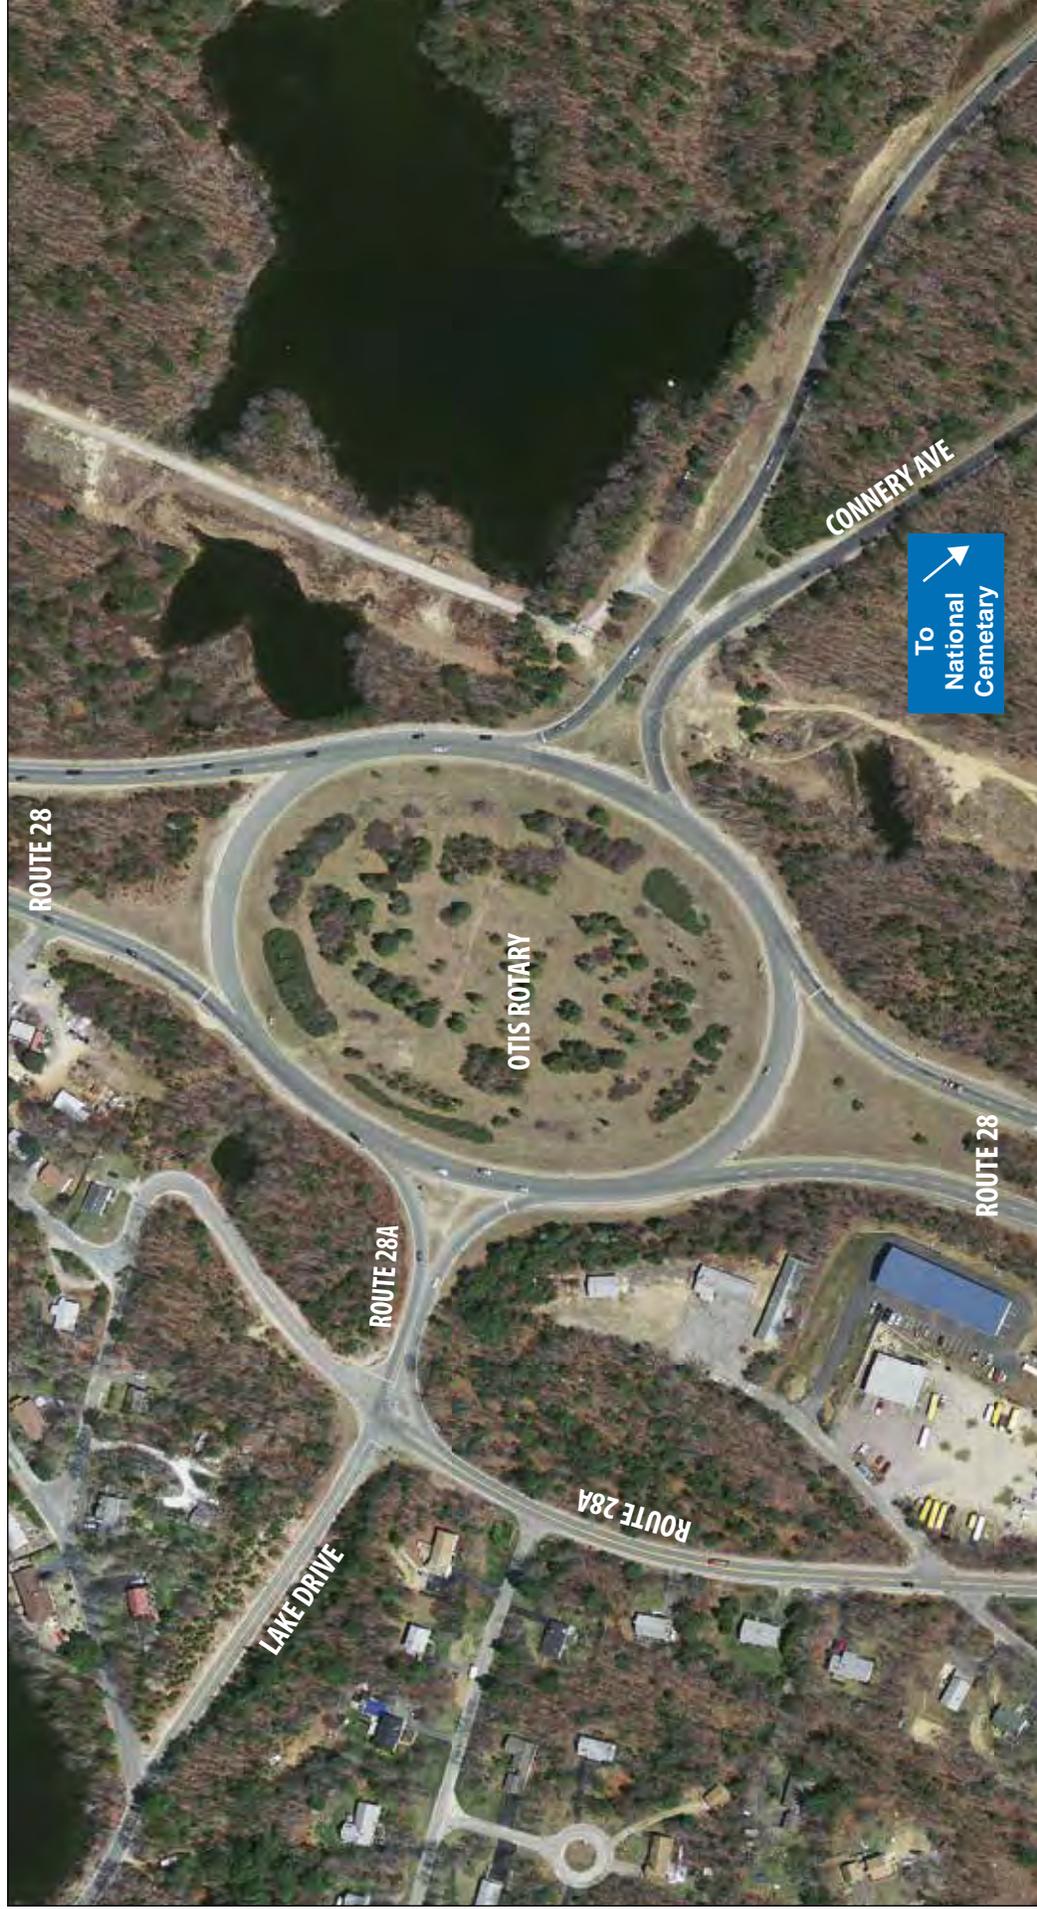
Figure 3. Otis Rotary

The ***Otis Rotary*** is an oval-shaped, two-lane rotary with four approaches. The Route 28A eastbound approach consists of one travel lane in each direction. The Connery Avenue westbound approach consists of one travel lane in each direction. The Route 28 northbound and southbound approaches each consist of two travel lanes in each direction, allowing vehicles to travel into and out of the rotary using both travel lanes. The diameter of the rotary is approximately 550 feet from east to west, but approximately 775 feet from north to south. This skewed geometry allows through traffic on Route 28 northbound or southbound to continue through the rotary along Route 28 without slowing down significantly. Public safety officials attending the RSA stated that vehicles often travel through the rotary at speeds that exceed the posted speed limit on the Route 28 mainline, which is generally 55 mph. The posted speed limit approaching the Otis Rotary is 25 miles per hour from Route 28 northbound and is 35 mph from Route 28 southbound. An aerial image of the Otis Rotary is shown in **Figure 3**.

RSA team members also noted that the sharp curve radius along the Connery Avenue exit from the rotary can be unexpected.

The sharp turning radii at the north and south ends of the Otis Rotary combined with tall vegetation in the center island of the rotary cause sight distance limitations, particularly at the Route 28A eastbound approach to the rotary. Twelve rear-end crashes were reported on this approach. At least six of these crashes occurred because a queued vehicle assumed the vehicle they were following had already entered the rotary.

RSA team members noted that the area between the Route 28 northbound approach and Connery Avenue is susceptible to flooding. One out-of-control crash was reported in the area that occurred on wet pavement conditions.

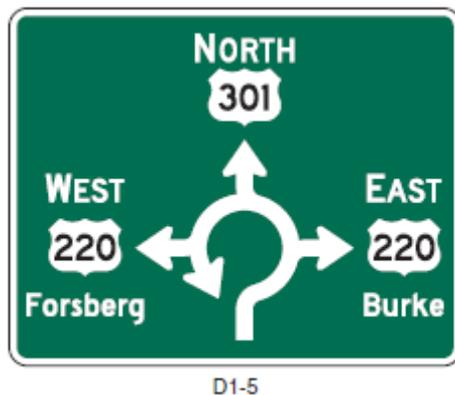
A diagrammatic guide sign shows each exit within the rotary before a vehicle enters the rotary (Source: MUTCD).
