TOWN OF TRURO

- Town Map
- Chart of Site Characteristics
- Sites 1 to 7

Location of Selected Salt Marsh Restrictions

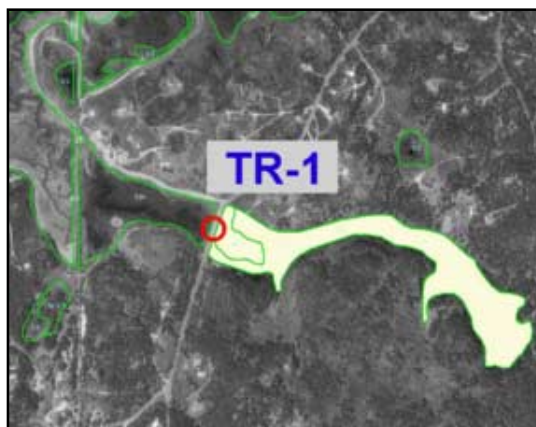
Site TR-1

Eagle Neck Creek flows under Old County Road via a 2-foot corrugated plastic pipe. The pipe was only visible on the upstream side of the road and is in need of immediate repair – rocks are visibly clogging the opening. Eagle Neck Creek is connected to tidal flow in Cape Cod Bay through Pamet Harbor. An abandoned, breached railroad bed running through the Harbor and its surrounding marshes lies seaward of this crossing. Storm tides eroded the bed that was partially breached in the late 1980s and finally by the no-name storm in 1990. While Eagle Neck Creek itself does not appear to support shellfish resource areas, Pamet Harbor supports areas that are open seasonally to shellfishing. The upstream affected area of this site is within the Cape Cod National Seashore.

Upstream Affected Area (acres): SS – 14.47; M – 1.72.

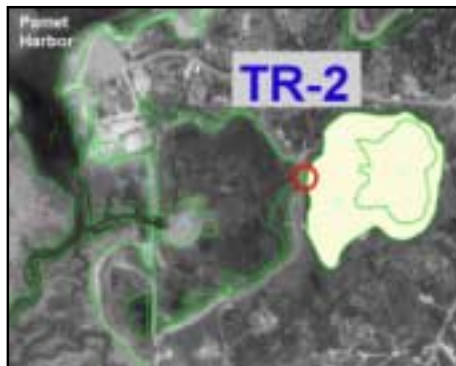
Upstream Affected Area (acres): SS – 8.35; M – 4.78.

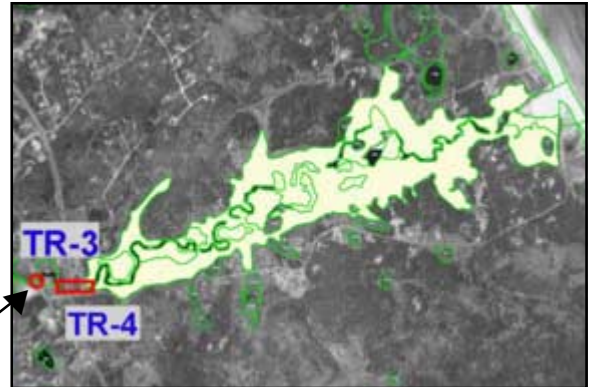
Site TR-3

Upstream Affected Area (acres): SS – 119.72; M – 32.66.

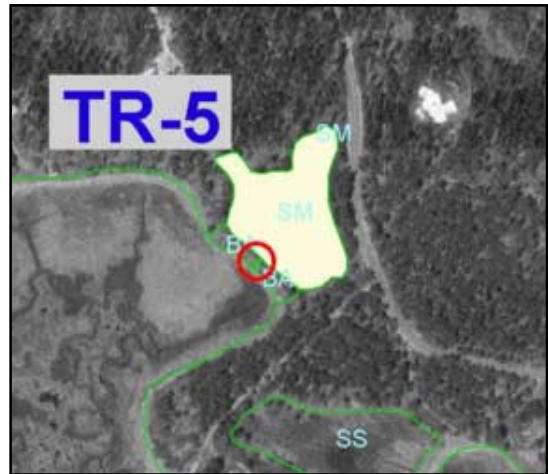
The channel seaward of the restriction varies between approximately 5 and 15 feet. Upstream of the berm it dramatically shrinks to about 2 feet. Visual indicators of a restriction on the seaward side include major scouring and erosion, and significant vegetation die off. Upstream of the berm scouring is reduced, likely due to a lack of flow. However, major back erosion has occurred. There is no *Phragmites* present in the upstream affected area.

- Restriction width – 10 inches
- Restriction length – 35 feet
- Upstream salt marsh – 1.55 acres

Upstream Affected Area (acres): SM – 1.55.

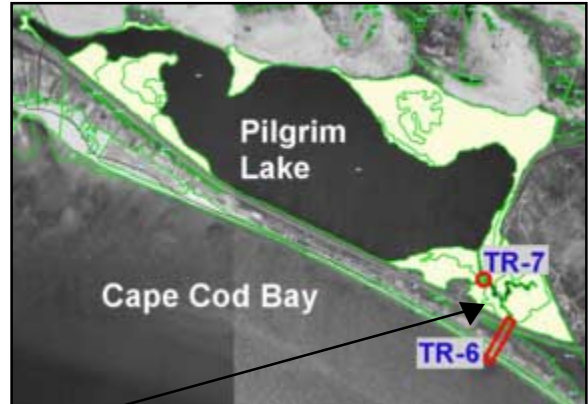
Site TR-7

A small channel located at the southeast corner of Pilgrim Lake is the lake's only tidal connection to Cape Cod Bay. This channel and its flow are controlled by various engineering structures that serve as the lake's present water control system. There are two restriction sites between the Bay and lake. The seaward site, site TR-6, consists of a culvert with two clapper valves (located in linear series) that extends along Beach Point from Cape Cod Bay under Route 6A and Route 6. Upstream site TR-7 has a weir and box culvert constructed under High Head Road. Upstream of Pilgrim Lake are two further restrictions that affect flow into Salt Meadow/Head of the Meadow (see Appendix B, sites TR-d and TR-e). Pilgrim Lake suffers from eutrophication, and does not support any known shellfish resources. Anadromous fish use Pilgrim Lake. The lake and all upstream affected areas are within the Cape Cod National Seashore, but Truro owns and manages the channel.

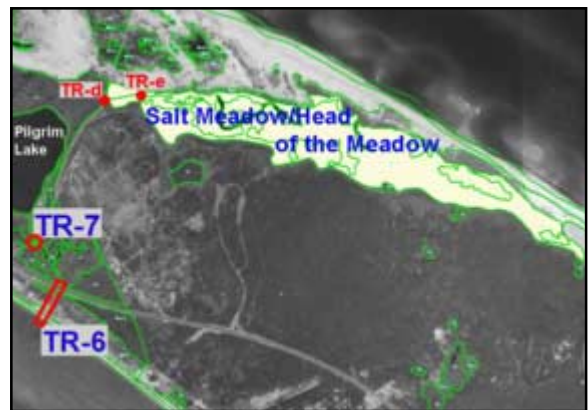
From the northeast corner of Pilgrim Lake a channel flows into a wetland area known as Salt Meadow, or Head of the Meadow. As was the lake, this wetland area was historically connected to tidal flow in Cape Cod Bay and was a vast intertidal salt marsh system. However, today it is comprised of 94.52 acres of shrub swamp and 50.94 acres of shallow marsh. Salt Meadow is severed by infrastructure in two places – first by the extension of High Head Road that serves as a jeep trail to the beach, and second by a dike lying to the east of the jeep trail (see Appendix B, sites TR-d and TR-e). These culverts were not accessible during fieldwork. According to the Cape Cod National Seashore, if tidal flow was restored the Pilgrim Lake system would realize most of its intertidal wetland benefits in the Salt Meadow area. Therefore, these two infrastructure crossings (identified in the image below) should be included in any remediation discussions.

Salt Meadow/Head of the Meadow Upstream Affected Area (acres): SS – 94.52; M – 50.94.
