TOWN OF WELLFLEET

Town of Wellfleet – Site Characteristics

WELLFLEET

Route 6 restriction of Fresh Brook

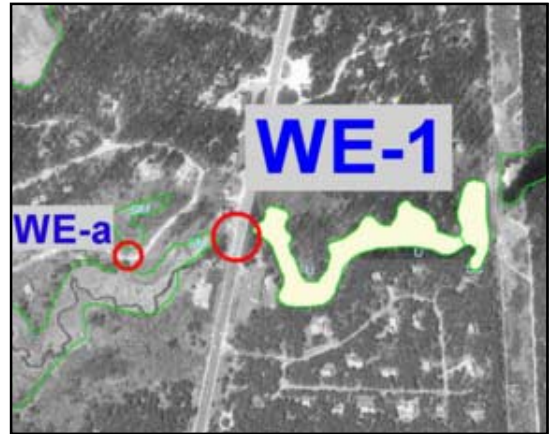
Site WE-1

Fresh Brook flows in a westerly direction from east of Route 6 and discharges into Wellfleet Harbor. Fresh Brook travels under Route 6 for approximately 120 feet via a 2-foot (approximate) pipe set under a stone head-wall. This culvert is in poor condition. The seaward opening was submerged in murky water during a low, outgoing tide cycle and obscured by a significant volume of trash and debris that collected at the Route 6 berm. Fresh Brook does support shellfish resource areas but does not act as an anadromous fish pathway. The boundary of the Wellfleet Harbor Area of Critical Environmental Concern runs parallel to Route 6 at this site and does not incorporate it or its upstream affected area.

Seaward of Route 6, Fresh Brook is approximately 20 feet wide, narrowing upstream to approximately 5 to 10 feet. The Wetlands Conservancy Program delineated salt marsh adjacent to the seaward side of the culvert, however within 15 yards of the Route 6 berm the vegetation observed was mainly forest-like. Upstream of the berm, shallow marsh and shrub swamp were delineated. Other visual indicators of restriction include minor scouring and major erosion both seaward and upstream of Route 6. *Phragmites* was not present on the seaward side, however once the upstream channel passes through a forested section it opens into an area with extensive *Phragmites* growth.

Upstream of this site Fresh Brook passes under the Cape Cod Rail Trail. (The railroad right-of-way is visible to the left of the highlighted affected area in the GIS image above/to the right.) According to the Cape Cod National Seashore, the brook passes under the Rail Trail via an 8-inch culvert that is reportedly collapsed, resulting in the development of a freshwater wetland system upstream of the railroad bed. Work on this culvert will not be undertaken until the blockage of Fresh Brook by the restricted Route 6 culvert is addressed.

Upstream Affected Area (acres): SS – 0.87; M – 3.07.

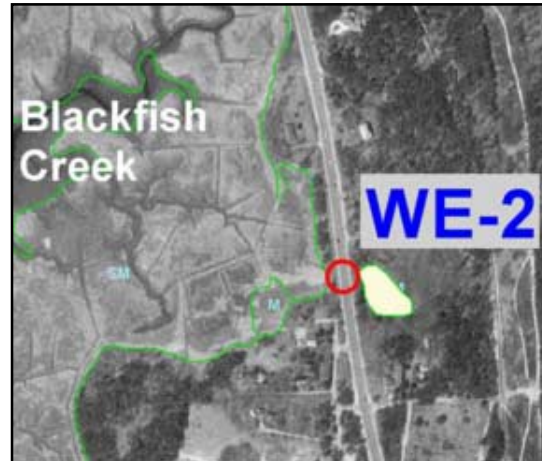
Site WE-2

South of Blackfish Creek and to the west of Route 6 lies an extensive salt marsh known as the Blackfish Creek Marshes. One channel traverses this marsh area to the south of Blackfish Creek and passes under Route 6 via a 2-foot concrete culvert. This restricted culvert is submerged at mean high tide and appears to be in good condition. While it does not appear to be broken, it is visibly clogged by sand and debris. Blackfish Creek, with which this unnamed channel shares its discharge area, supports productive shellfish resources and is not believed to be an active anadromous fishway. The boundary of the Wellfleet Harbor Area of Critical Environmental Concern runs parallel to Route 6 at this site and does not incorporate it or its upstream affected area.

The seaward channel is approximately 2 feet wide, narrowing to approximately 1-foot upstream. Flow appeared to be minimal in both channels. A large sand bar has formed near the upstream culvert opening. Visual indicators of restriction include minor scouring both seaward and upstream and a minor amount of vegetation die off along the seaward channel banks. The Wetlands Conservancy Program delineated salt marsh adjacent to the seaward side of Route 6 and 0.55 acres of salt marsh upstream. There was no *Phragmites* observed in the upstream affected area, however a minor amount was visible along the edge of the marsh lying seaward of Route 6.

Upstream Affected Area (acres): SM – 0.55.

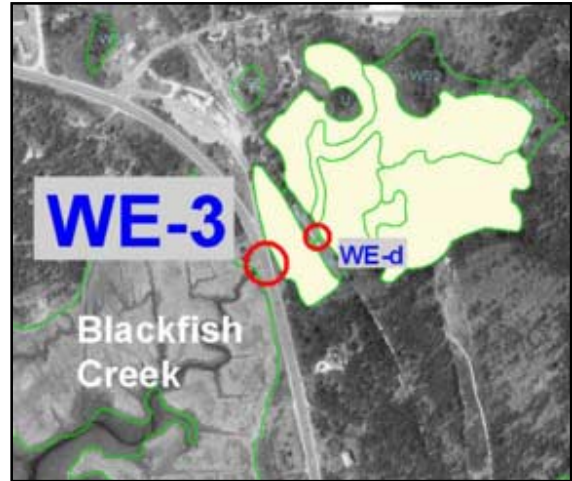
Site WE-3

The seaward channel is approximately 15 to 25 feet wide, narrowing upstream to approximately 5 to 10 feet. This site is severely degraded and visual indicators of a restriction were numerous. On both sides of Route 6 scouring, erosion, and vegetation die off are major. Marsh slumping is major on the seaward side and minor within the upstream affected area. There was no *Phragmites* observed. 4.16 acres of salt marsh lie upstream of this site, with 1.96 acres found between Route 6 and upstream site WE-d and 2.20 acres upstream of site WE-d.

Upstream Affected Area (acres): SM – 4.16; SS – 8.14; M – 5.03.

Under the present conditions at site WE-3, upstream site WE-d is not considered tidally restrictive of salt marsh (see Appendix B) because it is adequately sized to pass the quantity of tidal flow that reaches it. Should work to improve tidal flow through site WE-3 ever be undertaken, then the size of the opening of WE-d should be reevaluated. It is likely that the two, 4-foot culverts that are in place would be adequate.

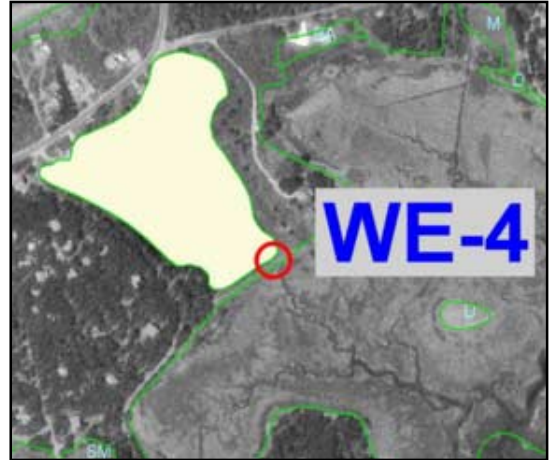
The Indian Neck Marshes lie to the south of Pilgrim Spring Road and to the east of Indian Neck. At the northern side of that marsh area an earthen dike segregates 6.69 acres of shrub swamp from the extensive salt marsh on the dike's seaward side. This site and its upstream affected area are within the Wellfleet Harbor Area of Critical Environmental Concern. Tidal flow passes under the dike via a 1-foot diameter corrugated metal pipe, which is in fair condition. A segment of pipe on the seaward side, which was exposed through erosion, has broken off and a large piece sits in the channel bed. Visual indicators suggest that the seaward opening is submerged at mean high tide. The upstream side appears to have a culvert invert problem, which would limit tidal flushing. The dike itself is severely eroding. Shellfish resources are present in the Indian Neck Marshes.

Both the seaward and upstream channels are approximately 2 feet wide. Visual indicators of restriction include significant scouring and erosion both seaward and upstream of the dike, with conditions slightly more degraded on the upstream side. The vegetation change is dramatic when crossing the dike – changing from seaward salt marsh to upstream shrub swamp with significant *Phragmites* growth.

Upstream Affected Area (acres): SS – 6.69.

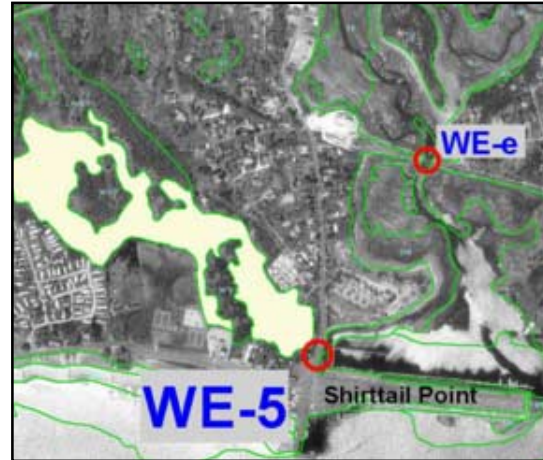
The upstream affected area, as defined by this Atlas, totals 19.33 acres of shallow marsh. Note however that the affected floodplain extends upstream of Chequessett Neck Road onto Wellfleet Conservation Trust land.

Upstream Affected Area (acres): M – 19.33.

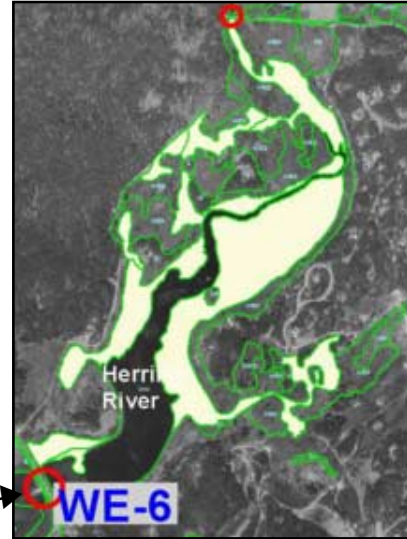
In 1908 a dike, now supporting Chequessett Neck Road, was constructed across the entrance to the Herring River and its associated marsh system. Three box culverts measuring 6, 7, and 7 feet wide, were placed to enable limited salt and fresh water exchange between the river and harbor. The two 7-foot culverts have flapper-type tidal gates and the 6-foot culvert supports an adjustable sluice gate. Historically, the Herring River and its upstream river systems were directly connected to tidal flow in Cape Cod Bay at both Duck Harbor and Bound Brook by Ryder Beach. The barrier beaches between these rivers and the Bay have since closed off and eliminated those estuaries, leaving the only option for a tidal connection at the Chequessett Neck Road dike. The Herring River and Wellfleet Harbor support vast shellfish resource areas. The Herring River is an active anadromous fishway. Both the river and its associated marsh system are located within the Wellfleet Harbor Area of Critical Environmental Concern.

This image shows the upstream affected area (as it is defined for this Atlas) between Chequessett Neck Road and High Toss Road. Note that the total affected area is approximately 1000 acres. Upstream Affected Area (acres): SM – 0.81; SS – 57.71; M – 7.07.²

Restoration of the Herring River’s natural free-flowing system has been discussed for years. The most recent study done on this system concluded that, “[r]estoration of pre-existing conditions in Herring River, defined as similar tidal ranges up and downstream of the dike, will require increasing the width of the opening to at least 30 meters.”⁵ According to the National Seashore, a 30-meter opening could equate to approximately 600 acres of potentially restored area.
