ROAD SAFETY AUDIT

Iyannough Road (Route 28) at Yarmouth Road

Town of Barnstable

September 2012

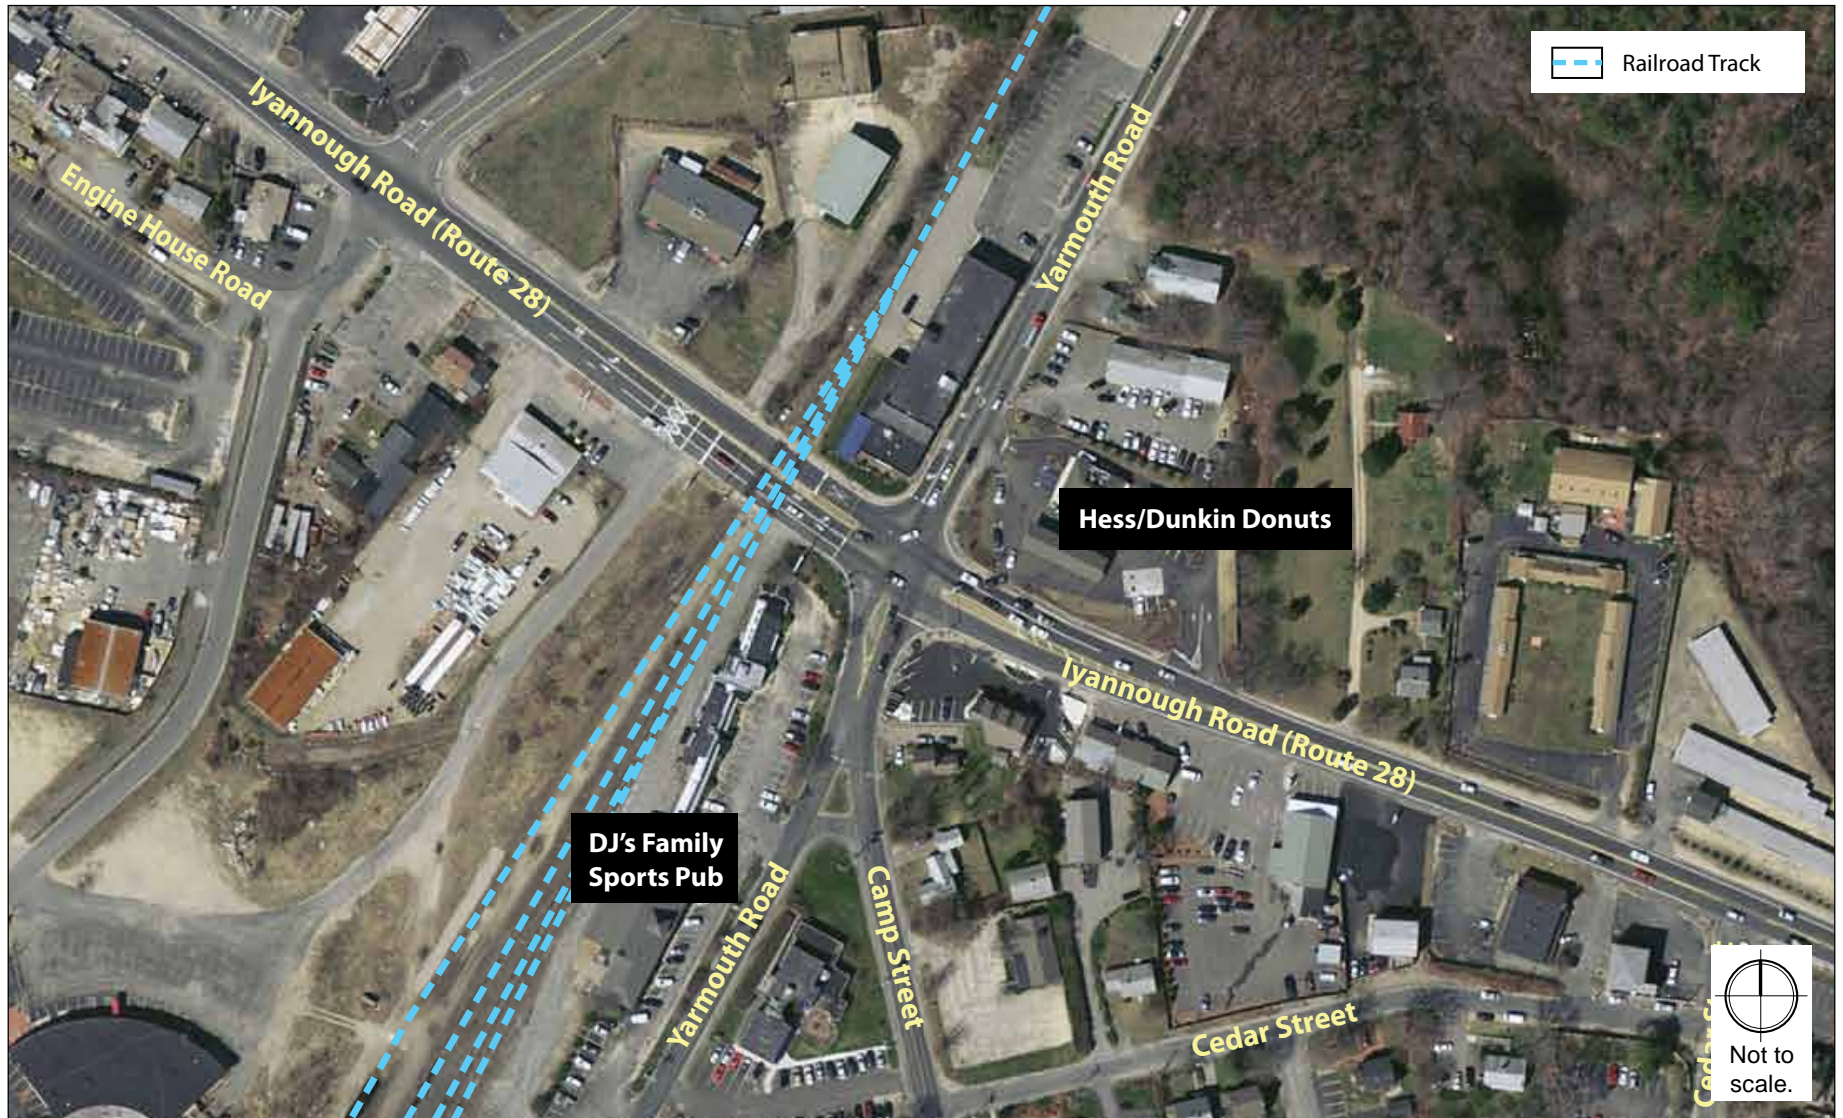
Figure 2. Iyannough Road (Route 28)/Yarmouth Road

Vehicles were also observed taking lefts onto Yarmouth Road southbound from Camp Street northwest-bound via the slip lane. There are no signage or pavement markings to show the intended use of the slip lane; it is unclear as to whether this lane is intended for right turns from Yarmouth Road northbound onto Camp Street southeast-bound, or for access to DJ's Family Sports Pub and access to Yarmouth Street southbound from Camp Street northwest-bound. Sidewalks are provided along both sides of Camp Street and along the east side of Yarmouth Road south of Camp Street. Crosswalks, pedestrian ramps, and bicycle accommodations are not provided.
