# Wellfleet: Route 6 Safety Study

December 2012

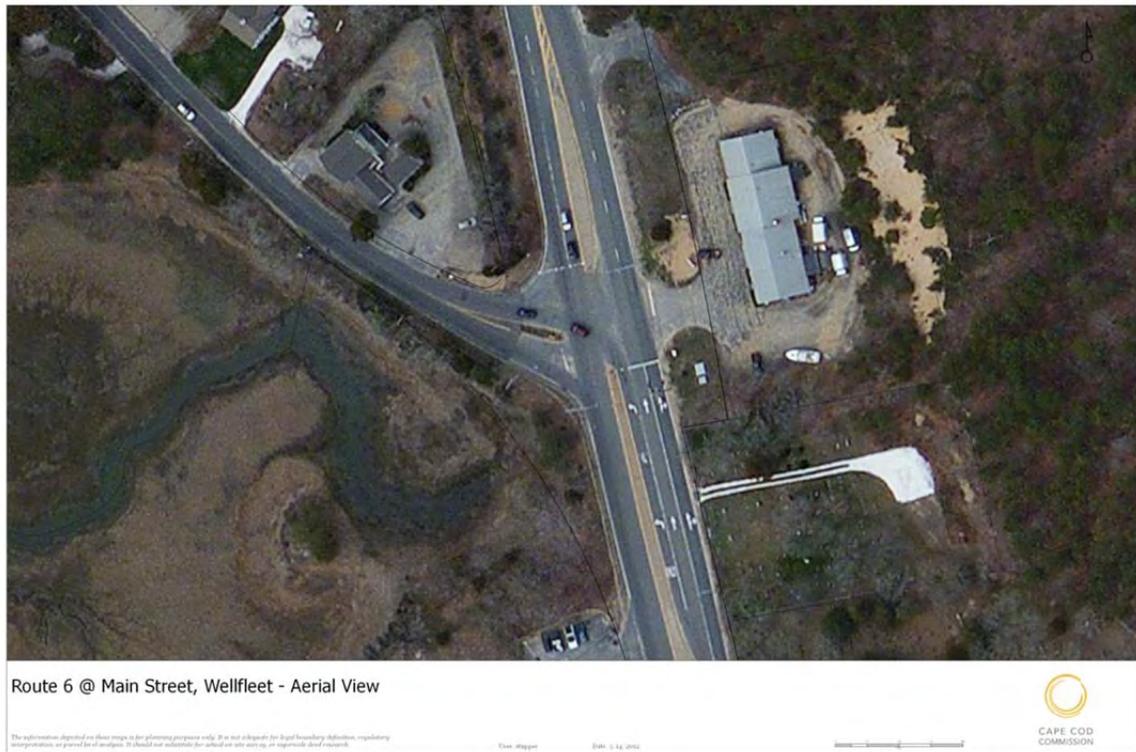
FIGURE 2 - ROUTE 6 AT MAIN STREET

Wellfleet's Main Street intersects with Route 6 from the west forming a four-way signalized intersection (the eastern approach to the intersection serves a commercial property). An aerial view of the intersection is shown in the figure below.

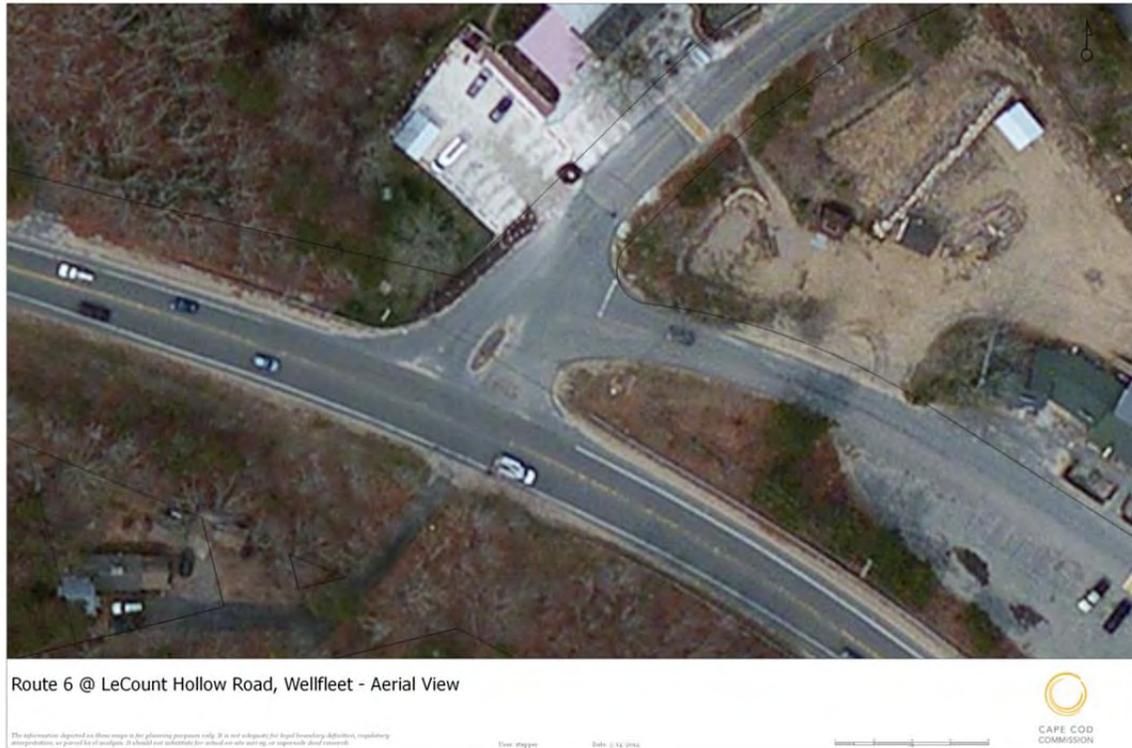
FIGURE 4 - ROUTE 6 AT LECOUNT HOLLOW ROAD

LeCount Hollow Road provides access to an adjacent commercial area just to the northeast of a curve in Route 6, as well as to residential areas, Atlantic beaches, and the Cape Cod Rail Trail. An aerial view of the intersection is shown in the figure below.

There were four (property damage only) crashes recorded at the intersection for the years 2009-2011. All four related to vehicles turning into or out of LeCount Hollow Road with vehicles traveling northbound to the south on the southern approach of Route 6.

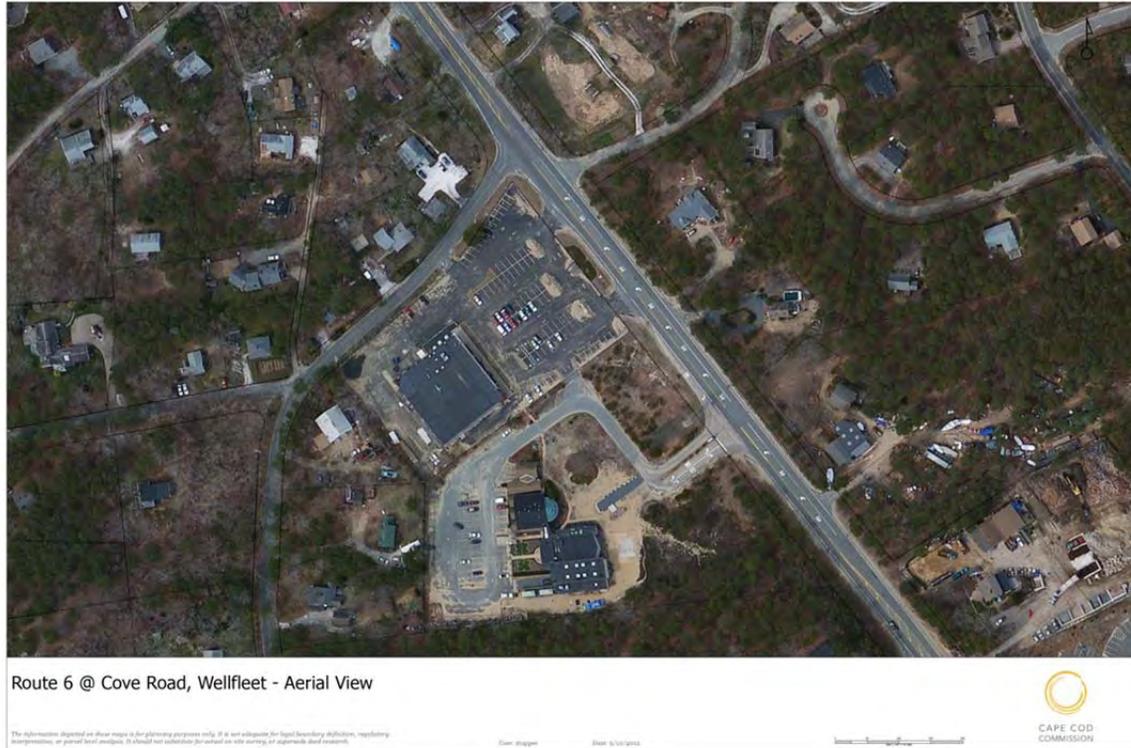
FIGURE 9 - ROUTE 6 AT COVE ROAD

Cove Road provides access to an adjacent commercial area to the west Route 6, as well as to residential areas. An aerial view of the intersection is shown in the figure below.

There were six crashes (all property damage only) recorded for the vicinity of the intersection for the years 2009-2011. None of these crashes were recorded directly at the intersection. Three of the crashes included rear-end collisions of northbound Route 6 vehicles. The remaining three correspond to crashes of vehicles accessing the commercial area to the south of Cove Road with through vehicles on Route 6.

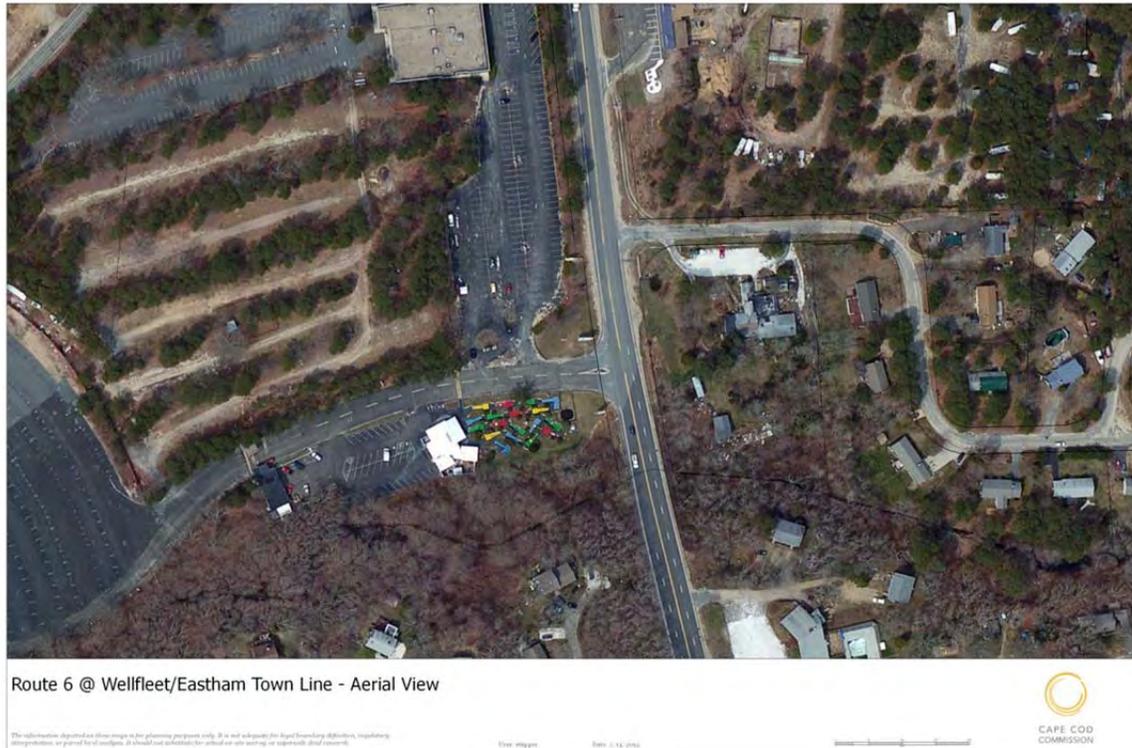
FIGURE 14 - ROUTE 6 AT EASTHAM TOWN LINE

The merge of Route 6 from four to two lanes is shown in the figure below as the north-south (center of photo from top to bottom). The driveway serving the Wellfleet Drive-In is shown to the left near the center of the picture.
